ROOT DOWN CONSULTANTS

ARBORIST REPORT

PROJECT SITE LOCATION: 30xx 69th Ave SE, Parcel 509330-1316
Mercer Island, WA

DATE: April 10, 2020 - REVISED December 2, 2023

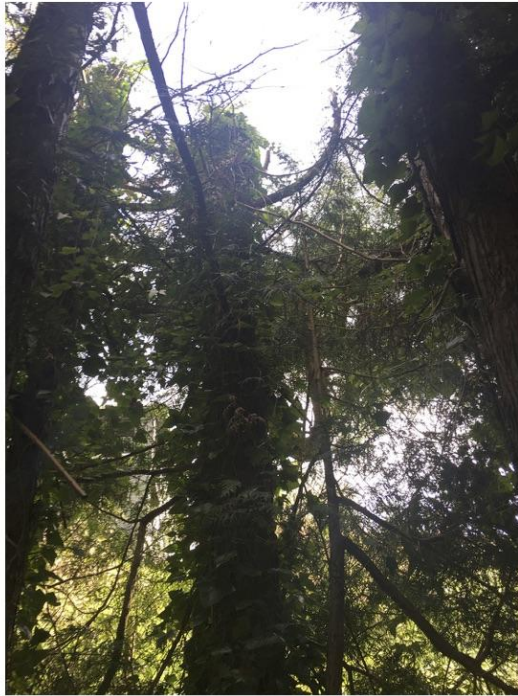
Tree #12 - Western Red Cedar - Topped Leader

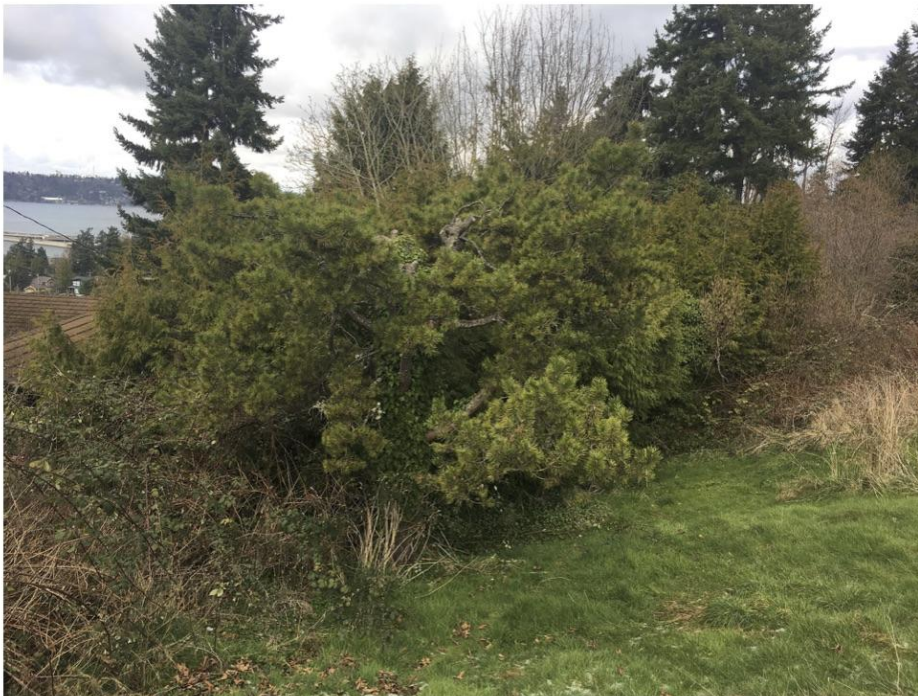
- Tree # 13 (17" dbh Shore Pine) is in a general poor condition due to structural defects from topping and is not viable for retention due to increased risk of failure and decreased longevity.

Tree #13 - Shore Pine - Topped Leader

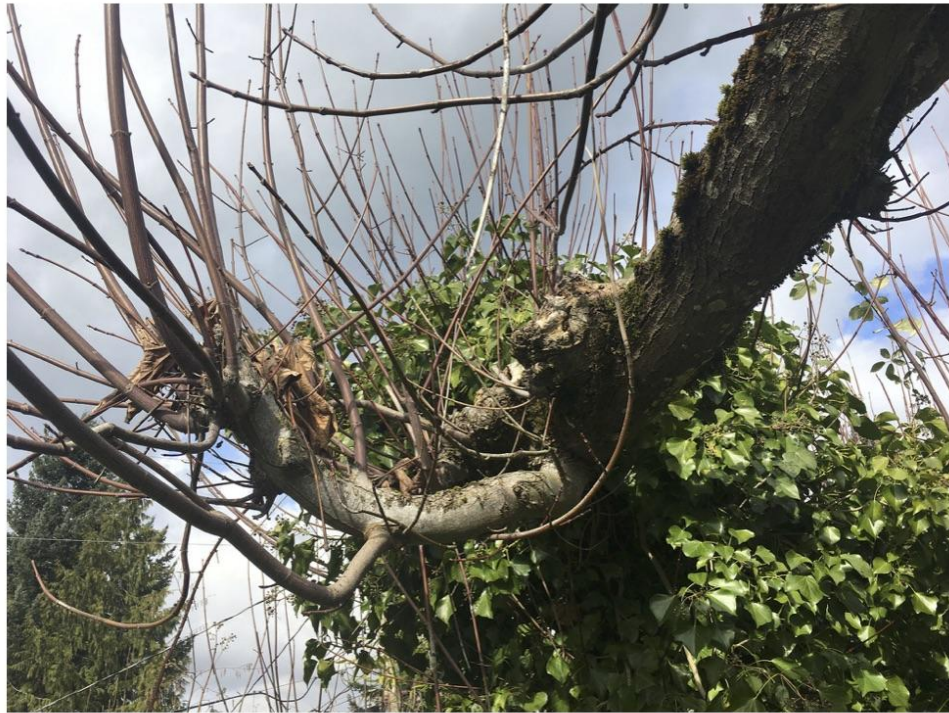
- Tree #14 (35" dbh, Bigleaf Maple) is in poor condition and would not be viable for retention due to severe topping of central leader and will have a high risk of failure due to structural defects.

Tree #14 - Big Leaf Maple - Topped Leader

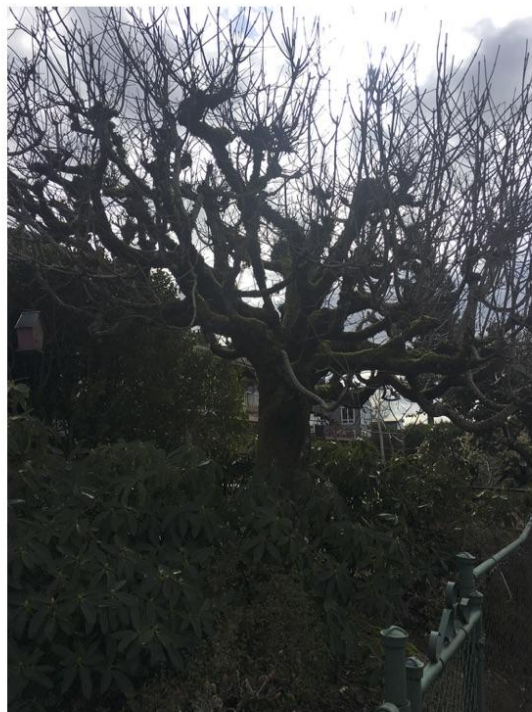
- Tree #16 (17" dbh Japanese Maple) as a root zone encroachment of approximately 25% of the overall tree protection zone (TPZ). The encroachment falls within the minimum limits of disturbance (MLOD) and in my professional opinion it will not be significantly impacted by this intrusion that would jeopardize the long-term viability of the tree.

Tree #16 - Japanese Maple - Topped Crown
