## Arborist Report

**Title:** Mastan Redevelopment Project – Tree Protection Plan

**Project site:** 2251 71<sup>st</sup> Avenue SE  
Mercer Island, WA 98040

**Date:** January 9, 2022

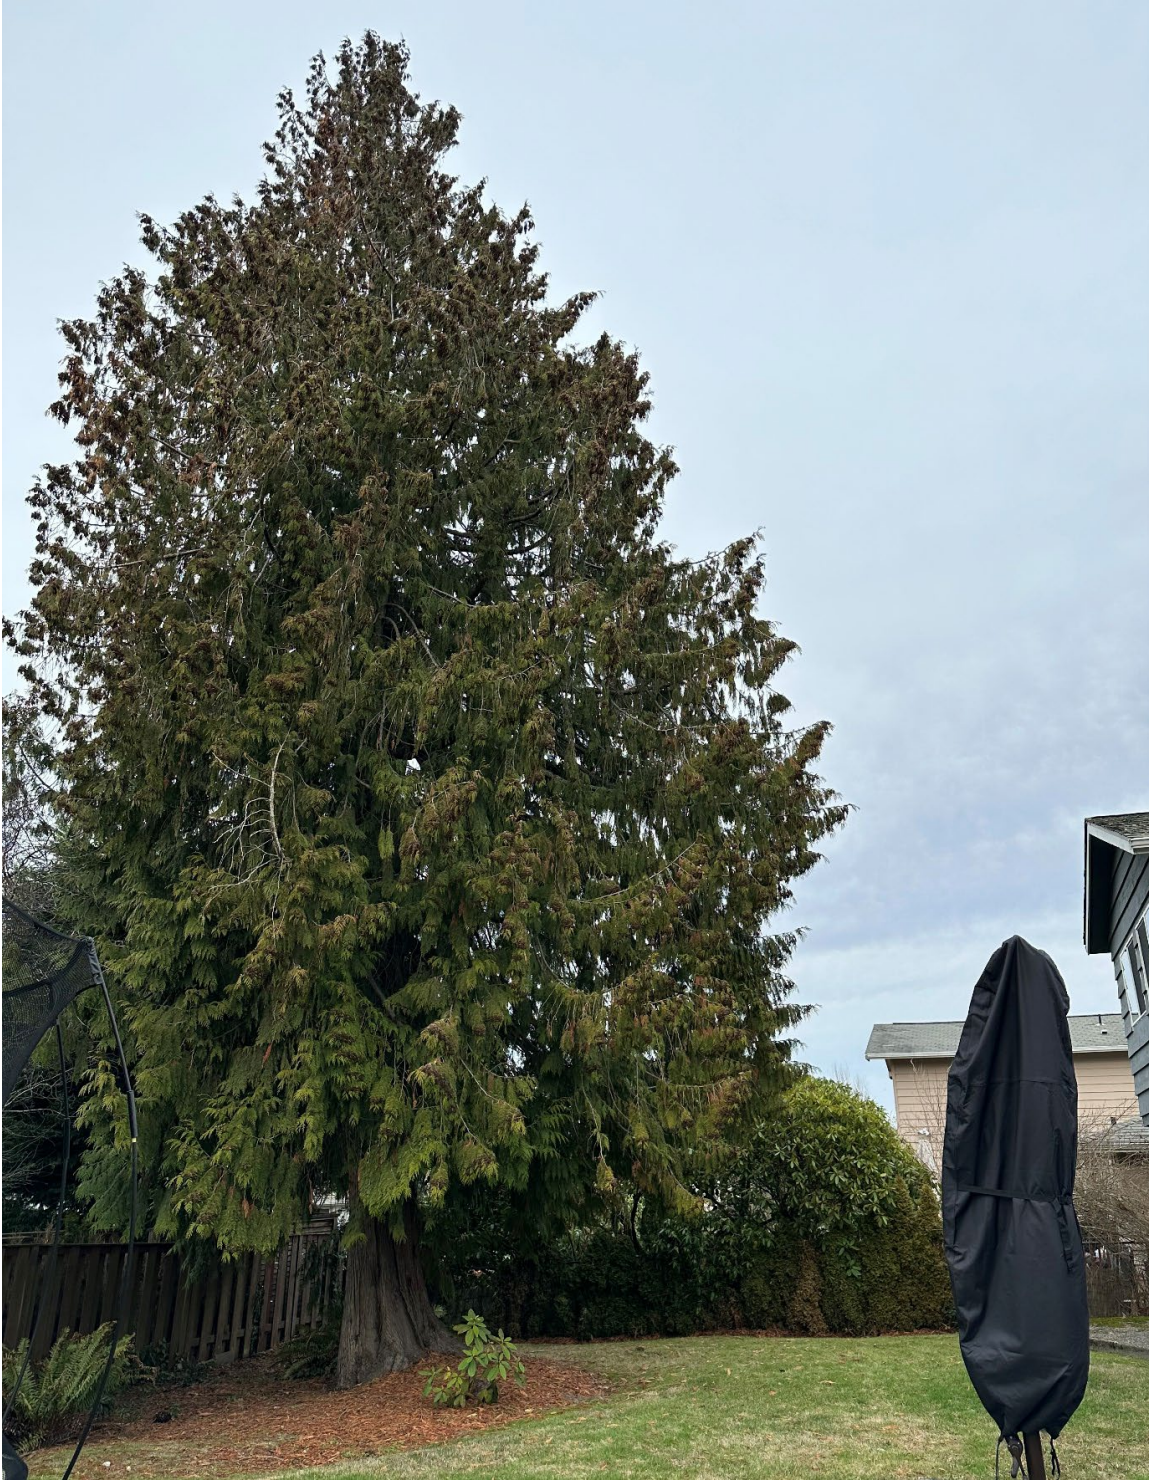
The larger of the two trees, #641, was a western red cedar (*Thuja plicata*) with a trunk diameter of 32.3 inches (Photo 1). It was about 45 feet tall with well-developed trunk taper and a full crown at 90 percent live crown to tree height ratio (LCR). The dripline radius was 14 feet. I saw one surface root about 3.5 inches in diameter above ground out to 9 feet from the trunk (Photo 2). The tree was in good condition, healthy, and viable. It was 29 feet west of the house.

The western red cedar is healthy and its form is consistent with trees better at resisting wind loading and whole tree failure. Construction and disturbance will be on the east side of the tree.

The ICRZ for this tree was a 16-foot radius from the trunk. I believe there would be minimal root loss and no significant impact on the tree with a limit of disturbance at 12 feet from the trunk. This requires that no construction activities, including but not limited to excavation, material storage, heavy machinery operation, scaffolding, or contractor foot access be within 12 feet of the tree on the east and south side of the tree. Some lower branches extending over the 12-foot limit of disturbance may need to be reduced in length. The exterior walls of any new structures should be a few feet set back from the tree's dripline to avoid potential conflict from branches encroaching on the building in the future.

**Photo 1.** The exceptional western red cedar is the largest tree on the property. The viewer is looking north.

- Erect 6-foot high chain-link tree protection fencing at a distance of 12 feet east and south of the trunk face. The tree protection fencing should be at the edge of the dripline on the other sides of the tree. The approximate location of tree protection fencing for the western red cedar is shown on the attached *Tree Protection Plan*. Alternative types of fencing may be considered provided they are relatively rigid and stay in place for the duration of the project.

- Prune the branches overhanging the project site up to a maximum height of 18 feet above grade. The height where the branches are cut back to the trunk may be somewhat higher due to the downward curve of the branch. Limit pruning to less than 15 percent of the entire crown. All pruning shall be done by an ISA Certified Arborist® following the ANSI-A300 standards for pruning.

- Have a certified arborist on-site to monitor the excavation.
- Document the size and quantity of roots encountered.
- If more than three roots over 4 inches in diameter need to be cut for the foundation of the new building, re-evaluate the impacts on the tree.
- Cleanly cut roots over 1 inch in diameter back to the edge of the grading limits.

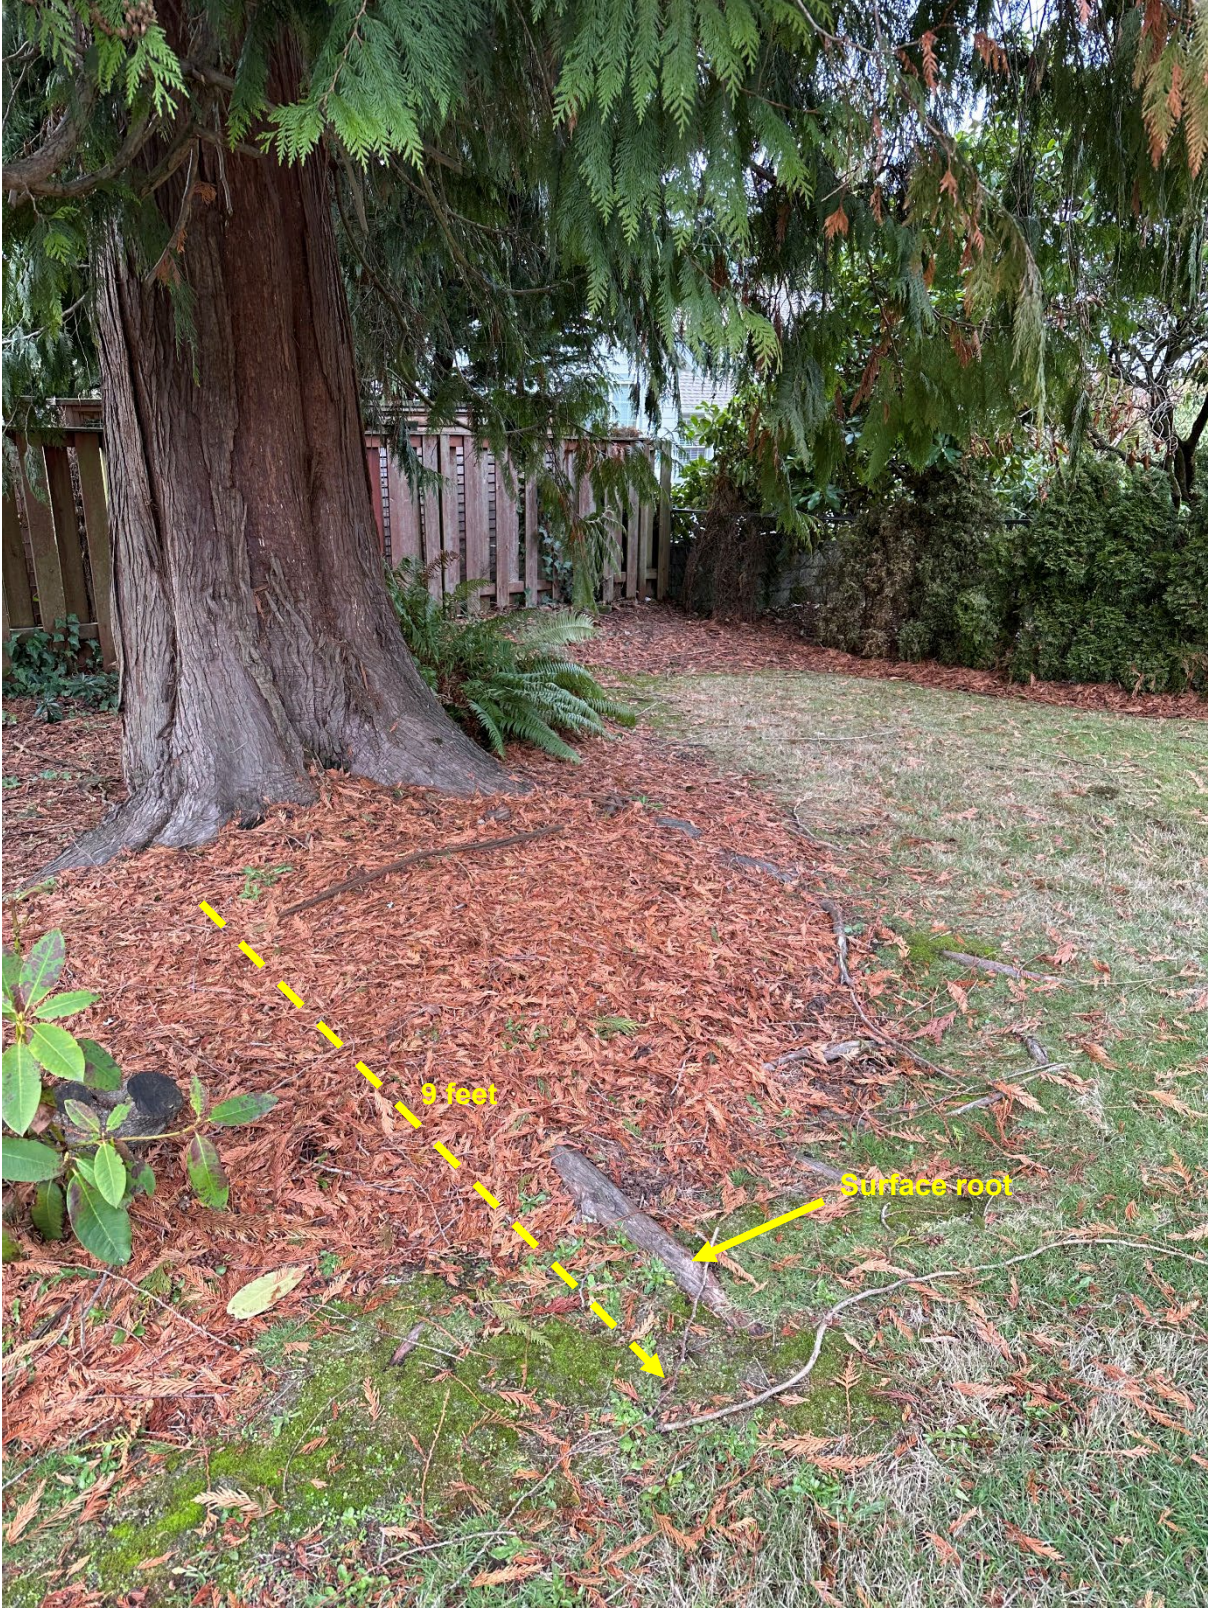
**Photo 2.** One surface root was visible out to a distance of 9 feet east of the western red cedar. The viewer is looking west.

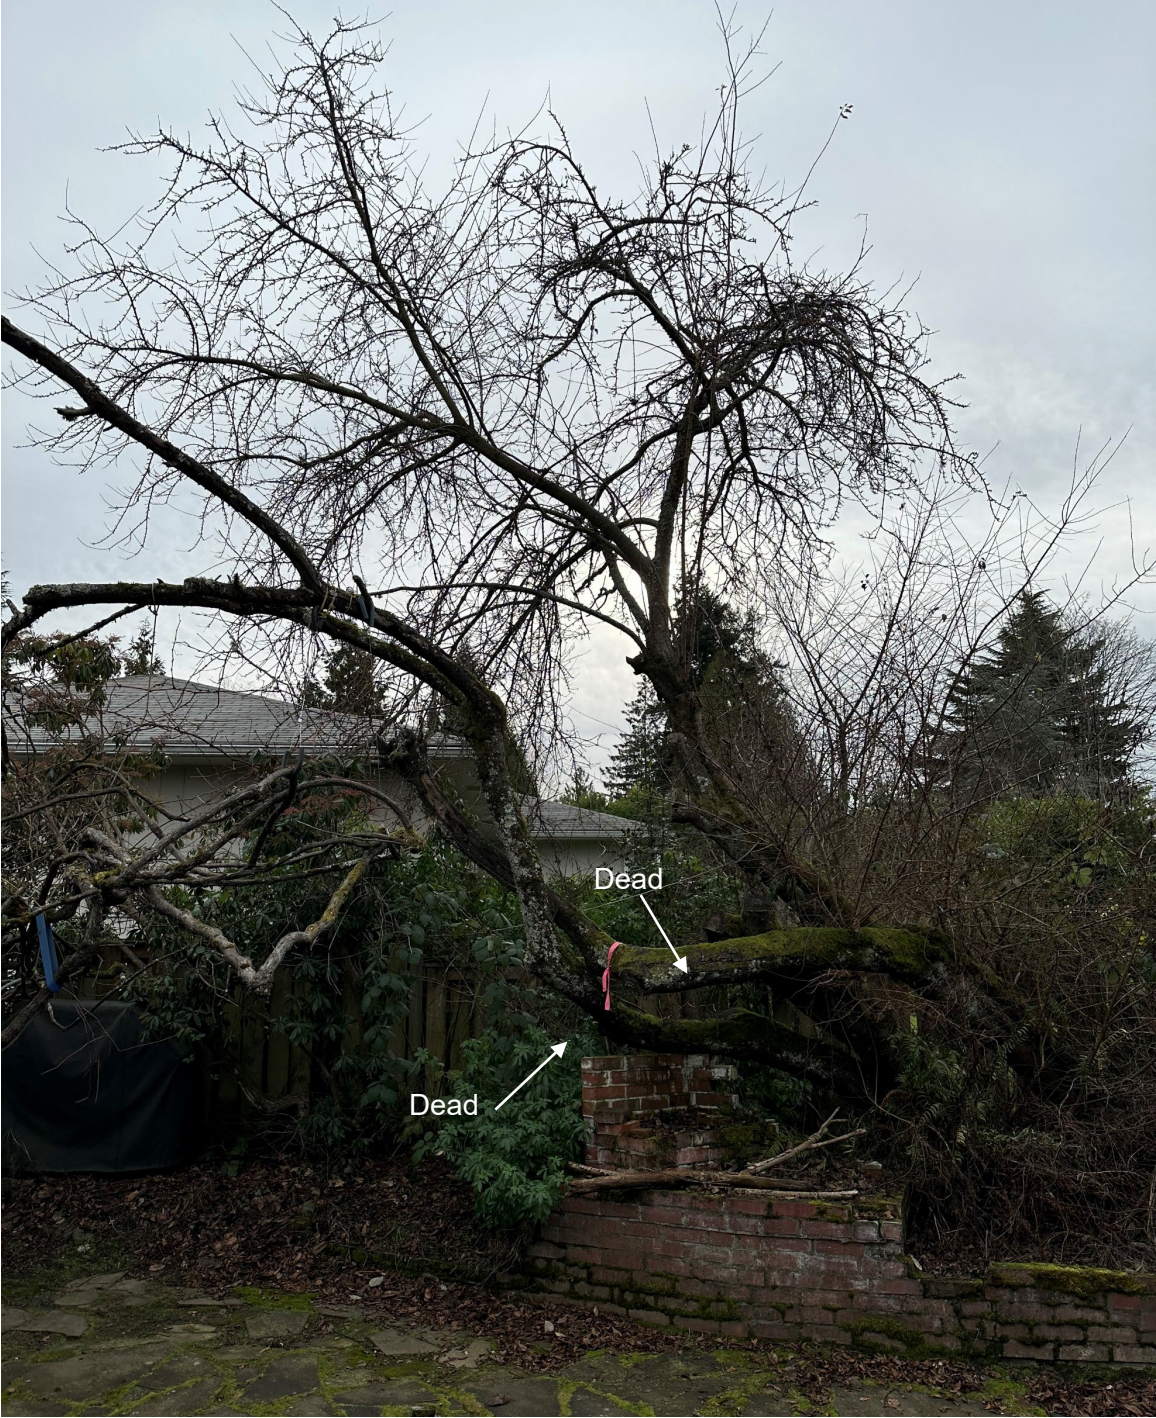
The smaller tree, #642, was a flowering plum (*Prunus cerasifera*) with three codominant trunks (Photo 3). Two of the trunks were dead and I did not include them in the measurement of trunk diameter. The one live trunk had a diameter of 14.3 inches. The tree had been pruned in the past and it was about 15 feet tall. There was some decay in the trunk but the crown had average vigor. It was growing in a planting area bordered by a short brick wall. Overall, the tree was viable but in poor condition.

The western red cedar is an exceptional tree in the City of Mercer Island and it must be retained during redevelopment. The flowering plum is in poor condition. It has a low preservation value and it may not be viable in the long term. Retaining the cedar tree and removing the plum tree would meet the minimum 30 percent tree retention requirement.

**Photo 3.** The backyard flowering plum was in poor condition with two of the three codominant stems dead. The viewer is looking south.

These general tree recommendations are intended to preserve the western red cedar in its current condition. I recommend removing the flowering plum and replacing it with a new tree that will perform better in the future.
