Milton Orellana  
Project Manager | We Design and Build Dreams  
Atera Homes

RE: Chen residence Mercer Island City file 2102-184

CHEN RESIDENCE

ARBORIST TREE PLAN

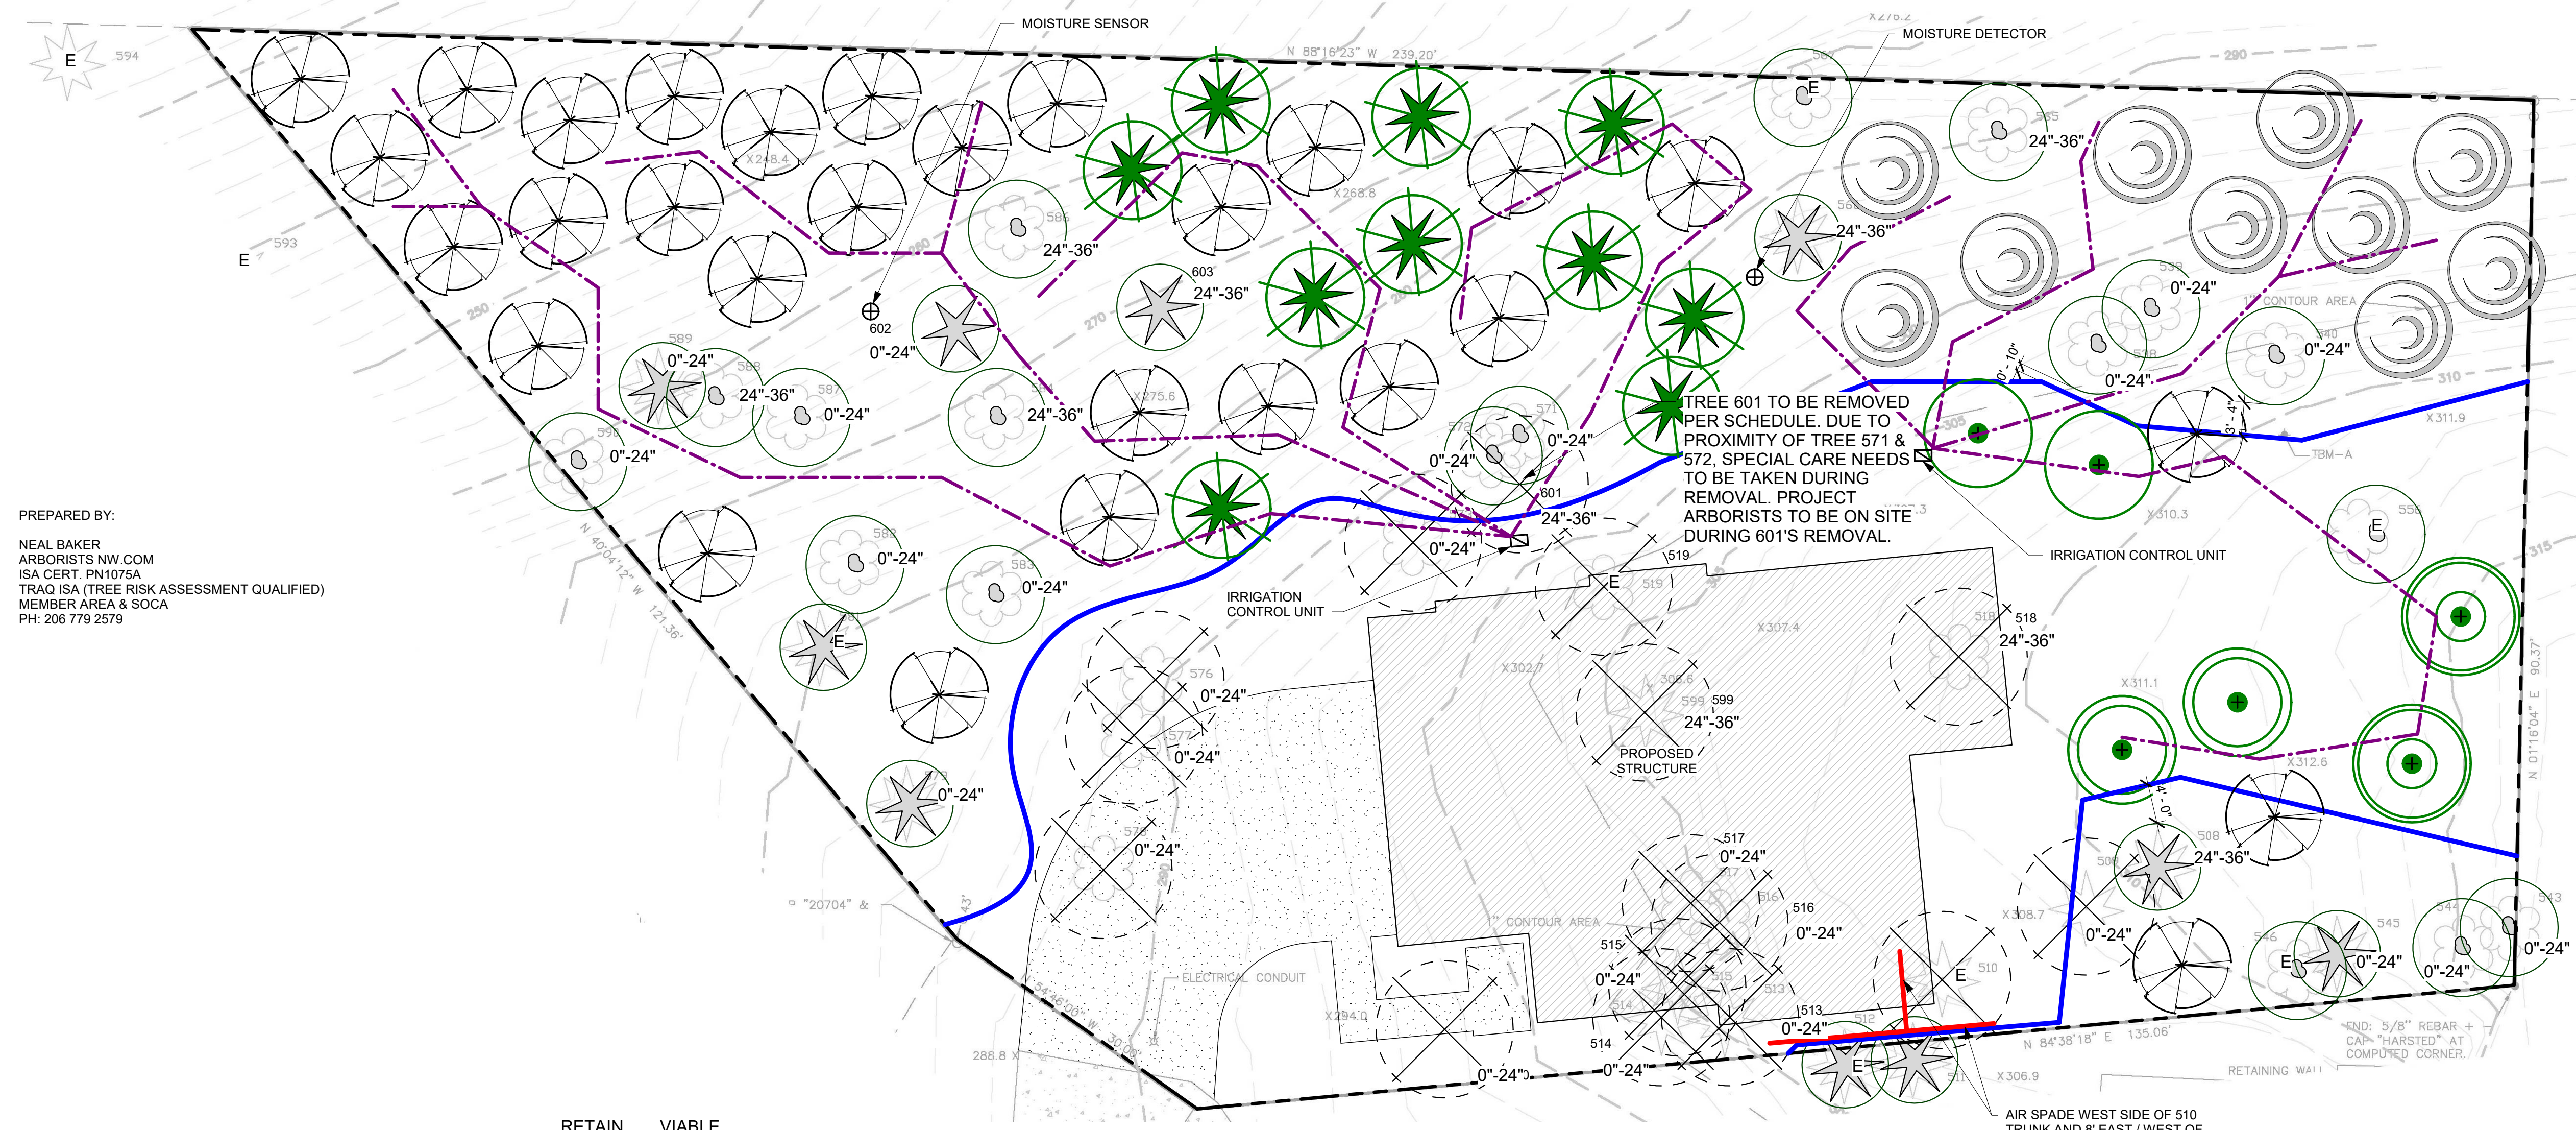
A102

Regarding Tree 508: Tree protection measures have been adjusted to show the full protection of the tree (sheet A102). The dripline for tree 579 has been re-scaled as required with appropriate tree protection locations. These are the responses to the comments below.

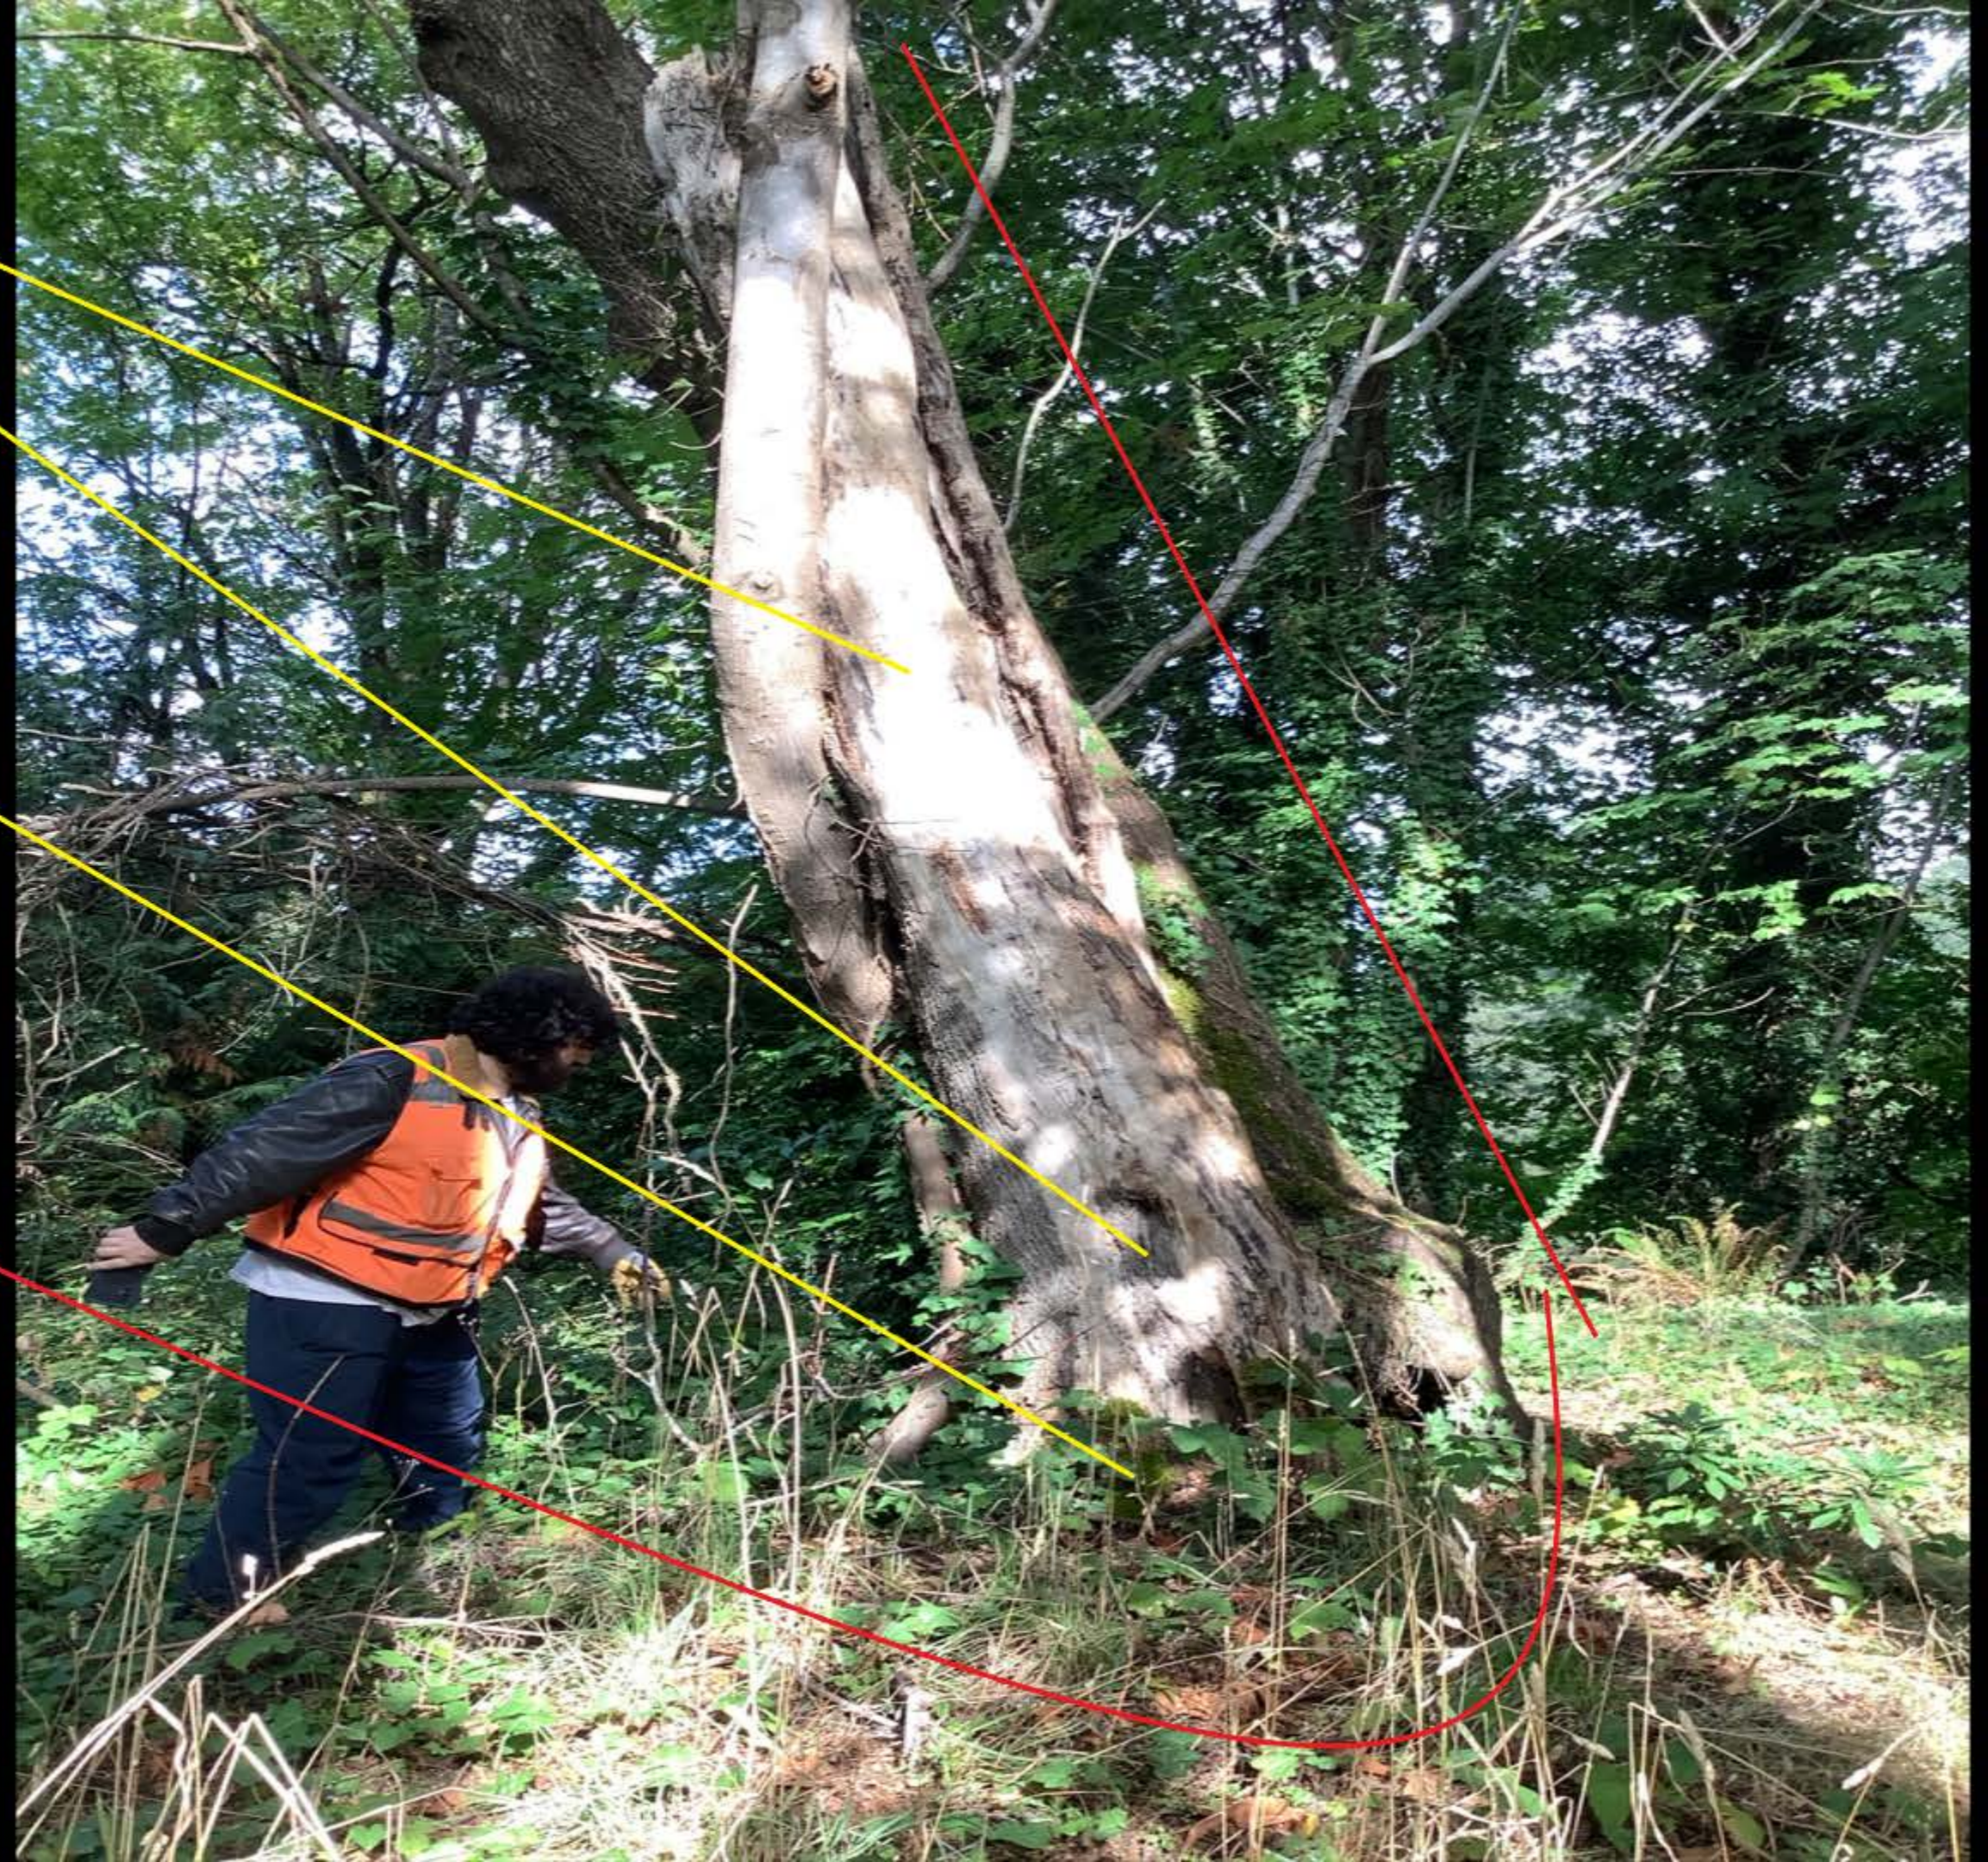
Tree 518 has a rotted trunk that runs from the root crown up 20 or more feet, more than 40% of the trunk. This stump is also severely undermined. The trunk has a 30% lean towards the west. The top of the tree has broken and is lodged in the top of T 519. The tree is also heavily infested with English Ivy. These are the responses to the comments below.

Trunk decay 80% interior  
65% of the circumference

Stump severely undermined

35% lean to the west

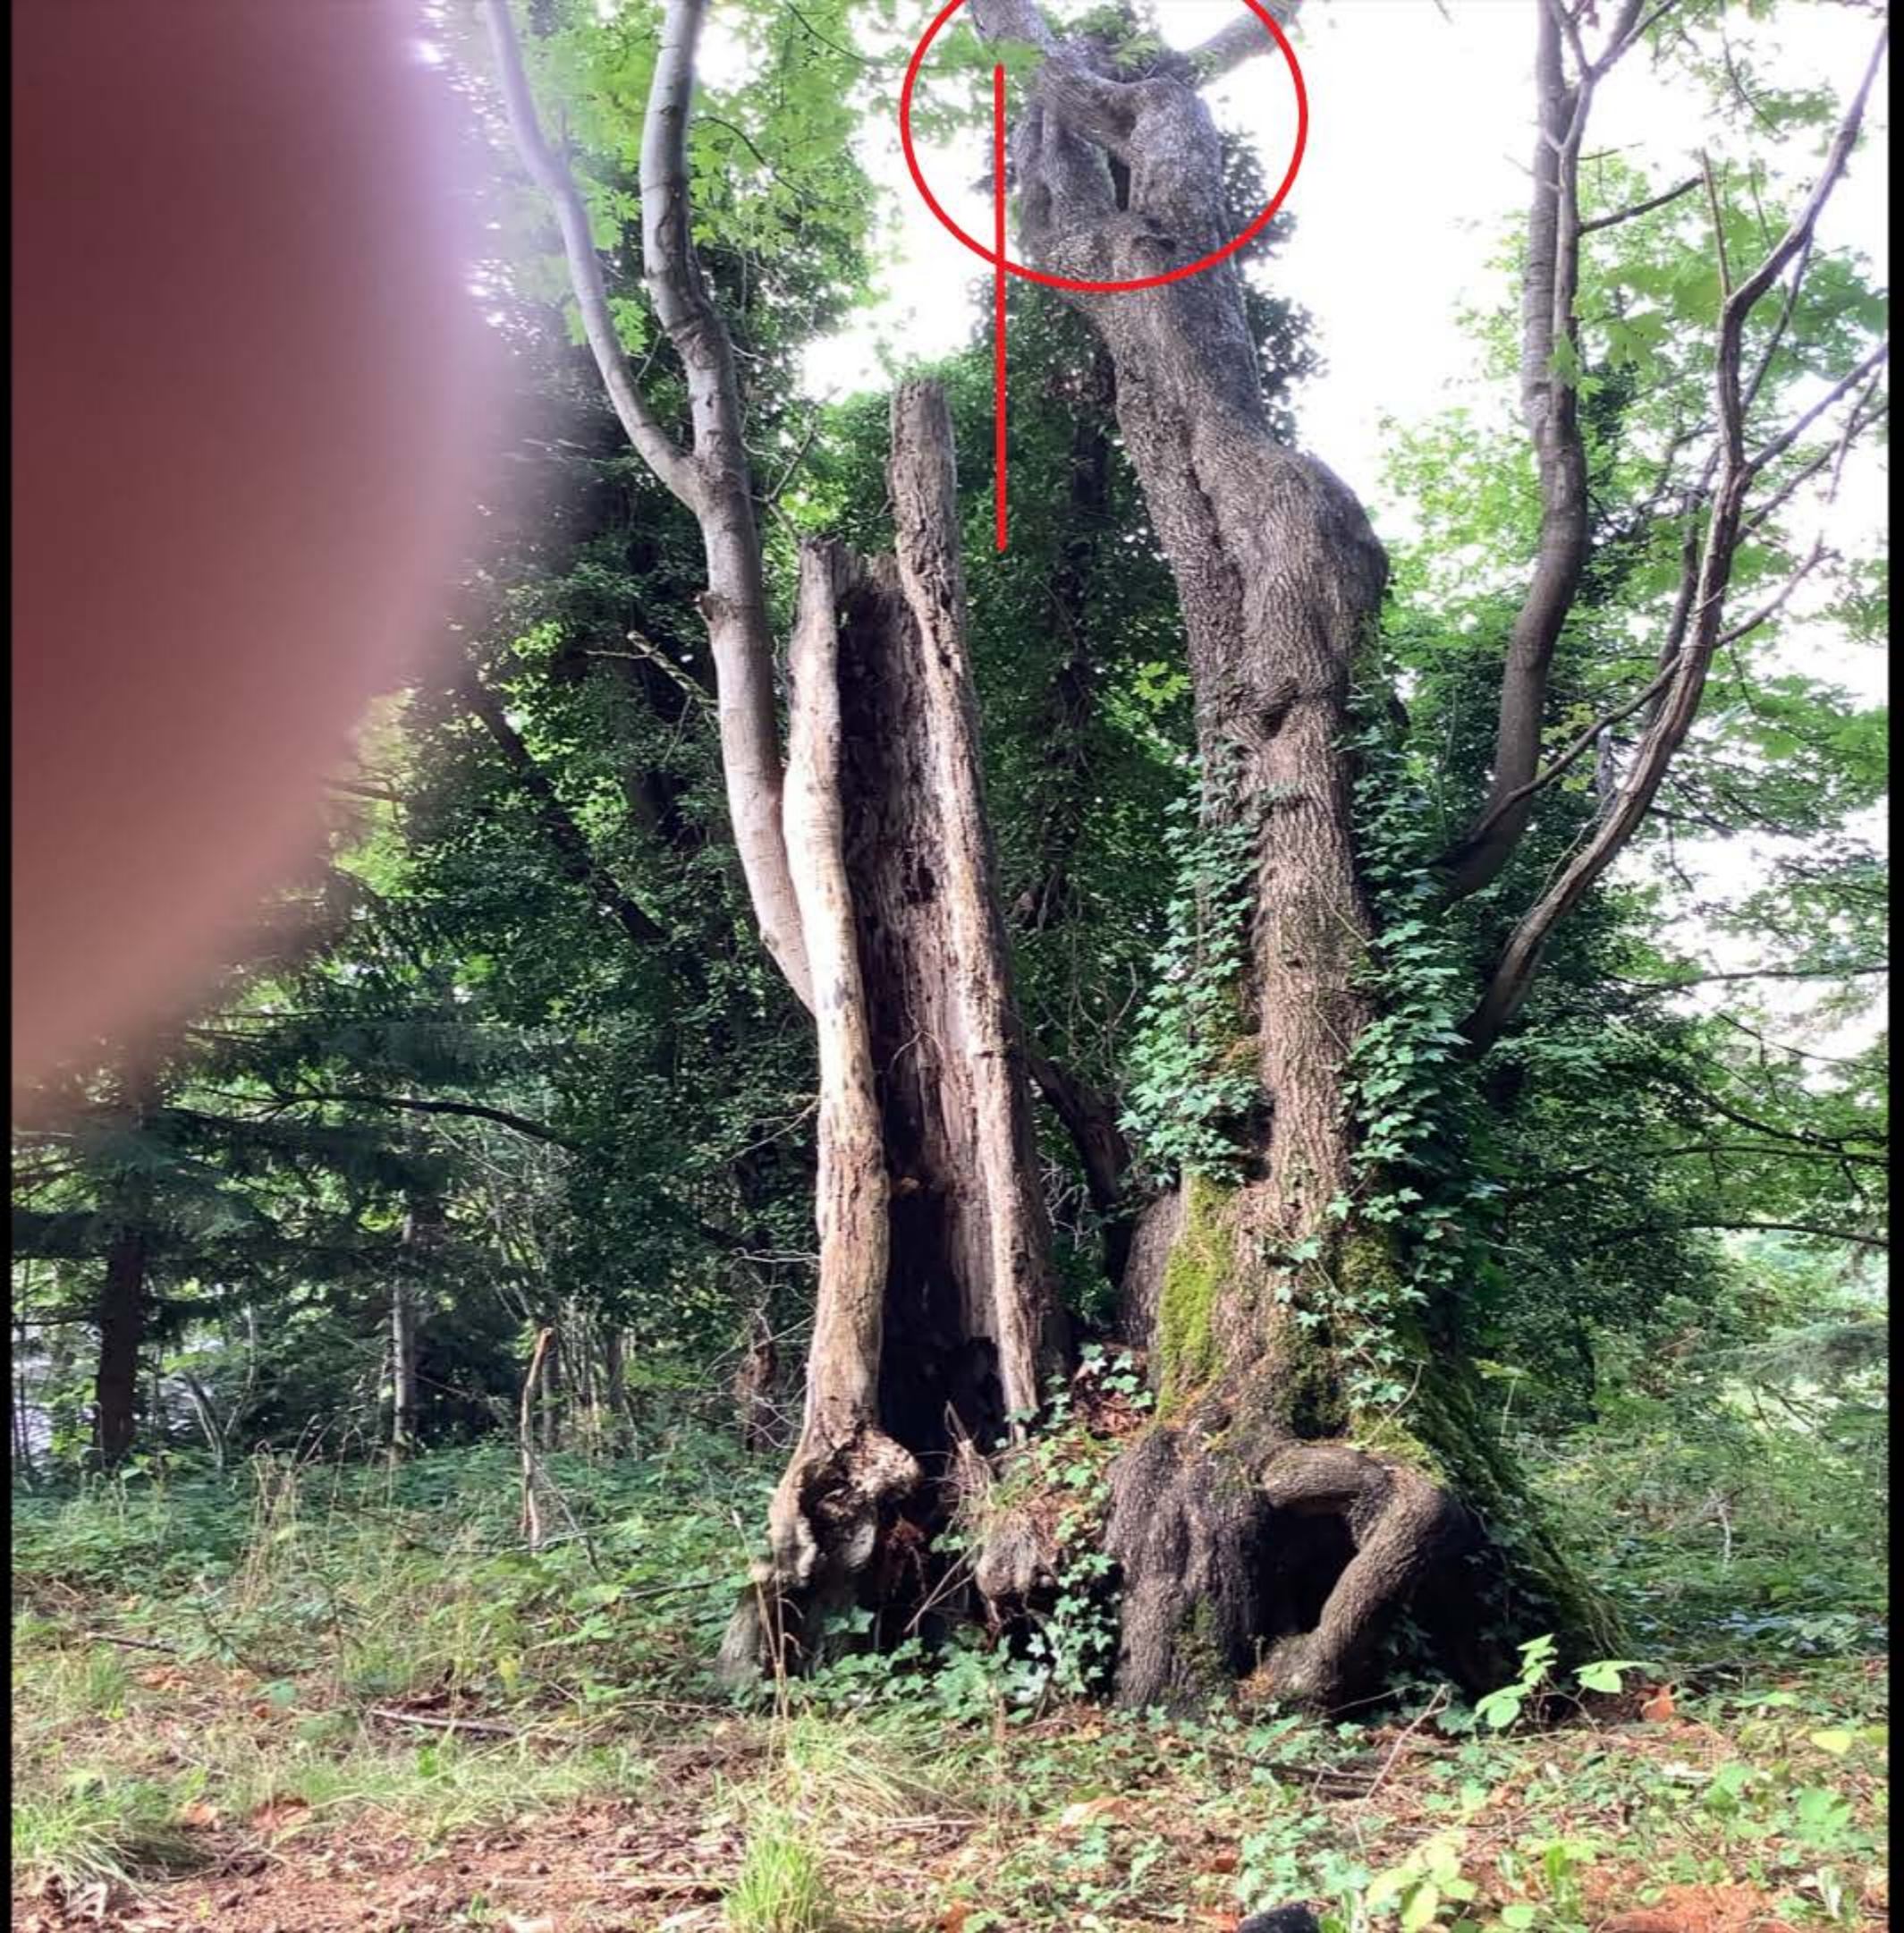
**Broken top half of  
518 laying in top of  
whats left of 519**

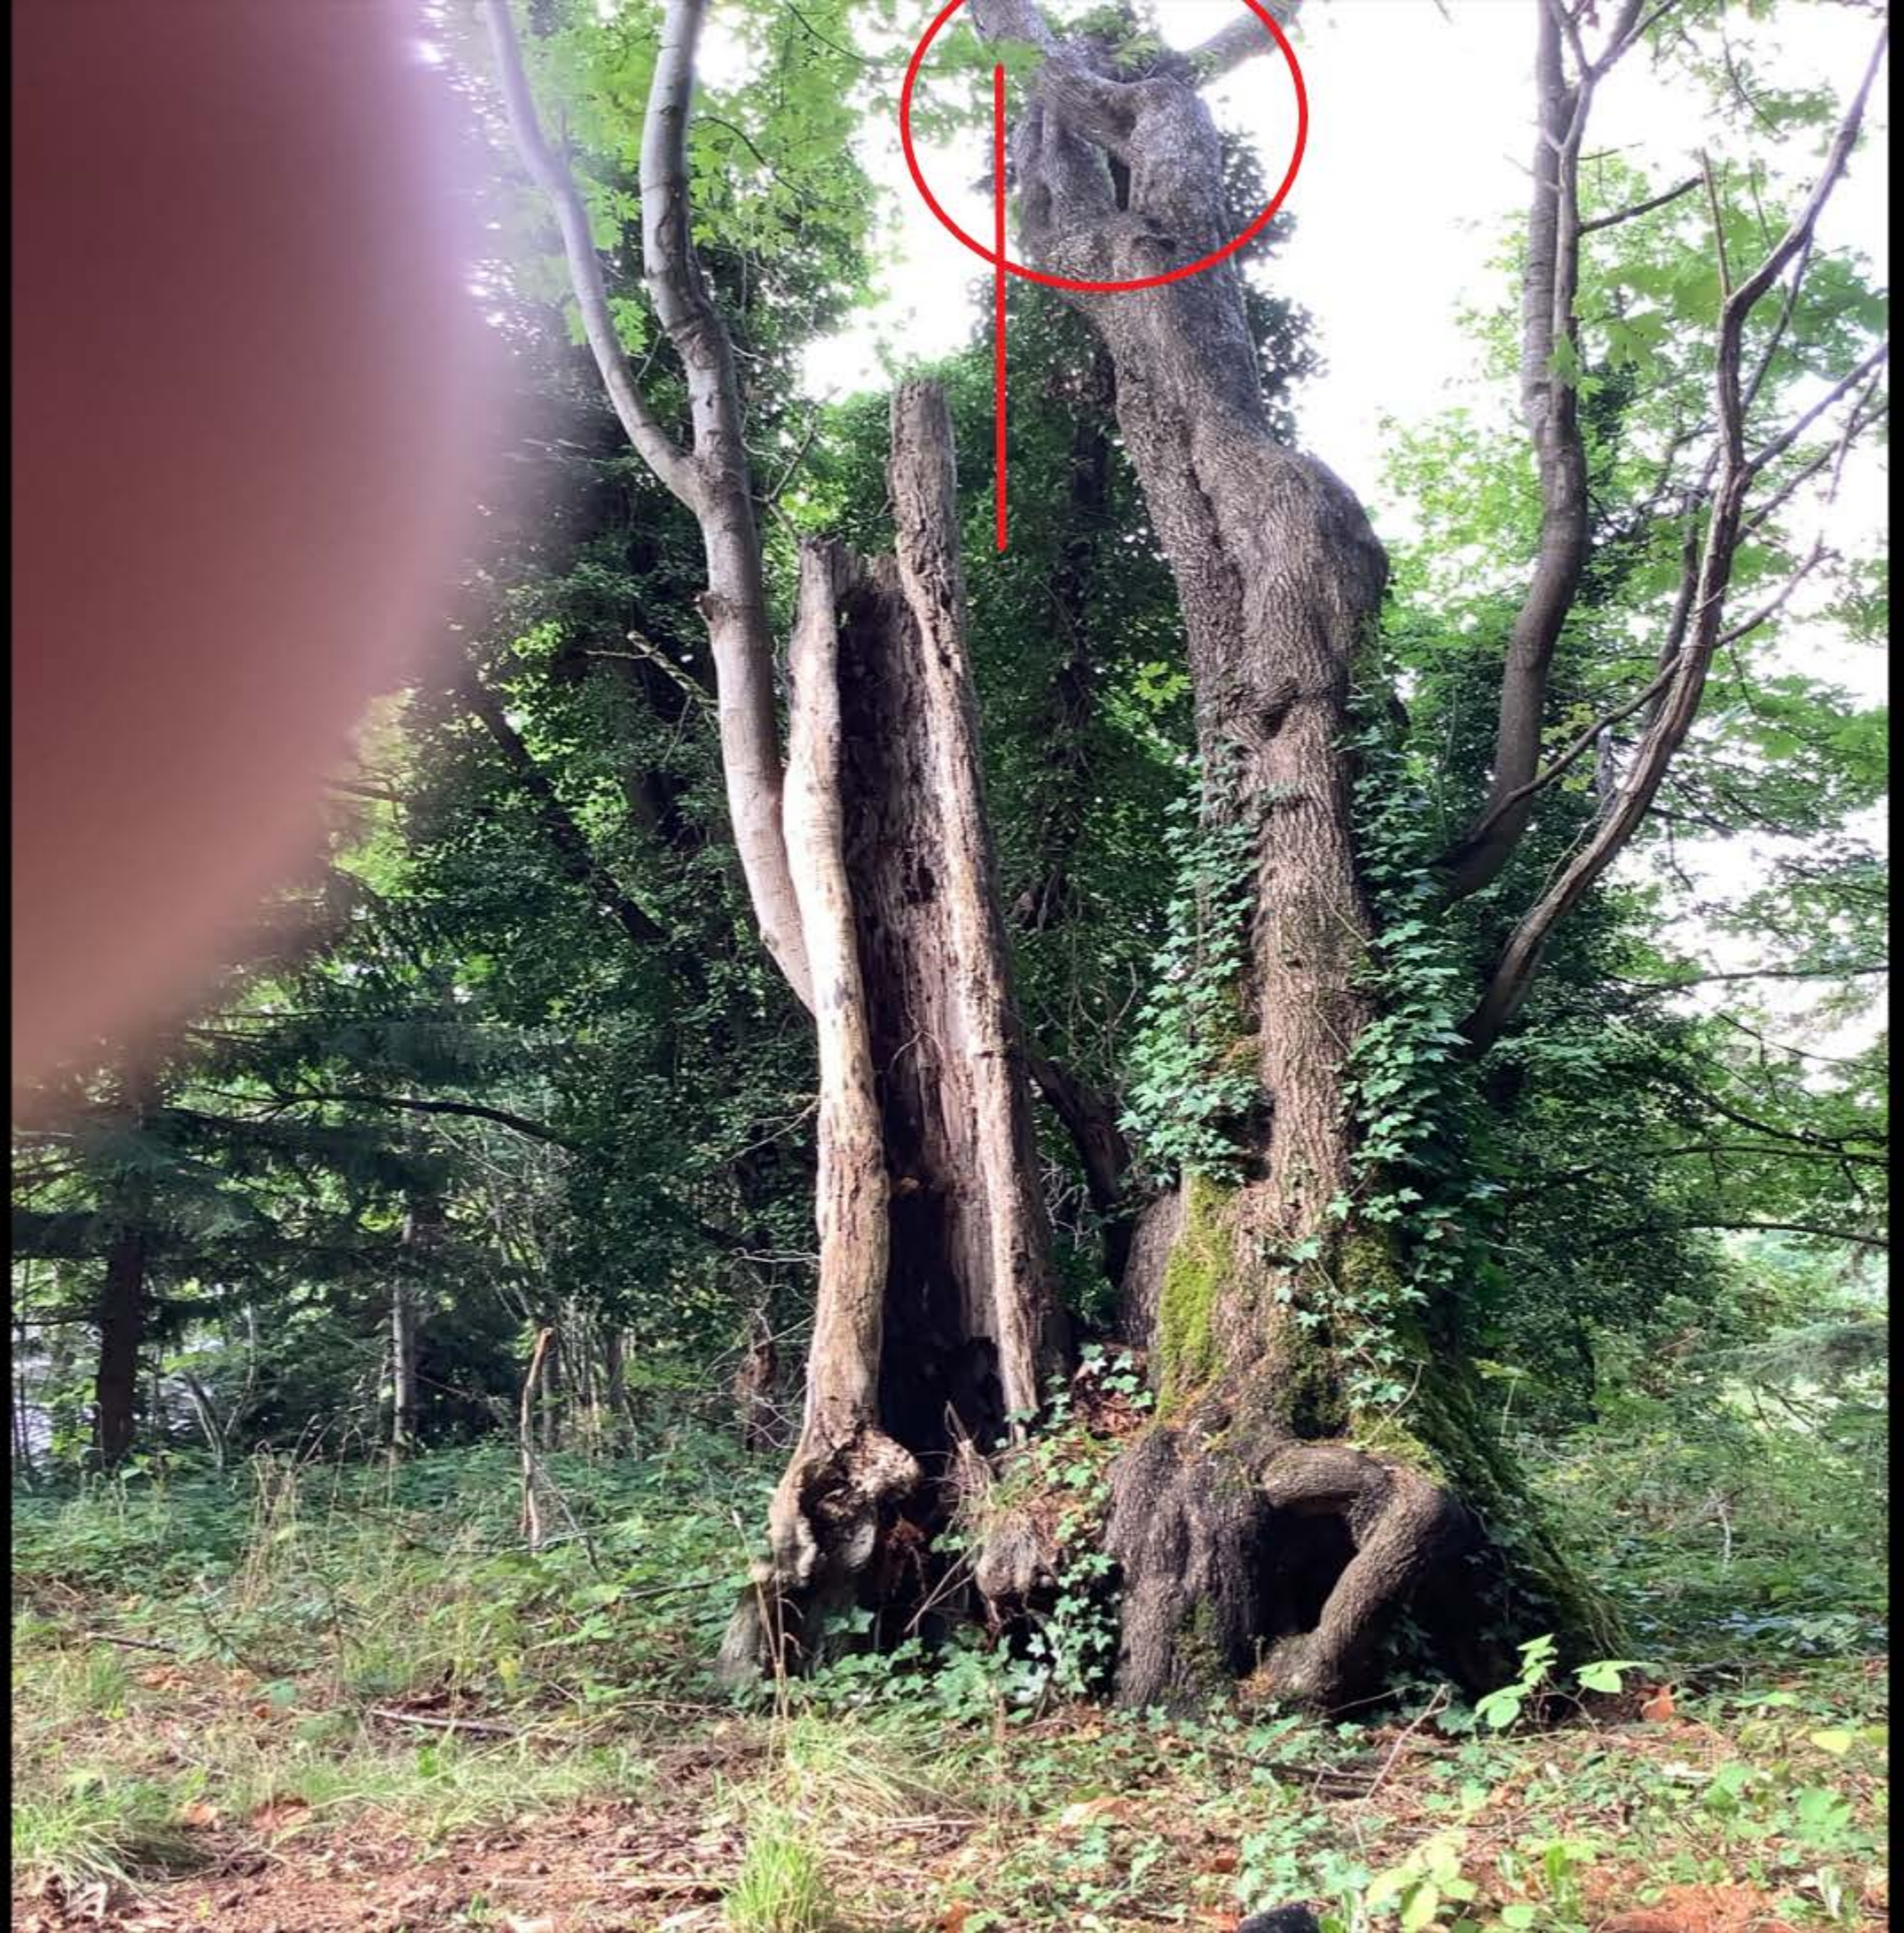
**Broken top half of  
518 laying in top of  
whats left of 519**

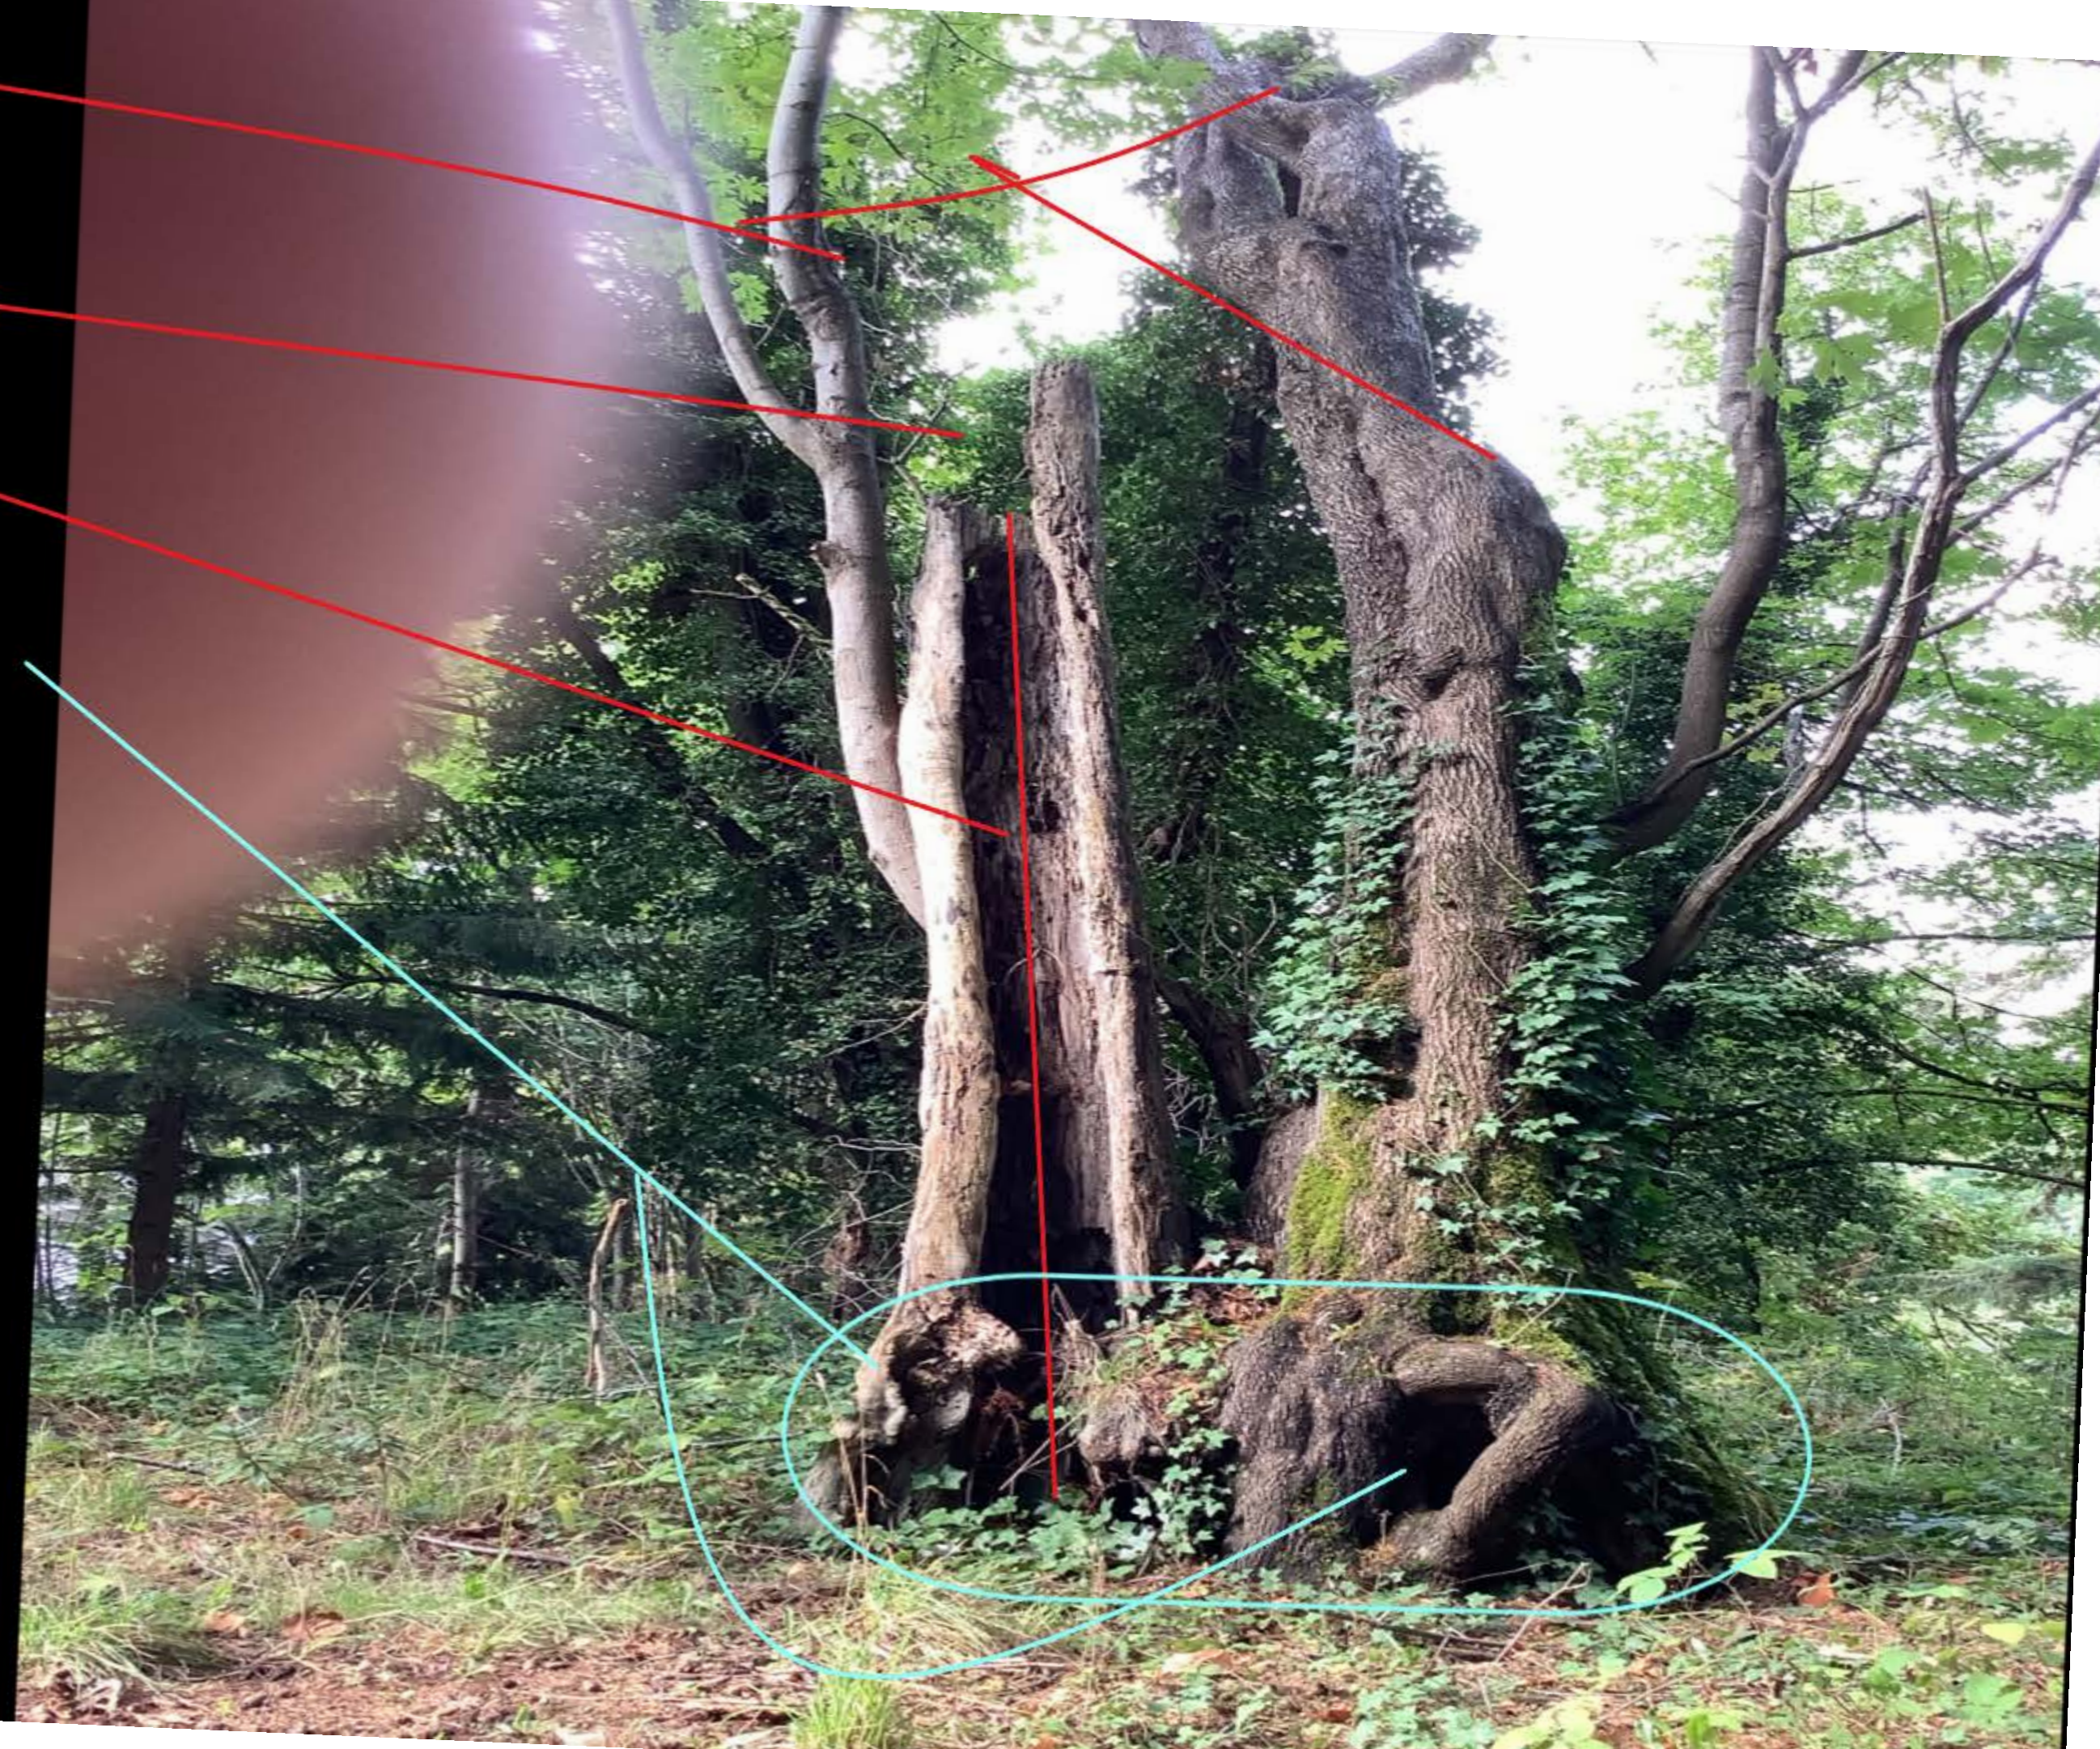
T 519

On 4/12/2023, I reinspected trees 518 and 519. Both trees are in advanced decline with extensive decay and large lost scaffolding branches. 519, a twin-trunk tree, has one completely dead trunk broken completely off at 25'. In addition, this trunk has an open cavity of more than 50% of the circumference of the trunk, the full length of the height that remains. The twin trunk to this one also has advanced decay that is open 15' up from 3' from the root crown. Wildlife is living in this part. There is the open wound of a large scaffolding branch that grew to the north. The broken top half of tree 518 is lodged in this area. The stump of this tree is 80% undermined and is holding up what remains of the tree on legs rimming the stump with no support under the tree. This stump is so bad that light travels from one side to the other under the tree.

Broken scaffold branches

Broken trunk

Near complete inner decay

Rotting & undermined stump

Light passes through the base of stumps from near total decay. This is a standing cavity

Whole remaining parts lean 25% to the west

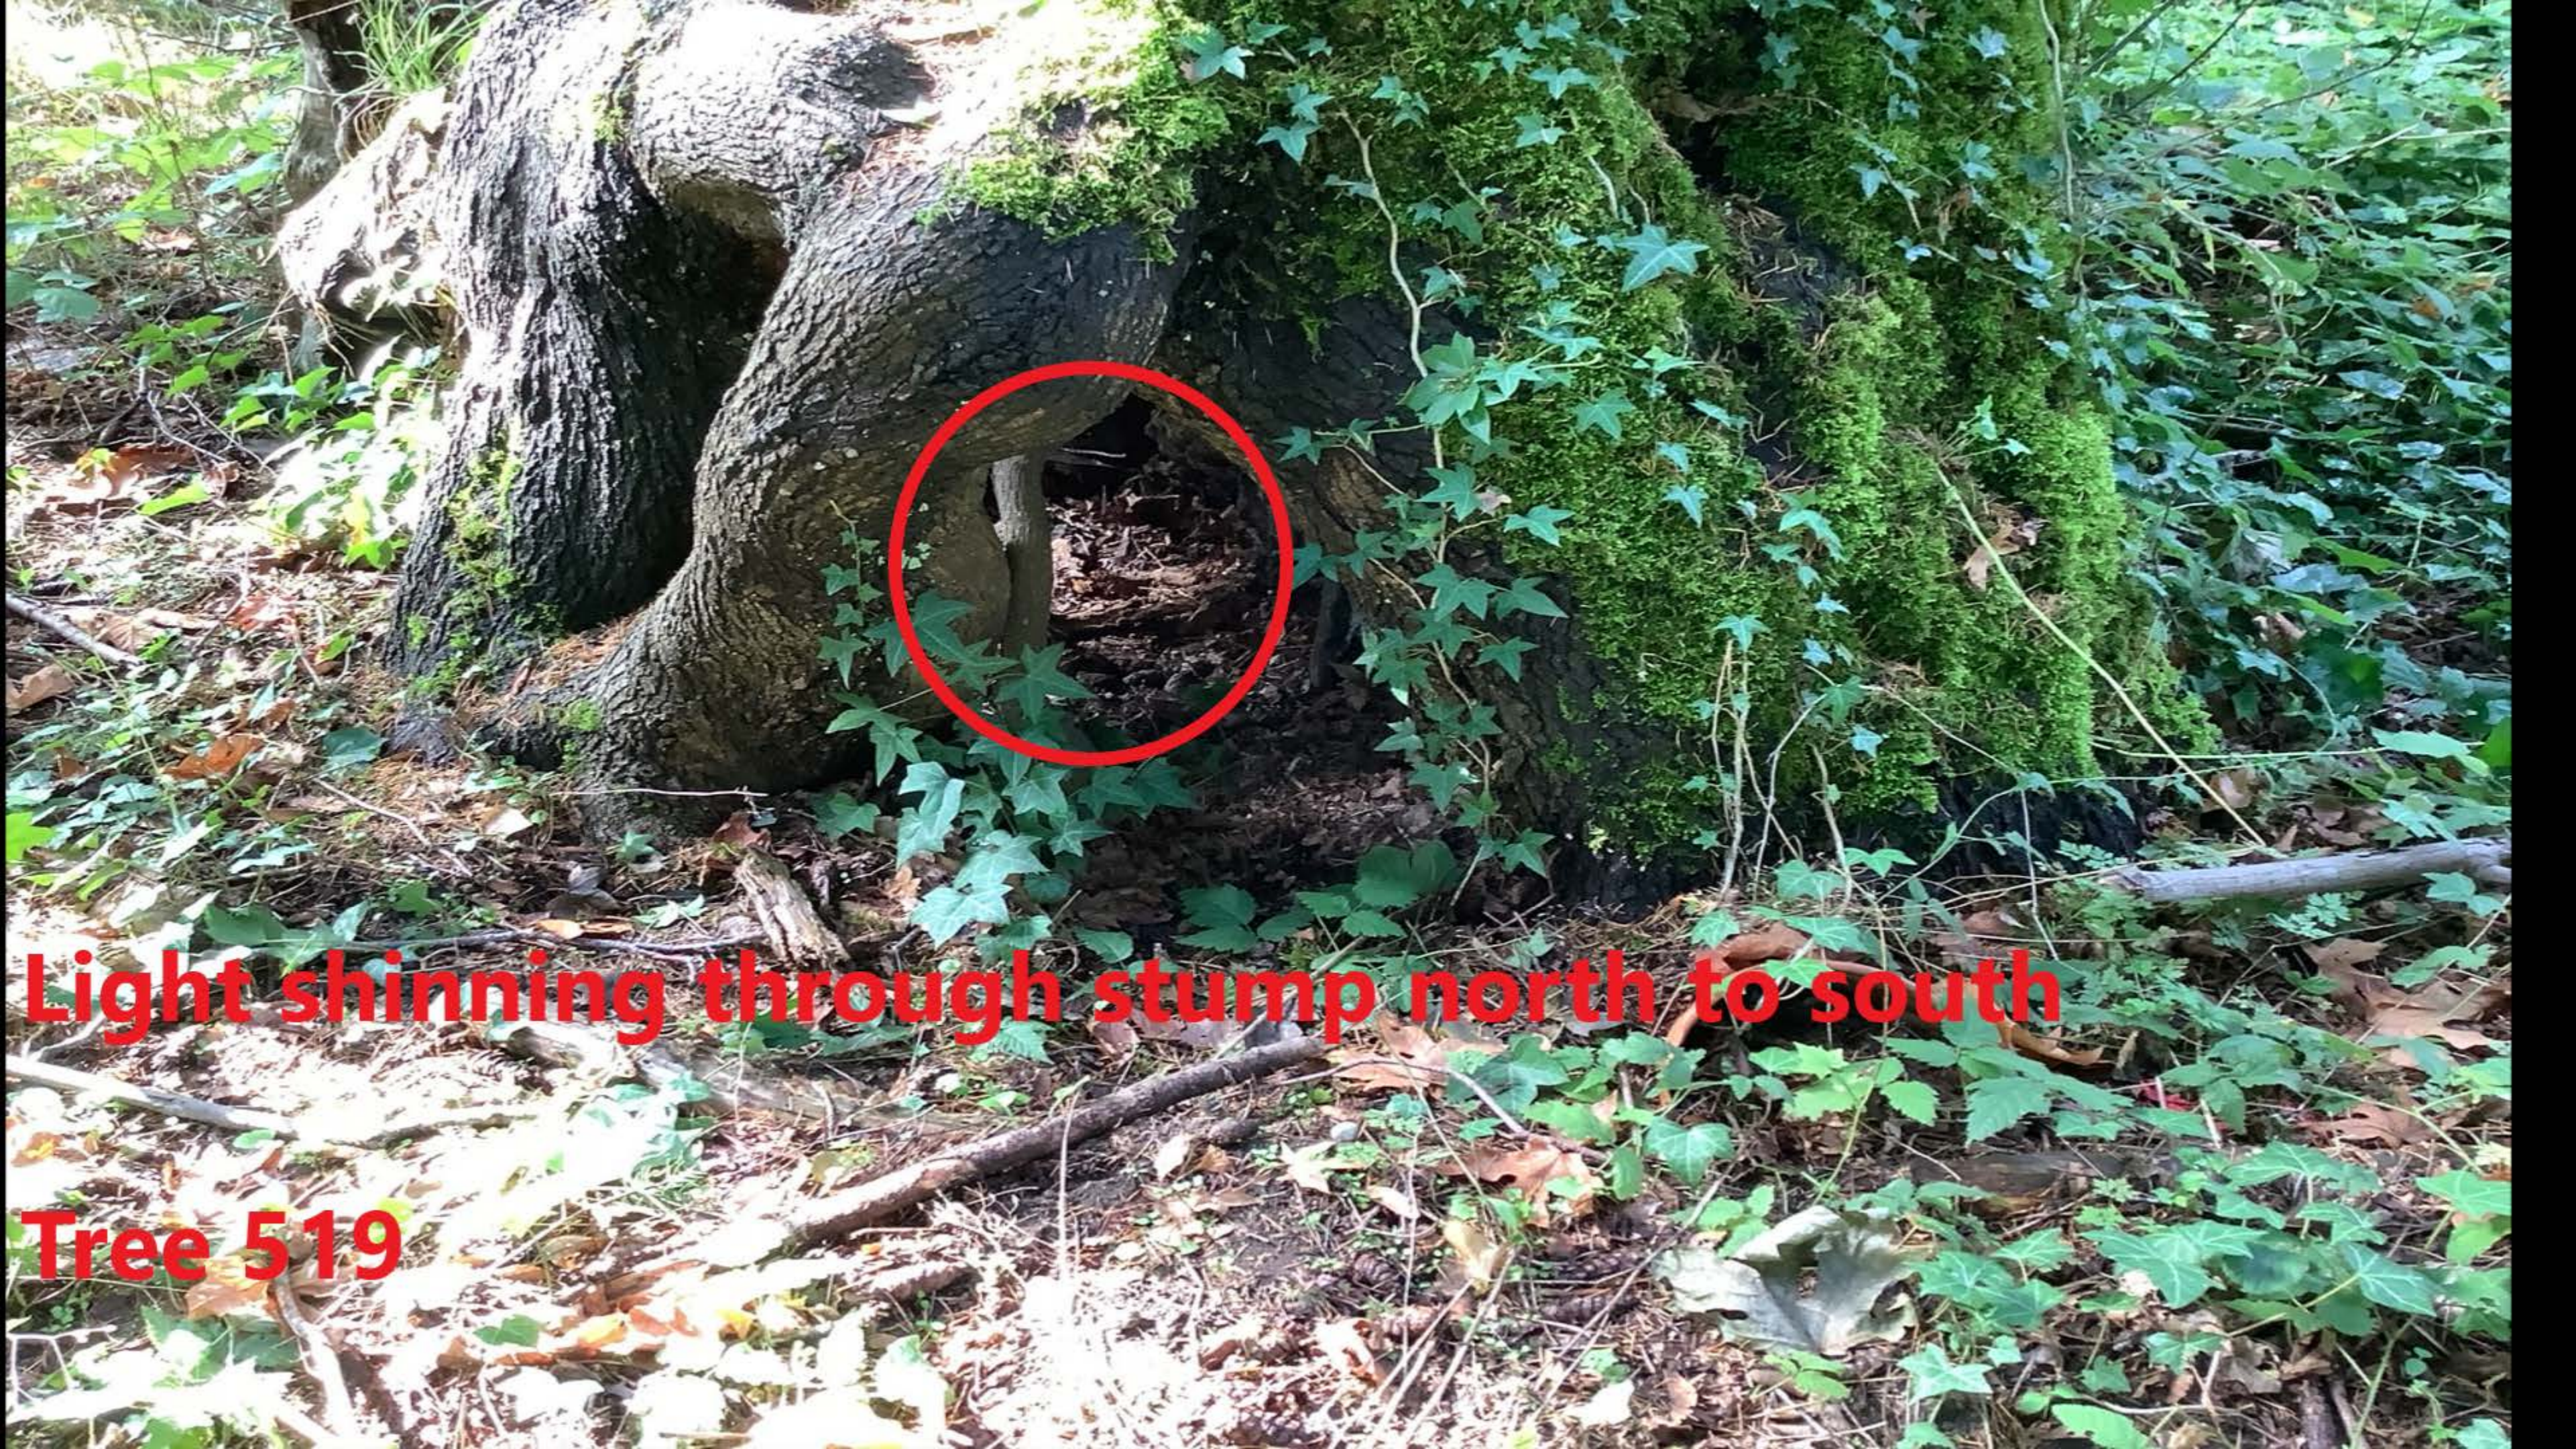
**Tree 519**

**Light shinning through stump north to south**
