RE: Tree Impact Assessment Report - Tree #23 MN 472 7119 80th Ave. SE Mercer Island, WA.

## 1.0 Impact Assessment

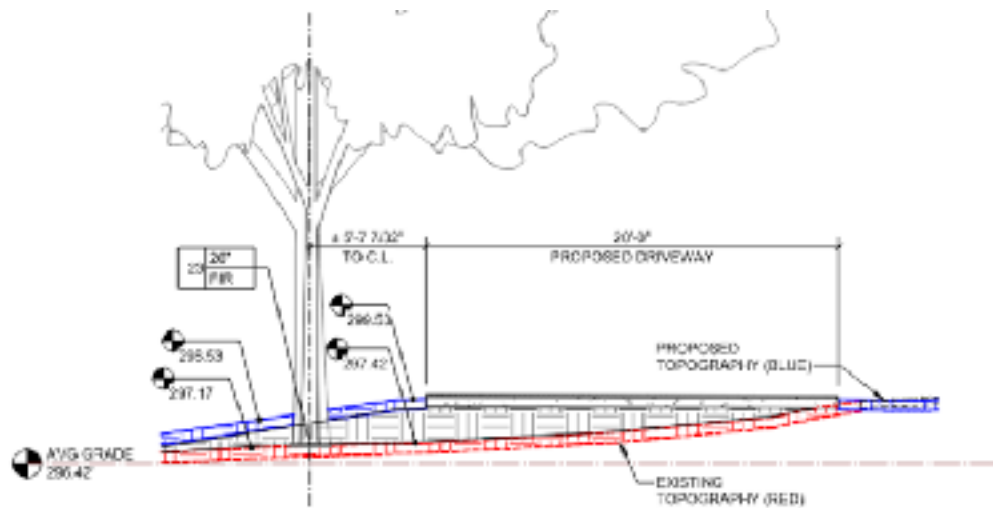
The following detail from sheet A1.1 shows the existing and proposed topography for the driveway within the drip line of tree #23.

As it specifies, the red line is the existing topography, the blue line the proposed topography. Installation of the driveway will not require any ground disturbance within the drip line of the tree; it will rather require a slight amount of fill. Therefore, since no roots will be impacted, an advanced root assessment is not necessary.

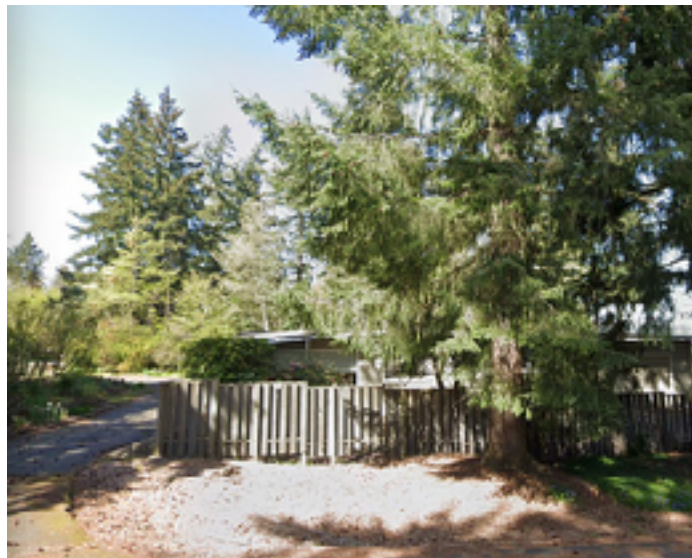
The following photo shows the conditions around the tree and in the location of the proposed driveway.

As the photo shows, the ground surface in the location of the new driveway is currently covered in gravel for use as vehicle parking. The concrete or asphalt placed over this area for the driveway will reduce compaction of the soil below as the paved surface will absorb the weight of the vehicles.

At a distance of 5'7" from the tree, the new driveway will be far enough from the tree to provide adequate protection. Following are the measures to provide protection for tree #23:

- Tree protection fencing is to be installed at the drip line prior to clearing and grading.
- Measures to take place within the drip line and protection zone include removal of the existing fence, ground surface preparation and installation of the driveway.
- When work is needed within the drip line, fencing is to be moved toward the tree far enough toward the tree to maintain and protection zone and to allow for the work to be conducted.
- Fencing is to remain in place throughout construction.
