ARBORIST REPORT

September 12, 2023

6550 80th Ave SE Mercer Island, WA 98040 / Lot # 5452800700

Kim Ettari - ISA Certified Arborist PN1301A / TRAQ

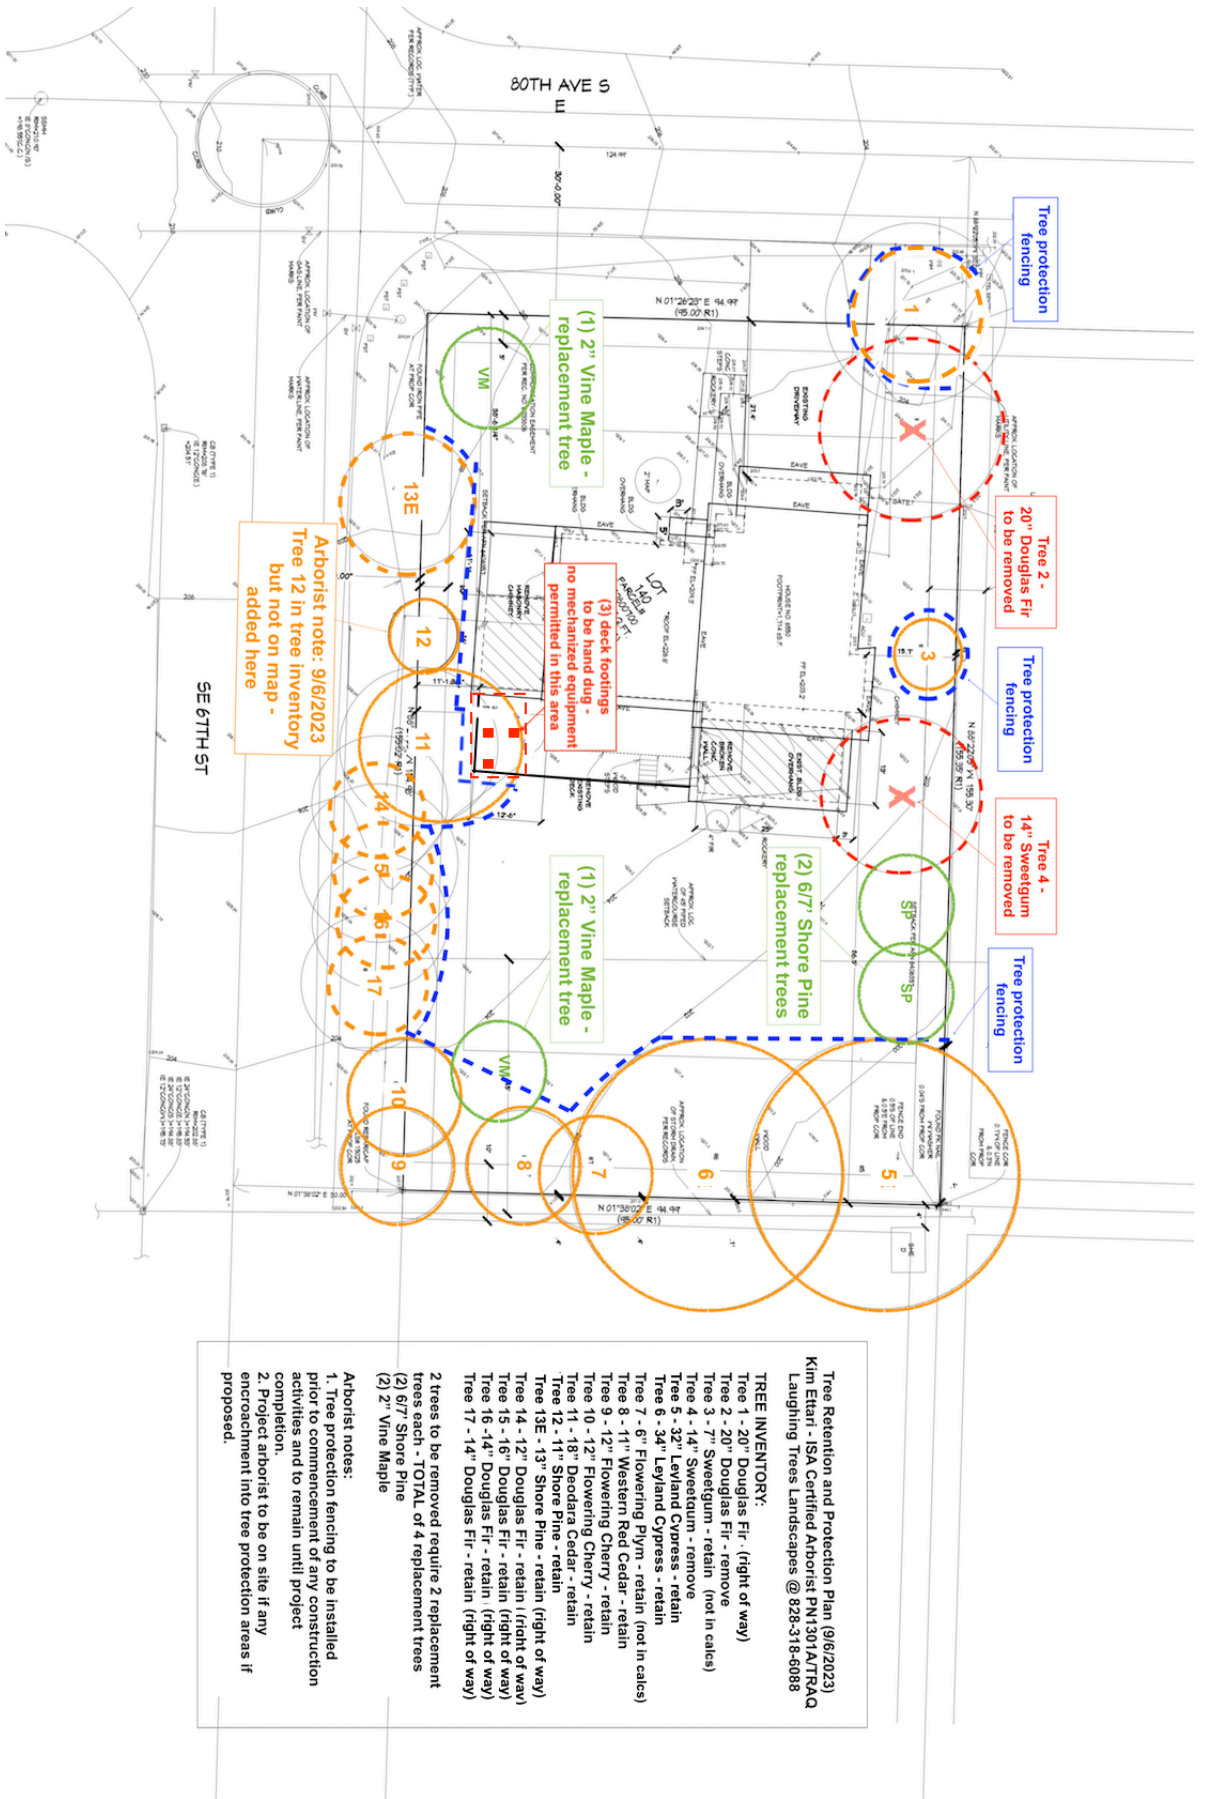
Tree Retention and Protection Plan (9/6/2023)
 Kim Ettari - ISA Certified Arborist, PNI301A/TRAQ
 Laughing Trees Landscapes @ 828-318-6088

TREE INVENTORY:
 Tree 1 - 20" Douglas Fir - (right of way)
 Tree 2 - 20" Douglas Fir - remove
 Tree 3 - 7" Sweetgum - retain (not in calice)
 Tree 4 - 14" Sweetgum - remove
 Tree 5 - 32" Leyland Cypress - retain
 Tree 6 - 34" Leyland Cypress - retain
 Tree 7 - 6" Flowering Plym - retain (not in calice)
 Tree 8 - 11" Western Red Cedar - retain
 Tree 9 - 12" Flowering Cherry - retain
 Tree 10 - 12" Flowering Cherry - retain
 Tree 11 - 18" Decidua Cedar - retain
 Tree 12 - 11" Shore Pine - retain
 Tree 13E - 13" Shore Pine - retain (right of way)
 Tree 14 - 12" Douglas Fir - retain (right of way)
 Tree 15 - 16" Douglas Fir - retain (right of way)
 Tree 16 - 14" Douglas Fir - retain (right of way)
 Tree 17 - 14" Douglas Fir - retain (right of way)

2 trees to be removed require 2 replacement trees each - **TOTAL of 4 replacement trees**
 (2) 6/7" Shore Pine
 (2) 2" Vine Maple

Arborist notes:
 1. Tree protection fencing to be installed prior to commencement of any construction activities and to remain until project completion.
 2. Project arborist to be on site if any encroachment into tree protection areas if proposed.
