TREE PERMIT

Project No.
Main Permit No.
Permit No. **2401-161**

Project: Assessment of three trees at 7058 82nd Avenue SE, Mercer Island, WA.
Parcel number 8732300120.

Objectives: Evaluate health of trees, their suitability of placement, and recommend solutions.

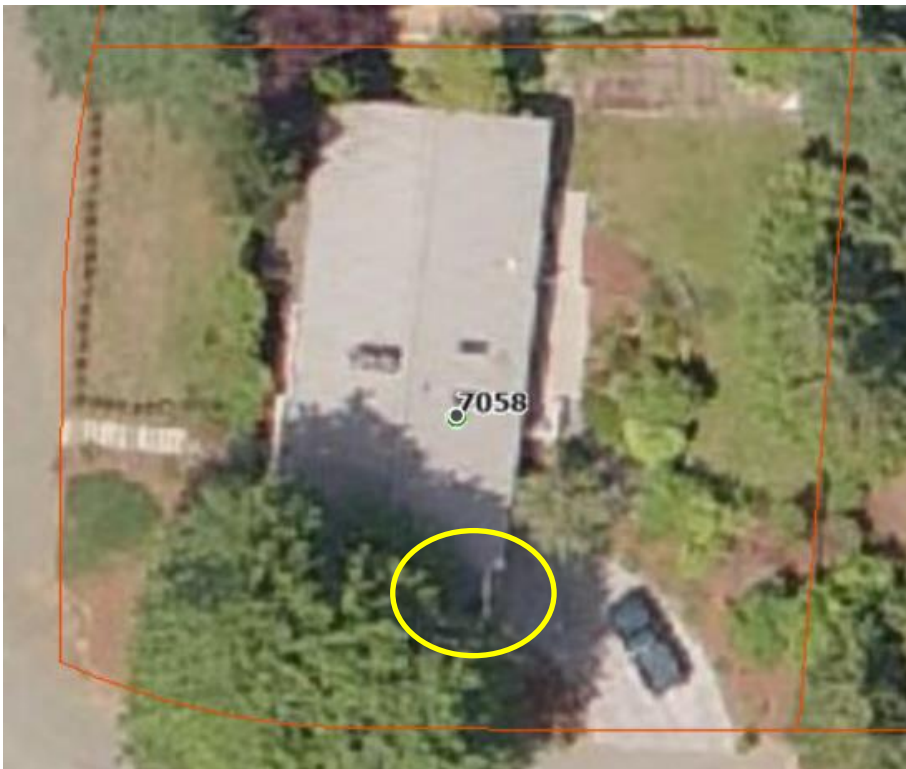
Figure 2. Aerial from 2007 showing the upper deck just peeking out on the east side of the trees.

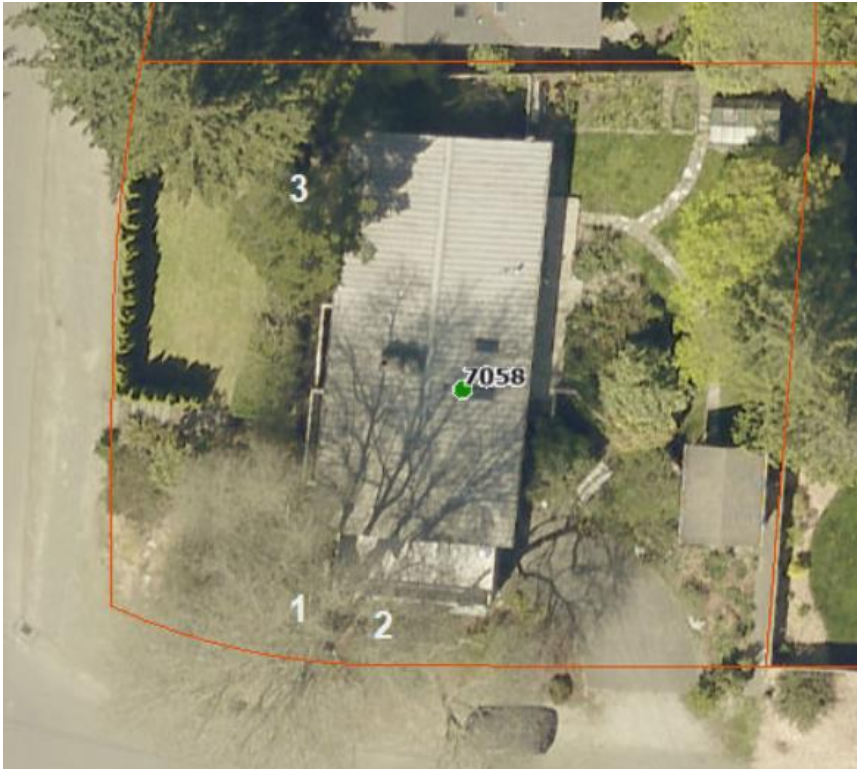
Figure 3. Aerial from 2021 showing the locations of the subject trees. Note the large deck over the garage more clearly seen in this image.

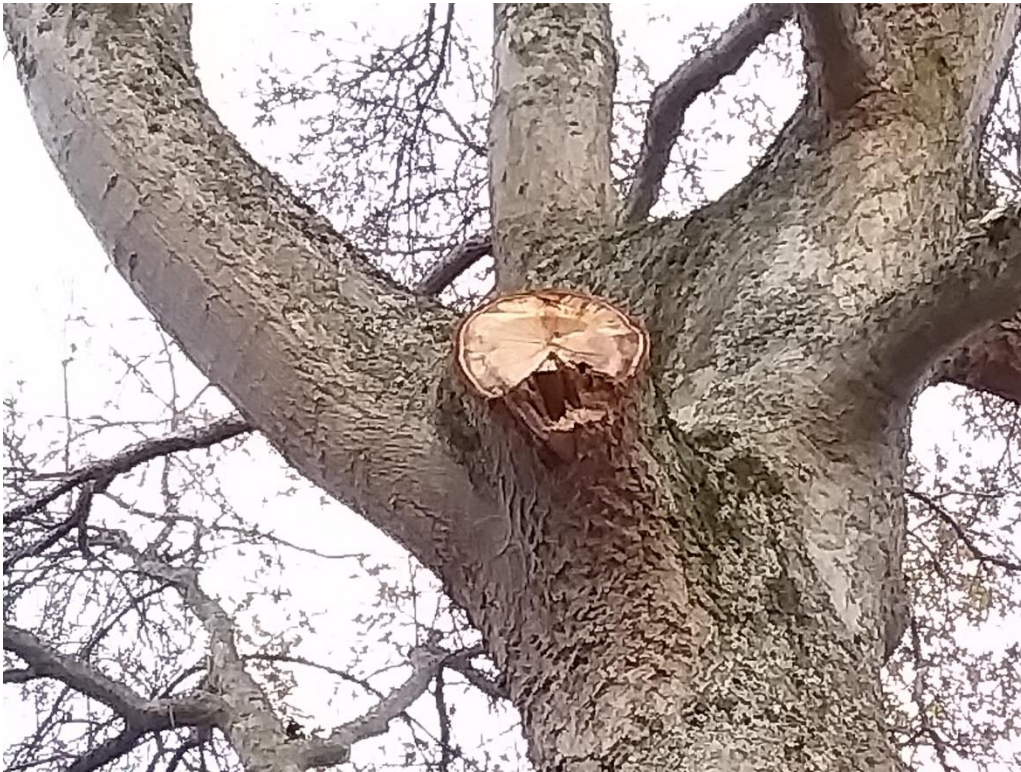
The two primary trees in question were Pin Oaks (*Quercus palustris*) standing in close proximity to the south side of the home (Figure 3). The first oak, at the SW corner of the garage/house measured 38" at the standard height of 54" above grade (DSH). It was roughly 70' tall with a 28' fairly even radial spread. The tree had extensive deadwood present that had been cleaned out within the last four months. The stub of a large lateral limb on the south side that was excised shows evidence of advanced decay close to the main union (Figure 4). The oak is in weak condition with limited new growth and twig died back throughout.

Figure 4. Looking at the point of the excised scaffold on the south side of the larger oak.

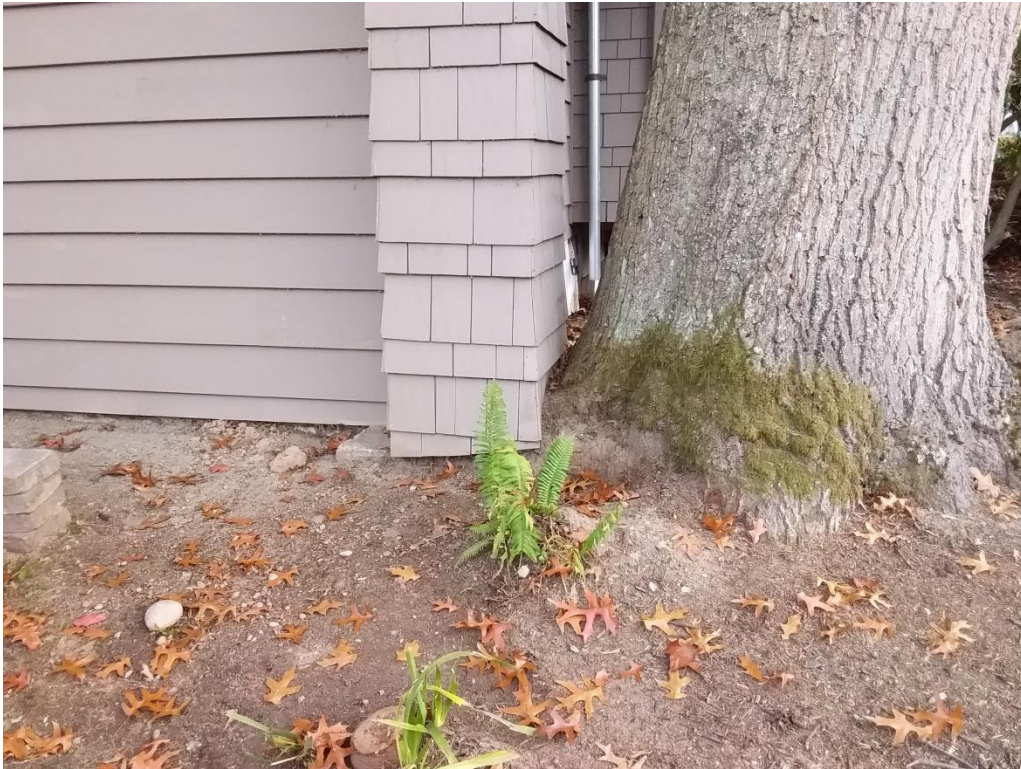
The root crown of the tree is pushing against and under the pillar pad (Figures 5 and 6). The post supported by the pad holds the SW corner of the 12'x 28' deck above the garage and forms the corner for the south and west garage walls. The siding is bowing out from the pressure of the tree uplifting the column.

Figure 5. Looking east at the base of the larger (#1) oak.

Discussion: There is literally no way to prune the roots of the larger oak because of its extremely close proximity to the home. Both trees are large enough to have full 10' radial structural root plates and any cutting within this area would critically compromise their holding power. It is highly likely that their roots are cross bound and any damage to one oak would affect the other.

The oaks essentially fall into the category covered by MICC 19.10.06(3)(a); they meet the criteria for removal because attempting to retain them creates an unavoidable hazardous situation. Namely the trees are currently damaging the home and are preventing its repair.

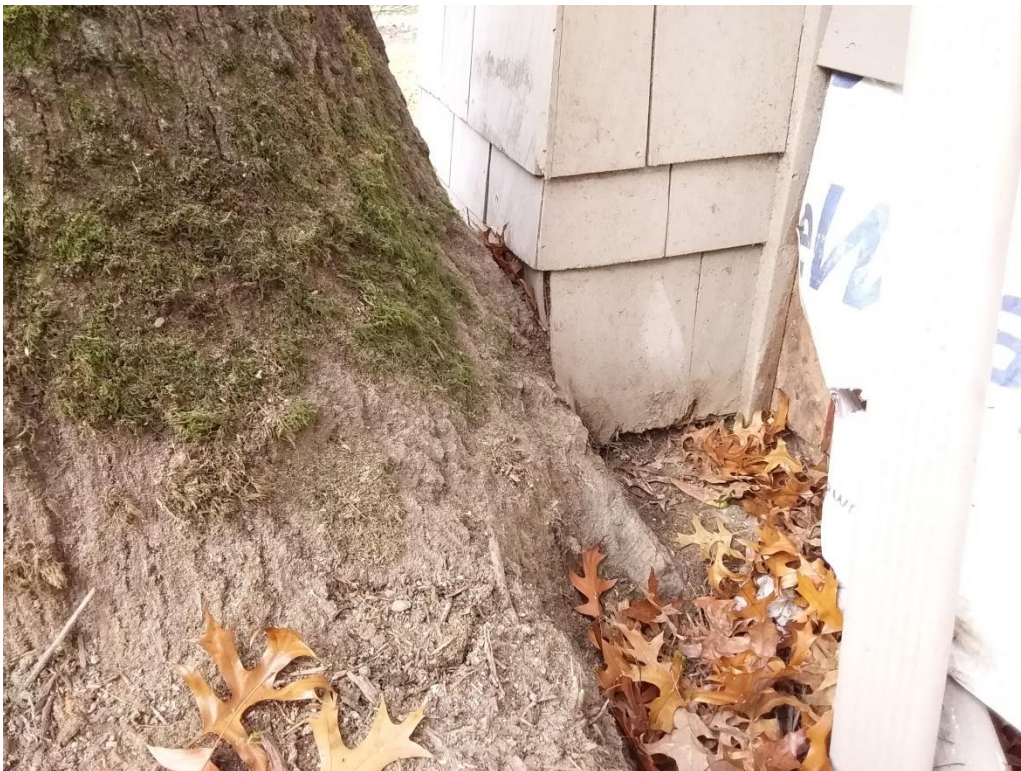
Figure 6. Looking NW at the base of the large oak pressing into the side of the garage. Note where the soil was removed to expose the roots in this area.

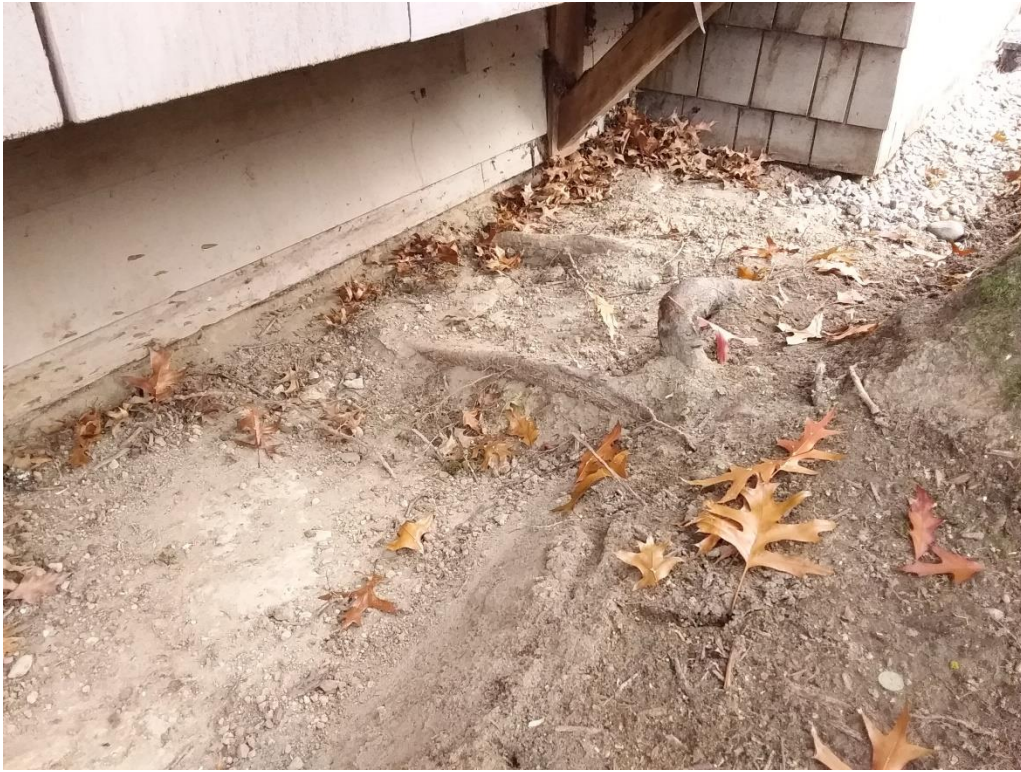
The second oak measured 23.5" DSH, (it was measured twice to make sure) was close to 55' tall, and spreads mainly to the southeast on a handful of scaffolds. It is in slightly better health than its larger neighbor. The tree stands 24" S of the corner of the garage wall footing where it jogs back to the north and 39" S of the main foundation (Figure 7). There are roots visible going under the footings in both directions.

Figure 7. Looking NE at the exposed roots of the smaller (#2) oak. The root crown is just visible at the right side of the image.

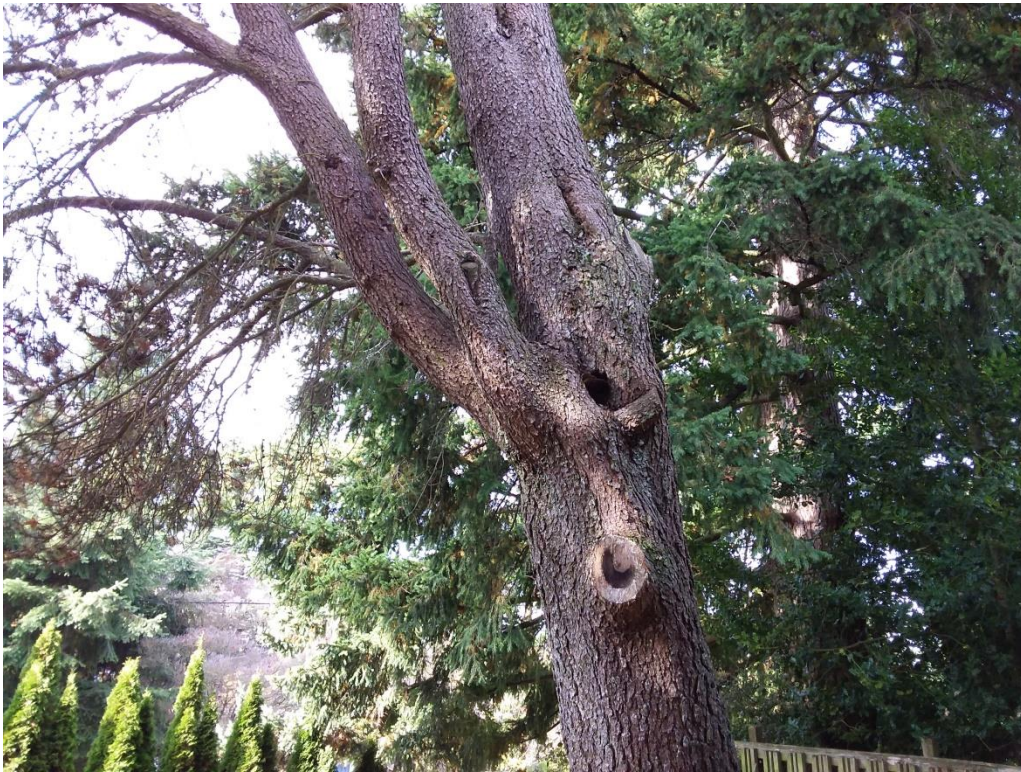
The third tree was a Black Pine (*Pinus nigra*) standing off the NW corner of the house. A previous arborist had already recommended its removal and applied for a permit. The pine had a noticeable lean and was weighted slightly toward the house. It measured 20" DSH, was 45' tall, and separated into multiple spars above the 9' level (Figure 8). The pine has an atypical basal formation that is often associated with trees growing over a stump or recovering around an atrophied area (Figure 9). The swelling is twice the diameter of the trunk up to 24" above grade. Fungal bodies are present in the SW quadrant of the base, where an atrophied structural root is seen on the base's east face, and at the main separation point of the trunk (Figures 10-12).

Figure 8. Showing the separation point of the #3 pine (looking NW).

The other arborist's recommendation to remove the pine makes sense because of the tree's abnormal basal structure, the decay present, the presence of the fungal bodies, and the lean of the tree toward the home.

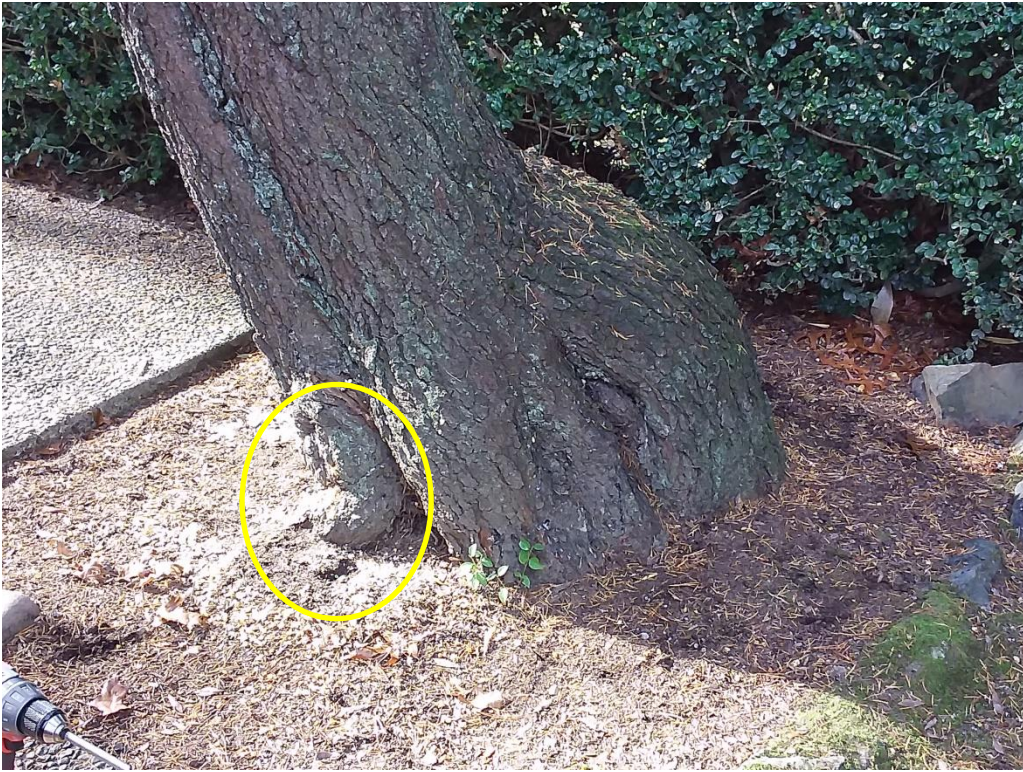
Figure 9. Showing the basal formation of the pine. The atrophied structural root is circled.

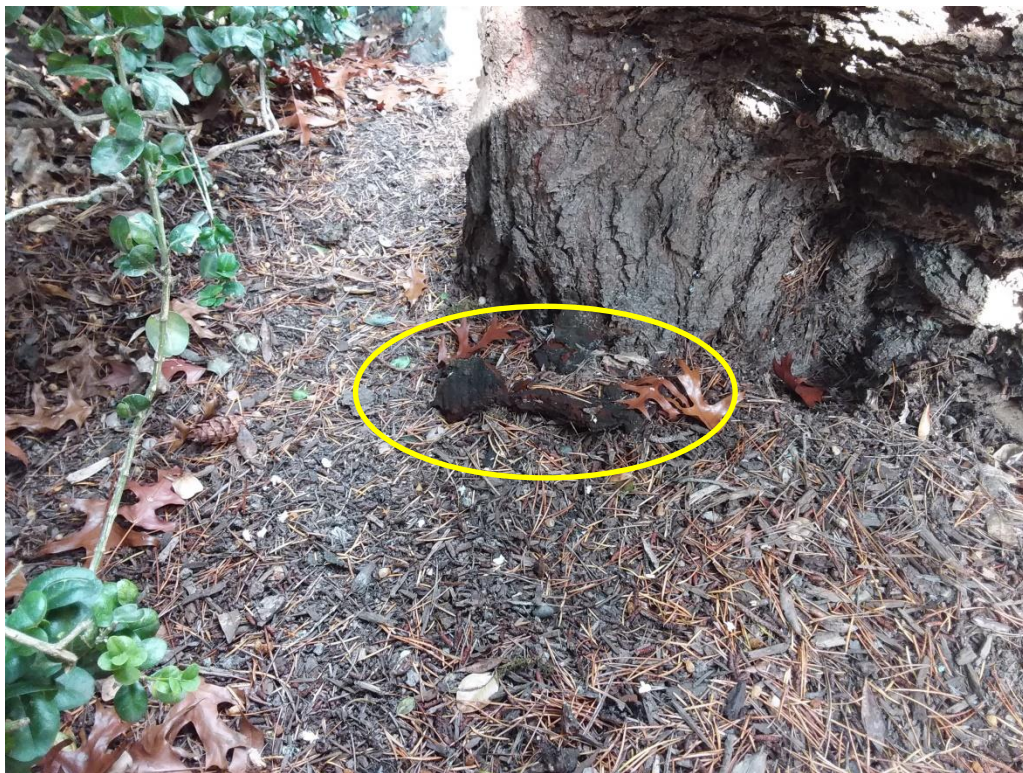
Core tests taken at 14" above grade revealed a localized decay column. On the north face there was a 3" sidewall and then 10" of decay. The one taken on the east face revealed no decay to 15" depth. On the west face the test the decay column was seen after a 6" side wall.

Figure 10. Showing the fungal fruiting body at the base of the tree.

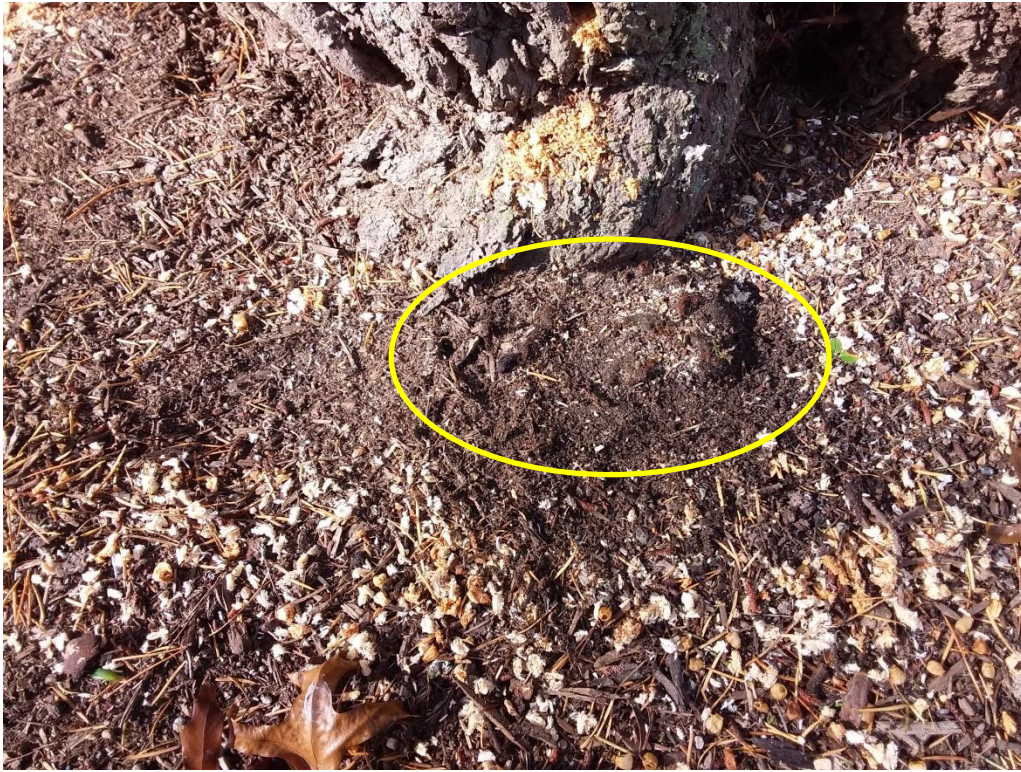
Figure 11. Fungal body where atrophied structural root should have been.

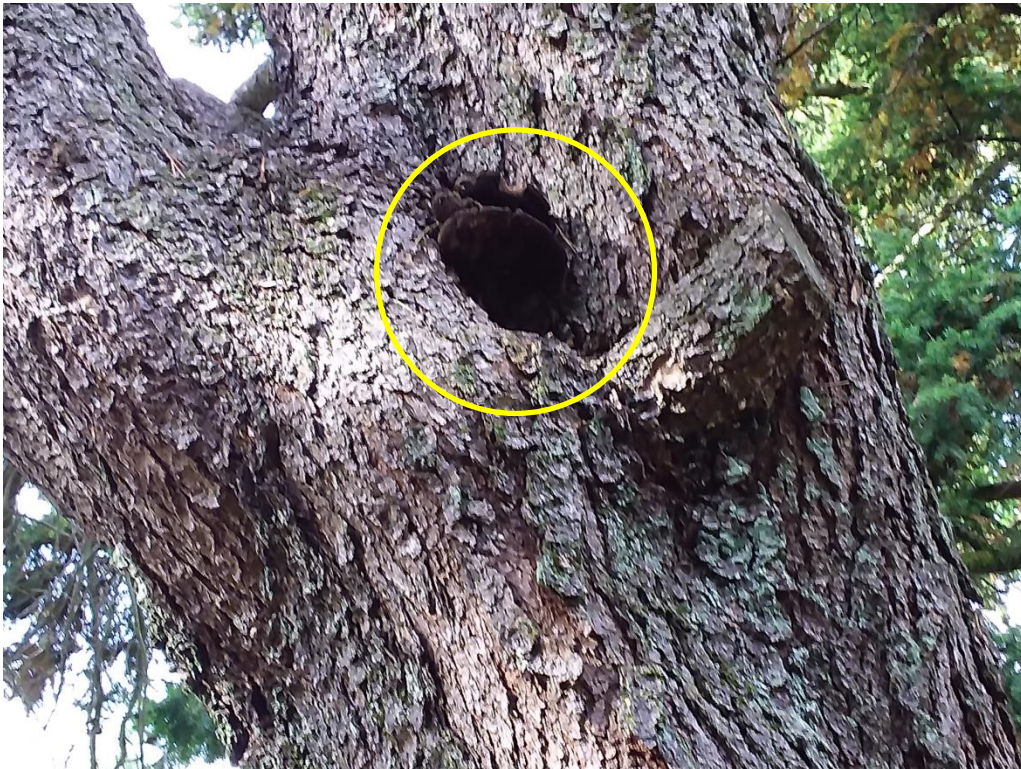
Figure 12. Fungal body near the separation point
