- Tree Protection Plan -

## AMERICAN CLASSIC HOMES

49xx 89<sup>th</sup> Ave. SE  
Mercer Island, WA

Prepared for: American Classic Homes  
Prepared by: Washington Forestry Consultants, Inc.  
Date of Report: January 7, 2021

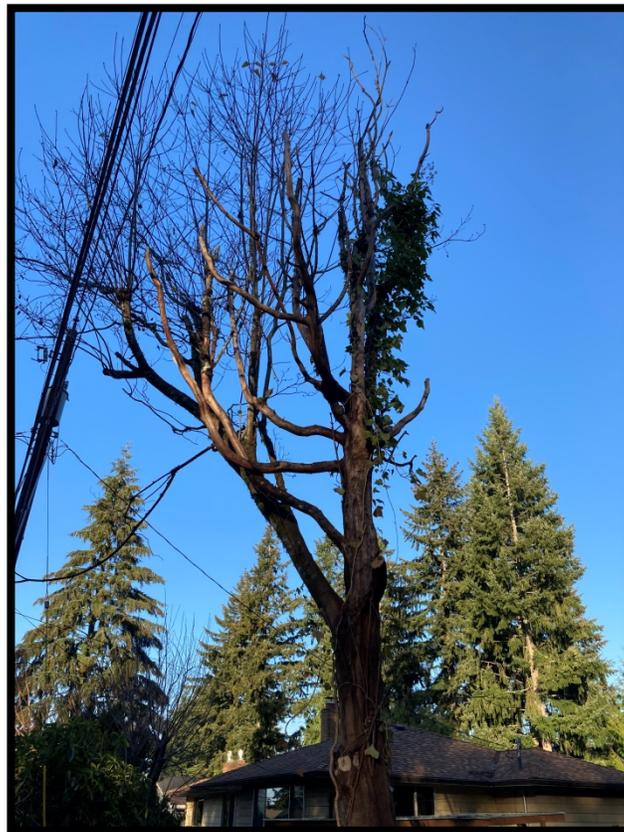
The threshold DBH for a Pacific dogwood is 6 inches. However, tree #322 is growing under the powerline, has been topped for powerline clearance repeatedly, and over 50% of the remaining crown has died. This is a highly defective tree. It cannot be repaired by pruning. It should be removed and replaced with a quality tree in a coherent landscape design.

**Photo A. View of tree #322 – topped and dying Pacific dogwood.**

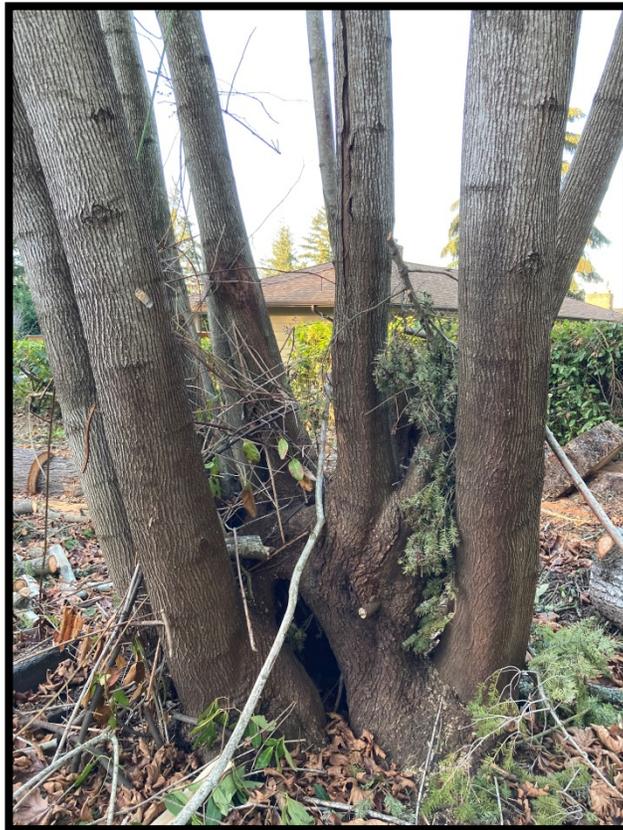
The bigleaf maples are all composed of stump sprouts growing from very low stumps. They will not make good long-term trees. As the sprouts increase in diameter, they will begin to exert pressure on each other, causing the stems to crack out and fail. Removal and replacement with quality trees in a coherent landscape design is the best short- and long-term plan for this site.

**Photo B. View of the stems of tree #339.**

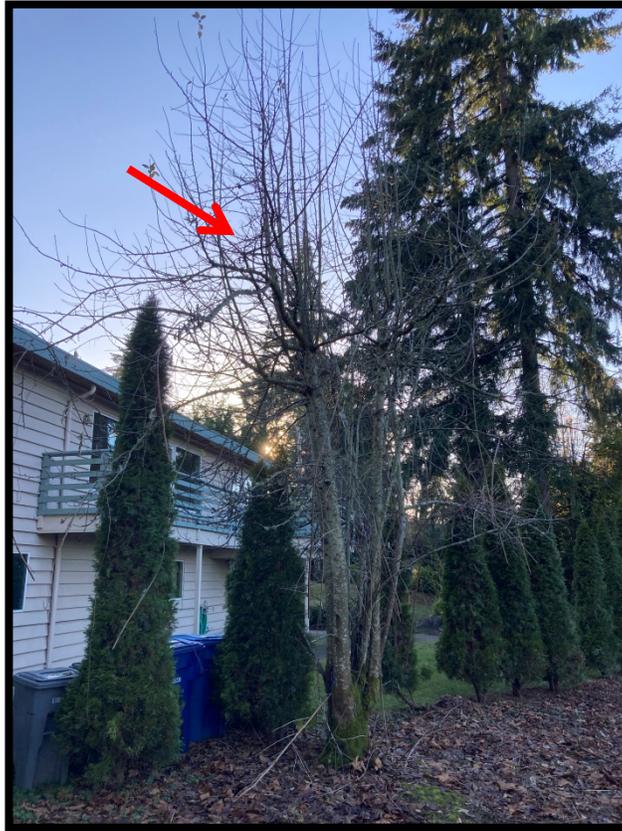
The Washington hawthorne (threshold of 9 inches DBH) is composed of 6 sprouts and rated as being in 'Very Poor' condition due to past breakage and/or poor pruning practices. It should not, in my opinion be considered to be an exceptional tree. Removal and replacement with a quality tree species in a coherent landscape design is the best short and long-term solution for this tree.

Photo C. View of the hawthorne #1. Defective tree.

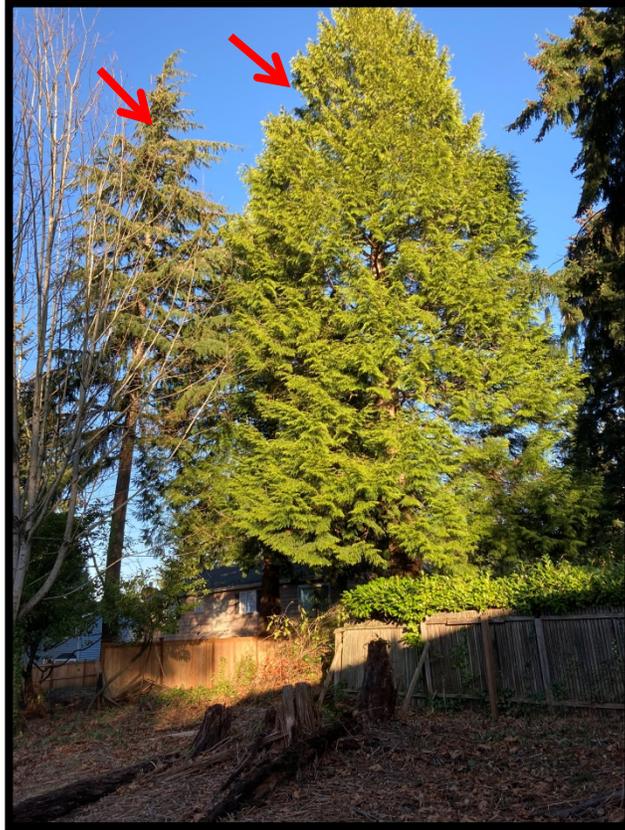
**Photo C. View of off-site western redcedar #A and Douglas-fir tree #G. Requires a tree protection fence 3 ft. inside ACH lot.**

Only trees #A and G require a tree protection fence to be located 2-3 ft. inside the project lot to protect the off-site trees. The remainder of the trees are buffered by root protection zone on the adjacent lots. Tree #C is deceptive in appearance on an aerial photo – it looks like the tree is on the property line, it is not. It leans to the north giving the appearance of being close to the property line.

There are 2 off-site trees that may require tree protection fencing. Trees in the vicinity of grading and construction to be saved must be protected during construction by temporary orange plastic mesh fencing on driven posts (Attachment 2.), located at the edge of the critical root zone. The individual critical root zones are 1 foot radius for each 1 inch of DBH unless otherwise delineated by WFCI.

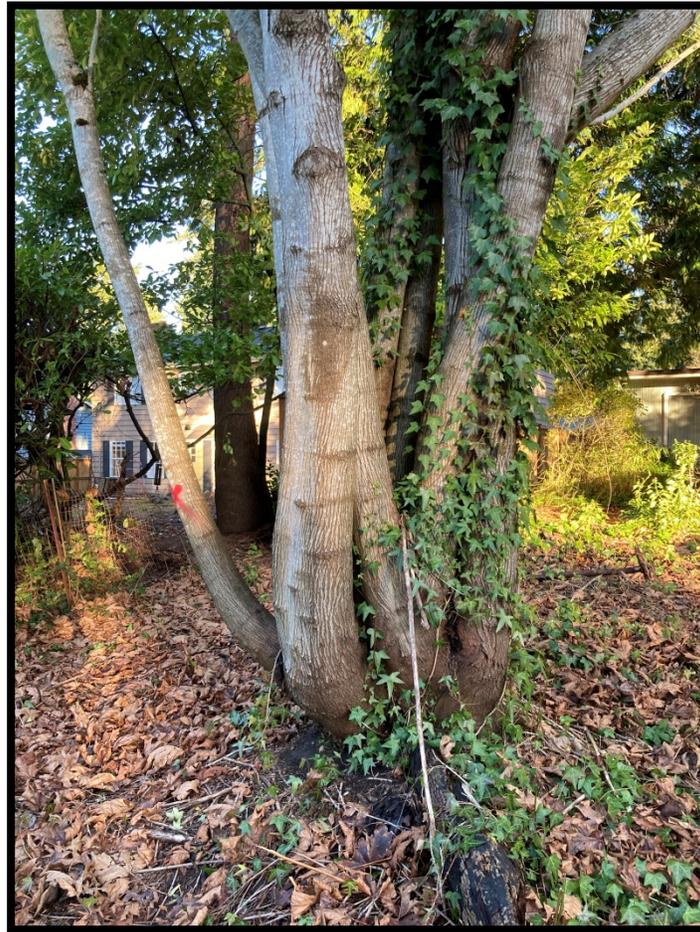
**Photo D. View of tree #330. Not a quality tree – future hazard tree.**

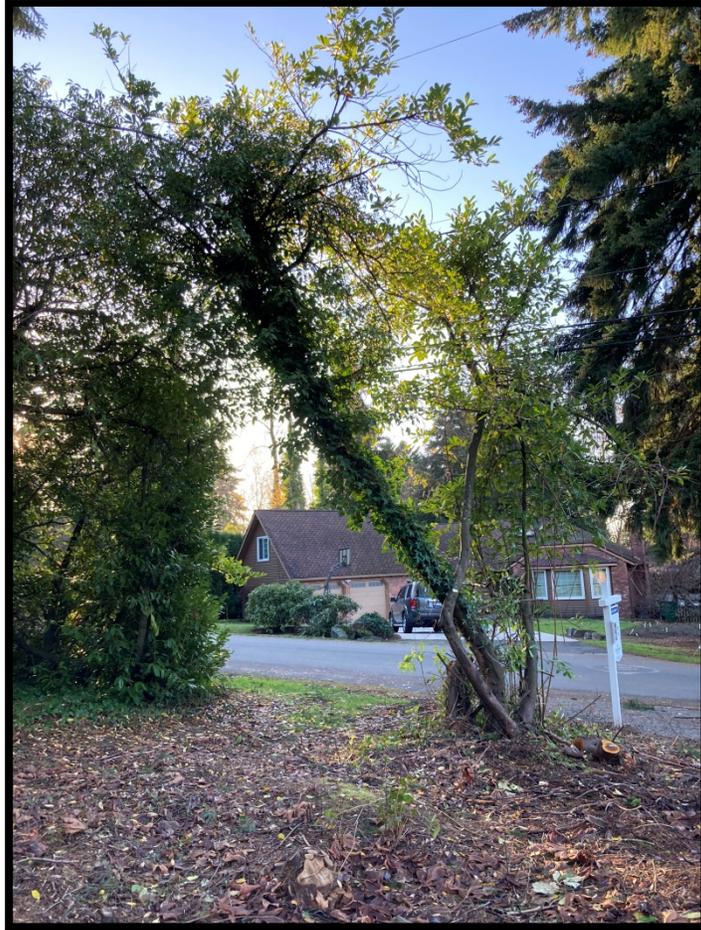
No other trees meet the exceptional status. The English (cherry) laurel is excluded from consideration since it is severely defective and listed as a noxious weed in the State of Washington and the King County Noxious weed lists. It is also growing under the powerline.

**Photo E. View of tree #314, the English laurel.  
Defective tree under powerlines.**

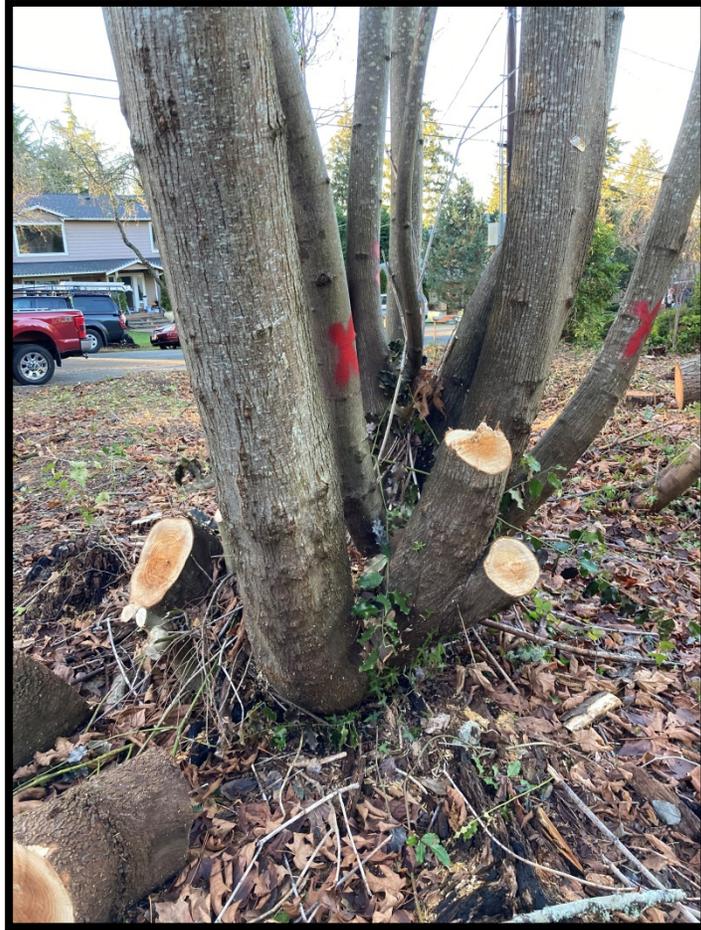
**Photo F. View of remains of tree #331.**
