## Arborist Report

To: Buping Wang & Wanqui Yang  
Site: 6450 E Mercer Way, Mercer Island, WA 98040  
Re: Tree Inventory  
Date: February 2, 2024  
Project Arborist: Charlie Vogelheim  
ISA Certified Arborist PN-9375A  
ISA Qualified Tree Risk Assessor  
Reviewed By: Tyler Bunton  
ISA Certified Arborist PN-8715A  
ISA Qualified Tree Risk Assessor  
Referenced Documents: Wang & Yang ADU, Architectural Proposed Site Plan A1.02 (Siyao Studios, 1/31/2024)  
Attached: Table of Trees  
Tree Site Map

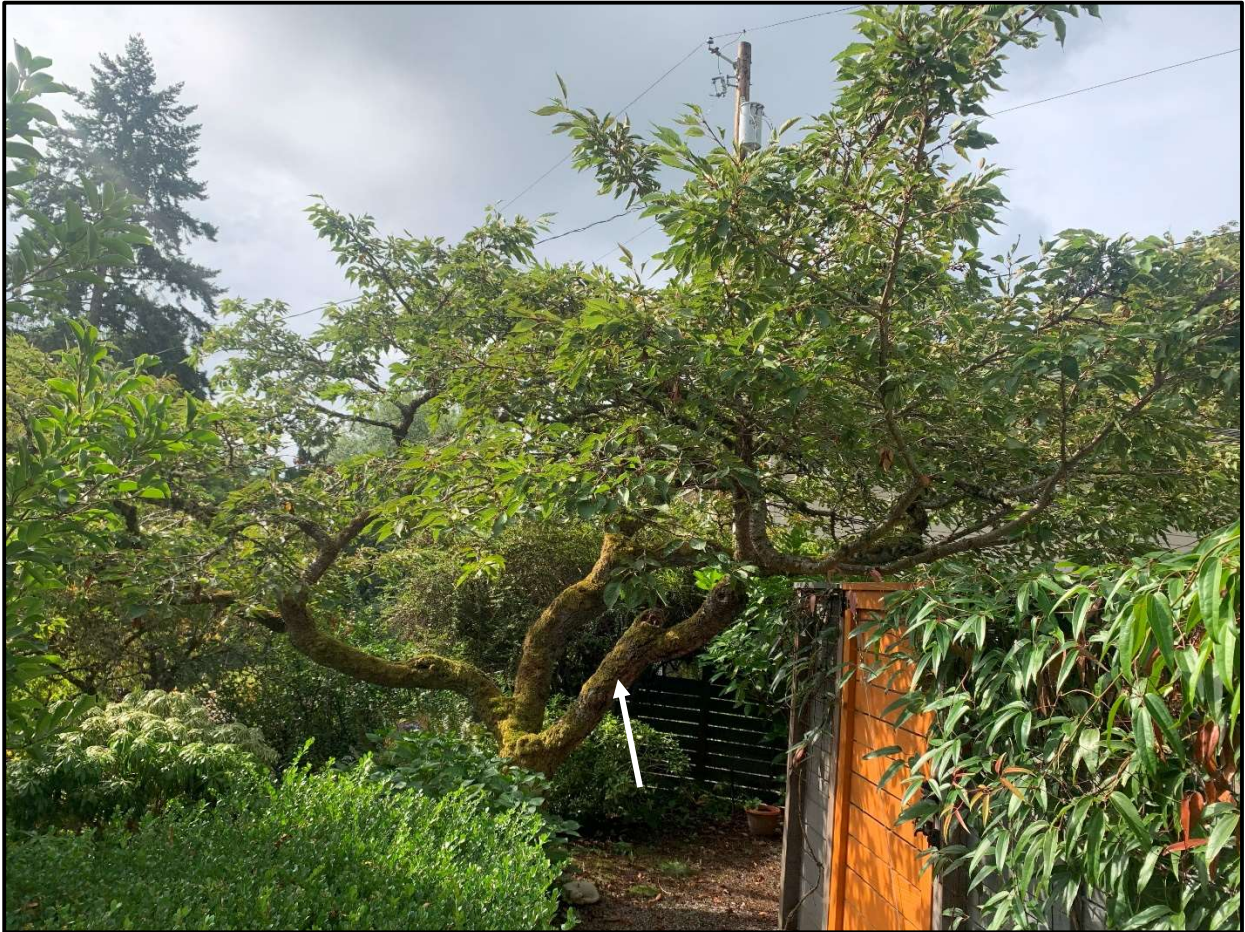
This tree has a RLOD of 9 feet and a RLOD of 6 feet, no ground disturbance or regrading may occur within 6 feet of this tree. The building footprint for the extension of the garage/ADU structure extends to approximately 8.5 feet north of tree 269 and is within the tree's dripline and its RLOD of 9 feet. Plans indicate that some sidewalk will be removed within the northern part of the RLOD, and that sidewalk panels will be installed in the northwestern part of the RLOD.

Since the dripline extends to the north 13.6 feet, this tree will require pruning for the installation of this structure. All pruning should be conducted by an ISA certified arborist following current applicable ANSI A300 specifications.

**Photograph 1.** Looking south at tree 269. Current plans call for the extension of a garage/ADU to be 8.5 feet of this tree. Branches on the scaffold to the northwest (arrow) will need to be pruned for building and construction clearance.

All work within the RLOD should specifications laid out in Appendix F. Notably, a flat-front bucket should be used when removing the sidewalk within the RLOD, air-excavation should be used for any excavation within the RLOD, and any required subgrade or fill should use well-draining aggregates with little fines.
