**ARBOR INFO LLC**

**Tree Assessment  
For  
Sturman Architects  
At  
Mounger Residence  
4006 E. Mercer Way  
Mercer Island, Washington**

**Date  
8/28/2020**

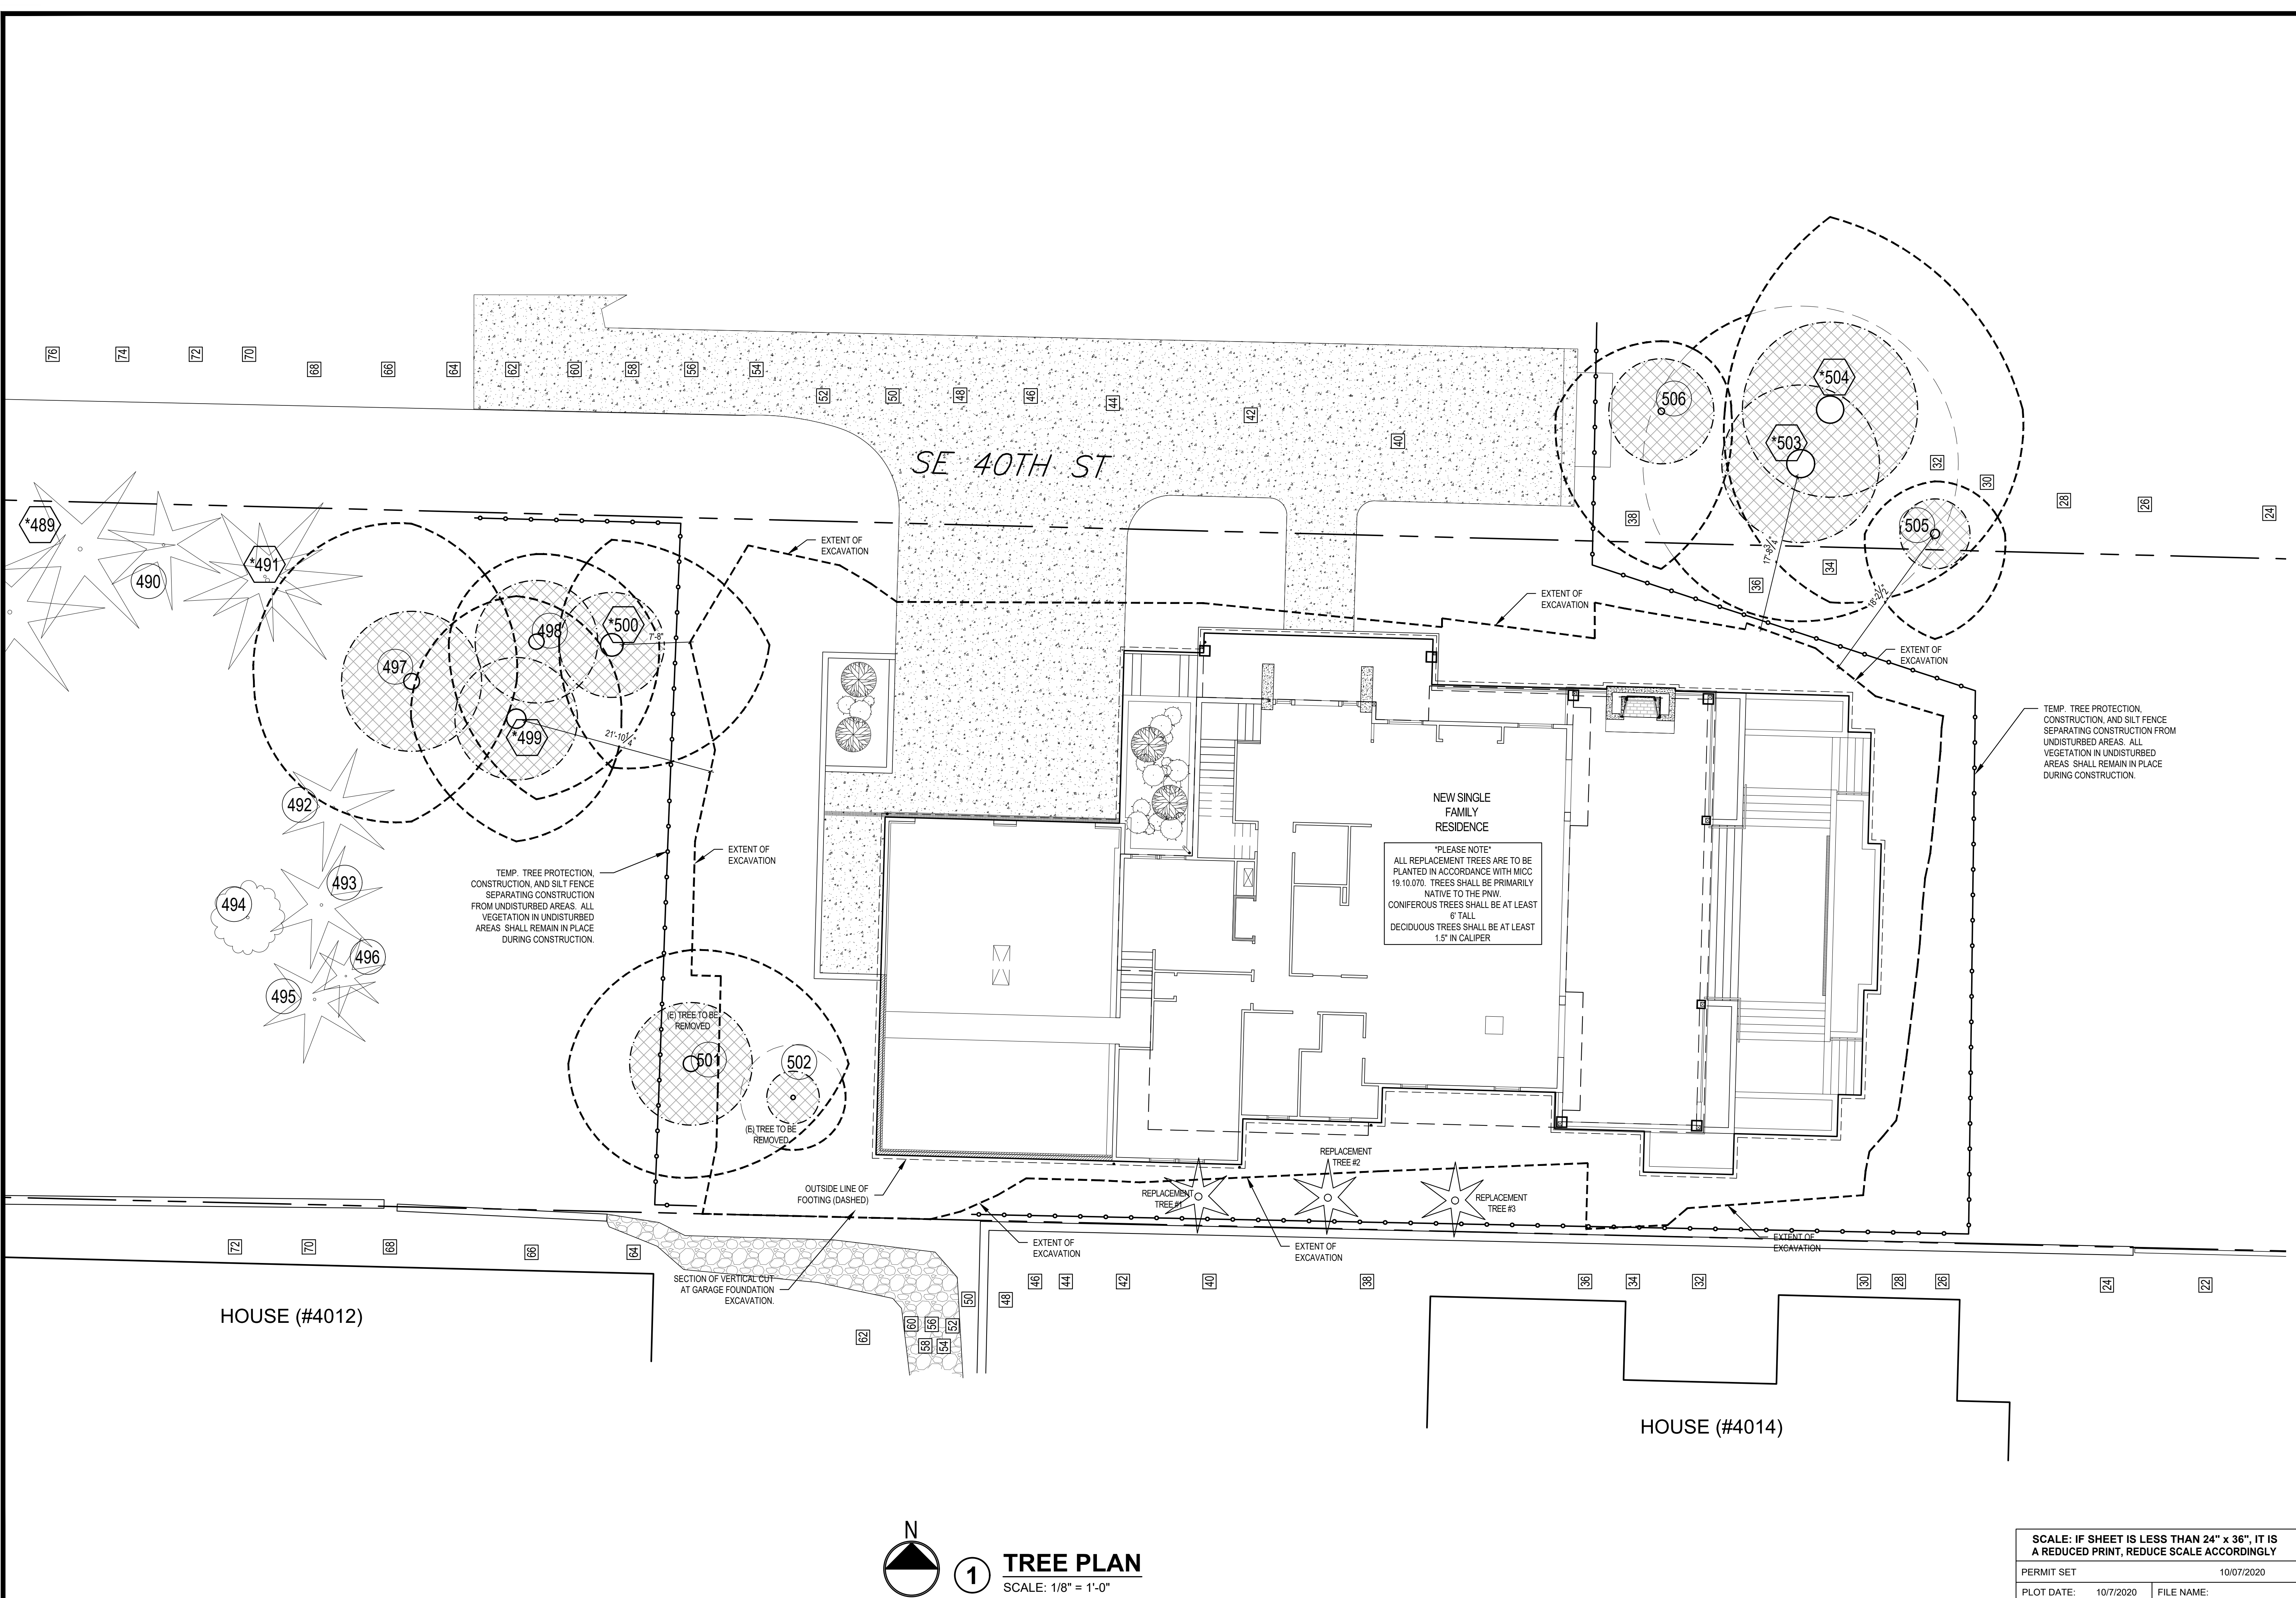
**1 TREE PLAN**  
SCALE: 1/8" = 1'-0"

Only tree No. 1 and No. 2 will be removed. Tree No. 3 is measured at 11.5 feet east of the excavation zone. This encroachment into the root zone will affect less than about 15-percent of the that zone and is within acceptable standards. No other trees are planned for removal or within dripline distance to the excavation.

The root zone of Tree No. 500 is within the proposed access excavation area. Excavation, down-hill from the tree will remove 93 square feet of the total 462 square feet or about 20-percent. Considering the down-hill location and the subsequent rebuilding of the retention wall, in my opinion this tree will not be significantly affected.

- Certified Arborist on site during excavation activities within the defined root zone of all trees.
- All trees to be retained are to be fenced at the edge of the recommended tree protection zone with 6-foot high cyclone type fencing.

- Utility lines should be bored. Bore access pits to be developed with 18” buckets or hand dug.
- Retaining wall footings to be minimally deep, no more than 12-inches.

- Tree roots over 1-1/2 inches in diameter encountered in all excavations are to be cut cleanly to the trench wall with clean sharp tools. Roots to be covered with soil or wetted burlap if they must remain exposed.

- Supplemental irrigation is to be provided during summer months (generally June-September) for all trees in the construction zones.
- Recommended protected tree root zones are to be covered with 4-inches of hog fuel at all times. Where machinery access is needed, the root zones should be covered with 12-inches of hog fuel, plywood or steel sheets.

- Stumps for trees to be removed are to be ground out (not excavated).
