Arborist Report

*Tree Protection Plan
September 29, 2023*

**Herzl-Ner Tamid Conservative
Congregation**

Davey Resource Group, Inc.

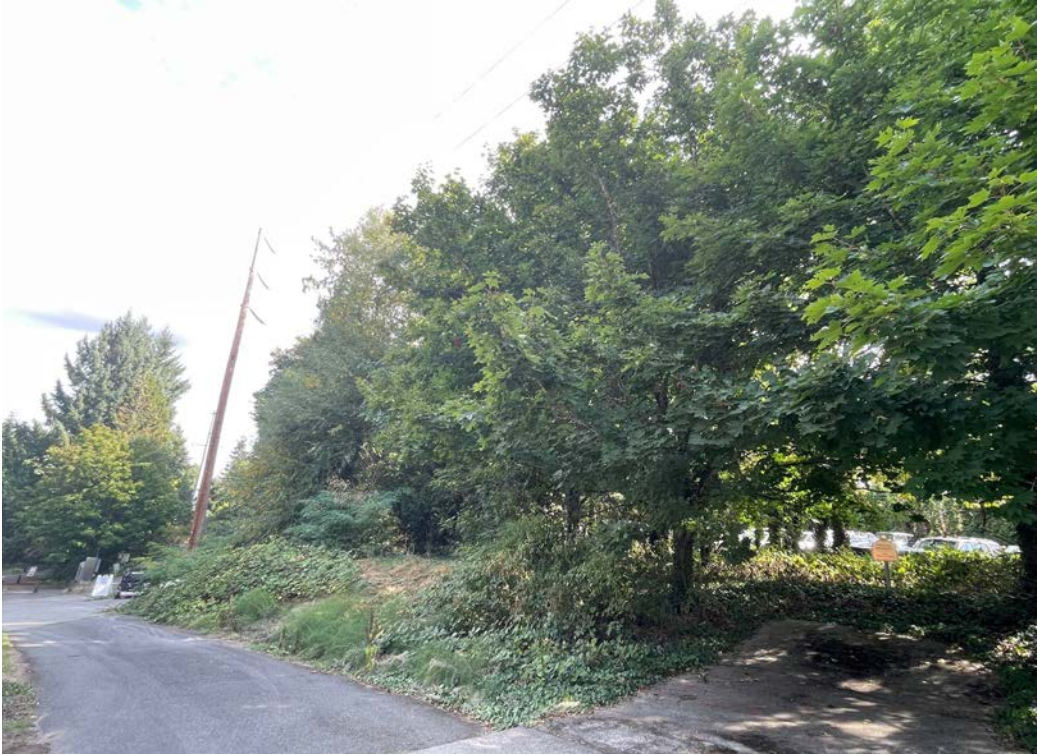
Image 1. Site picture of a portion of the natural area

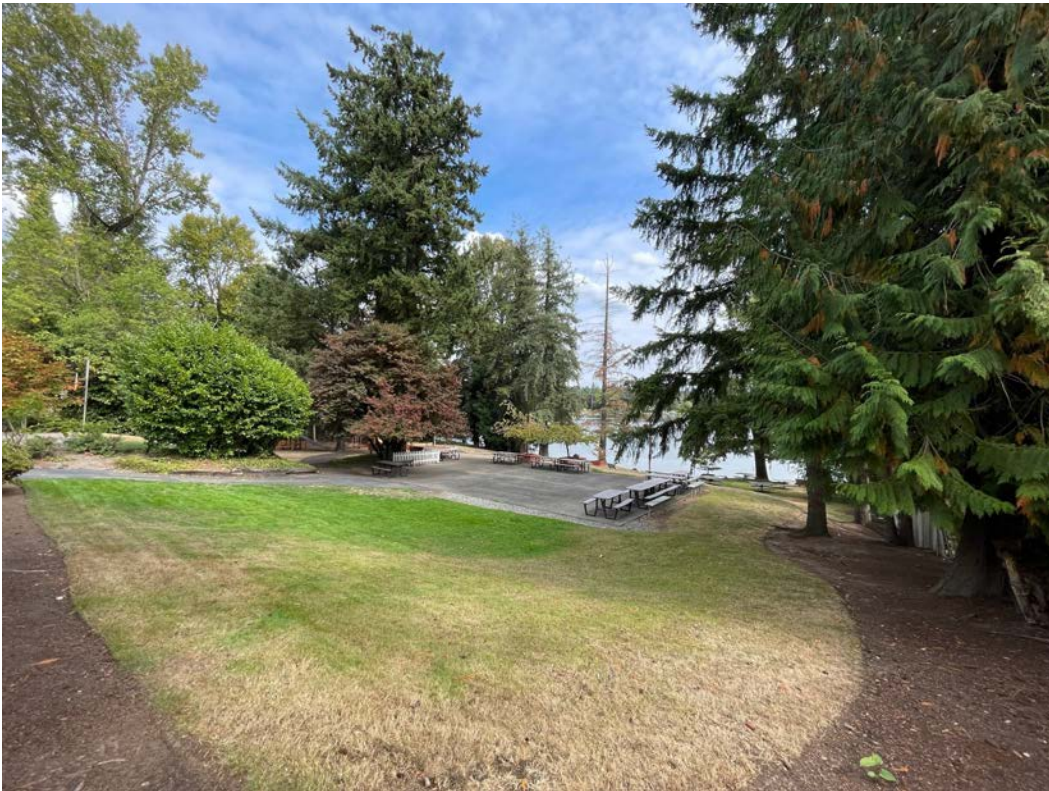
Image 2. Site picture of the waterfront park

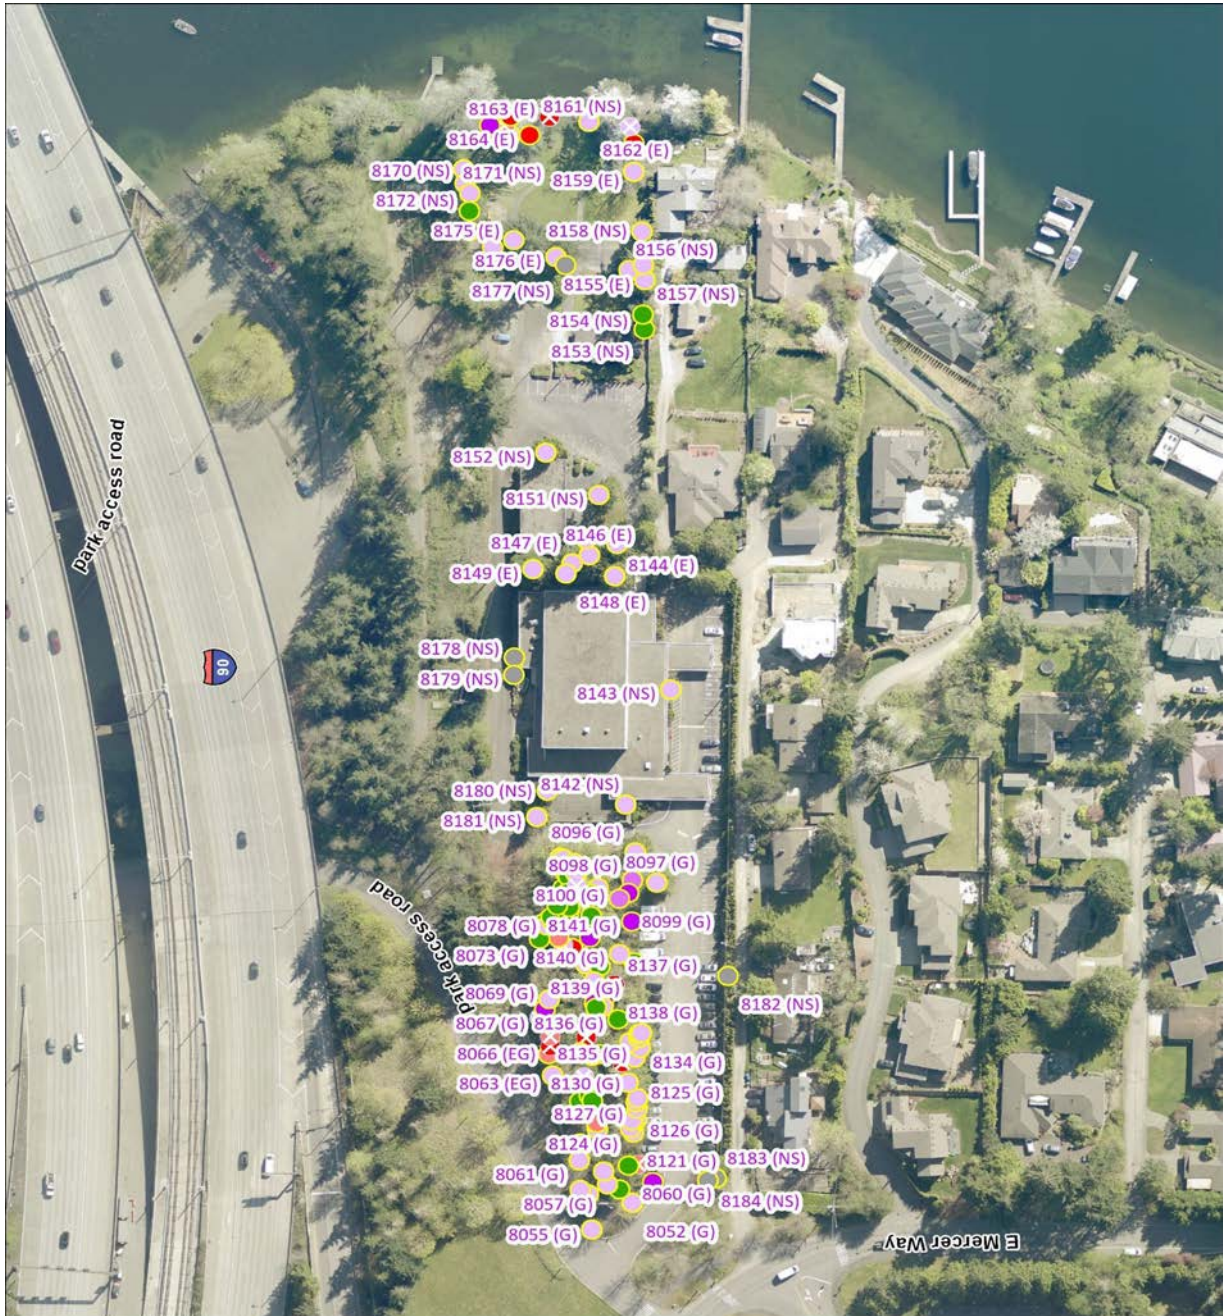
Map 1- Site map overview showing tree ID number. Aerial photos are only used for reference. Map projections may distort tree canopy size and locations.

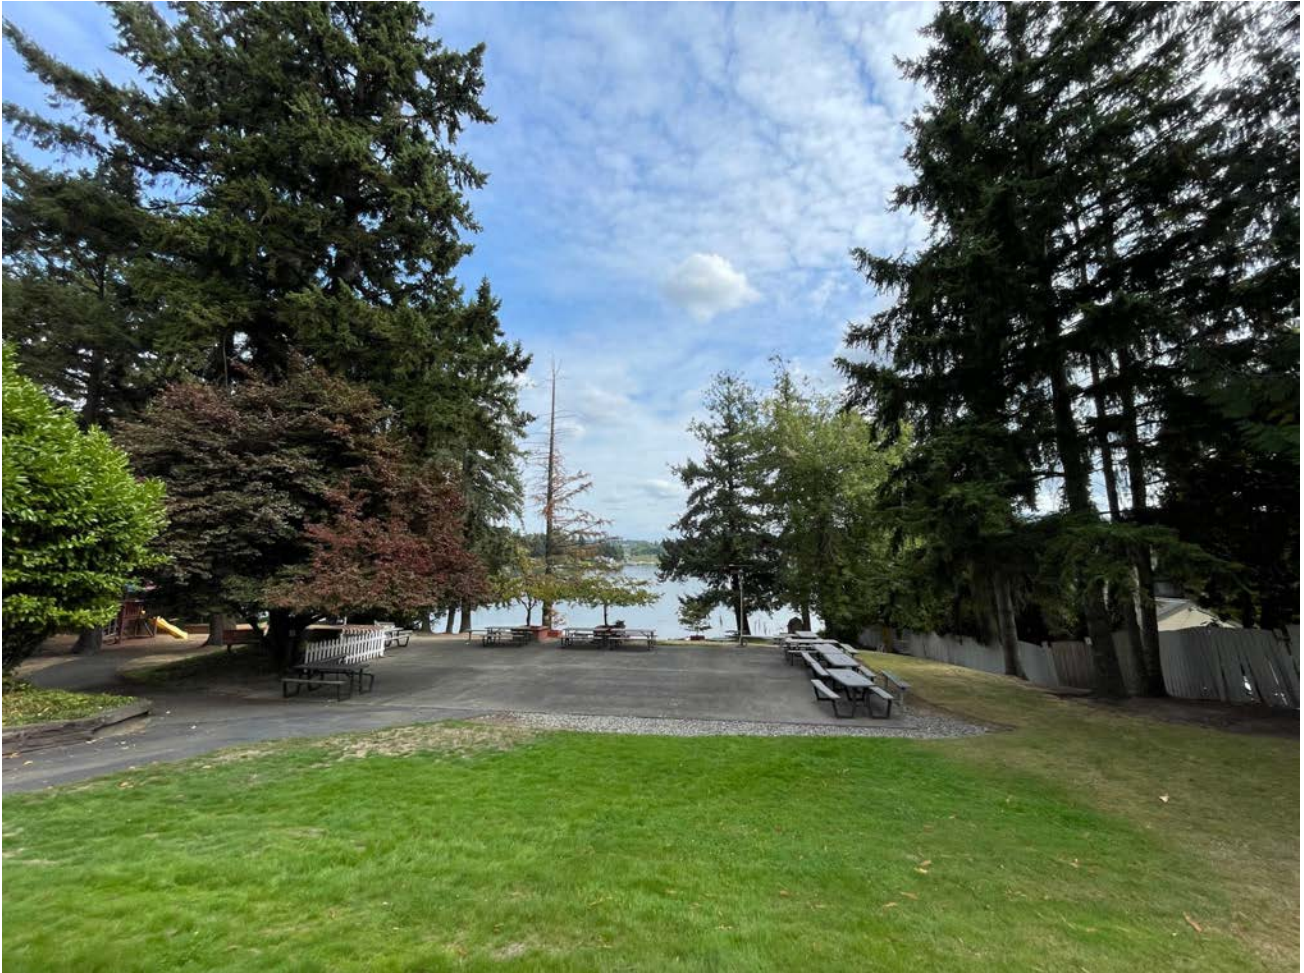
Image 4. Waterfront Park

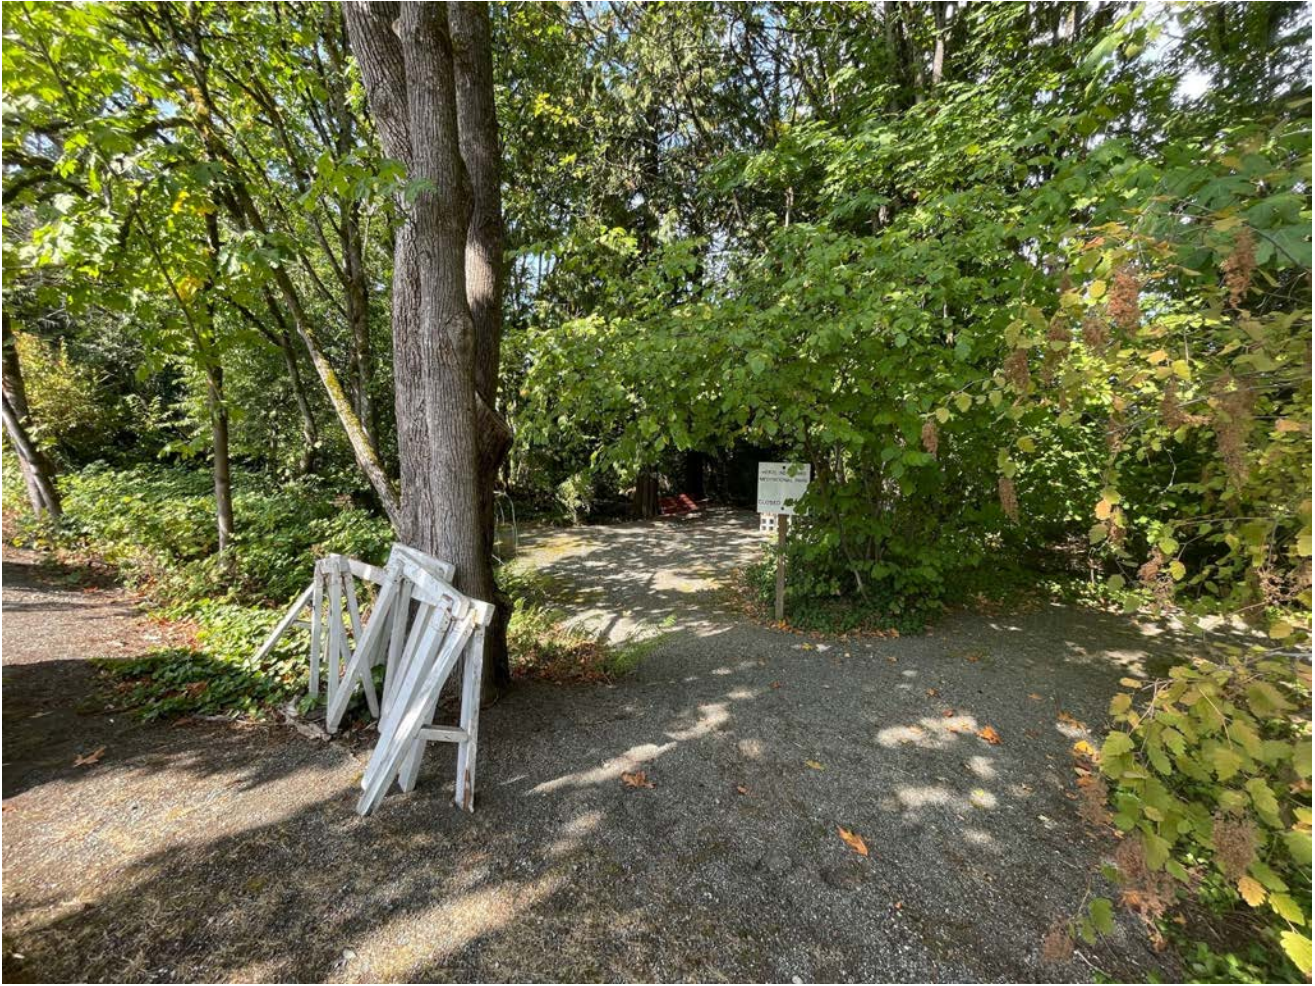
Image 5. Section of the Natural Area on parking lot side
