*Subsurface Exploration, Geologic Hazard, and
Geotechnical Engineering Report*

ARVIND RESIDENCE

Mercer Island, Washington

March 10, 2023

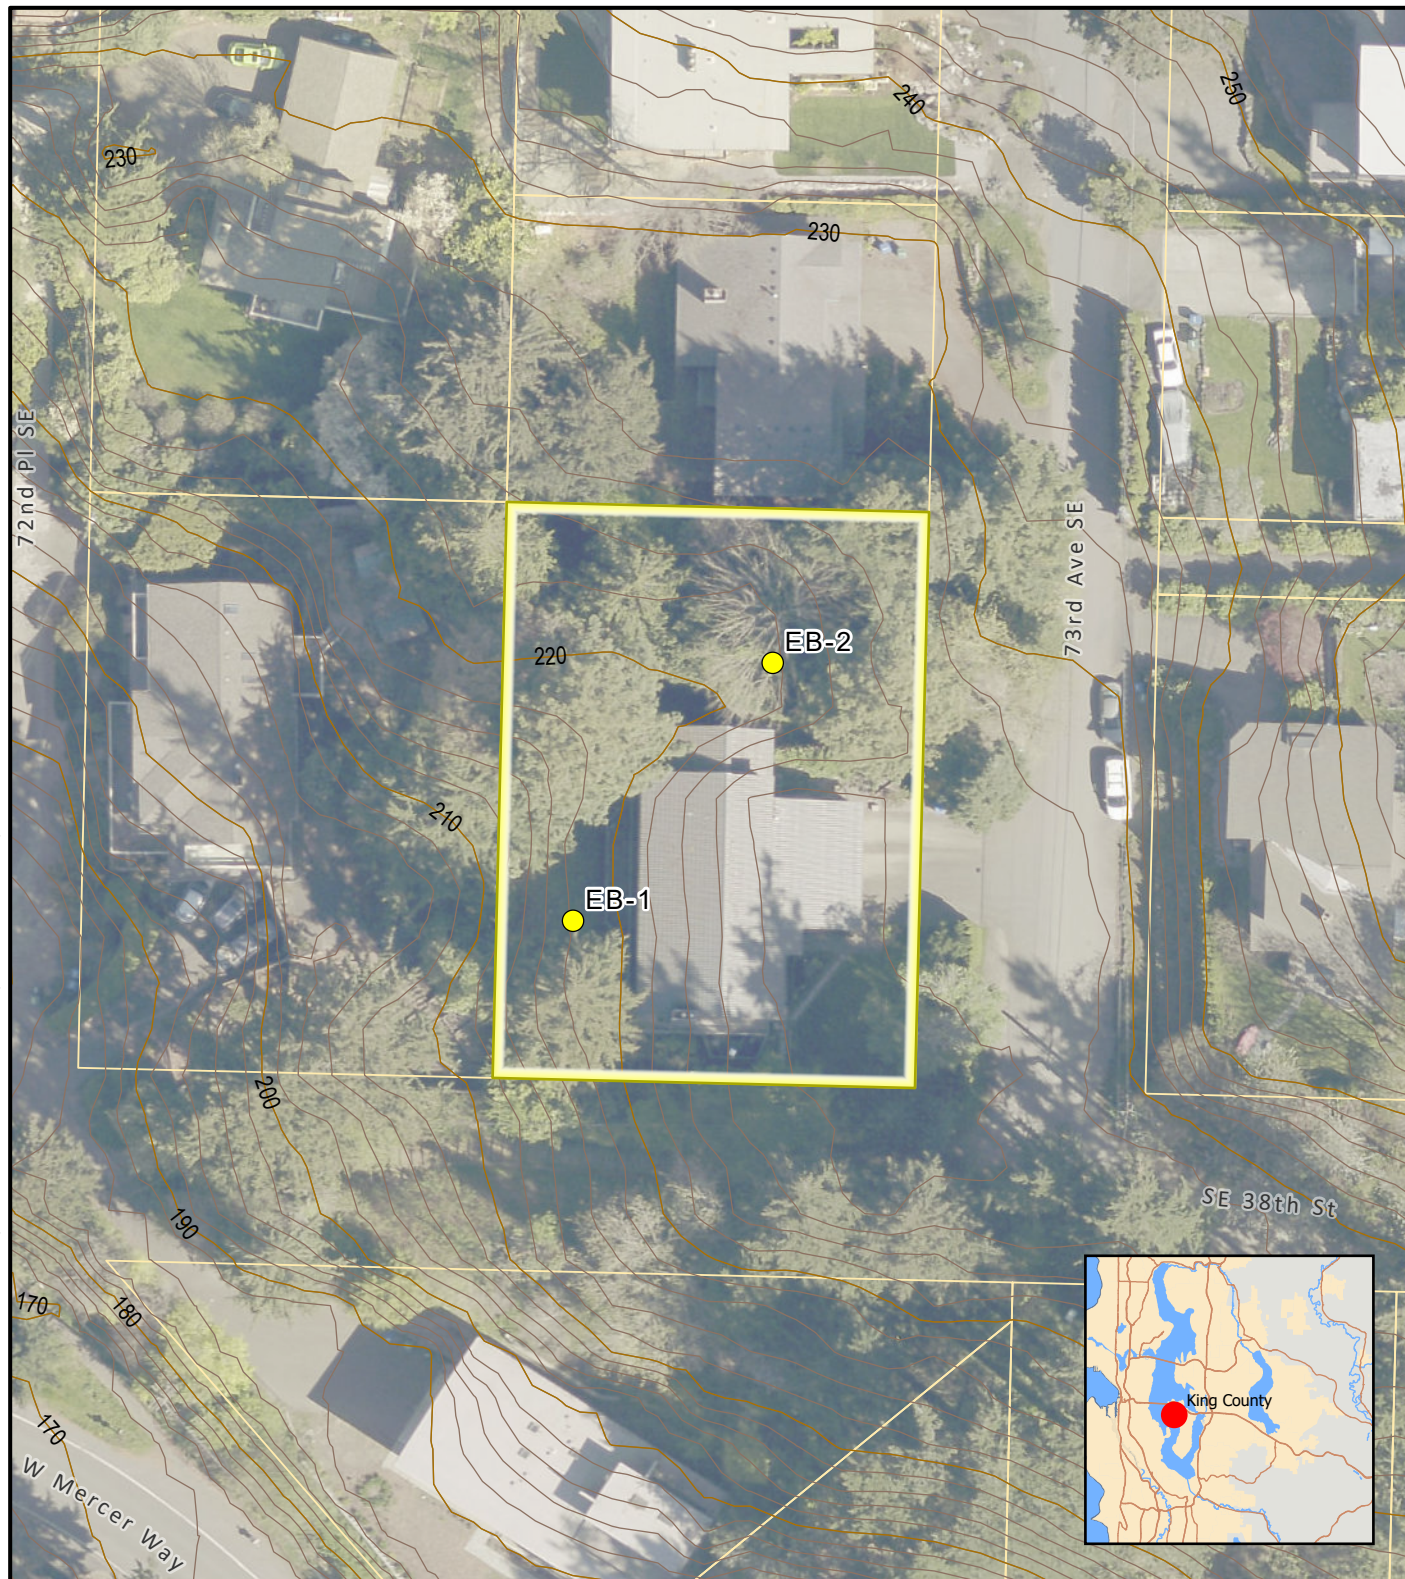
PROJ NO. 20220409E001	DATE: 3/23	FIGURE: 2
---------------------------------	----------------------	---------------------

The subsurface exploration and geologic site reconnaissance was conducted on February 8, 2023, and consisted of advancing two exploration borings to gain subsurface information about the site. The various types of materials and sediments encountered in the explorations, as well as the depths where characteristics of these materials changed, are indicated on the exploration boring logs presented in the Appendix. The depths indicated on the logs where conditions changed may represent gradational variations between sediment types in the field. If changes occurred between sample intervals in our borings, they were interpreted. The locations of the exploration borings are shown on Figure 2 and Figure 3.

- Inclinations on the slope had changed from the topographic contours shown on Figures 2 and 3, where slope inclinations were approximately 32 percent, to its current condition where fill soils were retained behind cast-in-place concrete walls approximately 4 to 5 feet tall west of the existing residence.

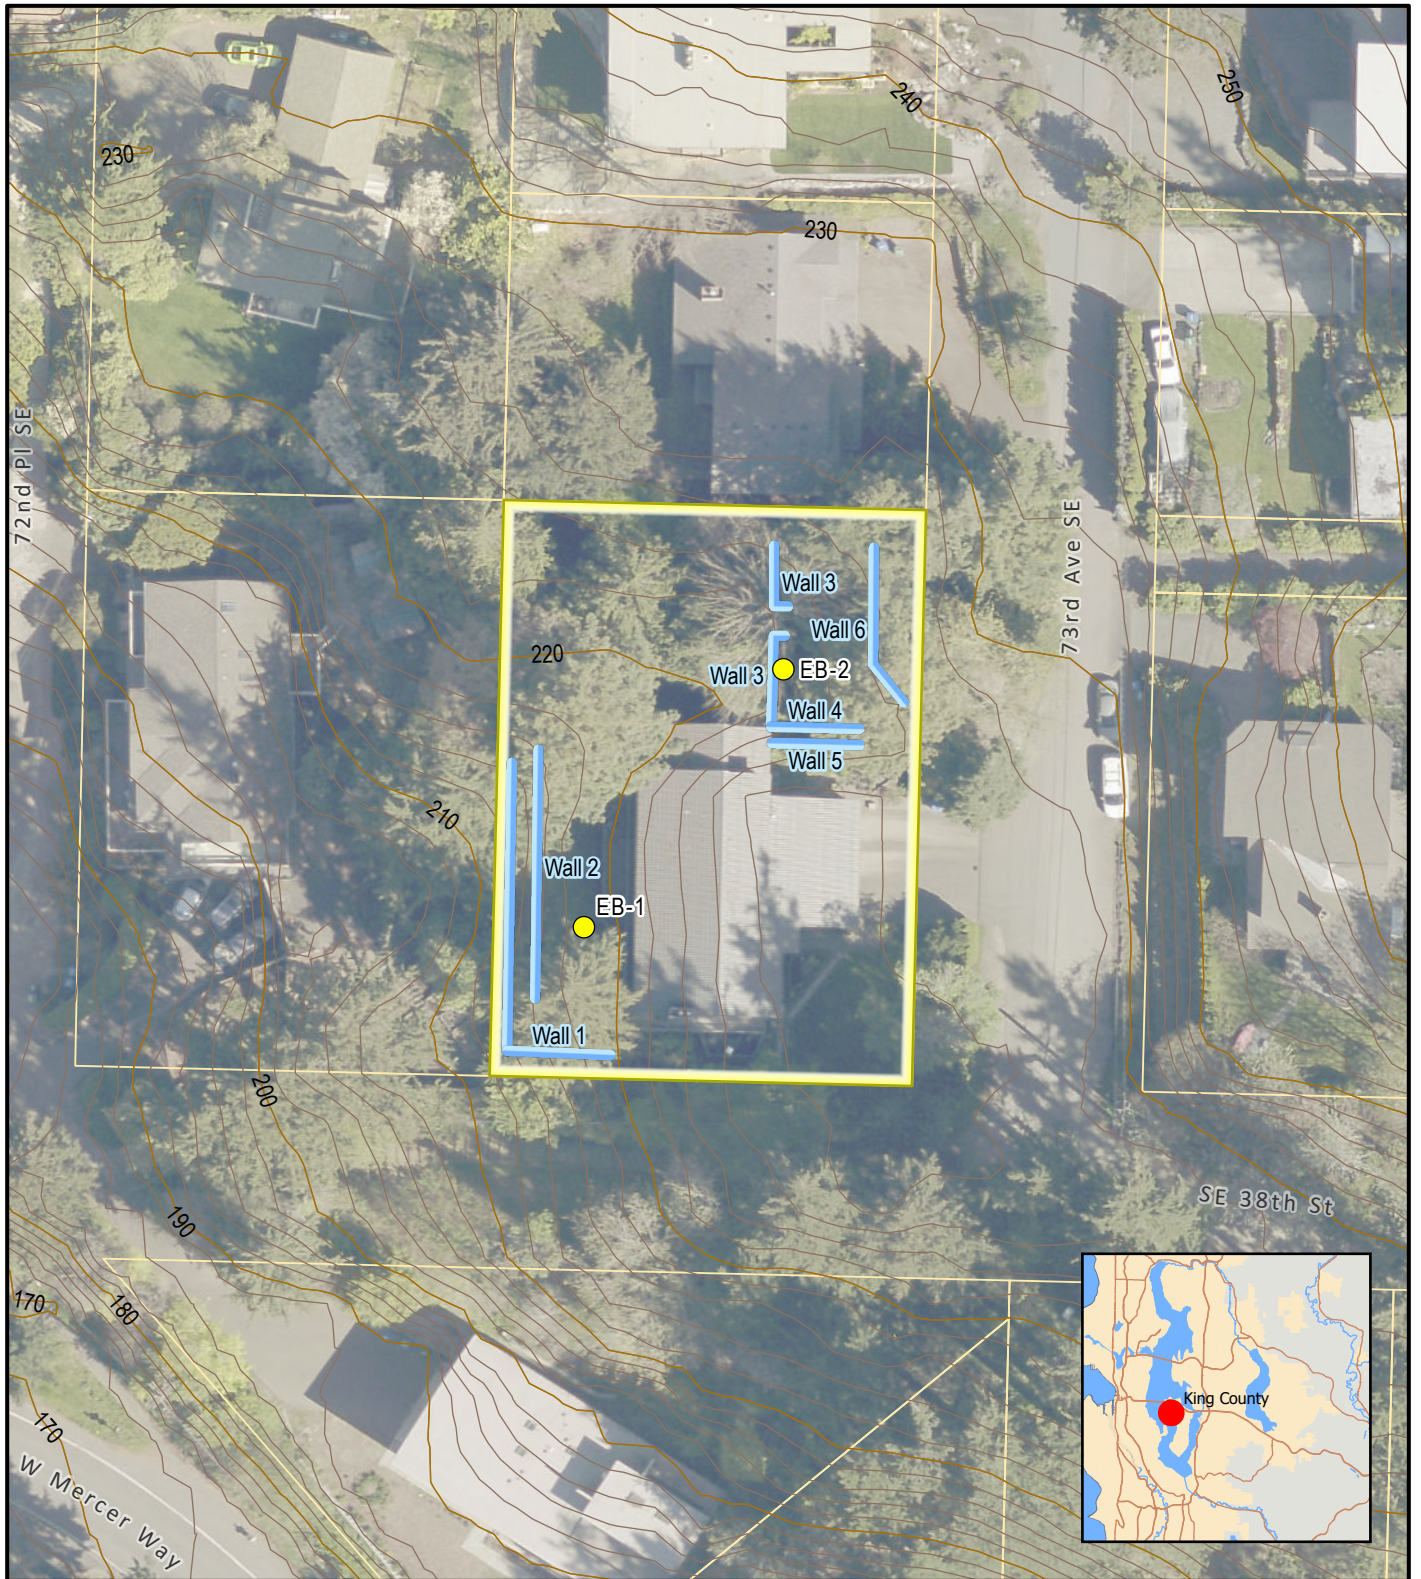
PROJ NO. 20220409E001	DATE: 3/23	FIGURE: 3
--------------------------	---------------	--------------

firm and unyielding wall foundation subgrade could not be confirmed across the lateral extent of Wall 3 through Wall 6. Based on conversations with the homeowner and our observations during our subsurface explorations, the walls were not constructed with a drainage blanket along the backside of the wall and no footing drains were provided. 4-inch diameter weep holes were observed near the base of the walls but were not visible along the entire length of each wall and no consistent spacing could be determined. Fill was observed behind these weepholes and no aggregate or other drainage material was present.

- The toe of the slope in its current condition at the western property boundary is supported by an approximate 4- to 5-foot-high cast-in-place concrete retaining walls (Wall 1 and Wall 2). The vertical relief of the slope is approximately 8 feet from the base of the Wall 1 to the existing residence. The slope has been cleared with the exception of a large conifer with a 1.5' diameter adjacent to Wall 2 west of the residence
