September 20, 2023  
PanGEO Project No. 23-284

Subject: Geotechnical Engineering Report  
Proposed East Pier Dredging  
1945 82<sup>nd</sup> Avenue SE  
Mercer Island, Washington 98040

**GEOTECHNICAL ENGINEERING REPORT  
PROPOSED EAST PIER DREDGING  
1945 82<sup>ND</sup> AVENUE SE  
MERCER ISLAND, WASHINGTON**

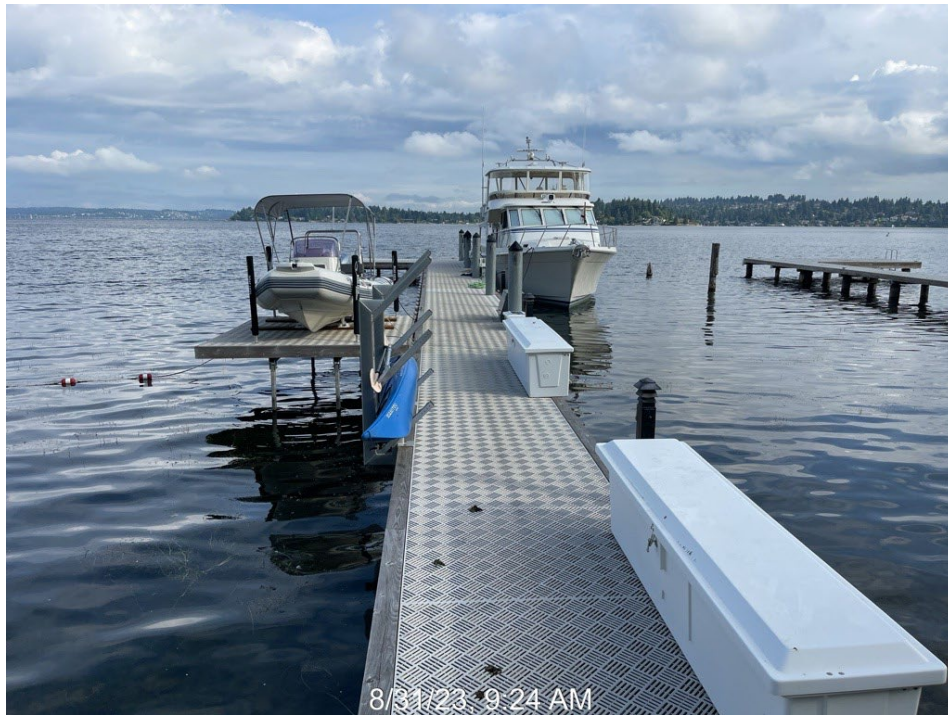
Based on our field measurements, at the time of our site visit (August 31, 2023) the water along the east side of the pier ranged from about 5 feet to 6 feet deep.

*Plate 1. Looking north at east pier. Dredging will occur along the right side of the pier.*

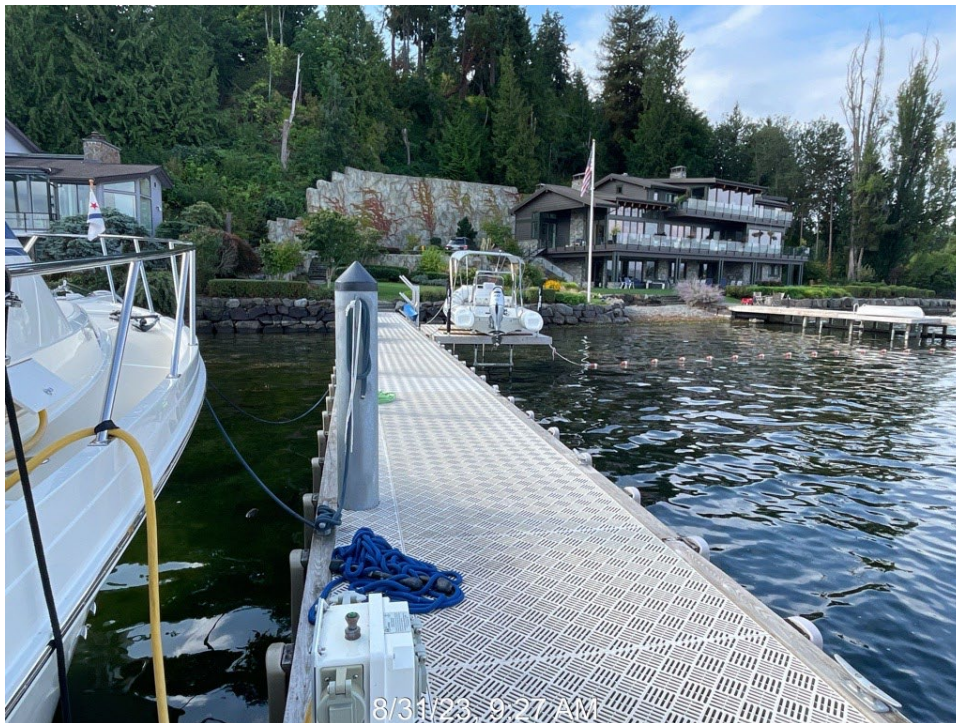
*Plate 2. Looking south at east pier. Dredging will occur along the left side of the pier.*

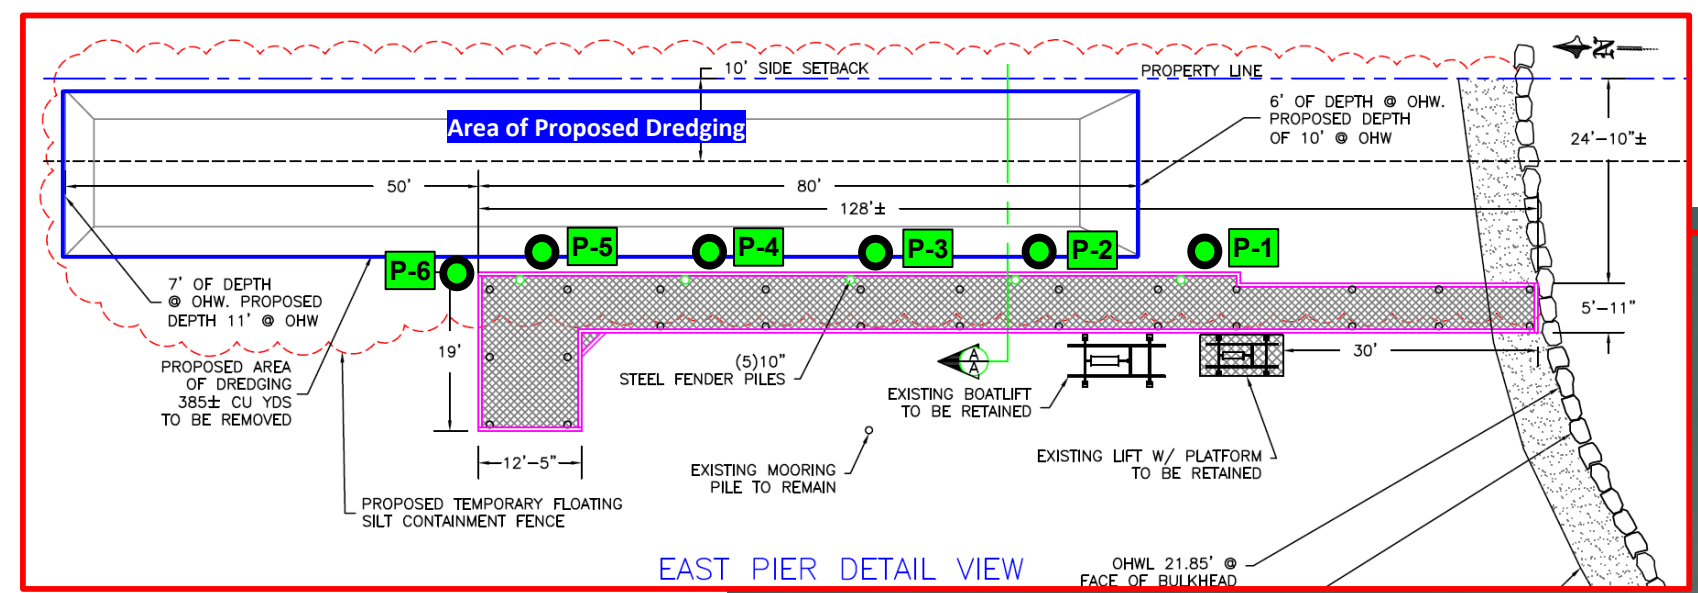
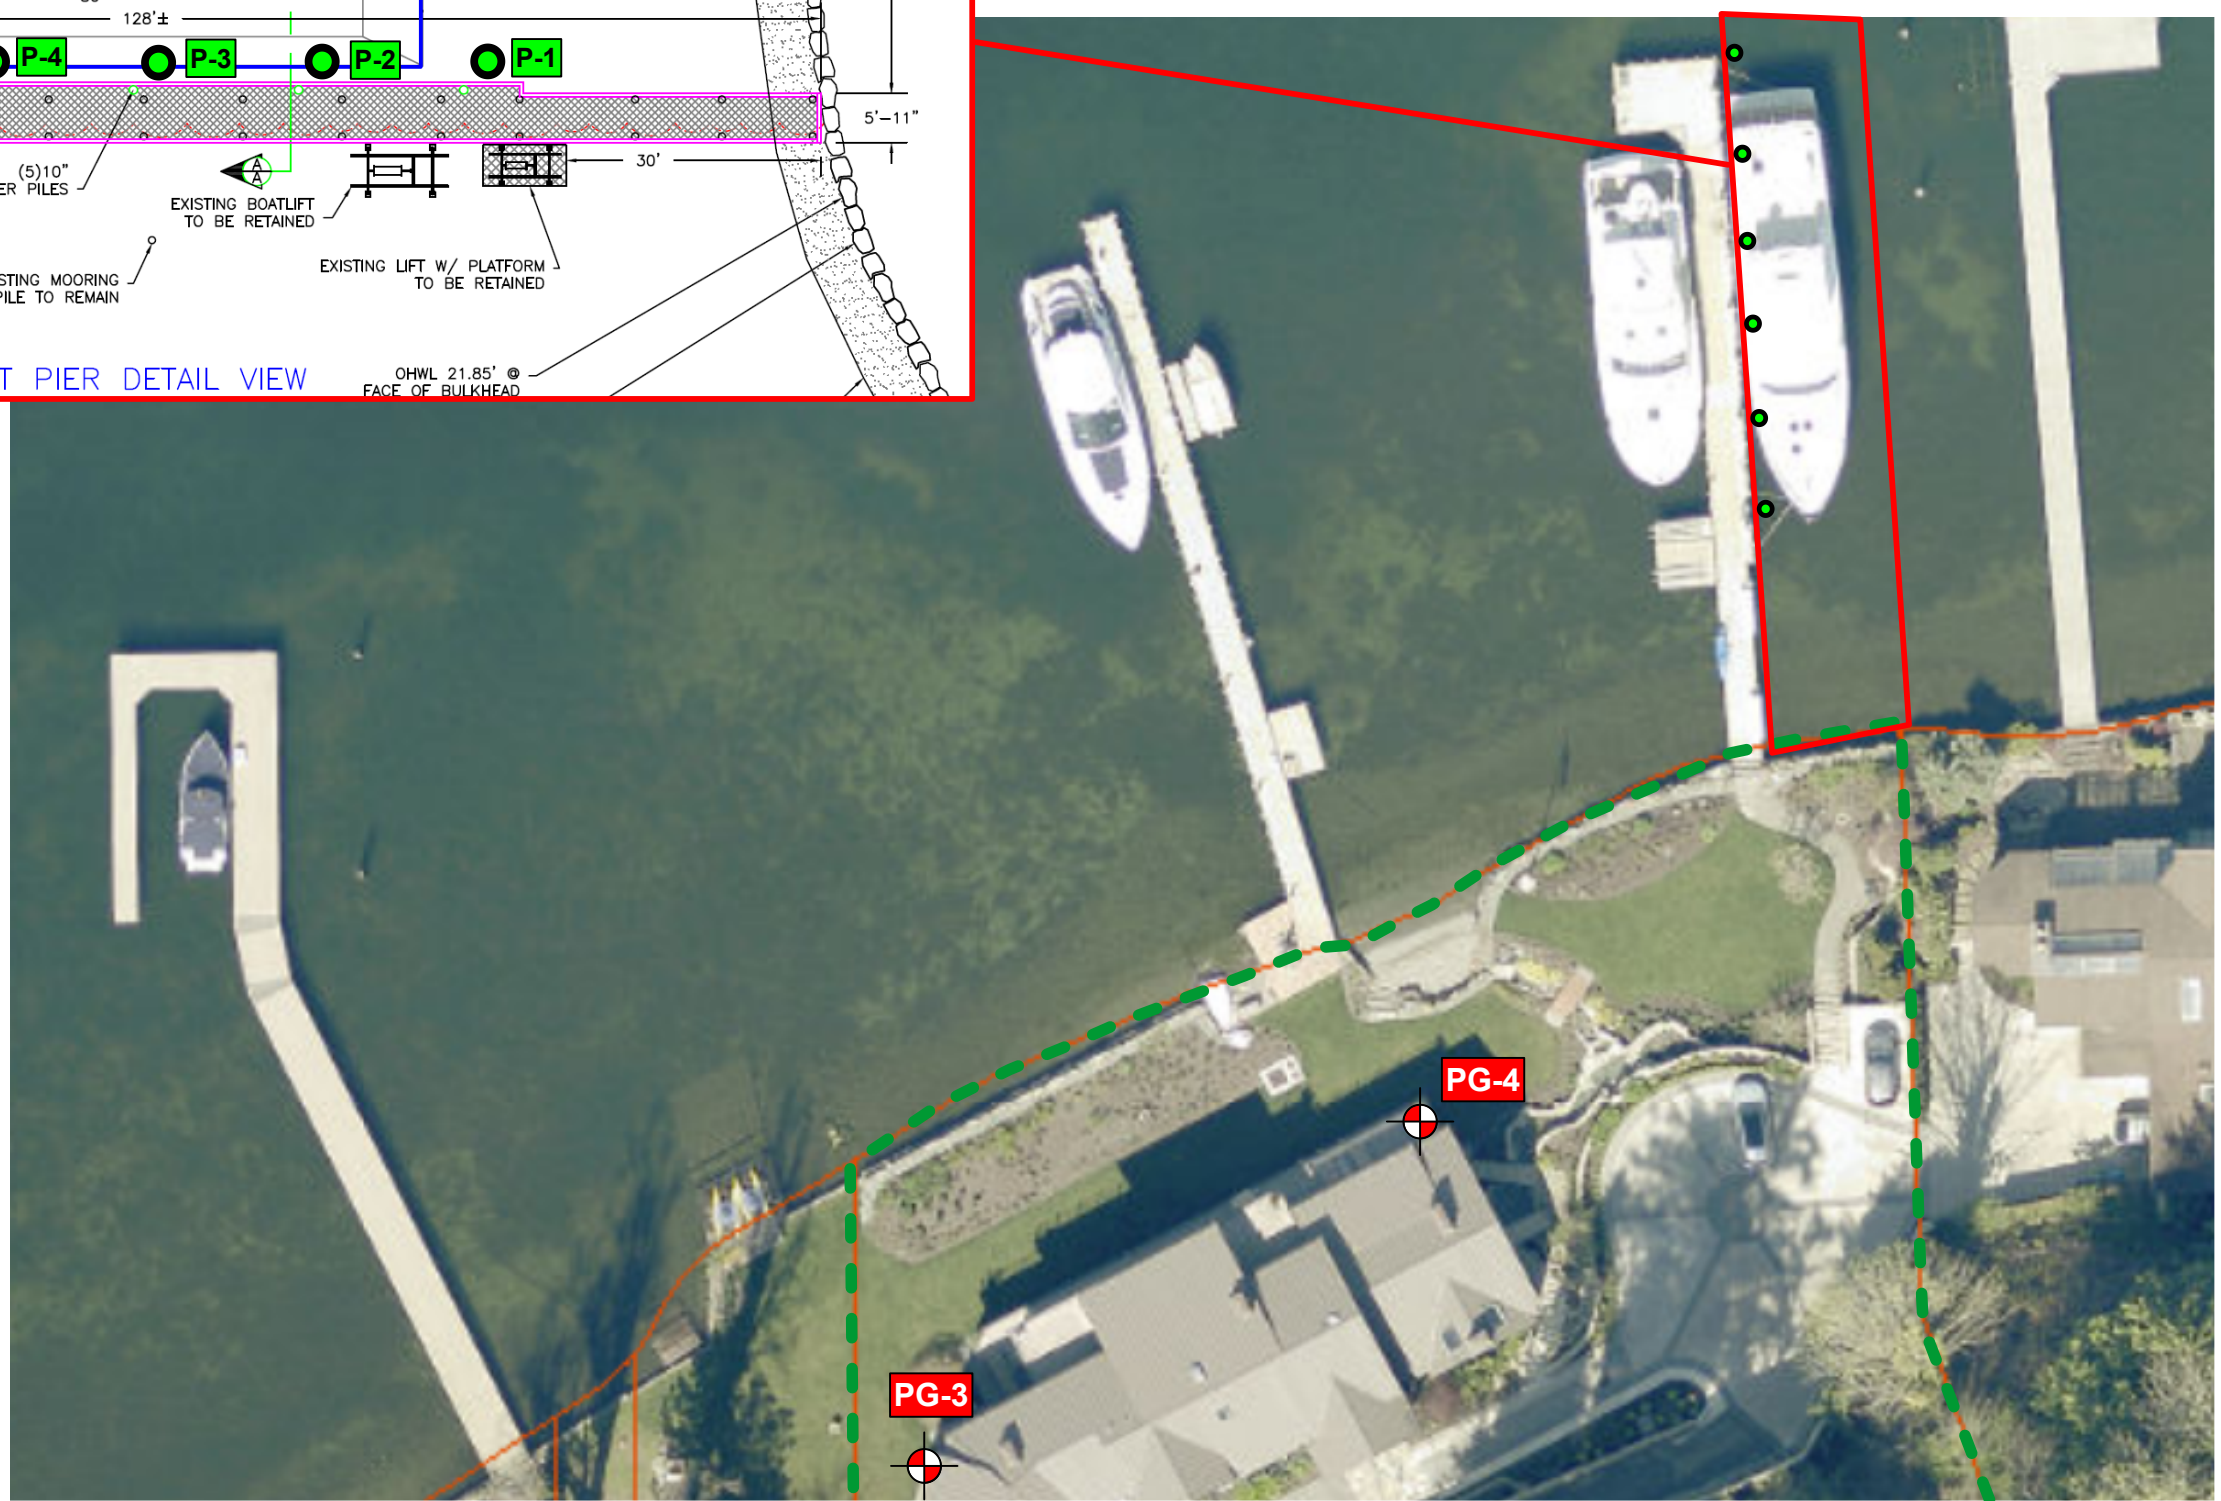
<b>Proposed Dredging</b> 1945 82nd Avenue SE Mercer Island, Washington	<b>SITE AND EXPLORATION PLAN</b>	
		Project No. 23-284	Figure No. 2

The approximate locations of the previous test borings PG-3 and PG-4 are shown on the attached Figure 2 (Site and Exploration Plan). The summary test borings logs are included in Appendix A.

To gain additional information regarding the soil conditions at relatively shallow depths below the mudline along the east pier, we conducted a limited subsurface exploration program that consisted of utilizing a 3/8-inch diameter extendable steel hand probe to evaluate the density or consistency of the soils below the mudline. The probe was advanced by hand from the dock at the six locations shown on the attached Figure 2.

At each location the depth interval that required easy to moderate effort, followed by significant effort, was recorded to establish a qualitative description of the density of the underlying soils. The results of our probing are summarized in Table 1 below. As noted from the table, in general, a layer of loose to medium dense soils extends from approximately 3 to 5 feet below the mudline. Below this layer of loose to medium dense soil, a layer of medium dense to dense/stiff to hard soils ranged in thickness from about 1 to 3 feet or more. The maximum depth of probing was about 8 feet below the mudline.

Probe Number	Thickness of Loose to Medium Dense Soil Below Mudline (feet)	Depth Below Mudline to Probe Refusal (feet)
P-1	2.7	3.6
P-2	2.8	5.0
P-3	3.7	4.6
P-4	5.0	7.8
P-5	5.6	7.1
P-6	5.2	+8
