From: Frank Close <fclose@guardiansecurity.com>
Sent: Tuesday, June 1, 2021 10:10 AM
To: Lauren Anderson
Subject: Freeman subdivision parking & Right of way Issues:
Attachments: Freeman Subdivision Parking 6-1-2021.pdf

From: Frank Close <fclose@guardiansecurity.com>
Sent: Tuesday, June 1, 2021 10:08 AM
To: Lauren Anderson
Subject: Freeman subdivision 4001 West Mercer way
Attachments: Freeman Subdivision drainage 6-1-2021-2021.pdf; Freeman subdivisioin arborist report iTree Letter (Mercer Island) (2).pdf

Environmental Degradation and Water Damage Pose Severe Slide Risk

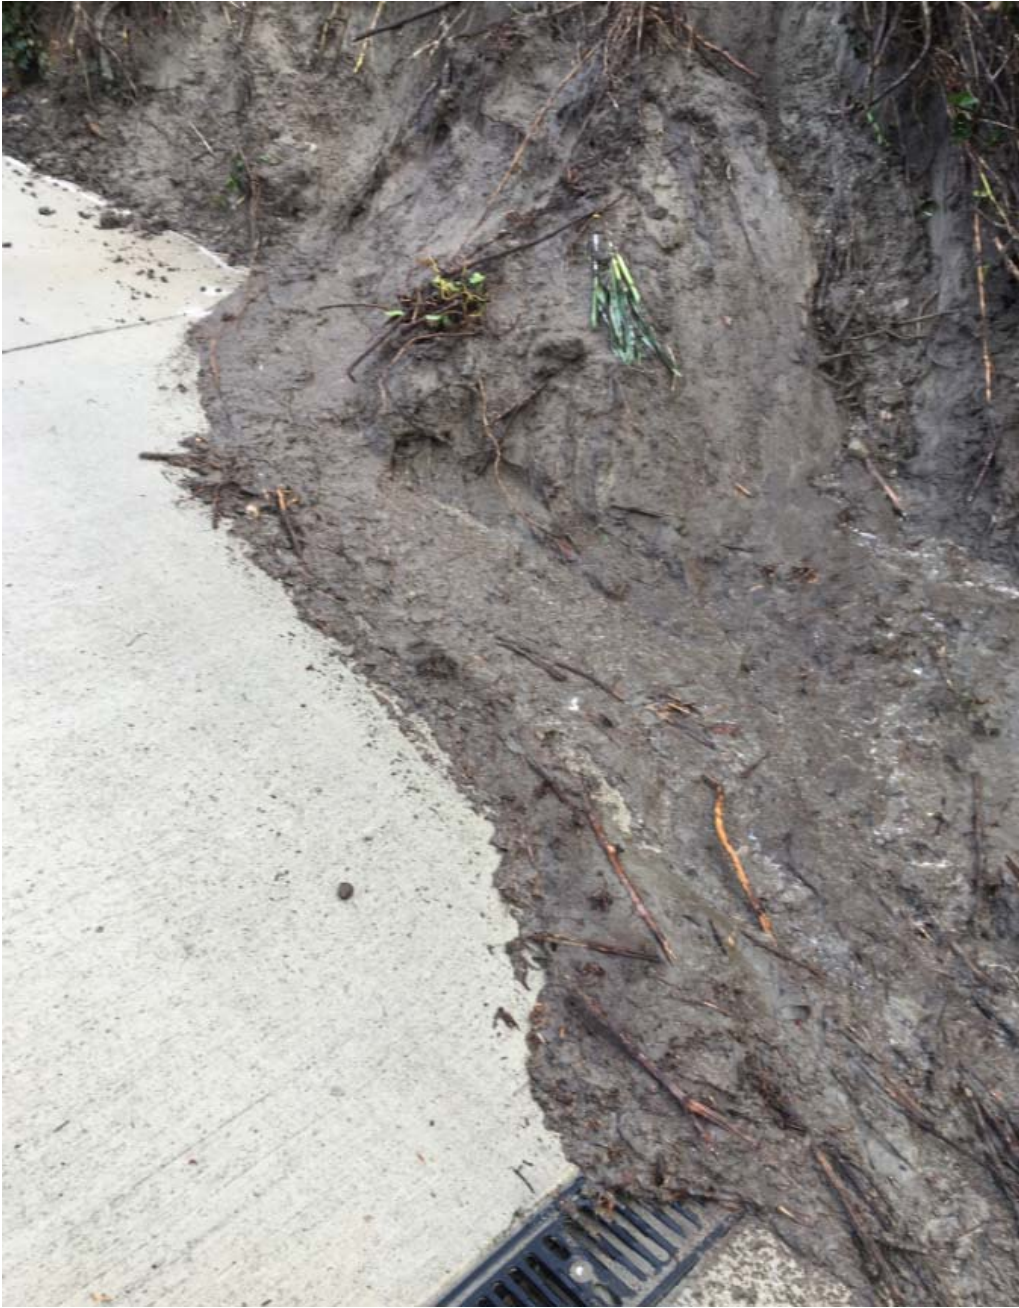
Figure 1

Here is one of the recent slides just south of the city property line:

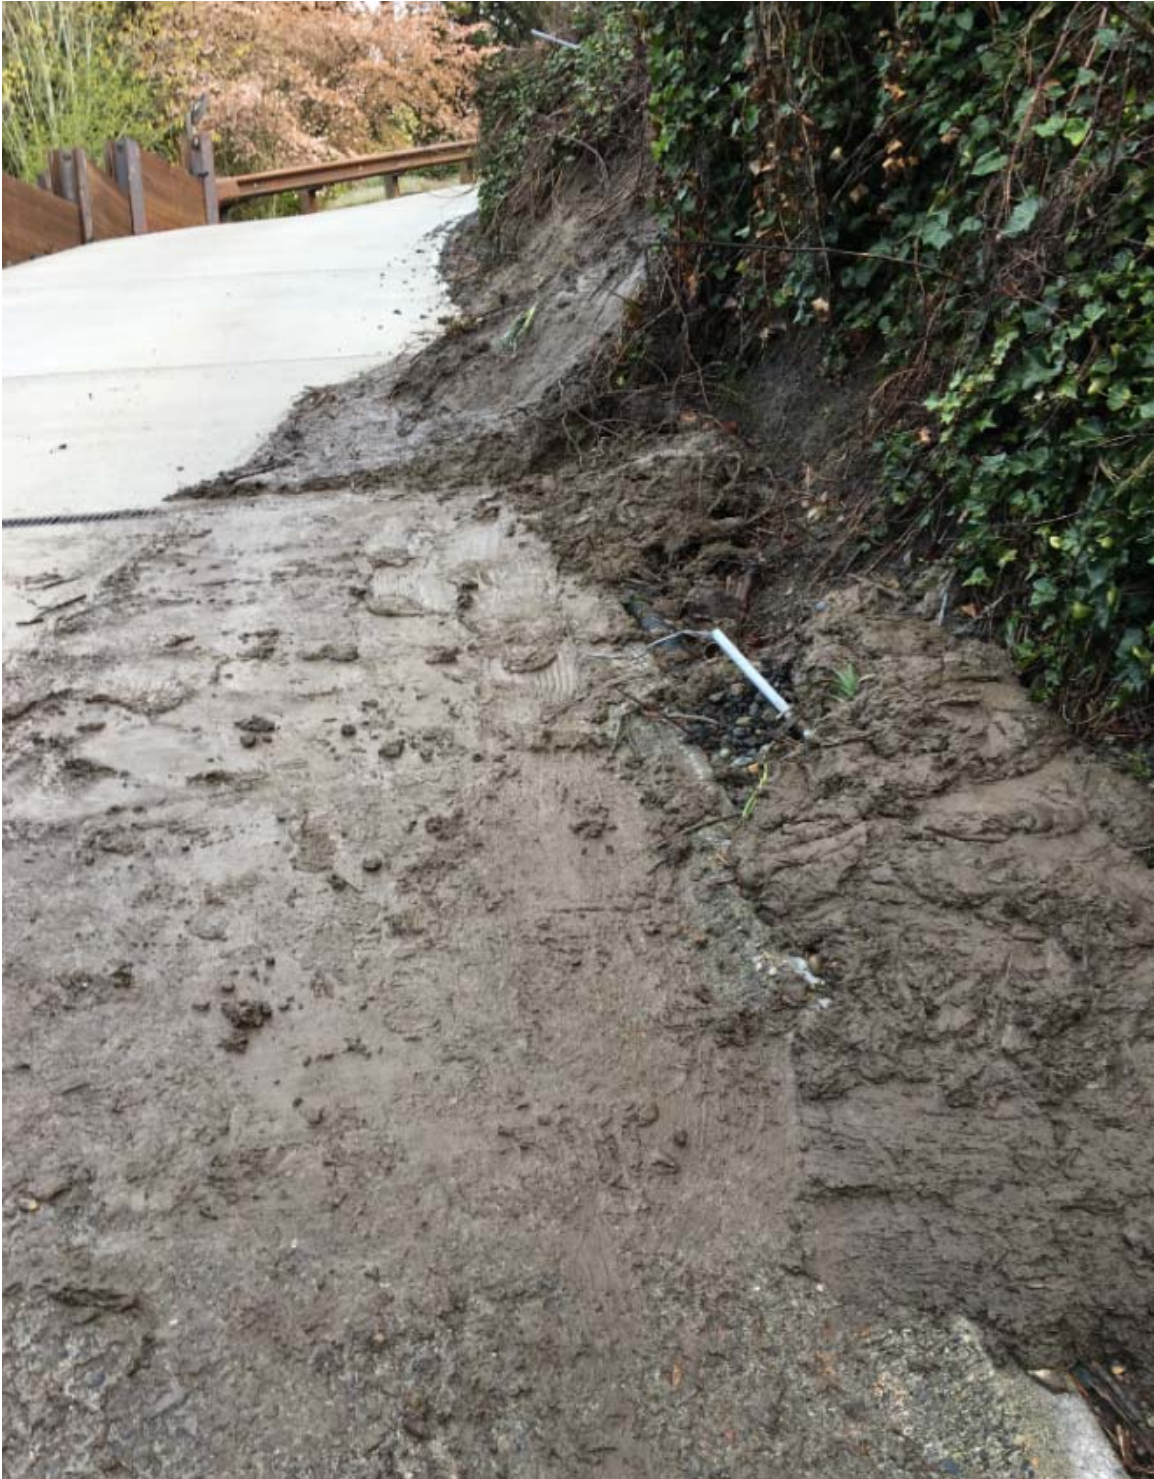
Figure 2

Here is another picture of this slide with a better perspective:

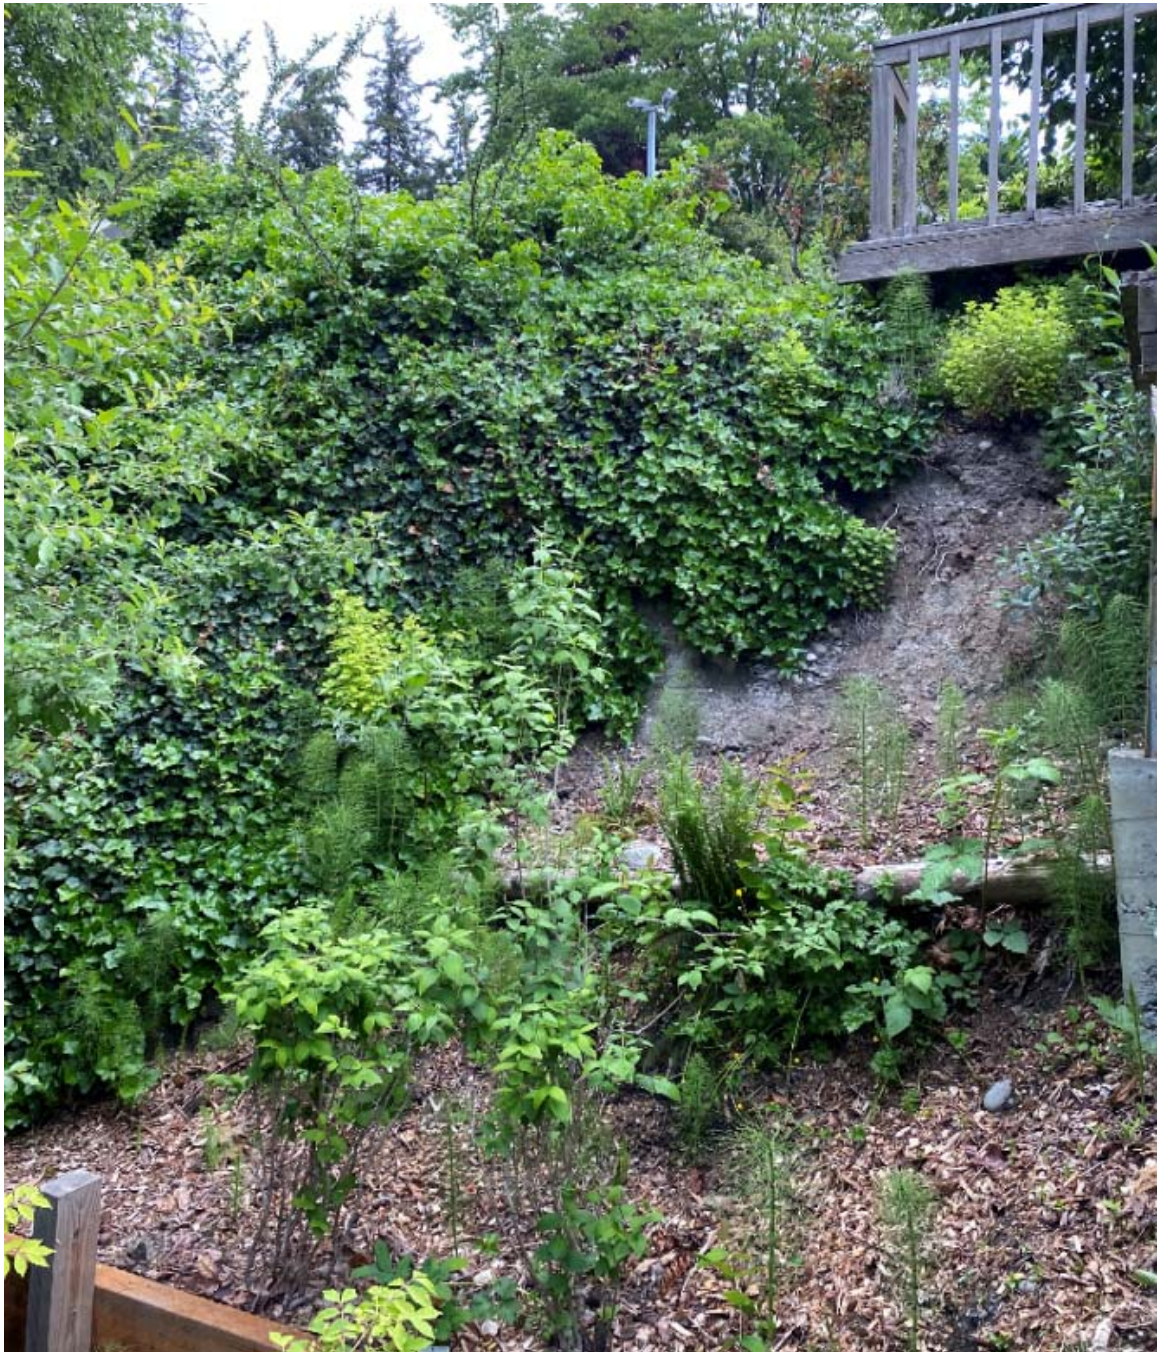
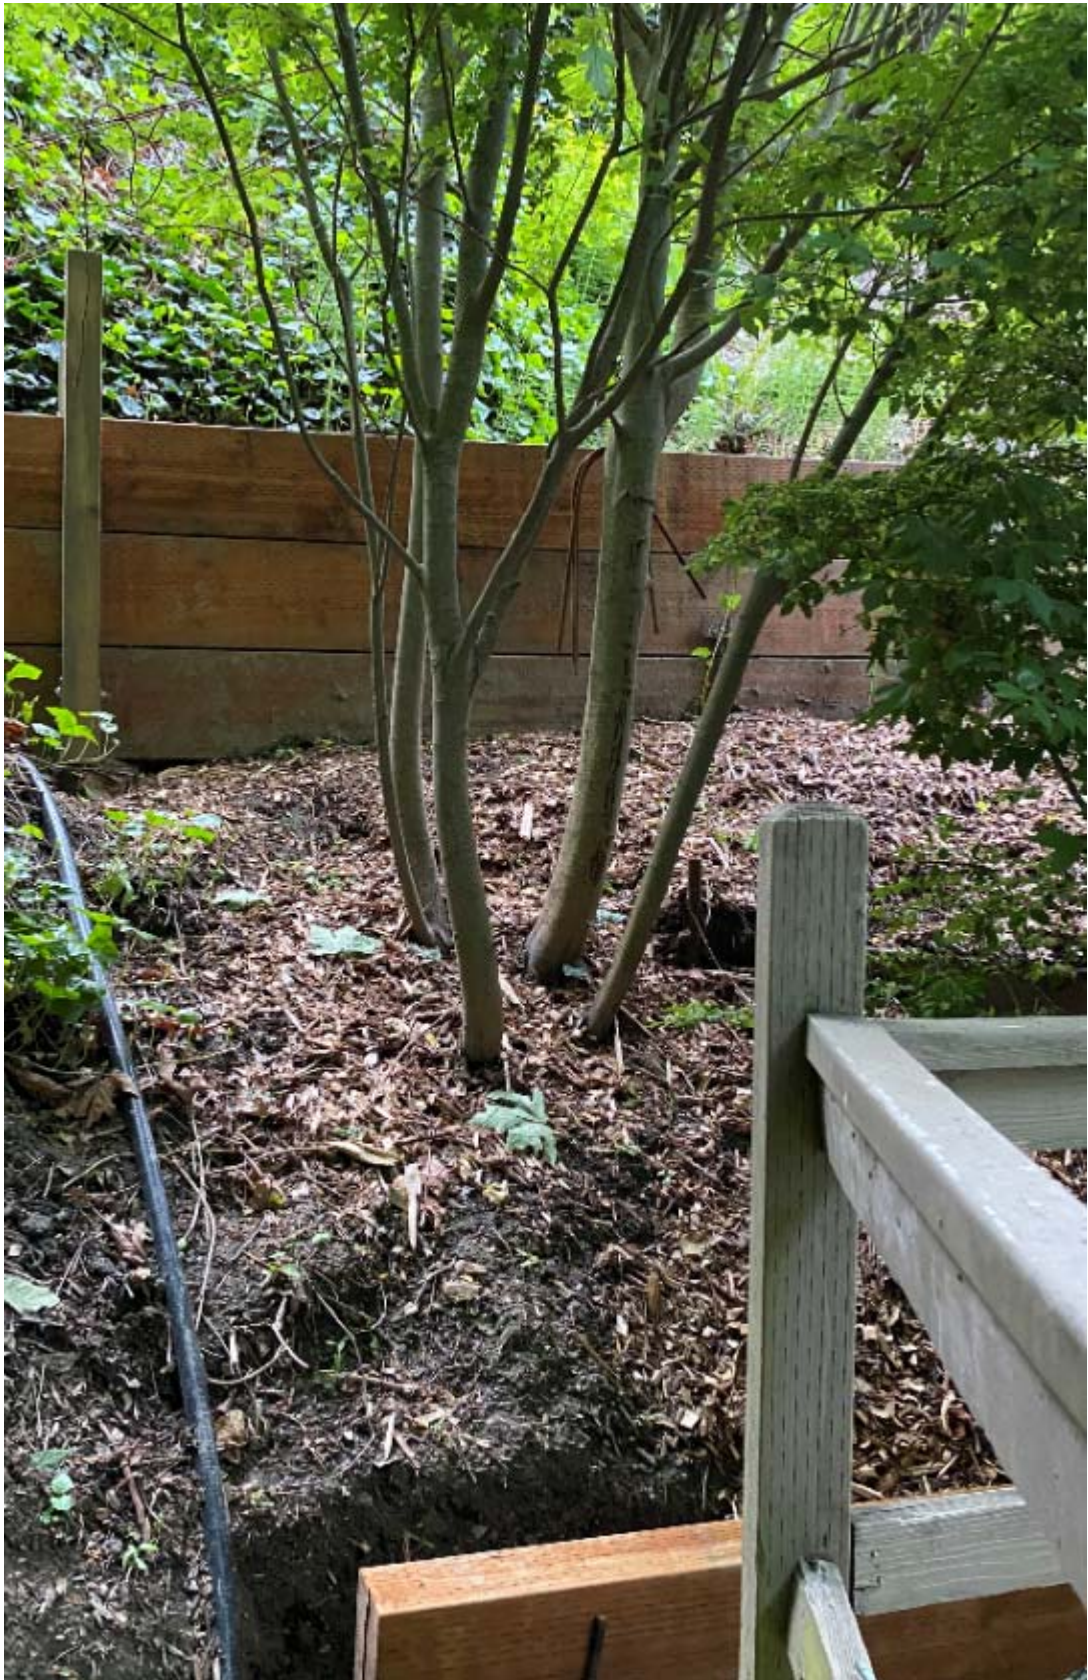
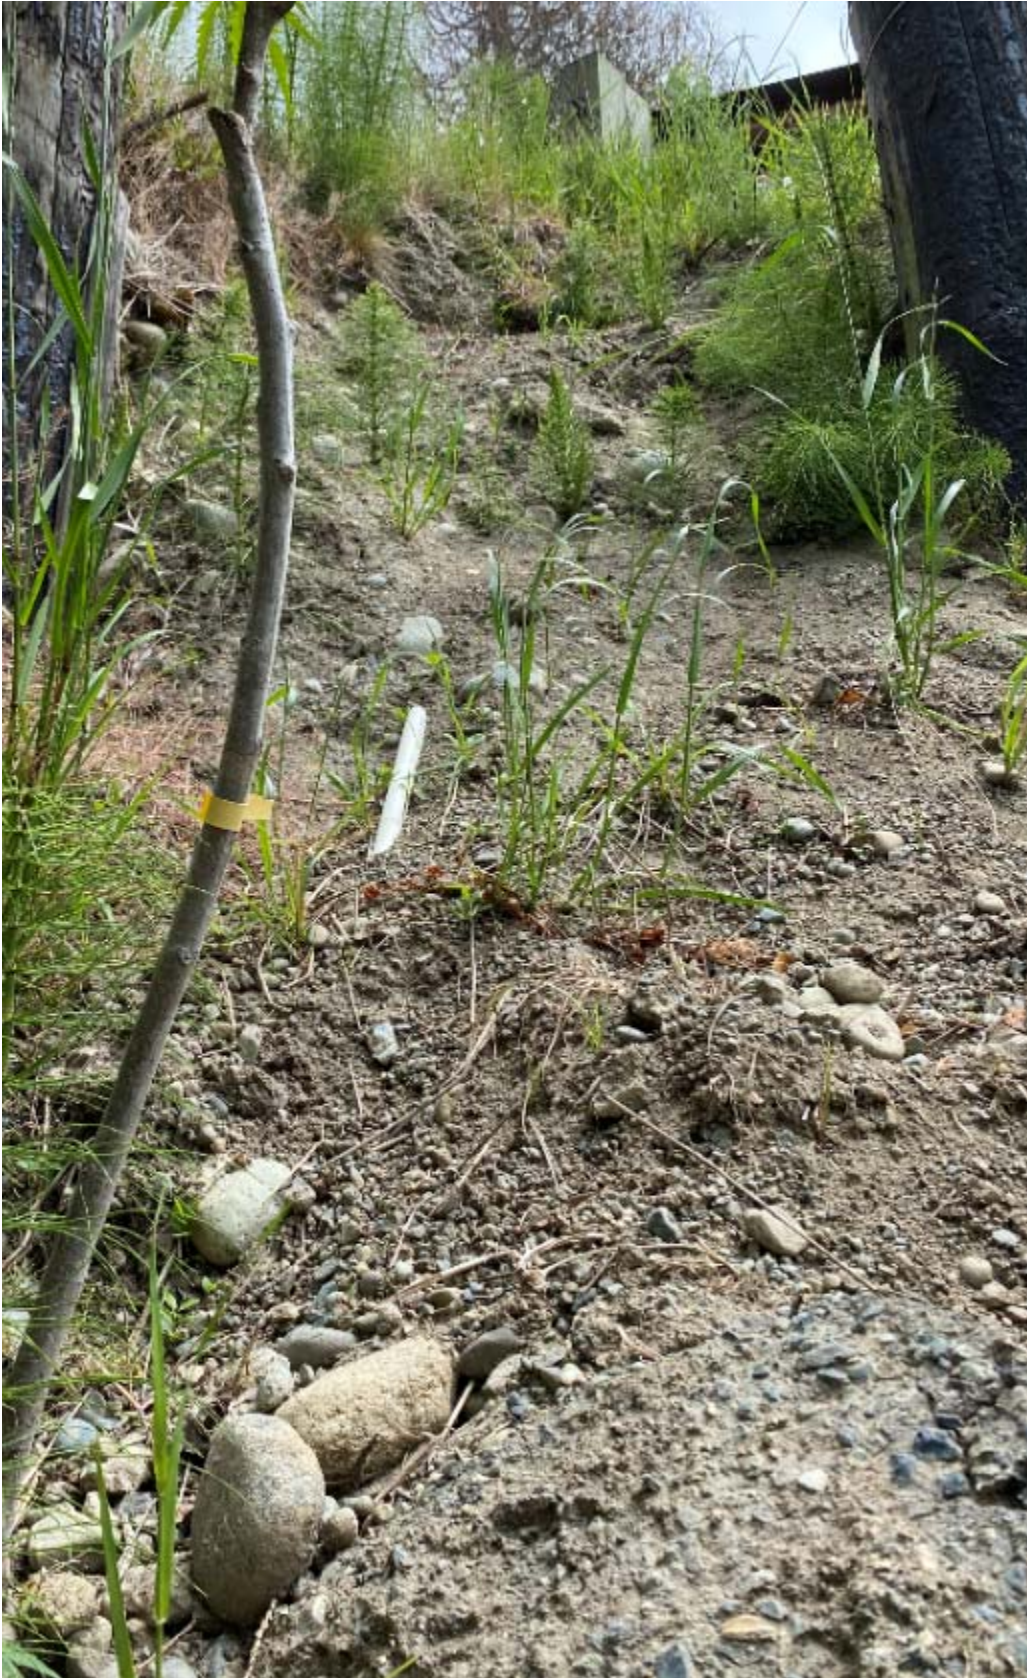
Figure 3 Next up is te slide south of the city waterpipe and

The next slide happened when the rain poured about 1.7 inches in 1 day. This was a slide on the Close property but the water comes from above. Clay flooded down the hillside from the top. Here is a picture after it was cleaned up.

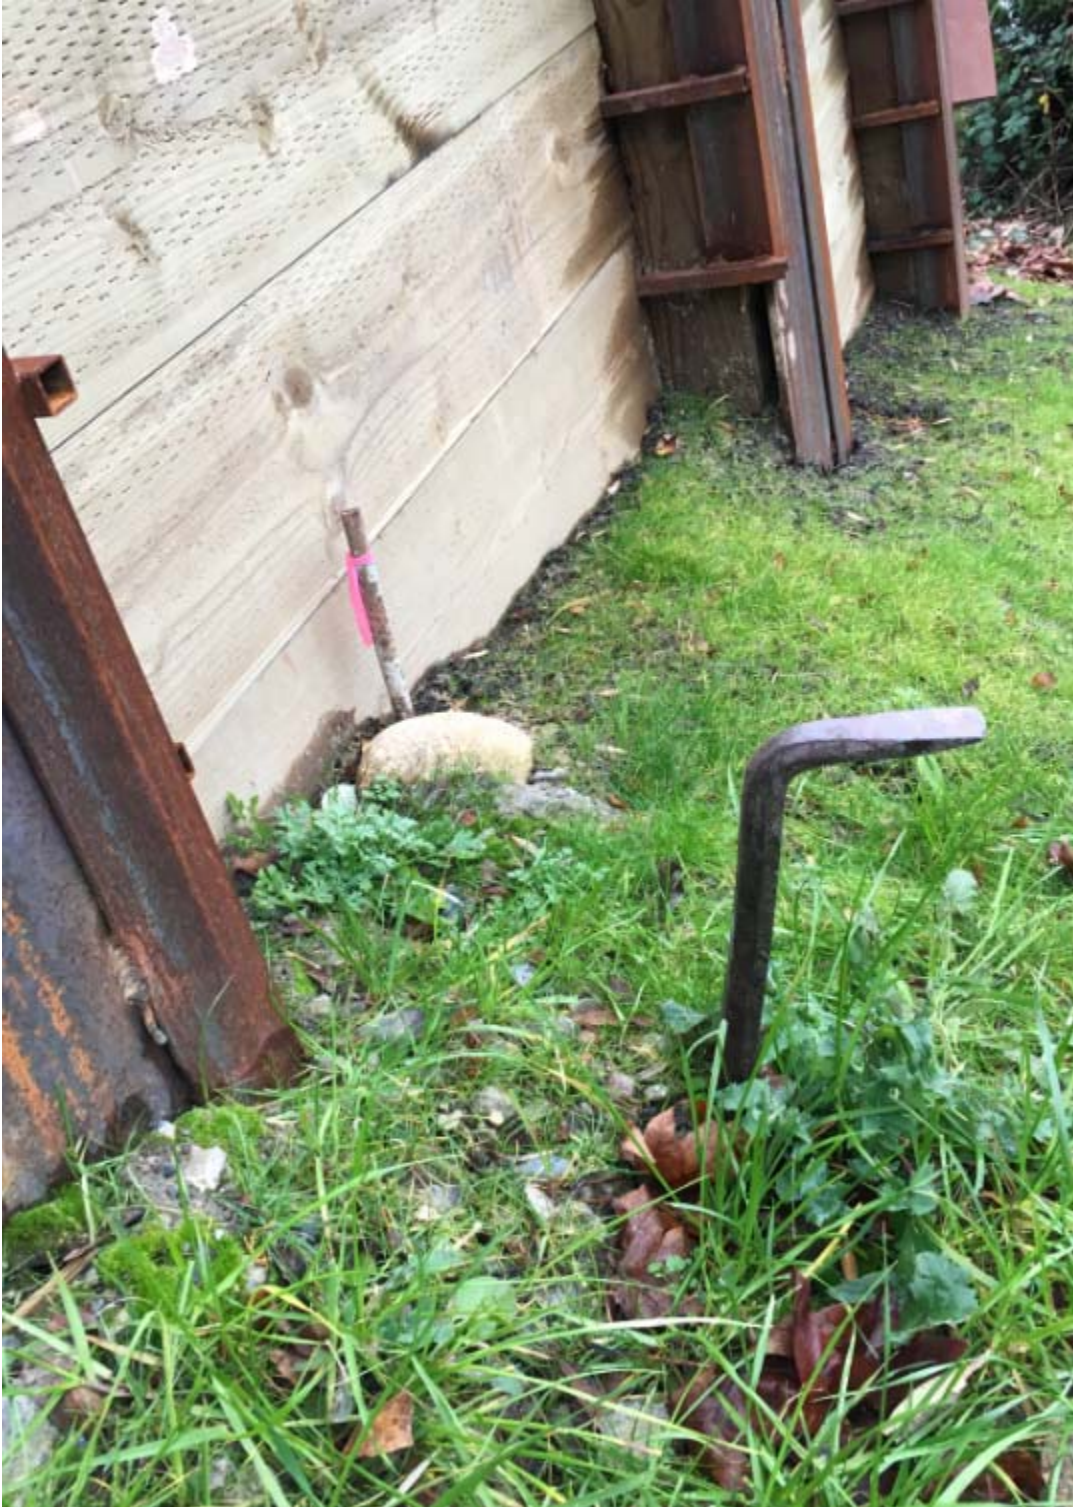
Figure 4

Here is a crowbar test. . You take a 5' crowbar and drop it at the ground and see where it settles in.

Here is the picture on the property line. It drops about 2.5' on the property border.

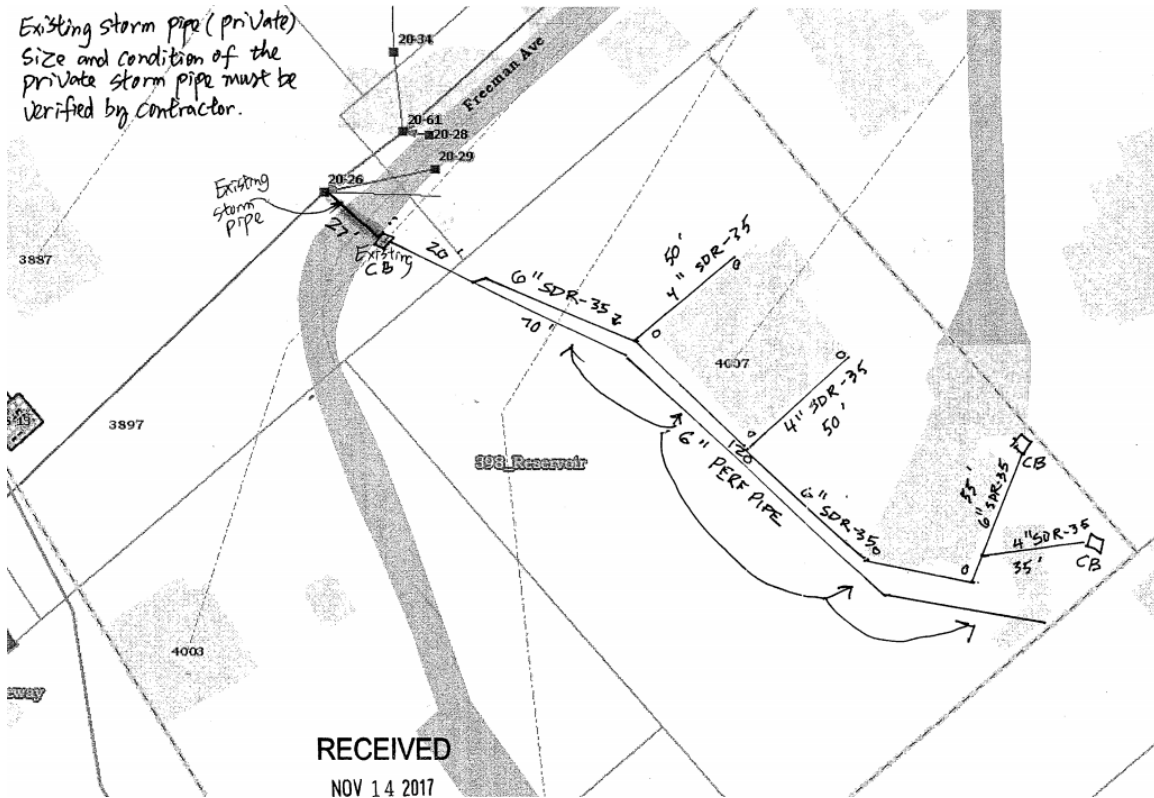
Figure 5

Here is the design. Figure 8.

As I reviewed the diagram, I wondered why the drainage was so far East of the hillside, as far as 30' away in parts.

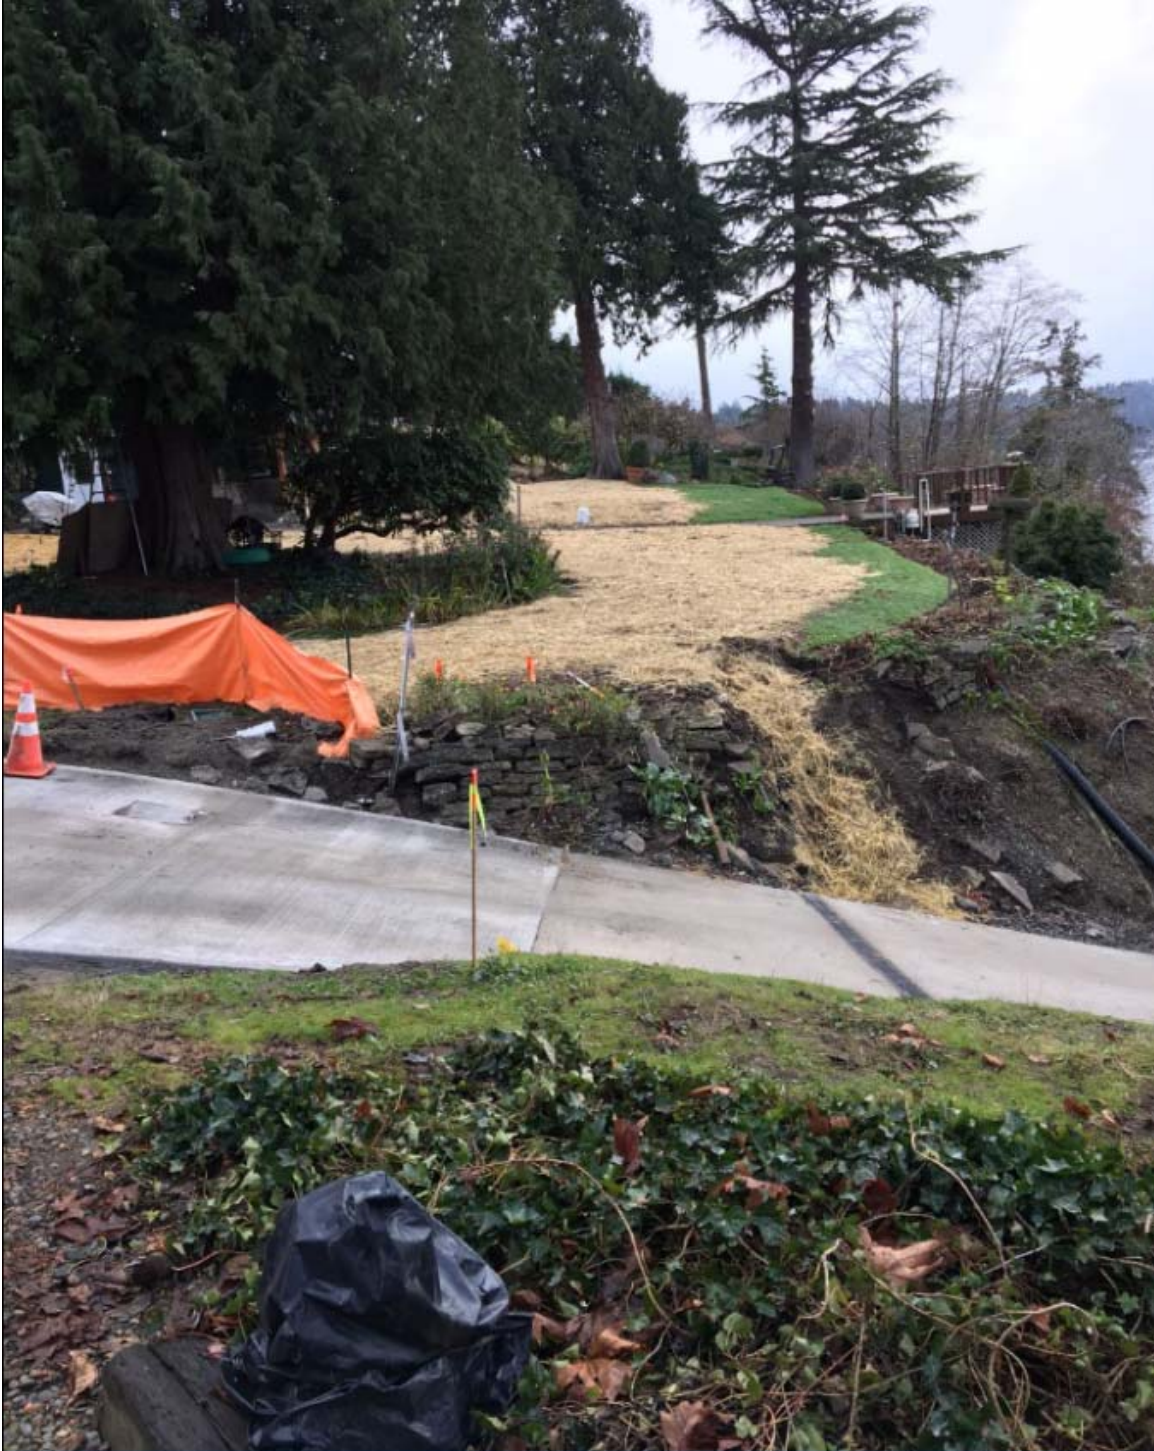
Figure 11 shows during construction for a 4-6" drain pipe.

Figure 8 Not implemented in a normal way and note the steep slope. Jeff Wischman.

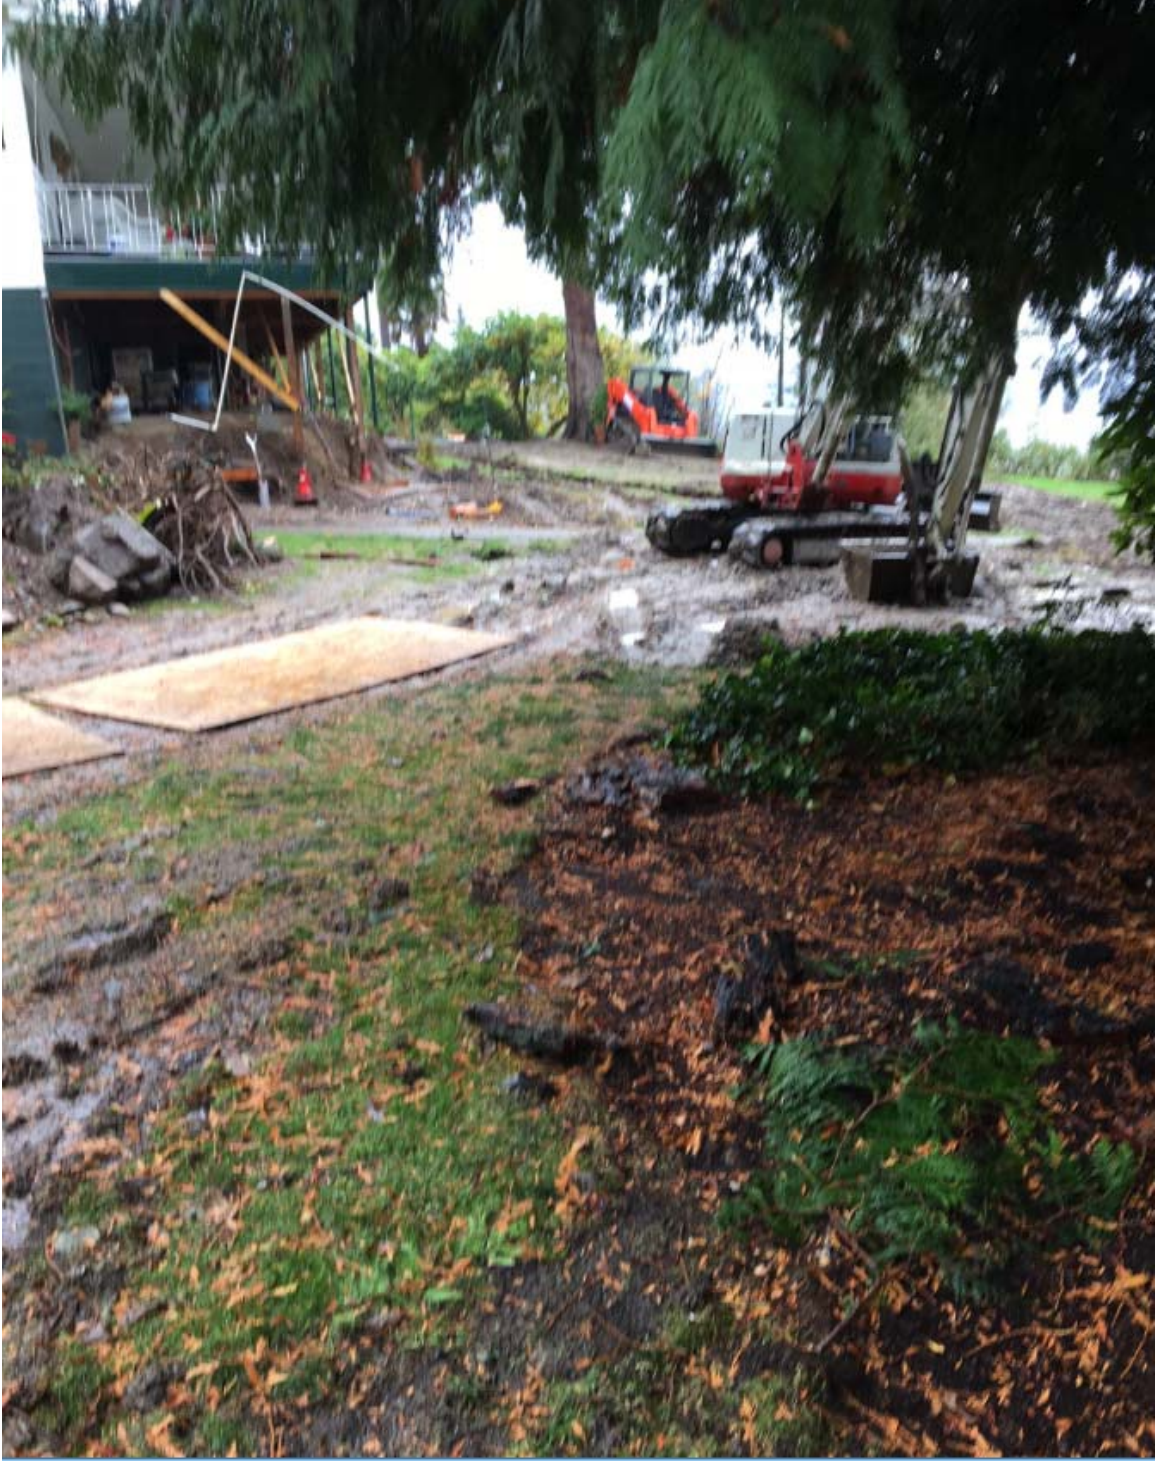
Figure 9 There used to be many plants in front of this house. Note the storage of equipment under trees.

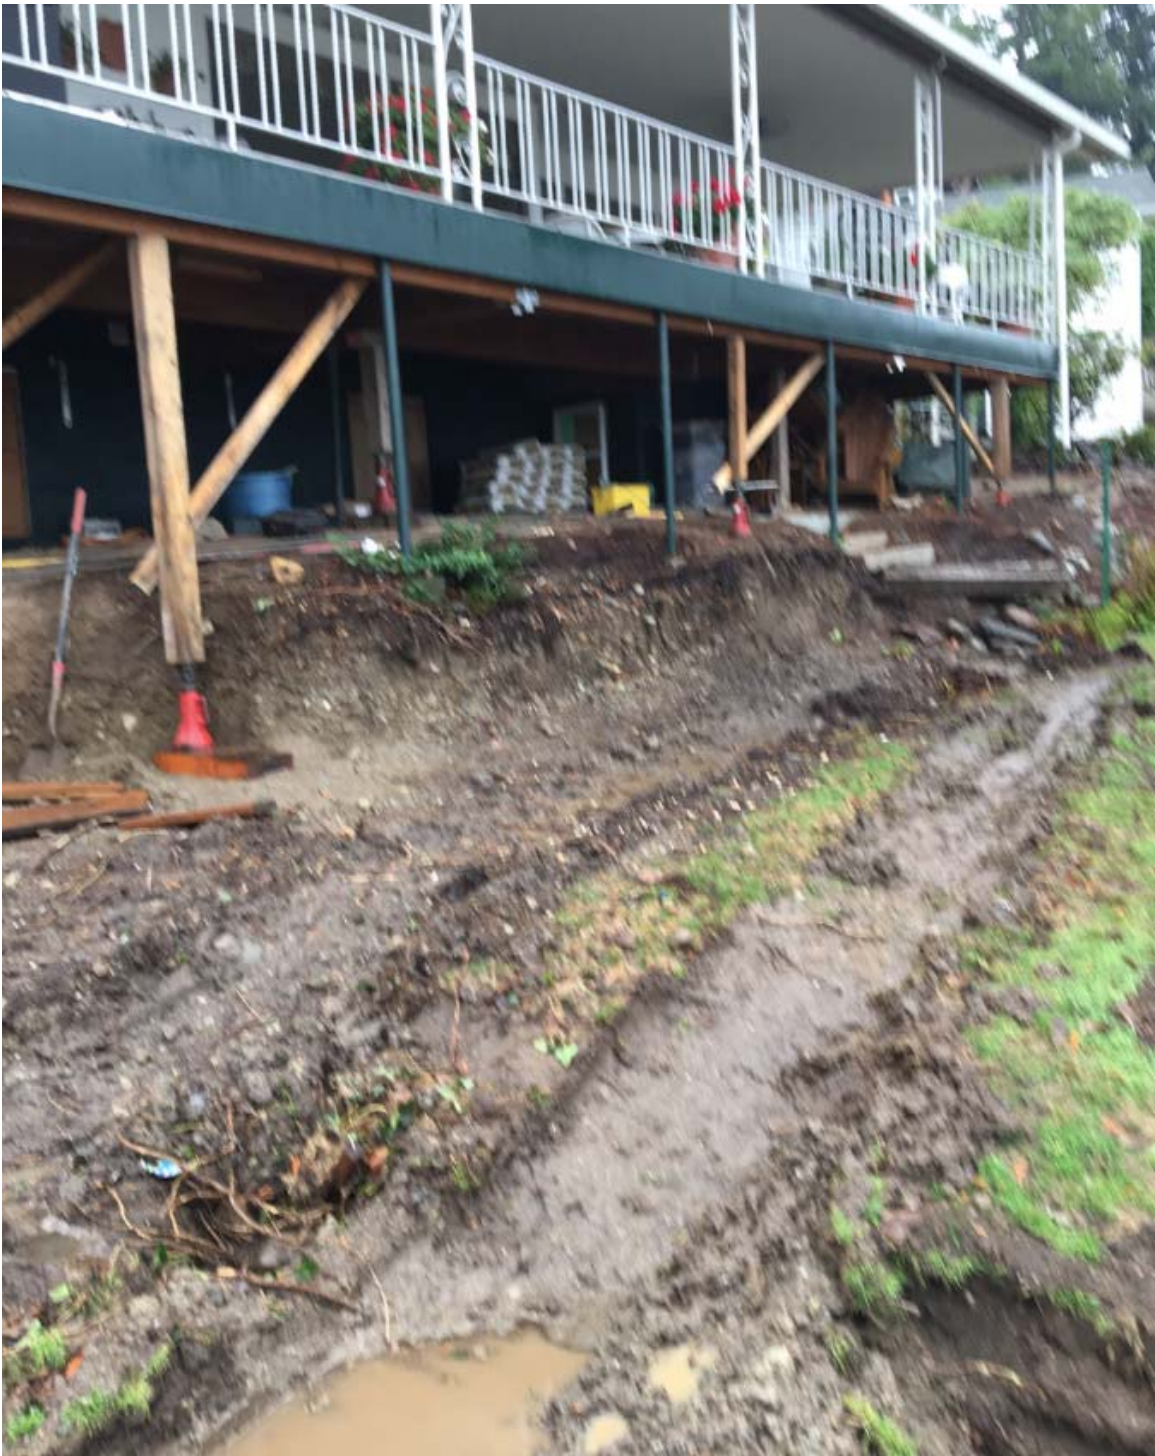
Figure 11 This used to have lots of trees and shrubs

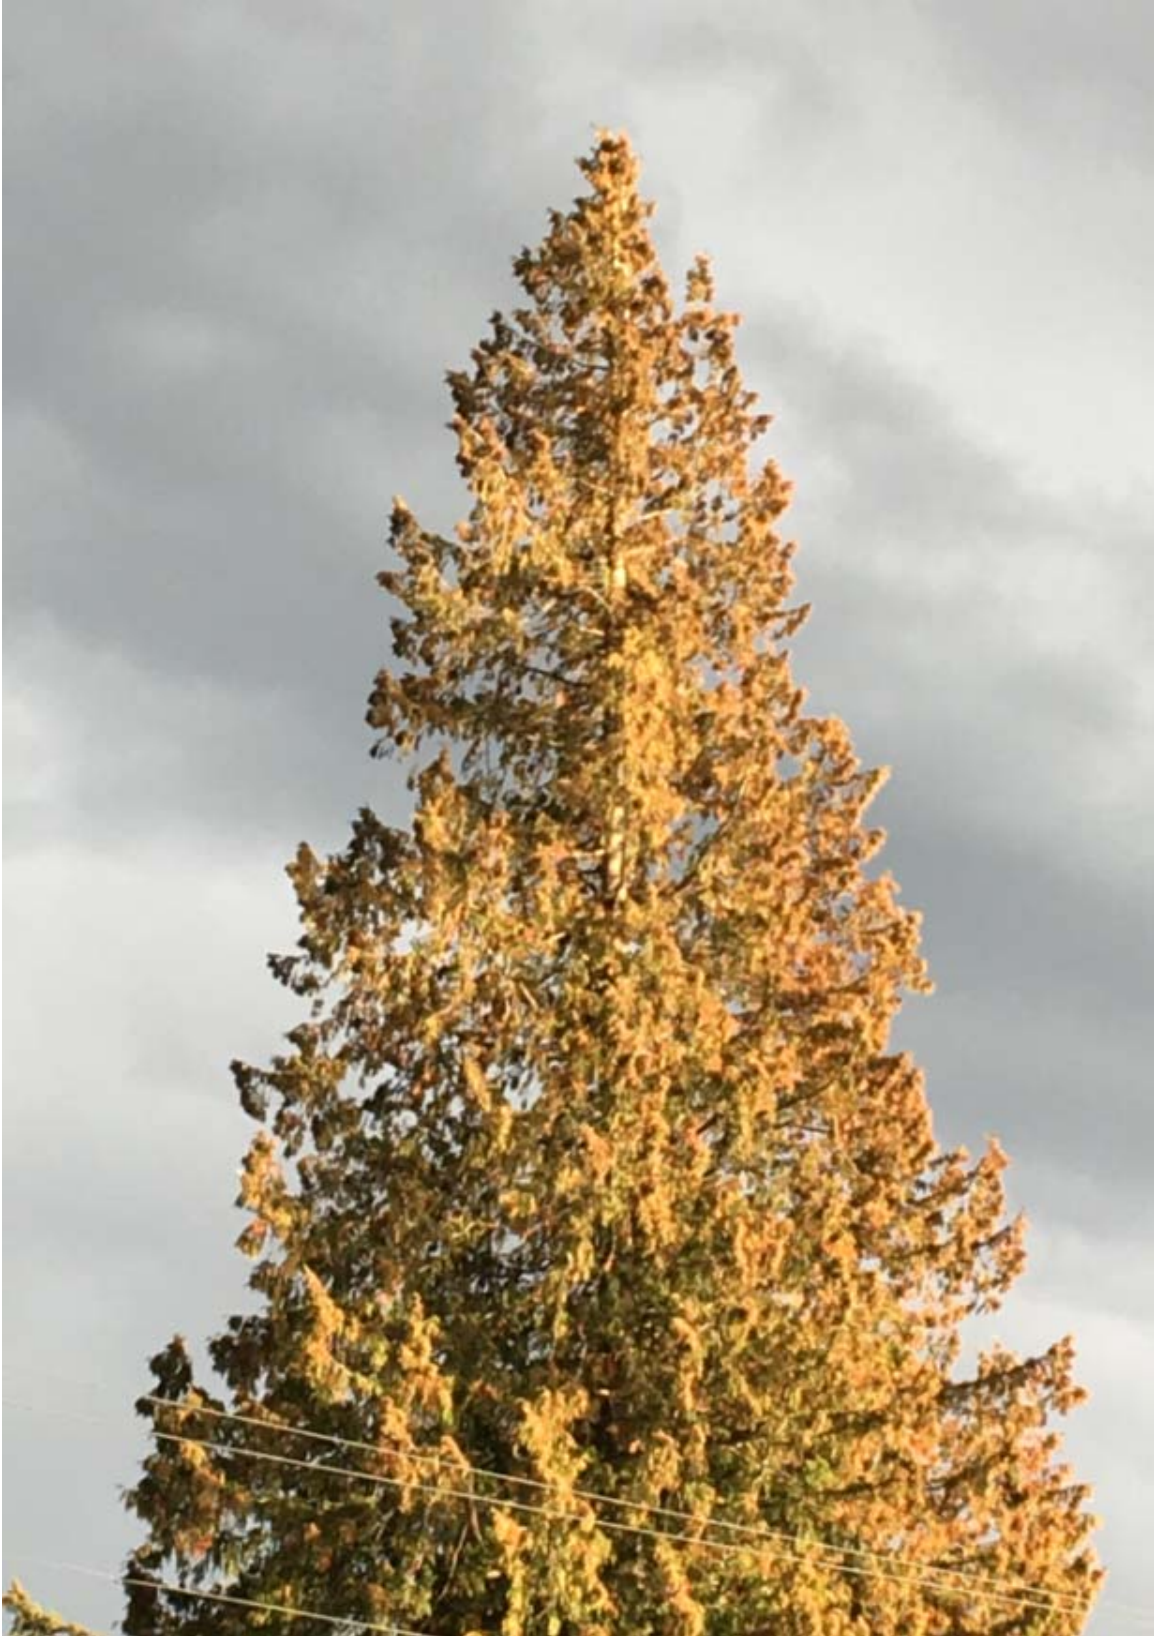
Figure 15

The result of this poorly executed construction project is the death of this cedar tree.

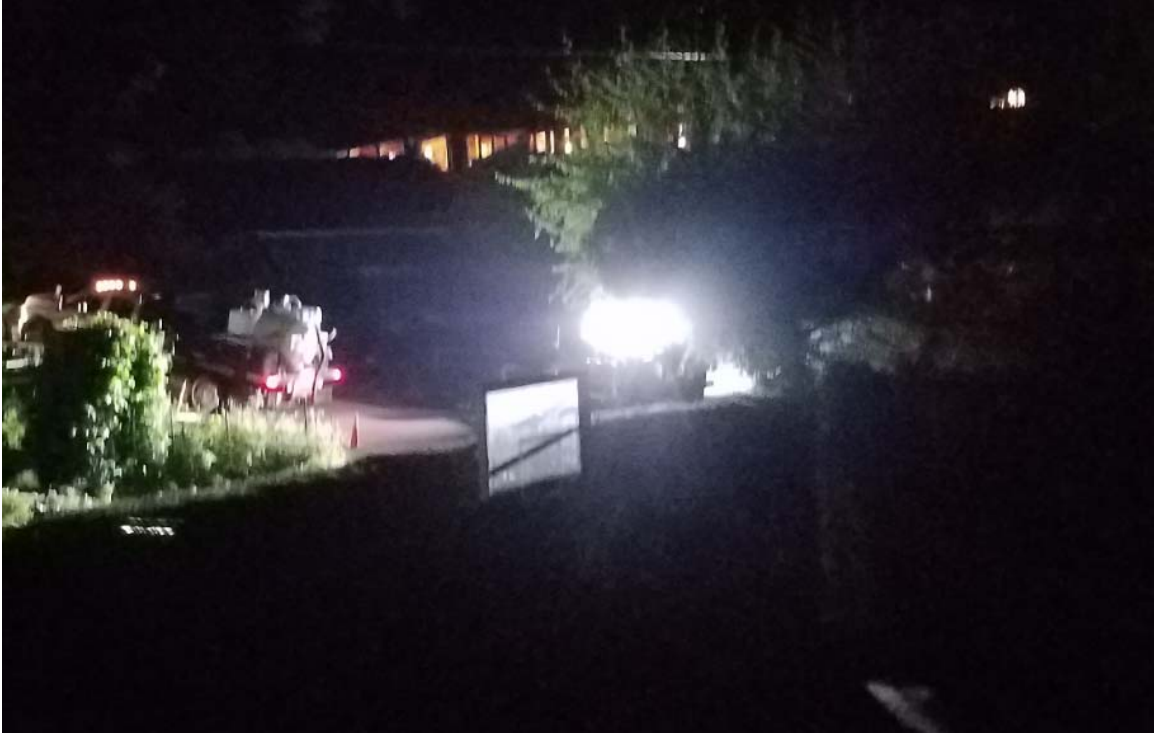
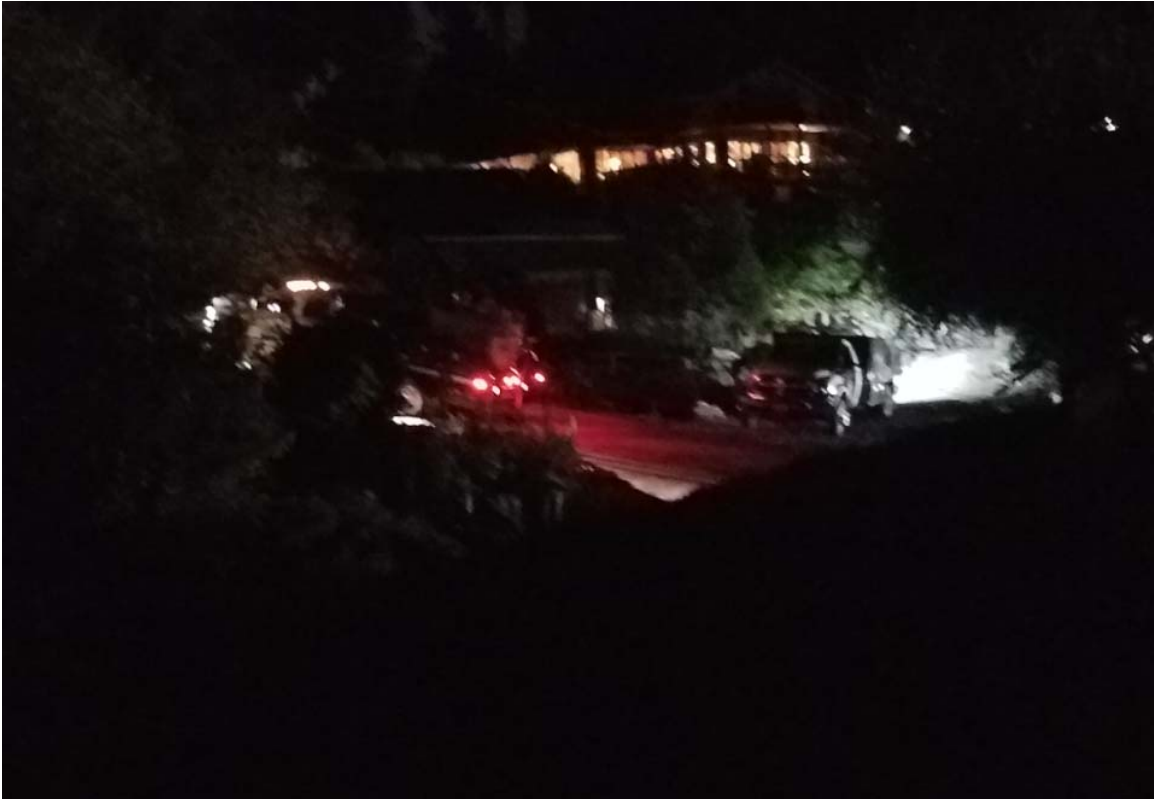
Here is the boring finished at night very late.

There is another water issue created by the Wischman's . They hired a boring company to bore from near the now dying cedar tree down 60 vertical feet to get water to the beach cabin.

This was not completed as desired. The boring missed it's target and the Wischman's kept working past their construction hours and finished at night about 9-10pm .

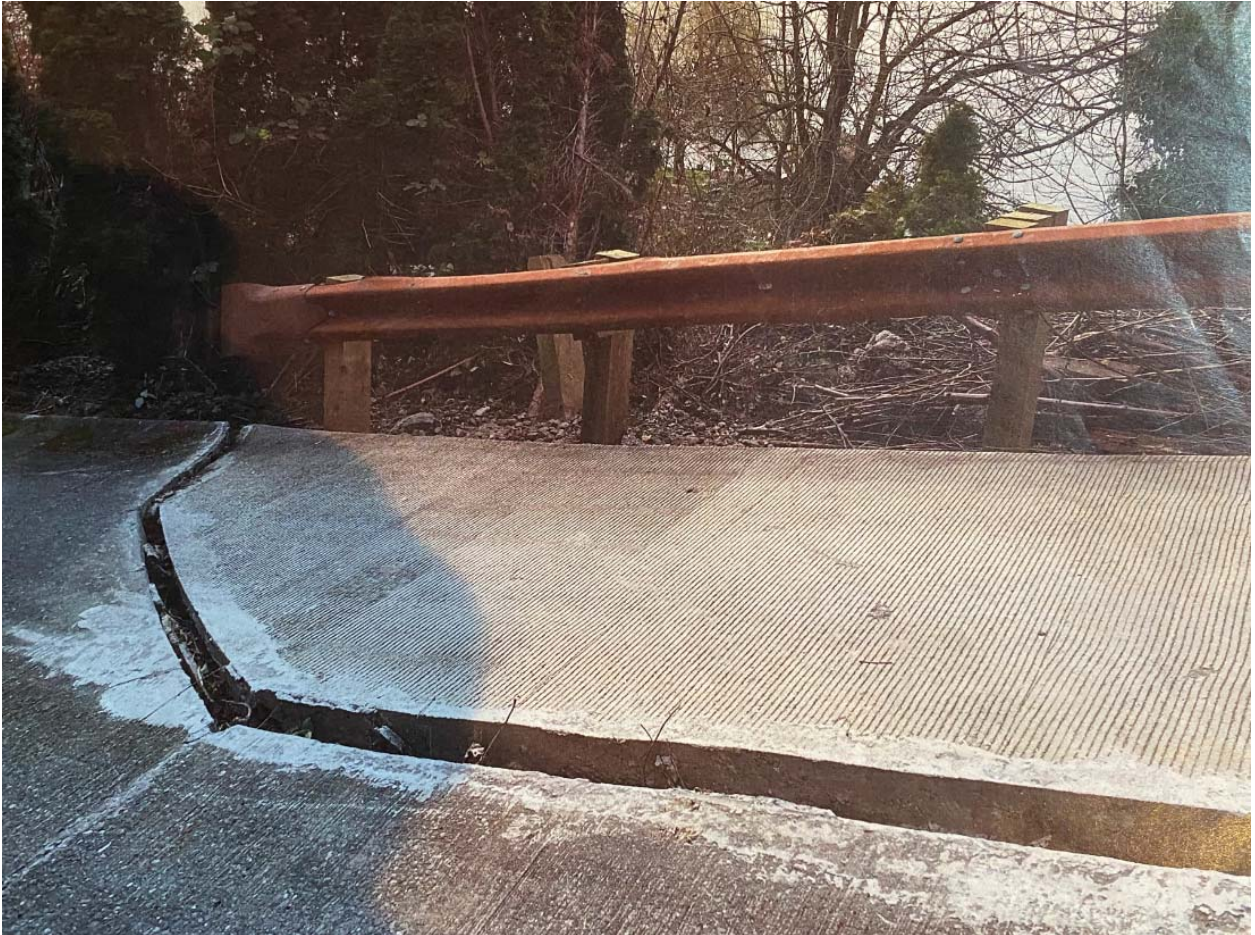
Here is the road before it was closed:

The road had water going under it and this led to gaps in the pavement.

Eventually this road was deemed unsafe by the City and closed to Michael Gladstein's use.

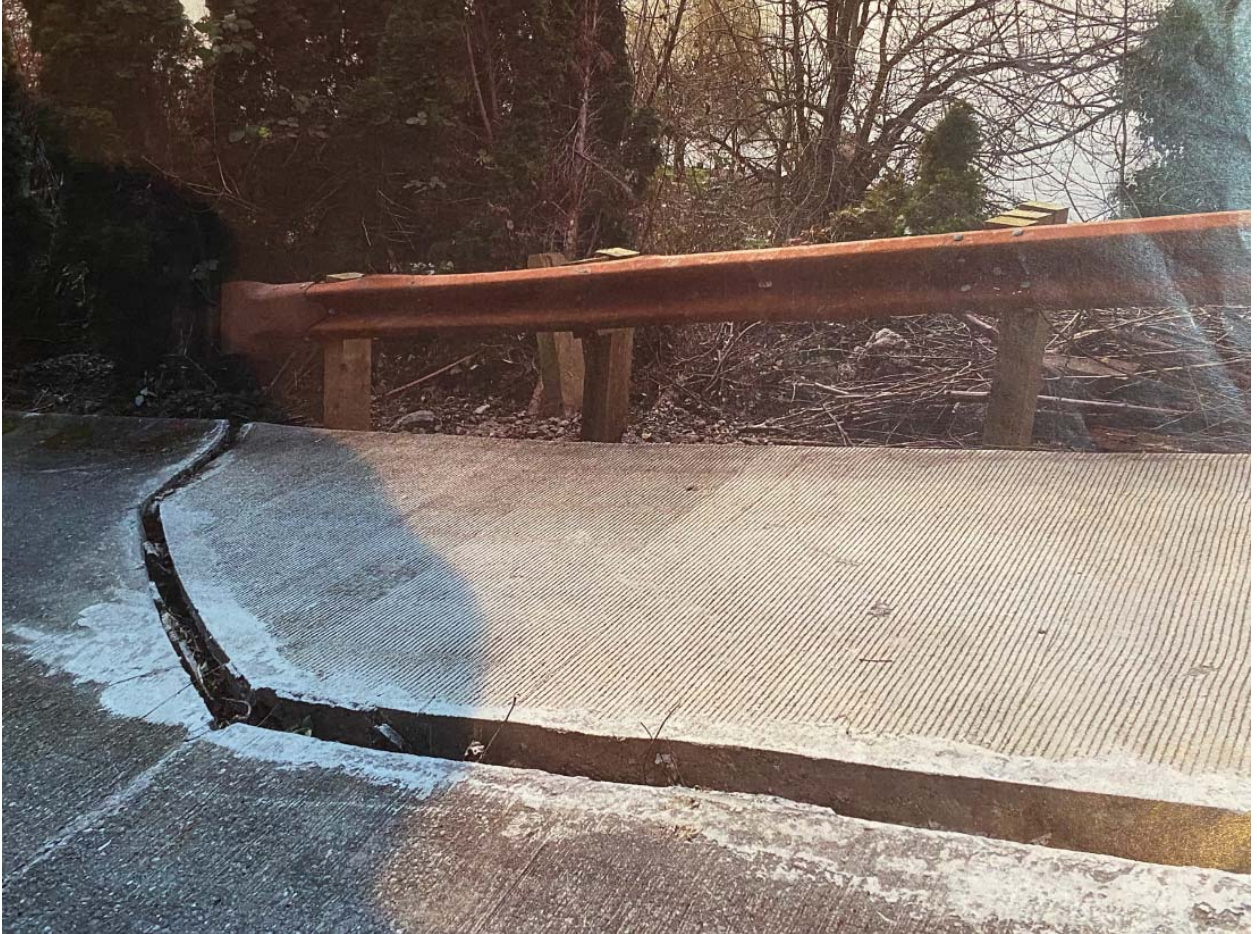
Here is the freeman road and the cracks that closed it:
