From: Frank Close <fclose@guardiansecurity.com>
Sent: Tuesday, June 1, 2021 10:10 AM
To: Lauren Anderson
Subject: Freeman subdivision parking & Right of way Issues:
Attachments: Freeman Subdivision Parking 6-1-2021.pdf

From: Frank Close <fclose@guardiansecurity.com>
Sent: Tuesday, June 1, 2021 10:08 AM
To: Lauren Anderson
Subject: Freeman subdivision 4001 West Mercer way
Attachments: Freeman Subdivision drainage 6-1-2021-2021.pdf; Freeman subdivisioin arborist report iTree Letter (Mercer Island) (2).pdf

Environmental Degradation and Water Damage Pose Severe Slide Risk

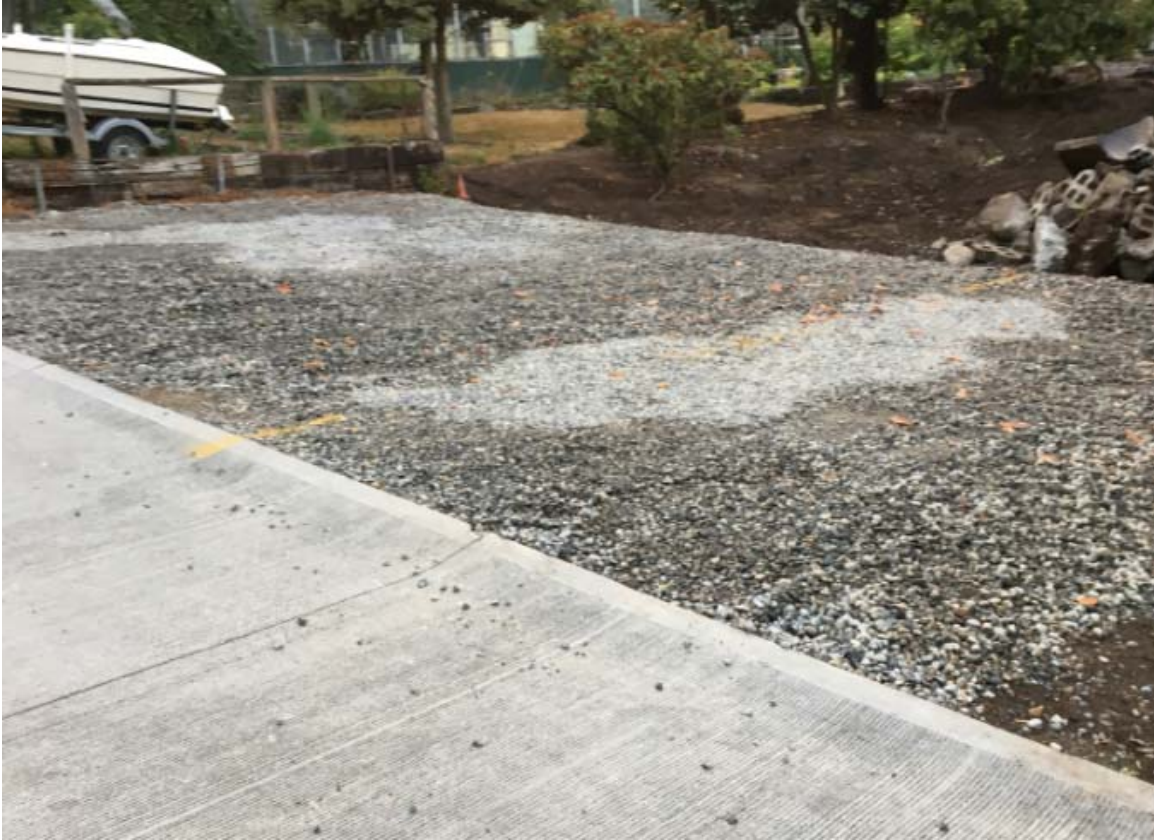
Here we go with how they resolved the parking: Note this was one space and now is space for 4, what about the responsibility of the RIGHT OF WAY to have Green spaces on City owned property?

They expanded the ones slot with the path to handle all of the added traffic.

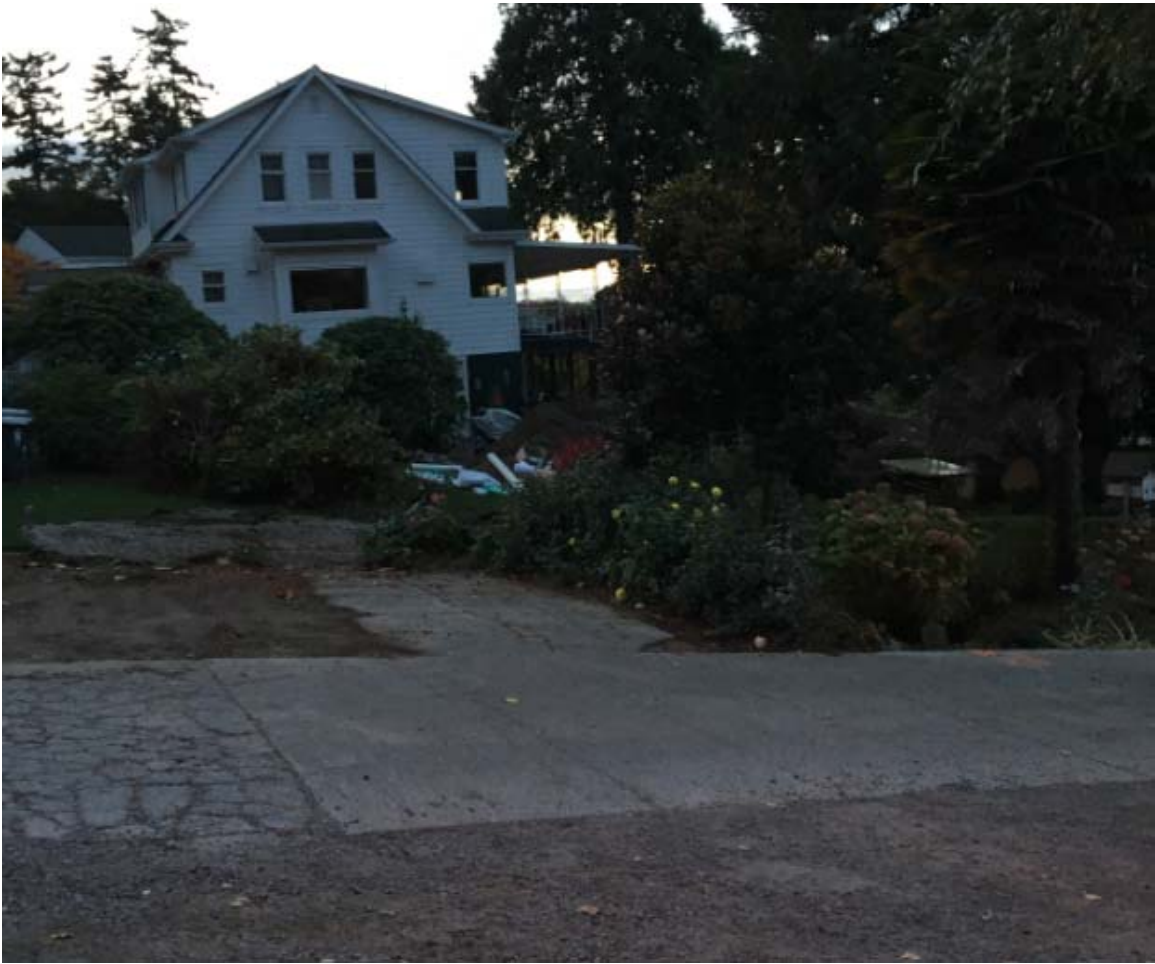
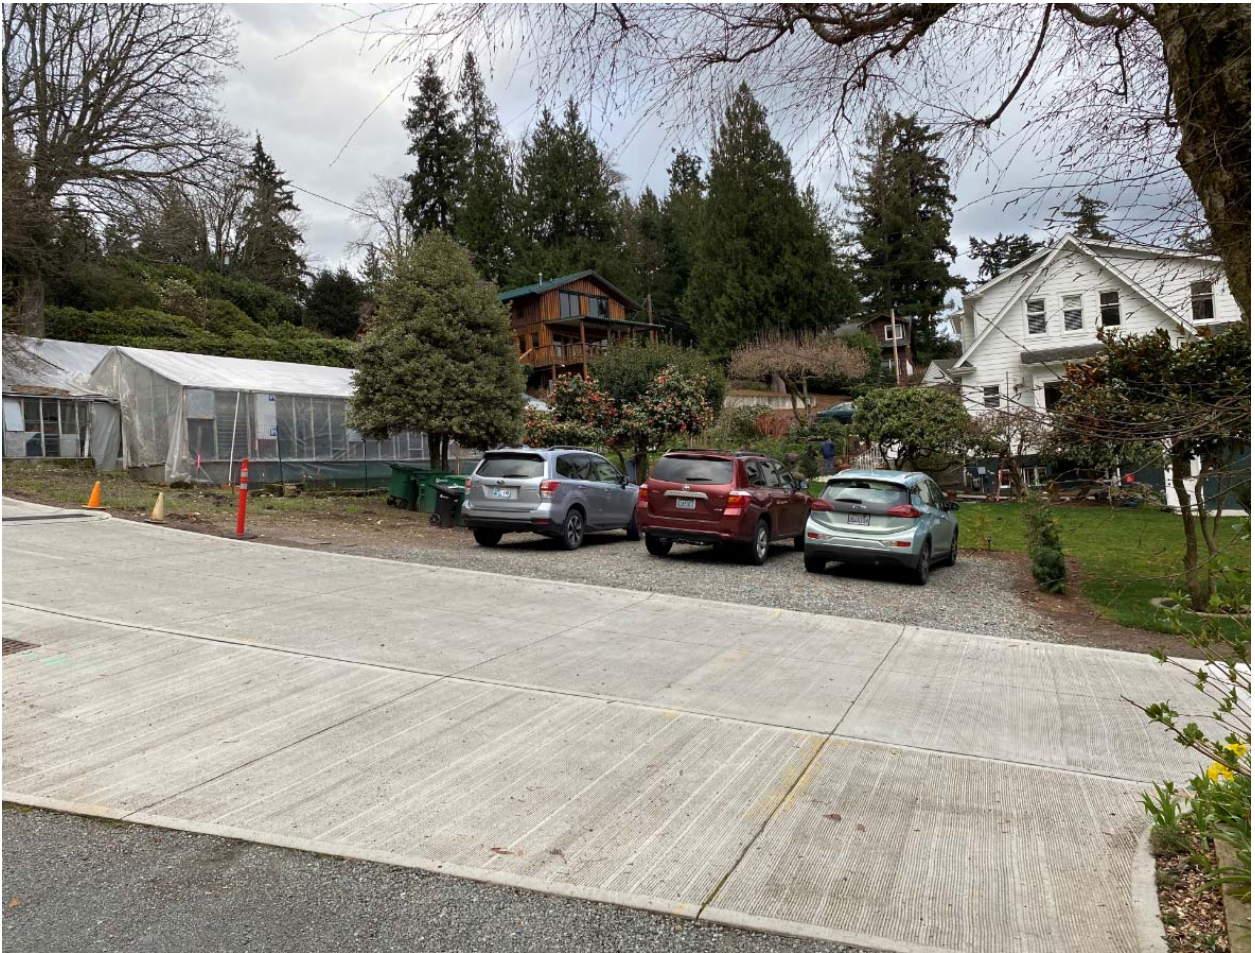
Just look at the current use verses the previous use. This access is not their current access, but it will now have lot's more vehicles.

THEY DID NOT LANDSCAPE THE PROPERTY THEY DID NOT OWN FOR ENVIRONMENTAL REASONS.

NOTE THE OLD DESCRIPTION OF ONLY ONE CAR SPACE AND GO FROM THERE TO 3 CARS AND ACTUALLY ROOM FOR 4?
