**SUBJECT: Interrupted Watercourse Buffer for Milestone Preliminary Short Plat
7621 SE 22nd Street, Mercer Island WA (Parcel 531510-1846)
City File # PRE20-019**

On June 10, 2021 I conducted a site review on the subject property. The purpose of the reconnaissance was to assess whether a small portion of the outer 120-foot watercourse buffer that extends into the northeast corner of the site is functionally interrupted by the two paved access roads that separate the site from the off-site watercourse.

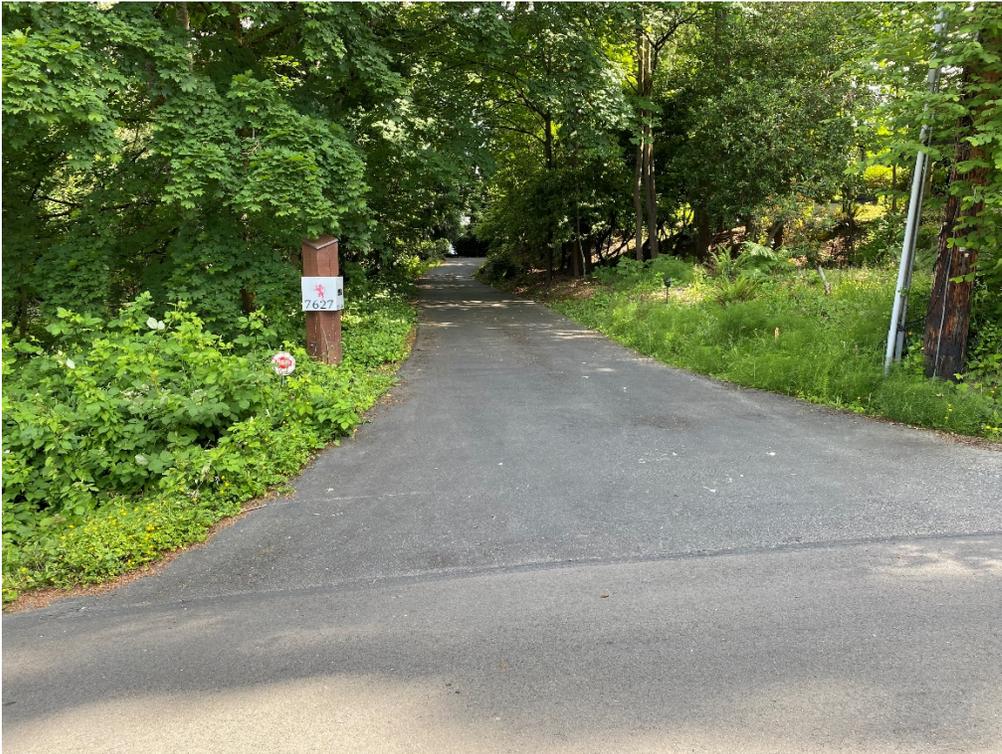
Existing paved access road separating on-site portion of buffer at right from off-site watercourse.

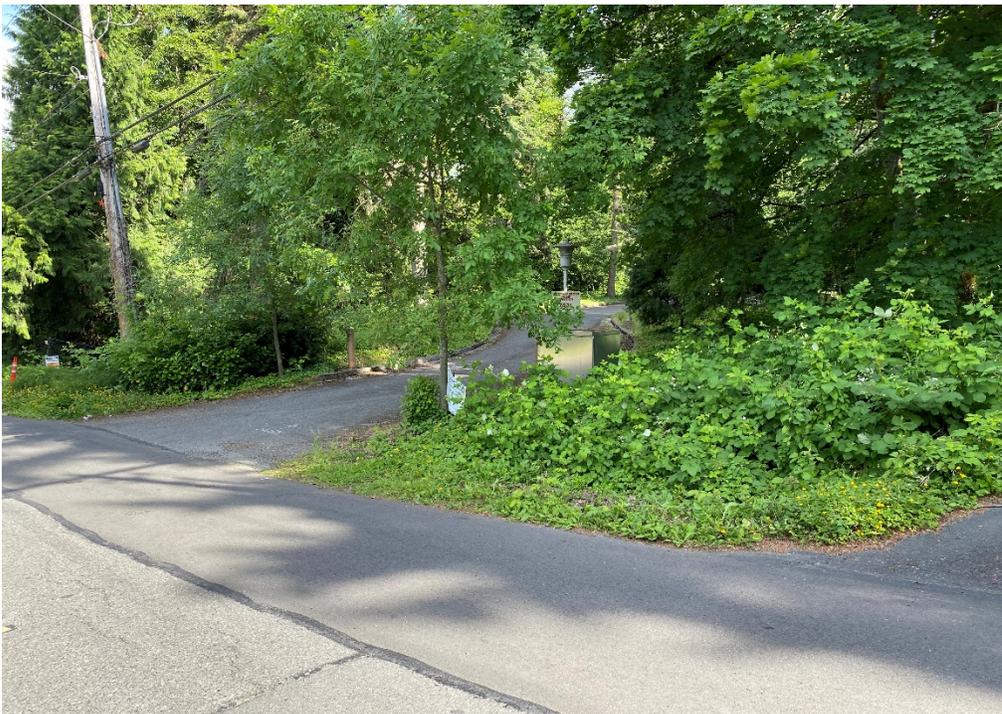
View of existing paved access drive to pump station.
