**SONDERGAARD GEOSCIENCE, PLLC**  
13012 65<sup>TH</sup> Avenue SE  
Snohomish, Washington 98296

J-0165

Subject: Critical Area Report

7216 93<sup>rd</sup> Avenue SE

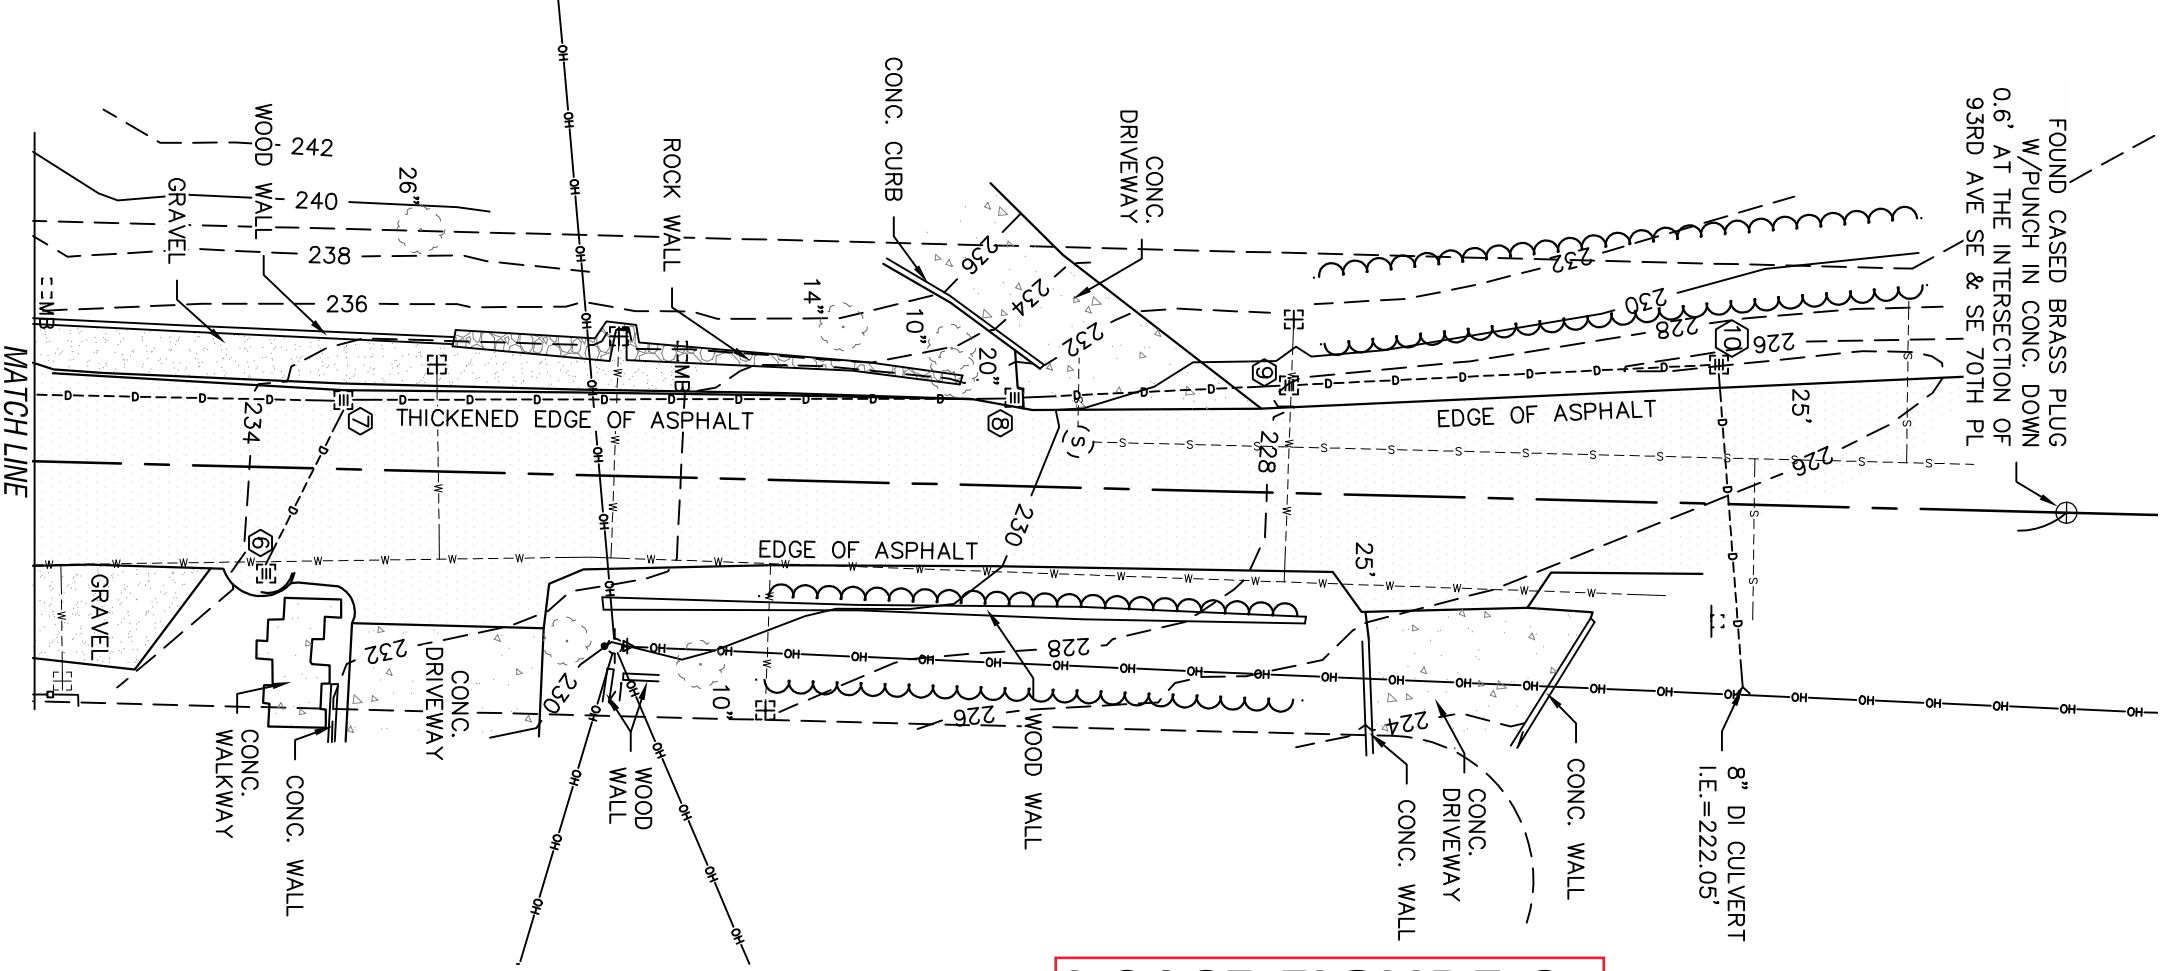
**J-0165 FIGURE 6**

The site is characterized by a slight slope down to the east on the west half of the property and on most of the northeast portion of the property. A gully runs along the southeast portion of the lot and along the east property line (Figure 4). Review of the Mercer Island Landslide Hazard map (K.G. Troost and A.P. Wisher (2009), Mercer Island Landslide Hazard Assessment prepared for Geomap Northwest and the City of Mercer Island indicates the east portion of the property contains slopes greater than 15 percent inclination (Figure 5). The topographic survey of the property shows that the slopes along the gully range height from about 8 to 20 feet with slope inclinations ranging from approximately 38 to 53 percent. According to MIMC Title 19, Chapter 19.16, Section 19.16.010(L) the gully slopes meet the definition of a landslide hazard area by having slope inclinations greater than 40 percent over a horizontal distance of 30 feet or greater (Figure 6). Based upon observation of the existing site conditions, including the large trees that remain on the site, in our opinion, there is no obvious evidence of past or present shallow or deep landslide movement at the site.

The subsurface soils at the site consist of medium dense to dense glacial till and advance outwash. Subsurface exploration at the site indicates shallow ground water was not present to depths of at least 7 feet and review of near by well logs indicates no groundwater within the upper 30 feet at the site (Washington State Well Report Viewer (2009). Based upon review of the Mercer Island Seismic Hazard map ((K.G. Troost and A.P. Wisher (2009b) and Chapter 19.16, Section 19.16.010(S) the subject property is not located in a Seismic Hazard Area (Figure 7).

1. Restrict development of the site within the designated landslide hazard area except those portions that meet the requirements of MIMC Title 19, Chapter 19.07, Section 19.07.160(B)(2). The current plan for Lots 2 and 3 shows that the southeast corner of the new home for Lot 2 extends into the buffer approximately 20 feet and the northeast corner of the new home for Lot 3 extends into the buffer about 10 feet. The proposed new home for Lot 1 does not intrude into the buffer. As per the geotechnical recommendations provided by Pride (RM Pride, 2020), foundations that protrude into the buffer should be extended to a minimum depth of 3 feet to reduce potential loads on the slope. An analysis of site specific geologic and topographic conditions indicate that the subject property has not experienced landsliding in the past and the development has been designed so that the risk to the site and adjacent property is mitigated such that the site is determined to be safe.

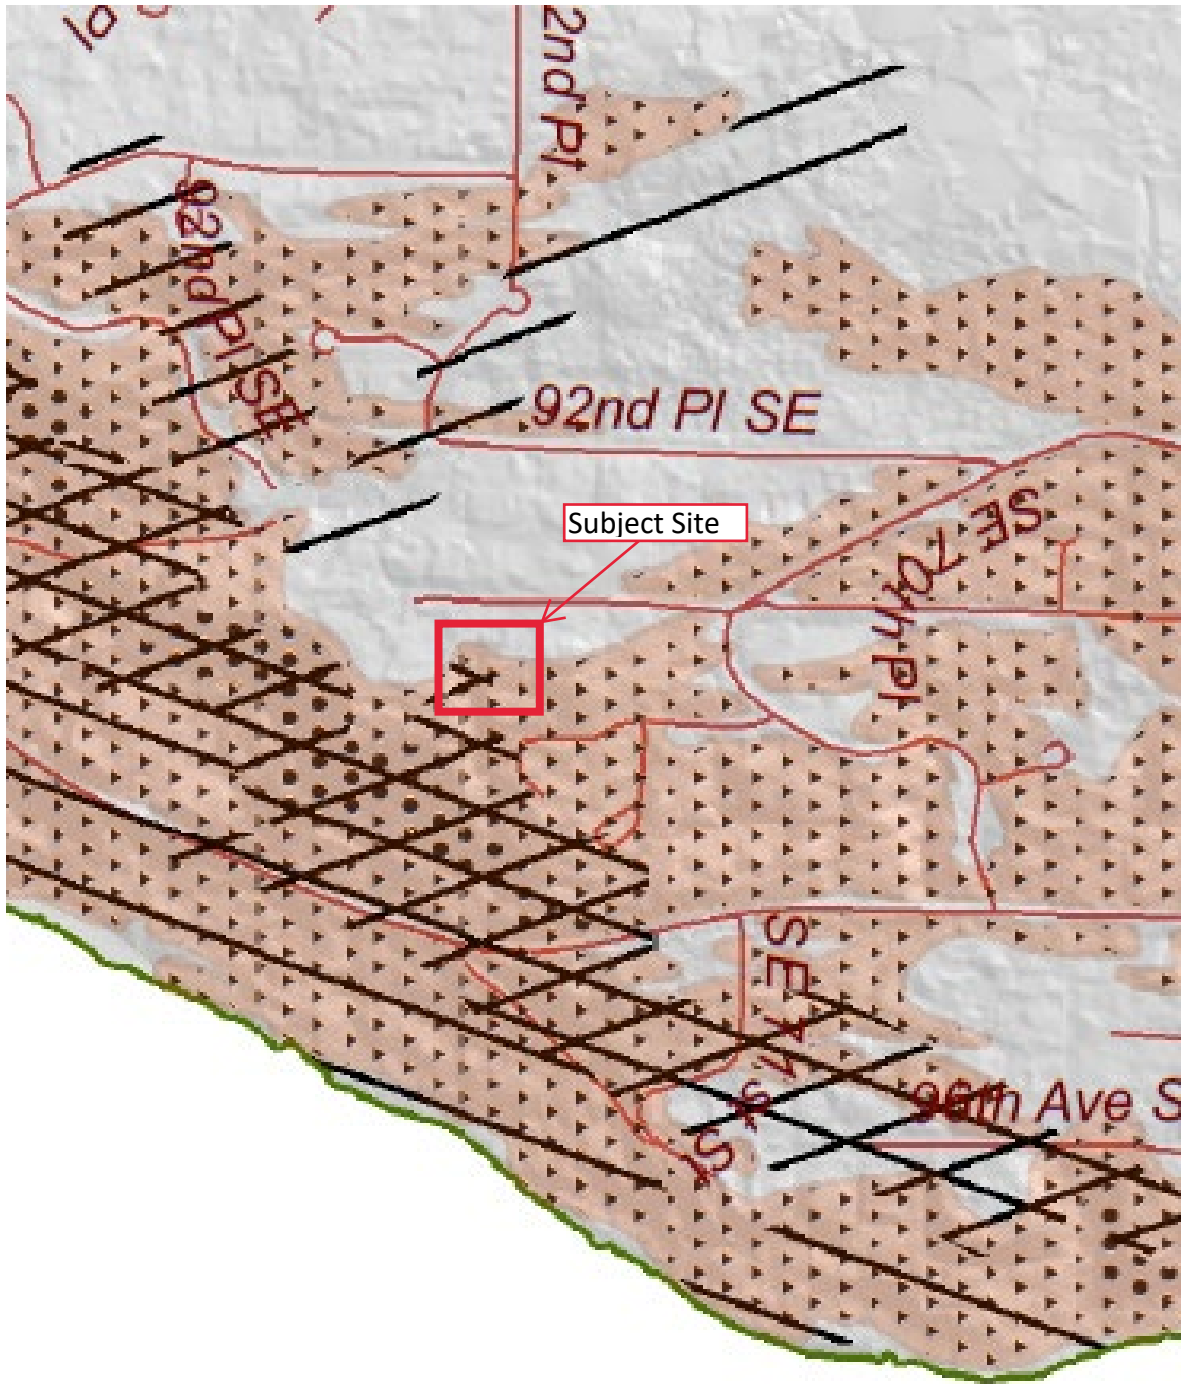
MERCER ISLAND EROSION HAZARD AREA MAP  
7216 93RD AVENUE SE  
MERCER ISLAND, WASHINGTON

Review of the Mercer Island Erosion Hazard map (K.G. Troost and A.P. Wisher (2009c) indicates that east portion of the subject property is located within an Erosion Hazard Area (Figure 8). MIMC Title 19, Chapter 19.16, Section 19.16.010(E) defines erosion hazard areas as those areas with slopes having inclinations greater than 15 percent including those areas underlain by soils with a severe or very severe rill and inter-rill erosion hazard. Review of the USDA Soil Survey (Web Soil Survey, 2021) of the site indicates the site is underlain by Everett-Alderwood gravelly, sandy loams on 6 to 15 percent slopes (Figure 9). According to the USDA, these soils exhibit a moderate erosion hazard. The steep slope area of the site exceeds inclination of 15 percent and are classified as an erosion hazard area (Figure 10).

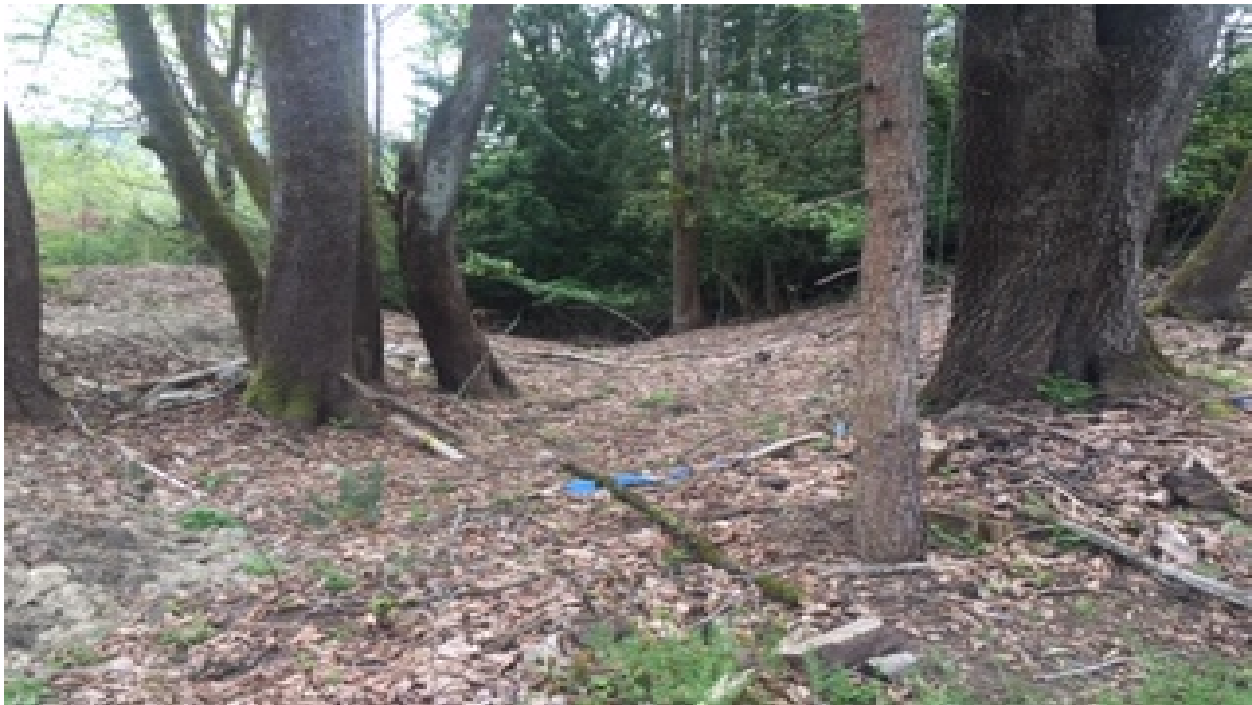
Photo 2: Looking east toward the southeast at the head of small gully that runs along the south side of the property.
