**From:** [Dan Grove](#)  
**To:** [Molly McGuire](#)  
**Subject:** Development Proposal Site for Permit 2207-019 is Illegally nonconforming  
**Date:** Friday, June 16, 2023 8:27:41 AM  
**Attachments:** [6950 Illegal Nonconforming Status \(1\).pdf](#)

Molly McGuire  
Mercer Island Community Planning and Development Department  
RE: Development Site for Permit 2207-019 is Illegally Nonconforming  
June 15, 2023

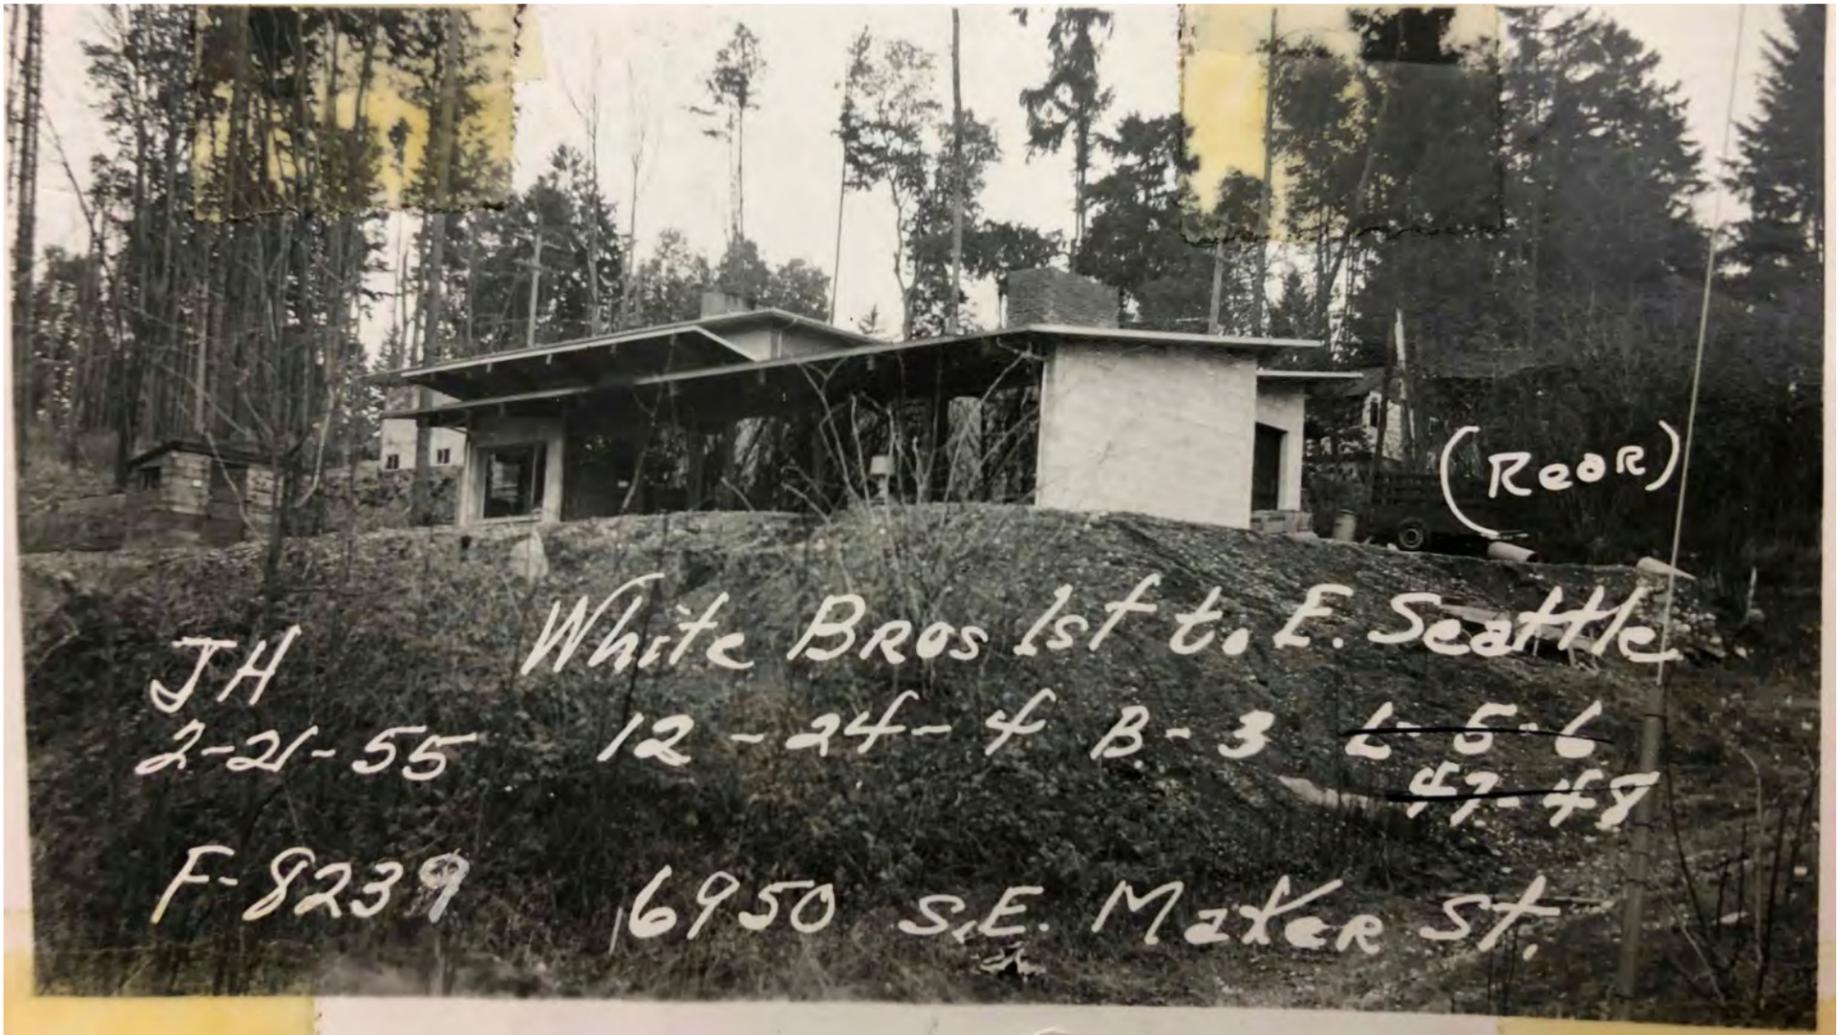
When this photo was taken, the area directly west of the house (and shown in this photo) had approximately 10' of fill in place (based on the 1963 Survey and 2022 Geotechnical Survey, shown below).

Figure 1. 1955 King County Assessor photo showing same hillside as 1963 Aerial Image in Figure 2b

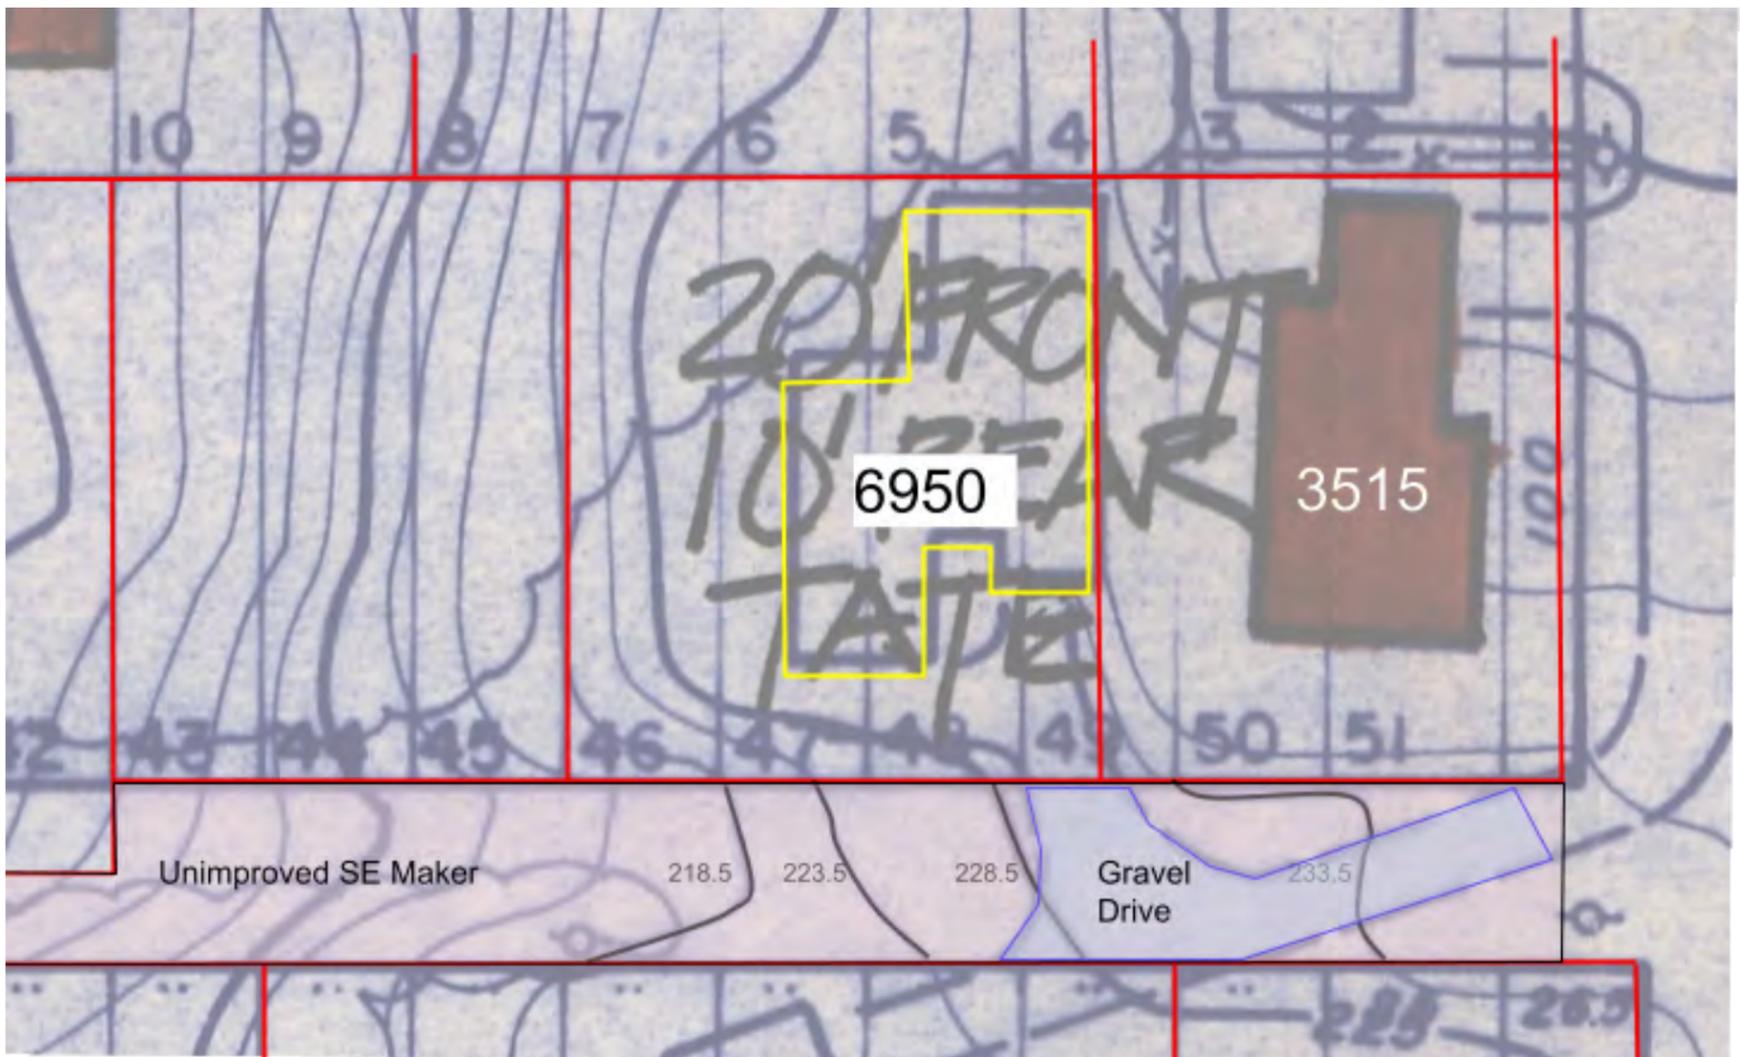
Figure 2 is taken from a [Mercer Island 1963 survey](#) that shows the contours of the Lot and the SE Maker right-of-way after the 6950 house was completed in 1955, but before the rockery was put in place around 6950.

It is important to note that there is no rockery in the SE Maker right-of-way south of 6950, and no rockery on the western boundary of 6950. This is confirmed by the 1963 aerial image in Figure 3a.

Figure 2. Survey showing original grade of SE Maker Street, 1963. The grade shown for 6950 is already Altered from the Existing Grade. ("1963 Survey")

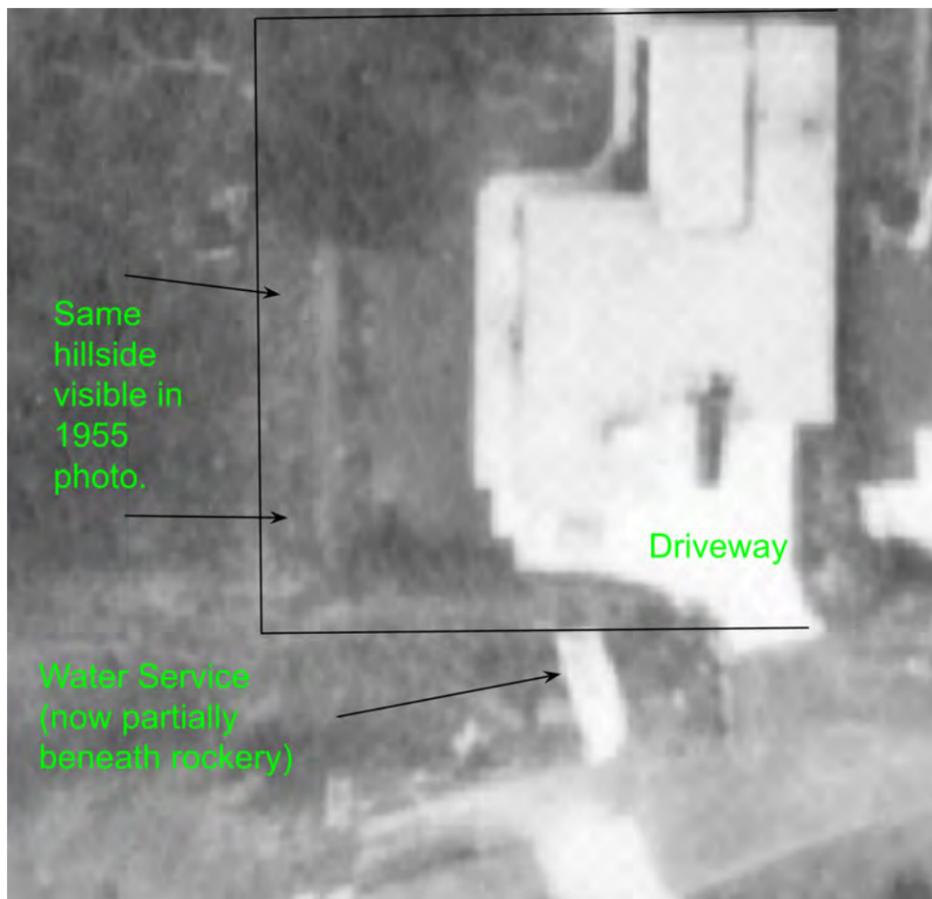
Figure 2a. 1963 Aerial Image showing no rockery to the west and no rockery in SE Maker ROW

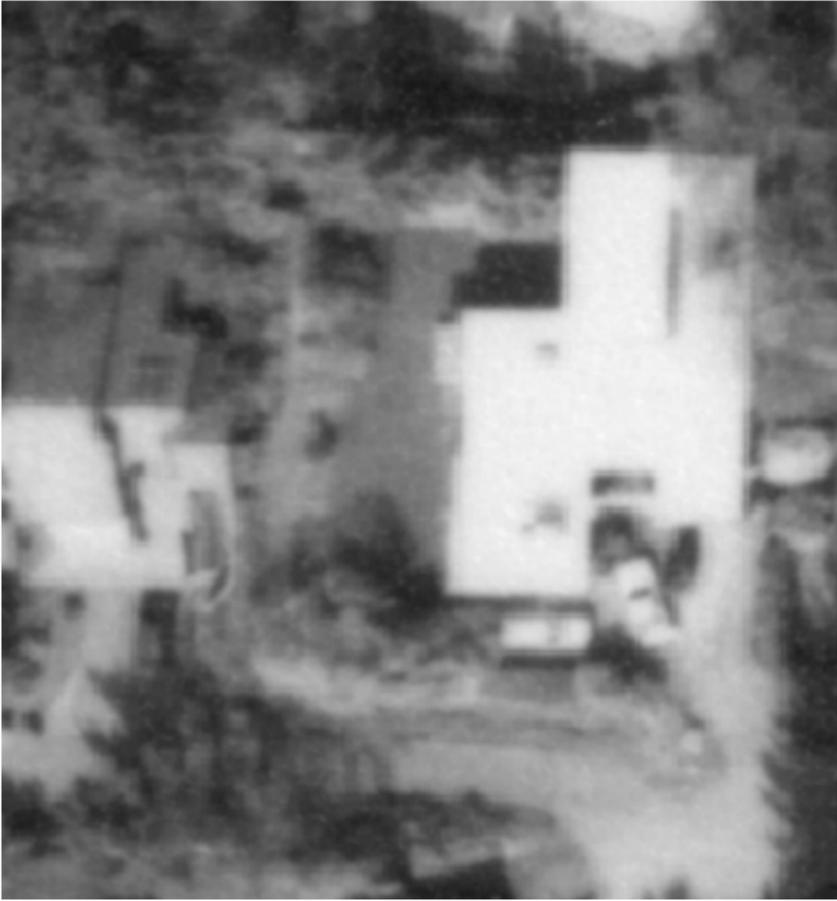
Figure 2b. For comparison, 1992 Aerial Image showing rockery to the west and rockery in SE Maker ROW

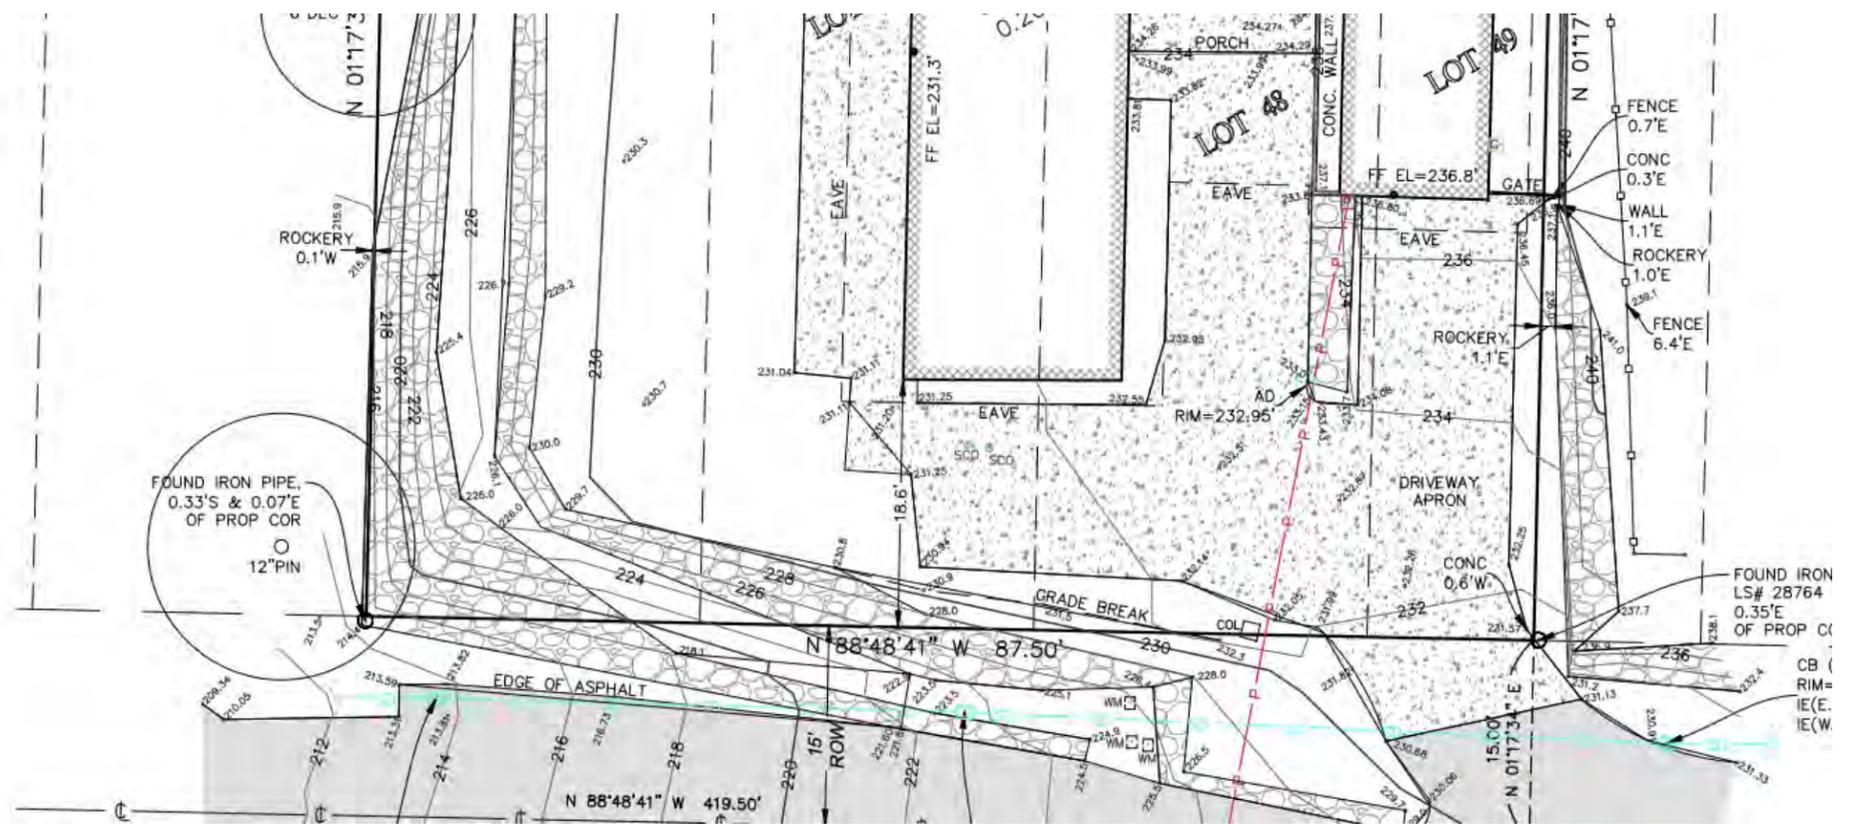
Another survey of SE Maker Street and 6950 SE Maker was done in 2021, as shown in Figure 3. The rockery installed after 1963 significantly altered the grade of the front and side yards of 6950 SE Maker (north and east of the rockery), as a second fill installation was done (to fill in the area behind the rockery, and to increase the grade of the front/side yards).

Figure 3. 2021 Survey of 6950 SE Maker and SE Maker Street

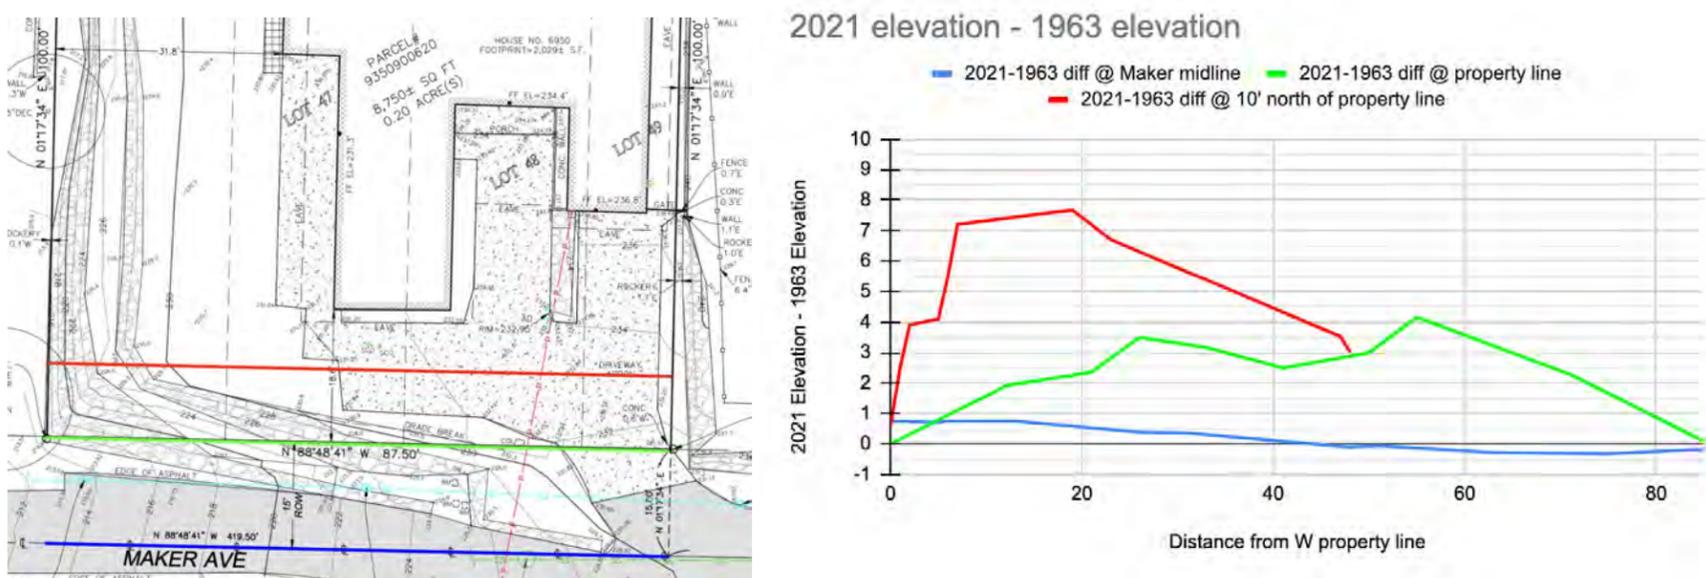
A comparison of cross sections (shown in Figure 4) of the 1963 Survey in figure with the 2021 Survey from 2207-019 clearly confirms that the rockery was installed between the dates of the two surveys. In these two surveys, 60 years apart:

- The elevation of the Maker Street midline (shown in Blue) is differs from 1963 to 2021 by only a few inches (despite the street being paved several times between the two surveys)
- At the south boundary of 6950 (in Green), the rockery that was added is clearly visible - as you can see, there are up to 4 feet of difference between 1963 and 2021.
- The cross section 10' north of the boundary (in Red) shows that the rockery increased the elevation of the yard by 7.5 feet when comparing 2021 and 1963 elevations.

Figure 4. Comparison of cross sections of 1963 and 2021 Survey elevations
