# FIELD REPORT:

| Project Address: | 4825 E. Mercer Way, Mercer Island, WA 98040 |

Field Report, Trees 916 & 917 4825 E. Mercer Way, Mercer Island, WA 98040 Gilles Consulting January 11, 2019 Page 3 of 10

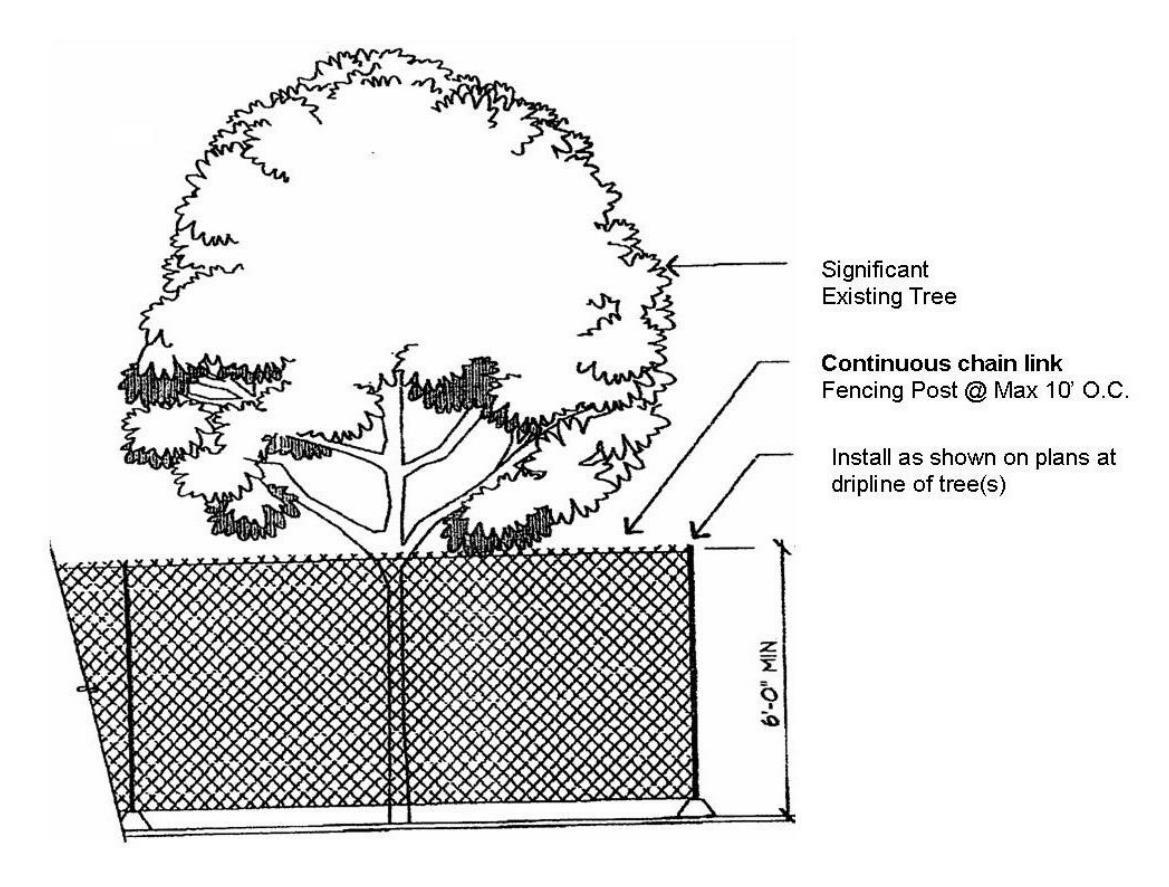
Six-foot high temporary chain link fence shall be placed as shown on plans. Fence shall completely encircle tree(s). Install fence posts using pier blocks only. Avoid driving posts or stakes into major roots.

- Make a clean straight cut to remove damaged portion of root for all roots over 1" in diameter damaged during construction. *All* exposed roots shall be temporarily covered with damp burlap and covered with soils the same day, if possible, to prevent drying. If not possible, burlap must be kept moist at all times.

- Work with the protection fencing shall be done manually. No stockpiling of materials, soil, debris, vehicle traffic, or storage of equipment or machinery shall be allowed within the limit of the fencing.

- Cement trucks must not be allowed to deposit waste or wash out materials from their trucks within the Tree Protection Fences.
- The area within the Tree Protection Fencing must be covered with wood chips, hog fuel, or similar materials to a depth of 8 to 10 inches. The materials should be placed prior to beginning construction and remain until the Tree Protection Fencing is taken down.
