**RE: Critical Areas Determination Report for King County Tax Parcel 3024059120,
Located at 6420 E Mercer Way, in the City of Mercer Island**

CRITICAL AREA DETERMINATION MAP

DE LA OSA/WELCH - 6420 E MERCER WAY ADDITION

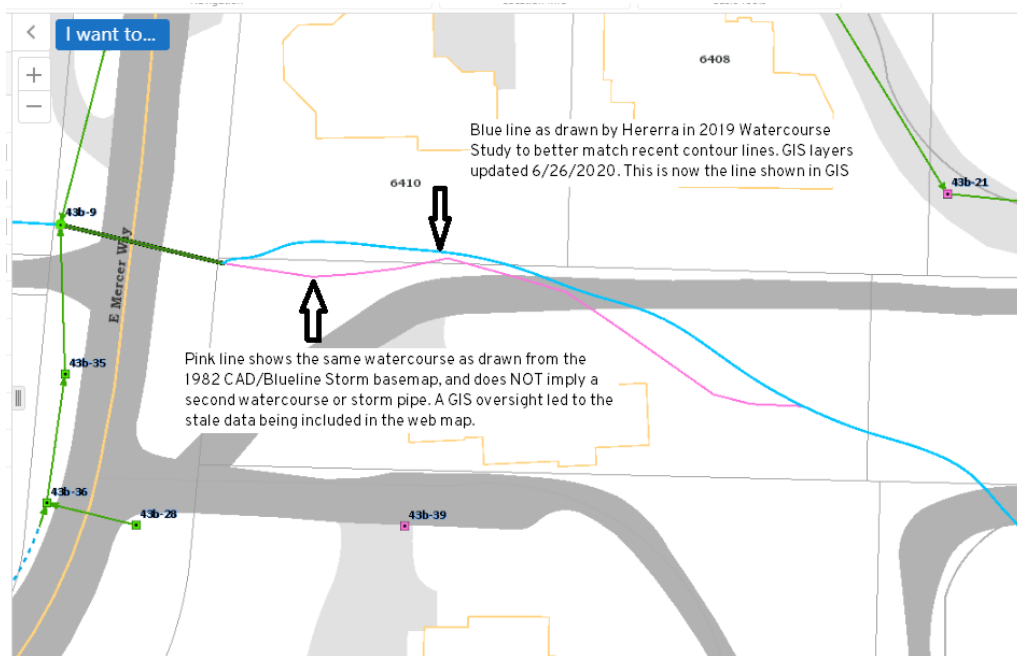
- The public GIS website showed two separate lines running nearly parallel to each other. This was an error on our part, as we failed to reconcile the older and newer data sources. The two lines represented the same feature, and edits have since been made to correct the issue.

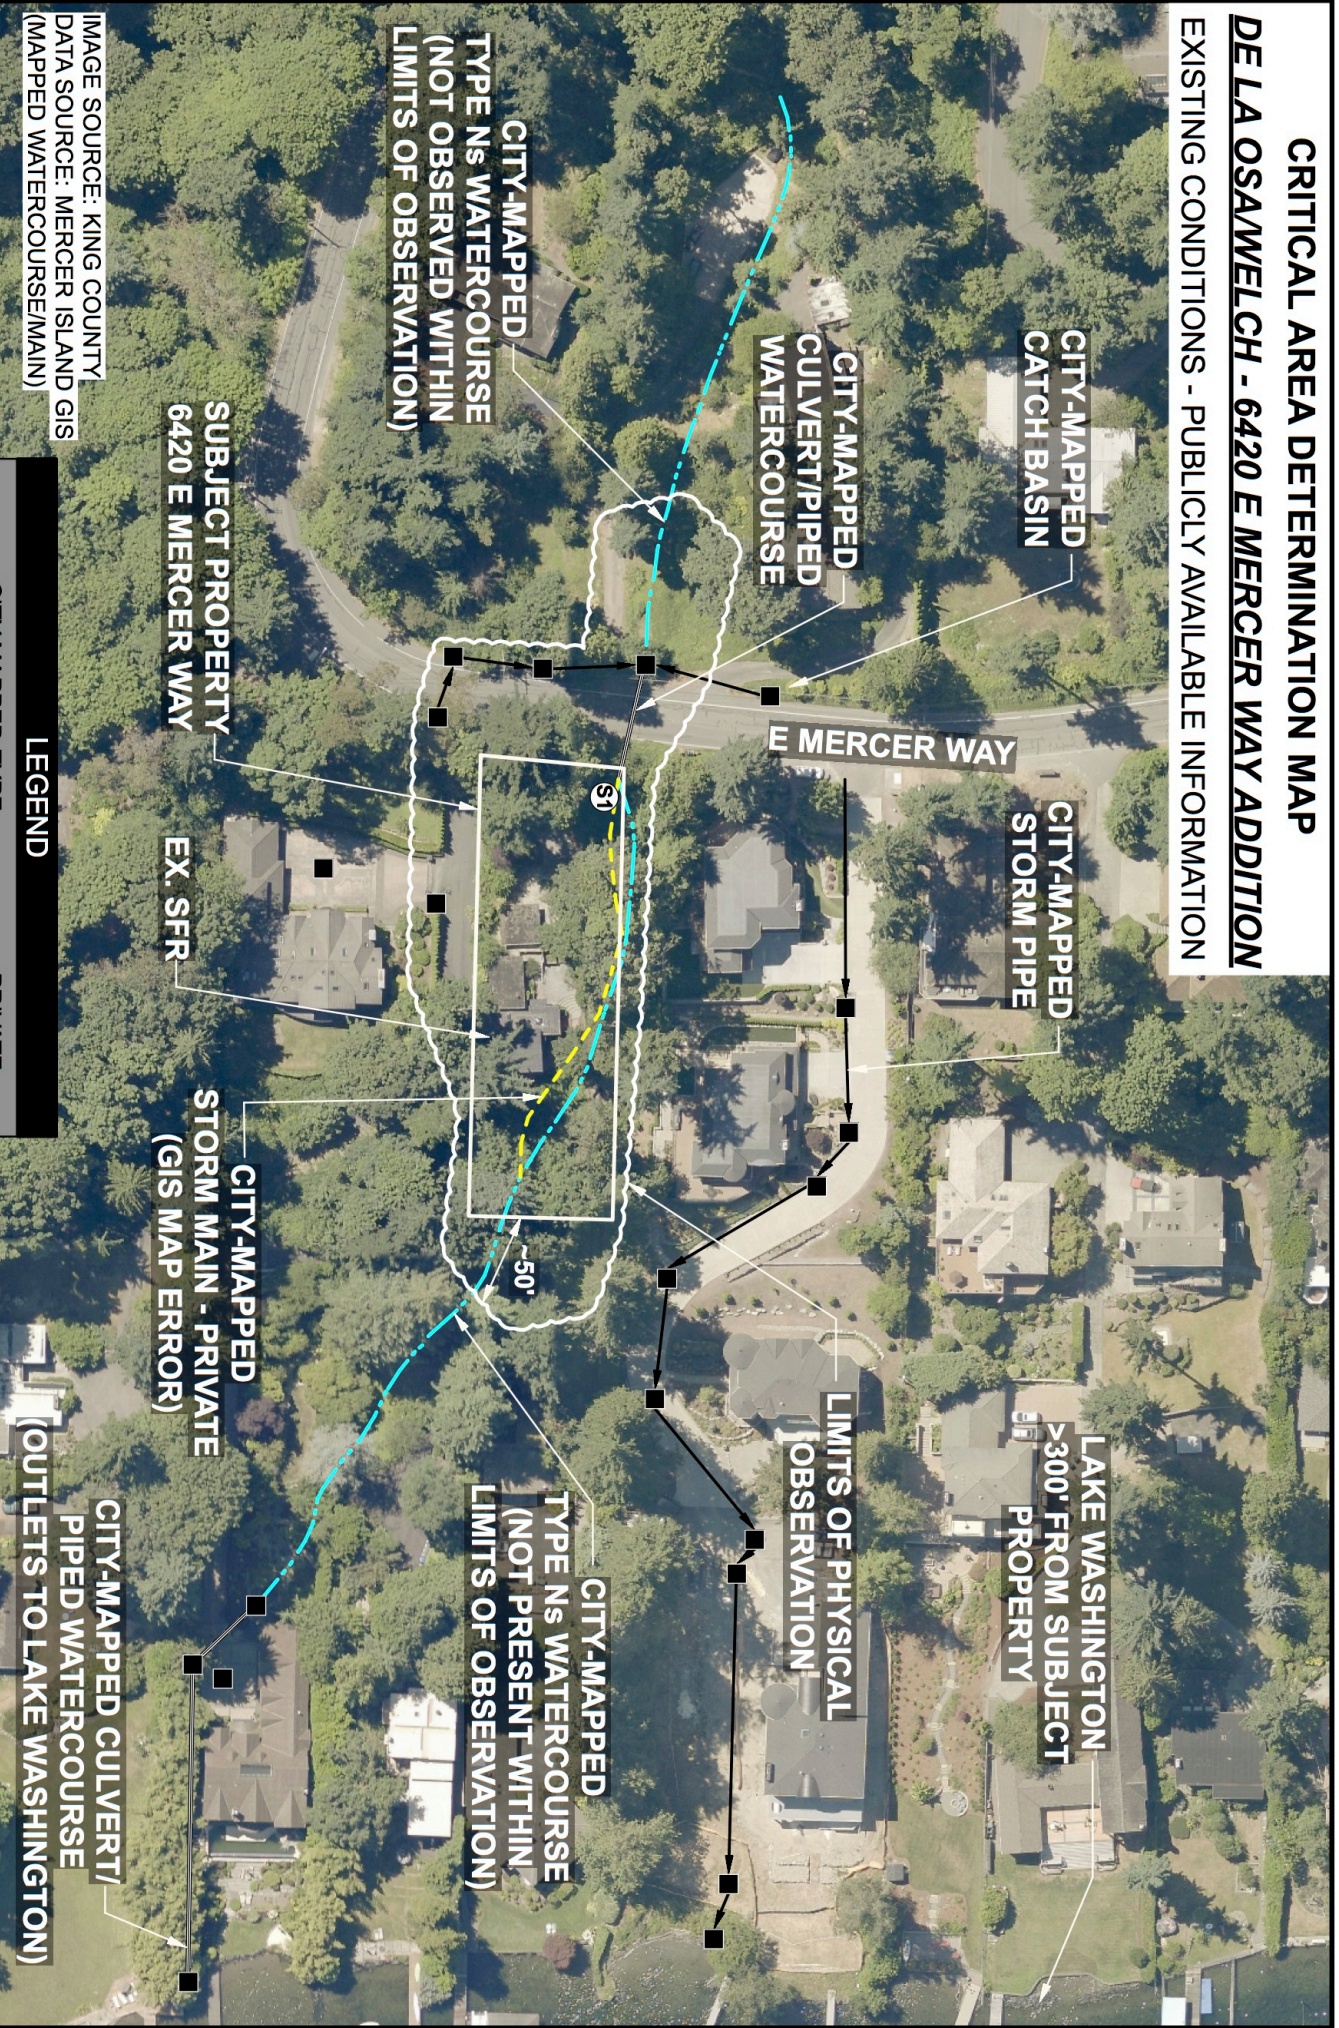
Critical Area Determination Map
(Sheet 1/1)

- One 12-inch diameter concrete culvert beneath E Mercer Way; the feature outlets at the northwest corner of the subject property (labeled SD-GM-03442)
- Open Watercourse/Type Ns stream; the feature flows through subject property (labeled SD-GM-03367)
- Storm Main – Private; feature is similar to the alignment of the Open Watercourse, but slightly to the south (also labeled SD-GM-03367)

The June critical areas delineation finds that no wetlands or above-ground watercourses are present on or near the subject property.

CITY-MAPPED
TYPE Ns WATERCOURSE
(NOT OBSERVED WITHIN
LIMITS OF OBSERVATION)

CITY-MAPPED
STORM MAIN - PRIVATE
(GIS MAP ERROR)

CITY-MAPPED
TYPE Ns WATERCOURSE
(NOT PRESENT WITHIN
LIMITS OF OBSERVATION)

The applicant asserts that, based on thorough physical inspection of the ground surface, and the absence of any indication that a pipe conveys stormwater beneath the subject property, that no regulated wetlands or watercourses are present within the subject property. Any proposed development of the subject property would not alter critical areas or buffers, and for these reasons the applicant request that the City waive the requirement to submit a critical area study, as allowed by MICC 19.07.110(C). Furthermore, any future development of the subject property should not require critical area review, and the City should eliminate the mapped Open Watercourse from all areas upstream of the subject property.
