**3603 W Mercer Way Mercer Island, WA 98040**

## **Drainage Report**

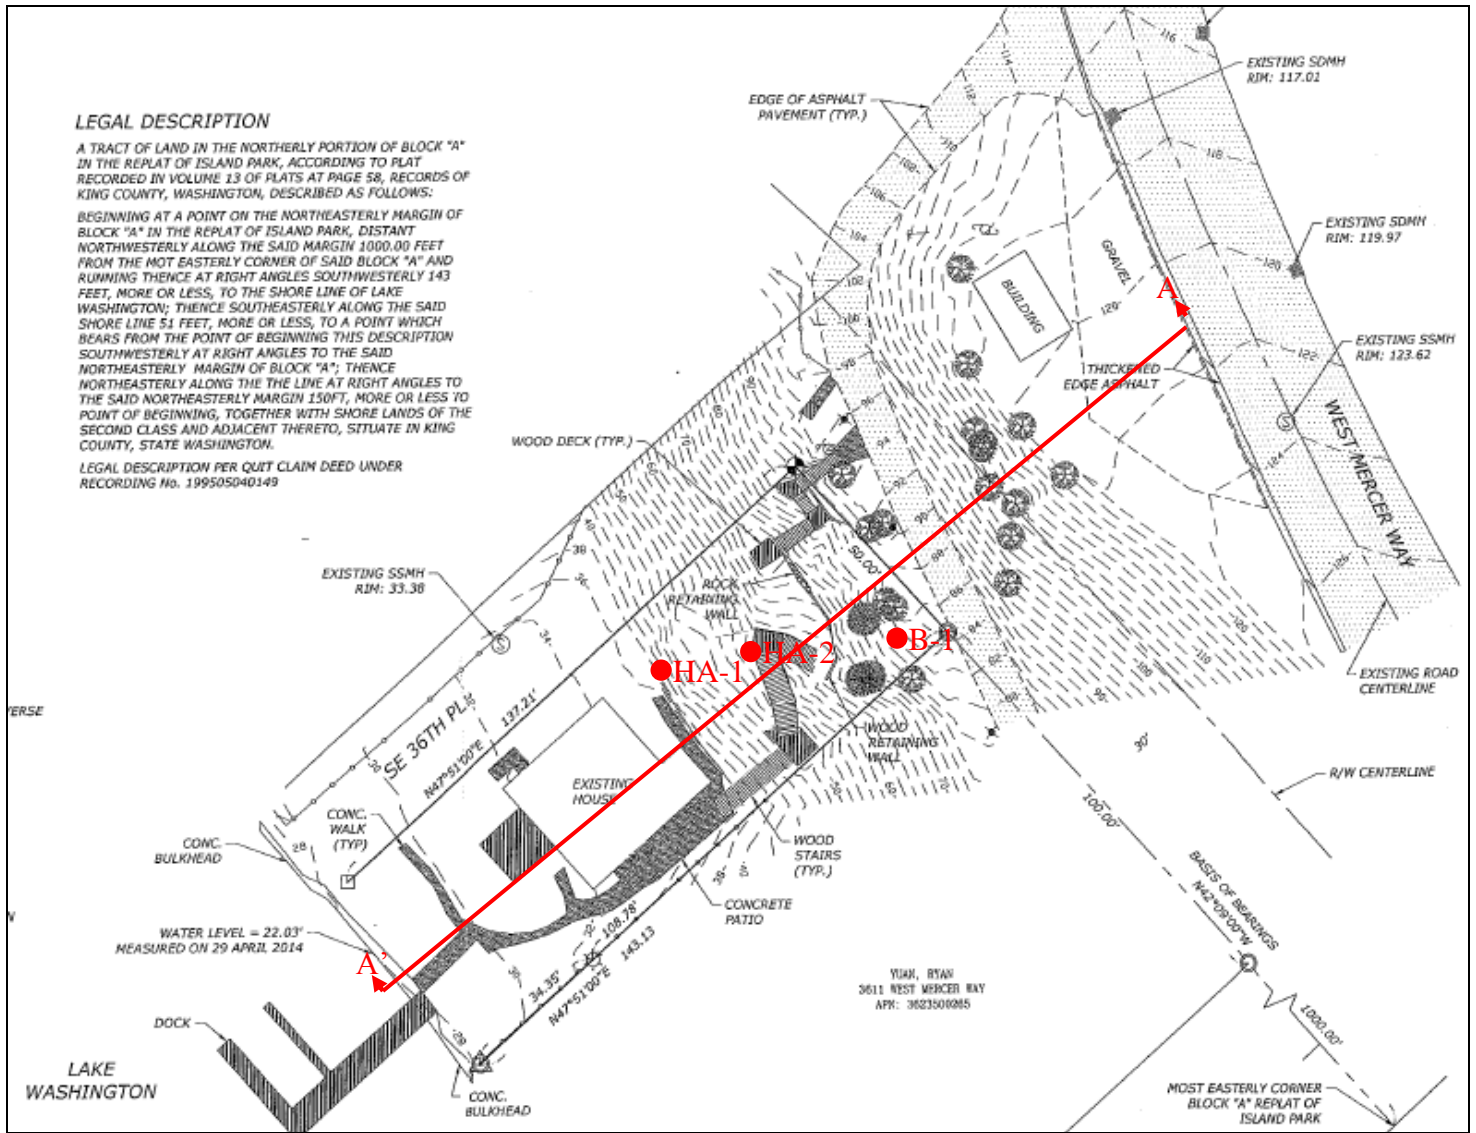
**Site and Exploration Plan**

**Approximate Site Location**  
(site plan by Beyler Consulting, 9/11/2014)

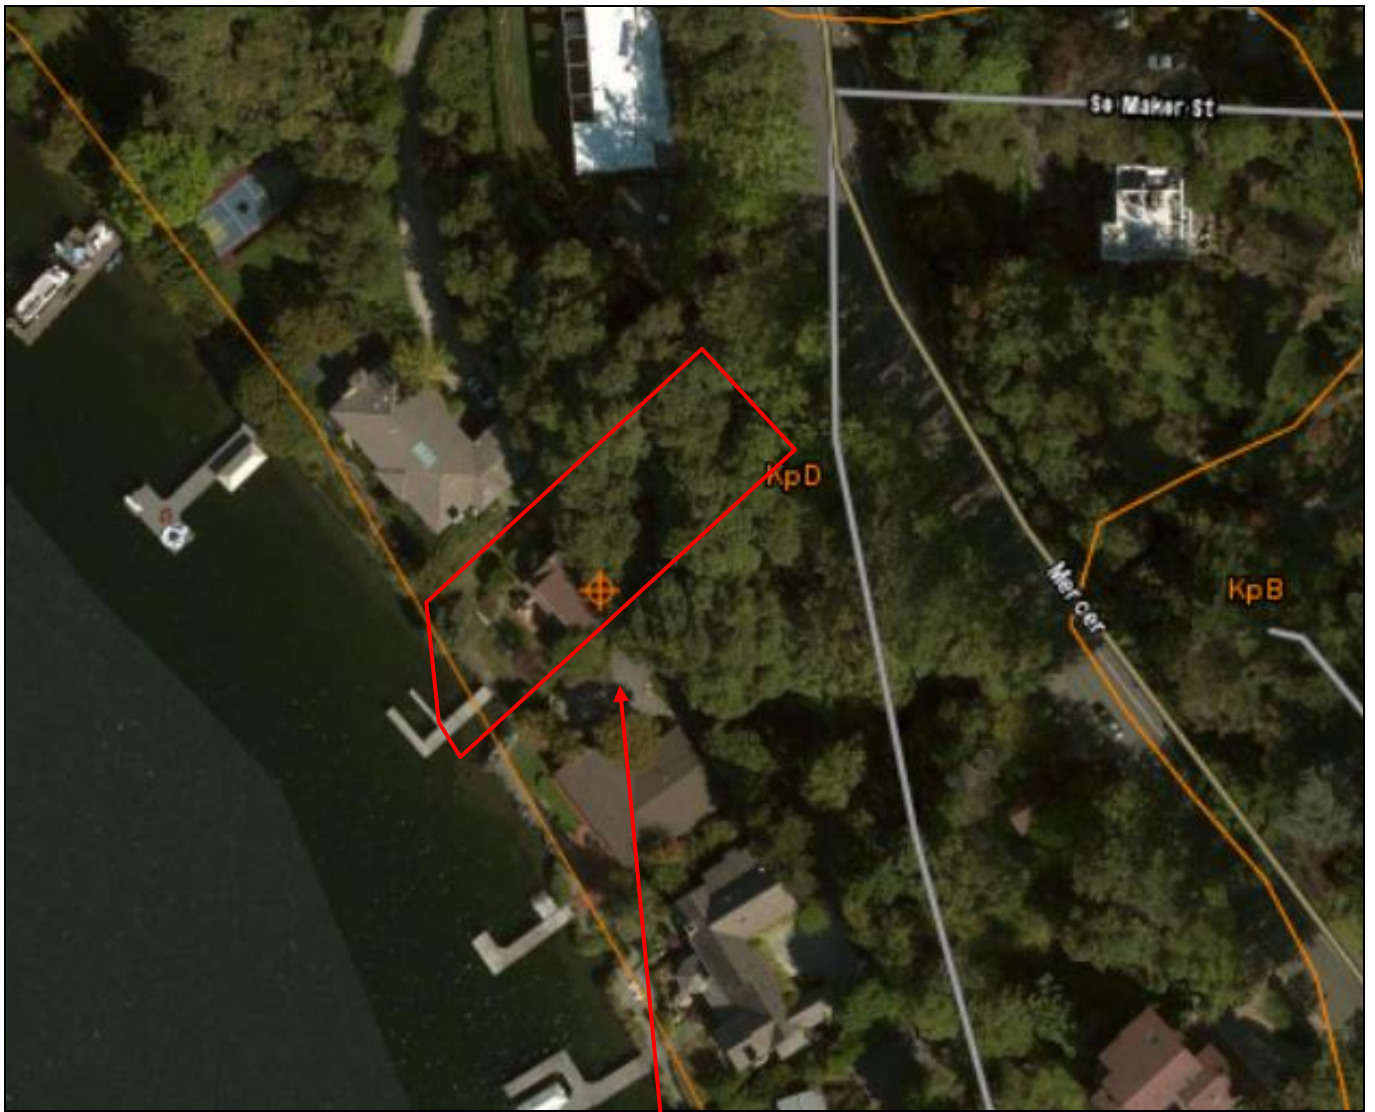
Figure 4

**Approximate Site Location**

(map created from the USDA Natural Resource Conservation Service Web Soil Survey)

The Natural Resource Conservation Services (NRCS) Web Soil Survey for King County indicates that the site soils consist of the Kitsap silt loam (KpD) soils that form on slopes of 15 to 30 percent. These soils derived from glacial lake sediments, have a moderate to severe erosion hazard, and are listed in hydrologic soil group C. A copy of the SCS soils map for the site area is attached as Figure 4.

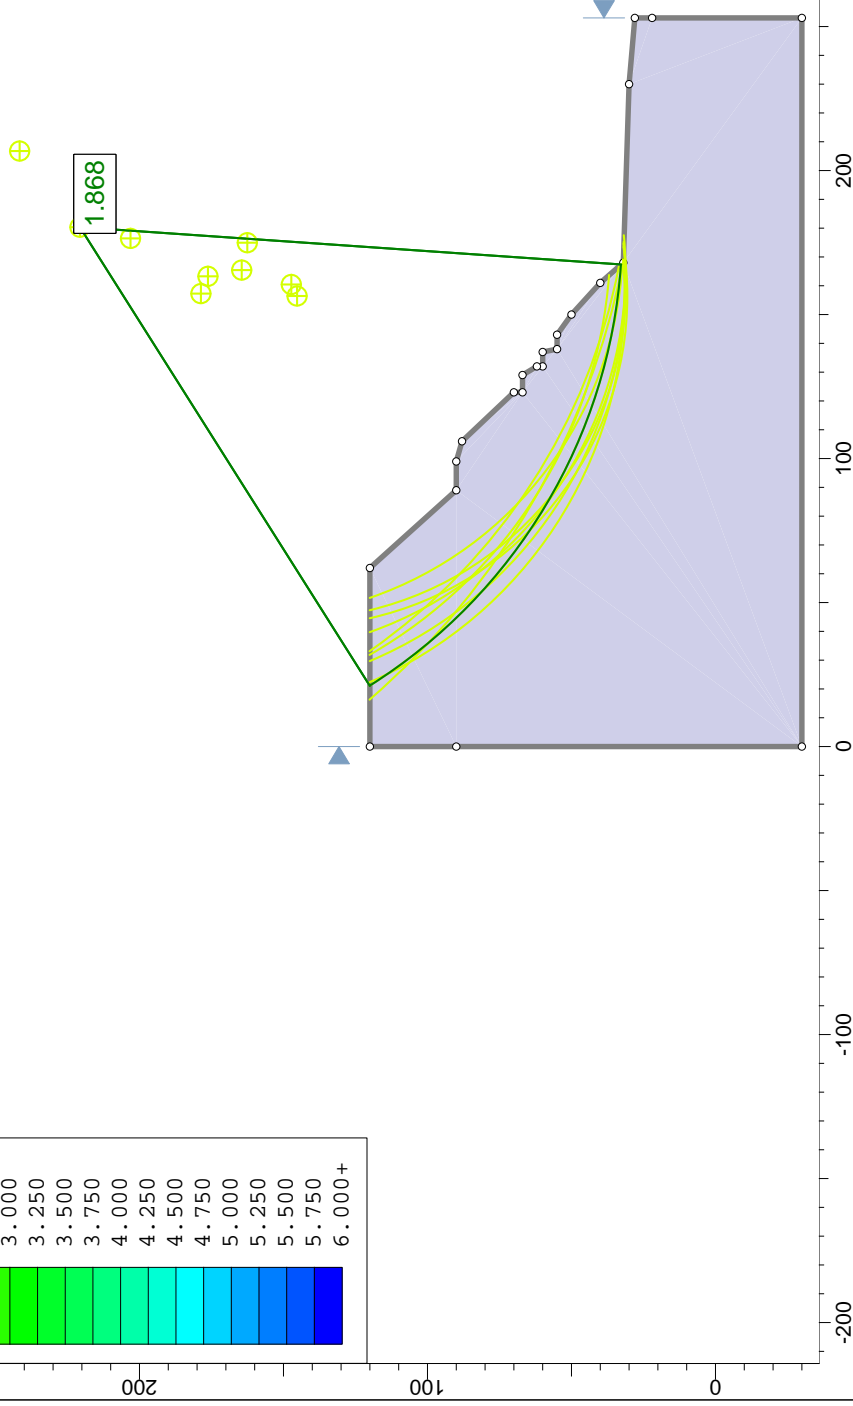
| Material Name | Color | Unit Weight (lbs/ft3) | Strength Type | Cohesion (lb/ft2) | Phi | Water Surface | Ru |
| Glacial Consolidated Silty Sand | | 130 | Mohr-Coulomb | 1000 | 33 | None | 0 |

We analyzed the global and internal slope stability of the existing slope geometries using subsurface profile A-A', as shown on Figure C-1. We used the computer program SLIDE version 6.020, from RocScience, 2012, to perform the slope stability analyses. The computer program SLIDE uses a number of methods to estimate the factor of safety (FS) of the stability of a slope by analyzing the shear and normal forces acting on a series of vertical "slices" that comprise a failure surface. Each vertical slice is treated as a rigid body; therefore, the forces and/or moments acting on each slice are assumed to satisfy static equilibrium (i.e., a limit equilibrium analysis). The FS is defined as the ratio of the forces available to resist movement to the forces of the driving mass. **An FS of 1.0 means that the driving and resisting forces are equal;** an FS less than 1.0 indicates that the driving forces are greater than the resisting forces (indicating failure). We used the Generalized Limit Equilibrium method using the Morgenstern-Price analysis, which satisfies both moment and force equilibrium, to search for the location of the most critical failure surfaces and their corresponding FS. **The most critical surfaces are those with the lowest FS for a given loading condition, and are therefore the most likely to move.** Based on our analyses, **the FS for the current conditions is about 1.8 and 1.2 for static and seismic conditions, respectively.** Details of the slope stability analyses for both static and seismic conditions are included in Appendix C.

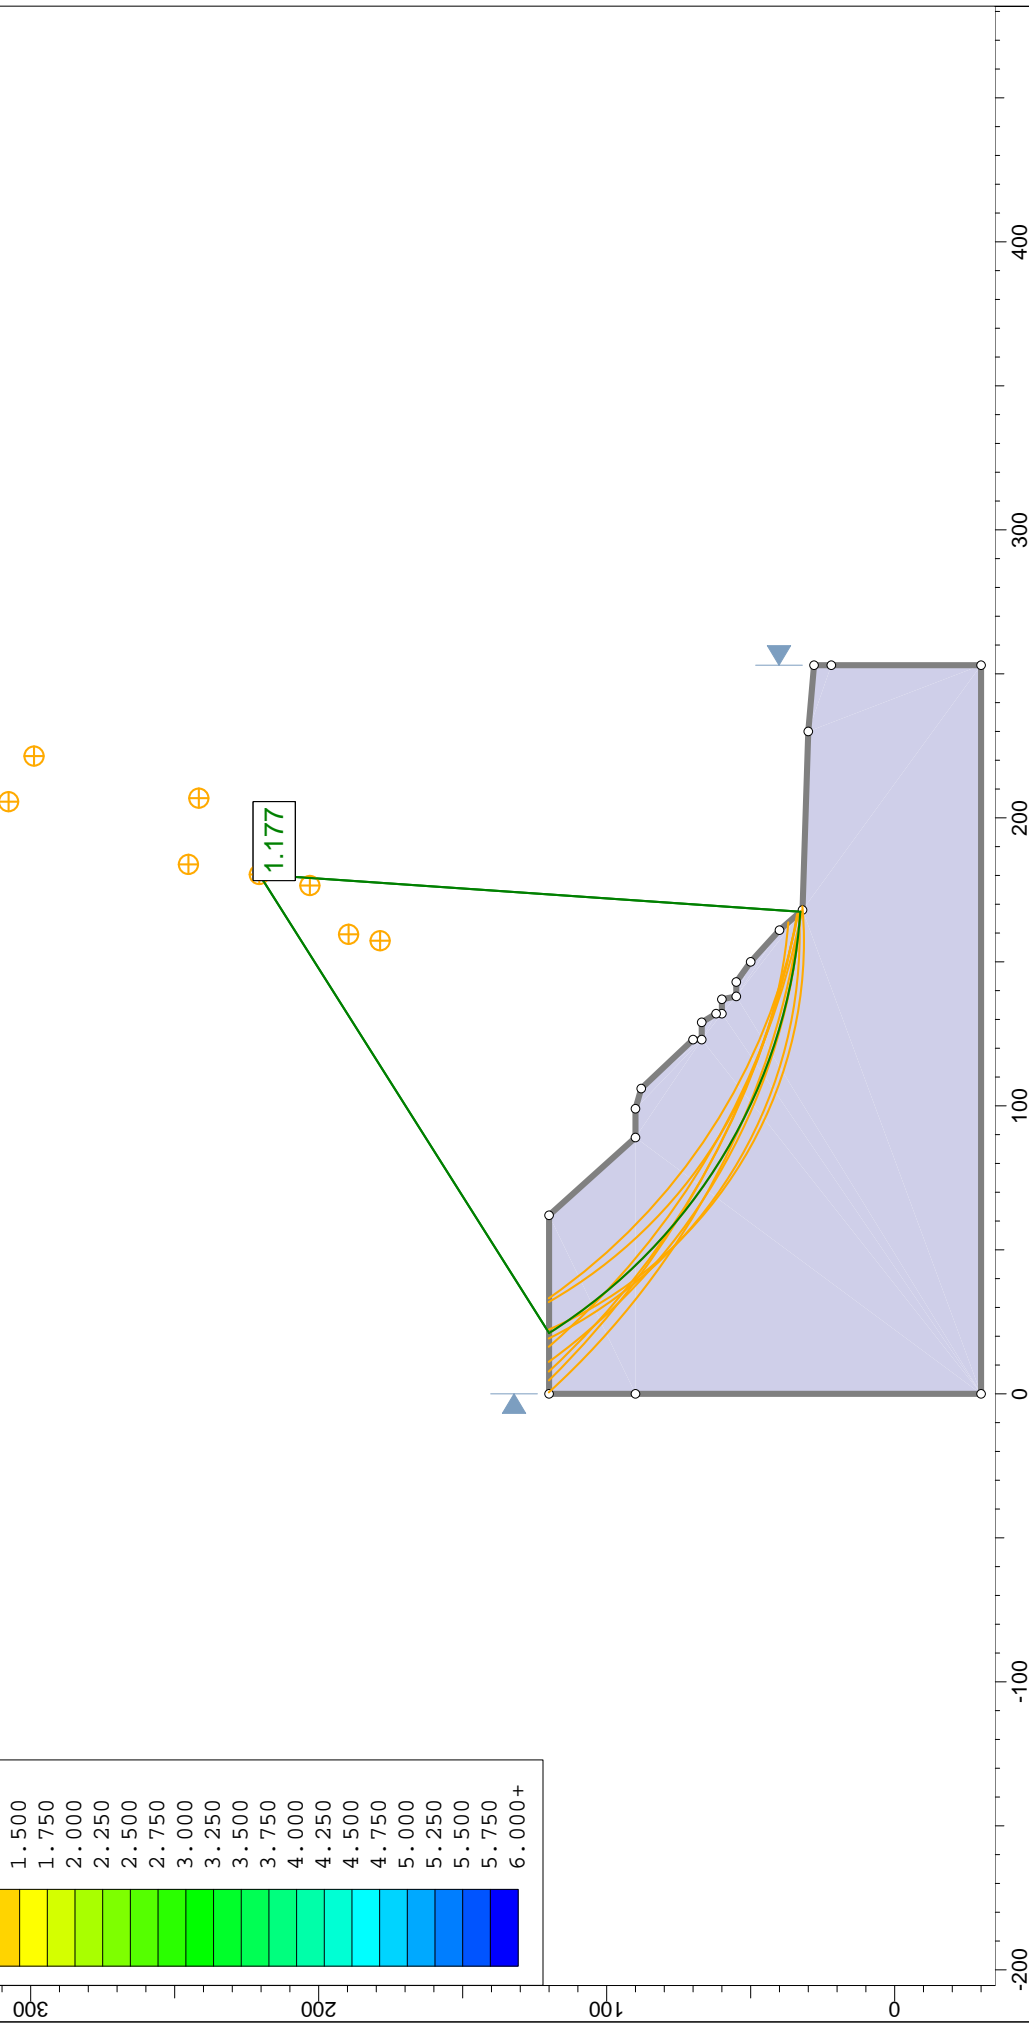
| Material Name | Color | Unit Weight (lbs/ft <sup>3</sup> ) | Strength Type | Cohesion (lb/ft <sup>2</sup> ) | Phi | Water Surface | Ru |
| Glacial Consolidated Silty Sand | | 130 | Mohr-Coulomb | 1000 | 33 | None | 0 |
