CRITICAL AREAS STUDY FOR THE EDWARD MILLS PROPERTY

5200 Block West Mercer Way Mercer Island, WA 98040

March 26, 2017 (Original: Wetland and Stream Delineation Report only)
October 22, 2017 (Updated to be Critical Areas Study)

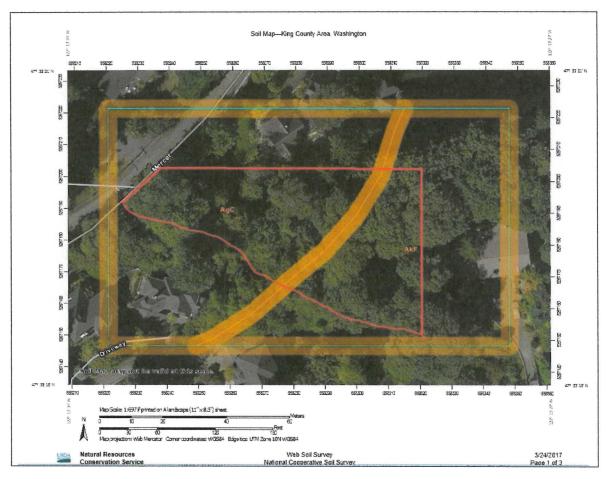
Figure 4: NRCS Soil Type Map

King County Area, Washington (WA633)						
Map Unit Symbol	Map Unit Name	Acres in AOI	Percent of AOI			
AgC	Alderwood gravelly sandy loam, 8 to 15 percent slopes	1.3	55.3%			
AkF	Alderwood and Kitsap soils, very steep	1.0	44.7%			
Totals for Area of Interest		2.3	100.0%

Per the NRCS online Web Soil Survey (NRCS, 2016), two soil types cover the site. *Alderwood gravelly sandy loam* 8-15% slopes (AcG) covers the west half of the site. This soil type developed from glacial outwash. The east end of the site is covered in *Alderwood and Kitsap soils, very steep* (AkF). This soil type developed on glacial moraines and till plains. Both soil types are moderately well drained and feature water tables that are generally 18 to 37 inches below the surface. Neither of these soil *types* is hydric but field investigations area required to determine if hydric soils occupy small areas.

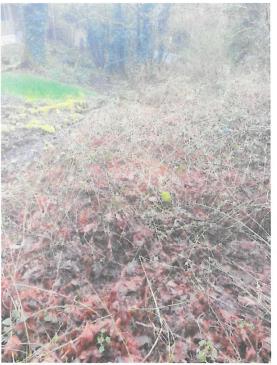
Picture 1: View of the western end of Wetland W. The onsite stream is in the upper left and the lawn is part of the property directly south of the site.

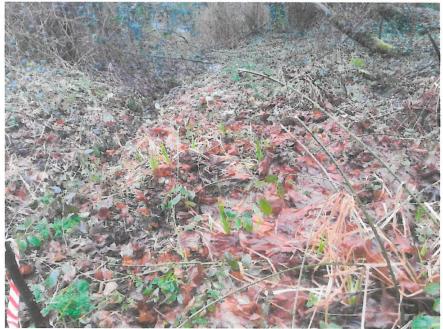
Picture 2: View of Sample Point 1, located within the east end of *Wetland W*. The photo was taken in mid-March and various emergent plants were sprouting including sawbeak sedge and giant horsetail.

hydric soil indicator and is exemplified at SP-3 (Figure 5, Photo 4). SP-1 is located on a shelf within the ravine and has deep silty chroma 1 soils that were probably deposited from the stream and are held in place by plants. For additional soils information, see the Wetland Data Forms (Figure 6).

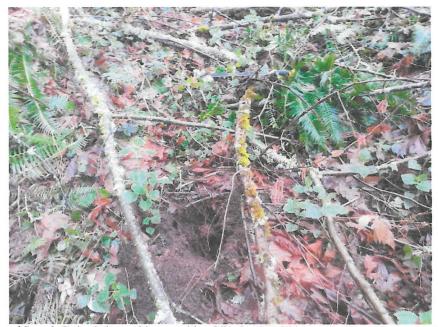
Picture 3: View of Sample Point 2, located just outside of *Wetland W*. This area had some hydrophytic plants such as stinging nettle but the plant community was not hydrophytic. Additionally, the soils had chroma 2 colors without redoximorphic features and were therefore not hydric and wetland hydrology was not present.

The fieldwork took place in mid-March 2017 and the preceding winter had been wetter than average. Primary hydrologic indicators for wetlands were therefore apparent. Sample Point 2 is in a gully just upslope from *Wetland W* but nonetheless did not reveal saturation in the upper 12 inches of soil (Figure 5, Photo 3). SP-1 is in the east end of *Wetland W* on a small ledge that retains silty soils that are saturated by the seasonal stream. SP-3 is in the central part of *Wetland W* and well away from the stream but is saturated to the surface from a seep located further upslope (Figure 5, Photo 4). For additional hydrology information, see the Wetland Data Forms (Figure 6).

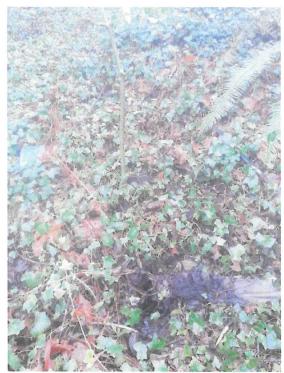
Picture 4: View of Sample Point 3, located on the central part of the site and within *Wetland W*. This area featured a hydrophytic plant community (lady fern had was dead and had not emerged at the time of the photo and red alder is not visible in this picture). The area also featured soils with chroma 1 colors that were saturated to the surface.
