CRITICAL AREA STUDY

Headrick Garage and Pool Addition – 8822 SE 62nd St Mercer Island, WA

Wetland Resources, Inc. Project #18303

First Submittal: May 1, 2019
Revision 1: October 25, 2019
Revision 2: December 16, 2020
Revision 3: March 8, 2021

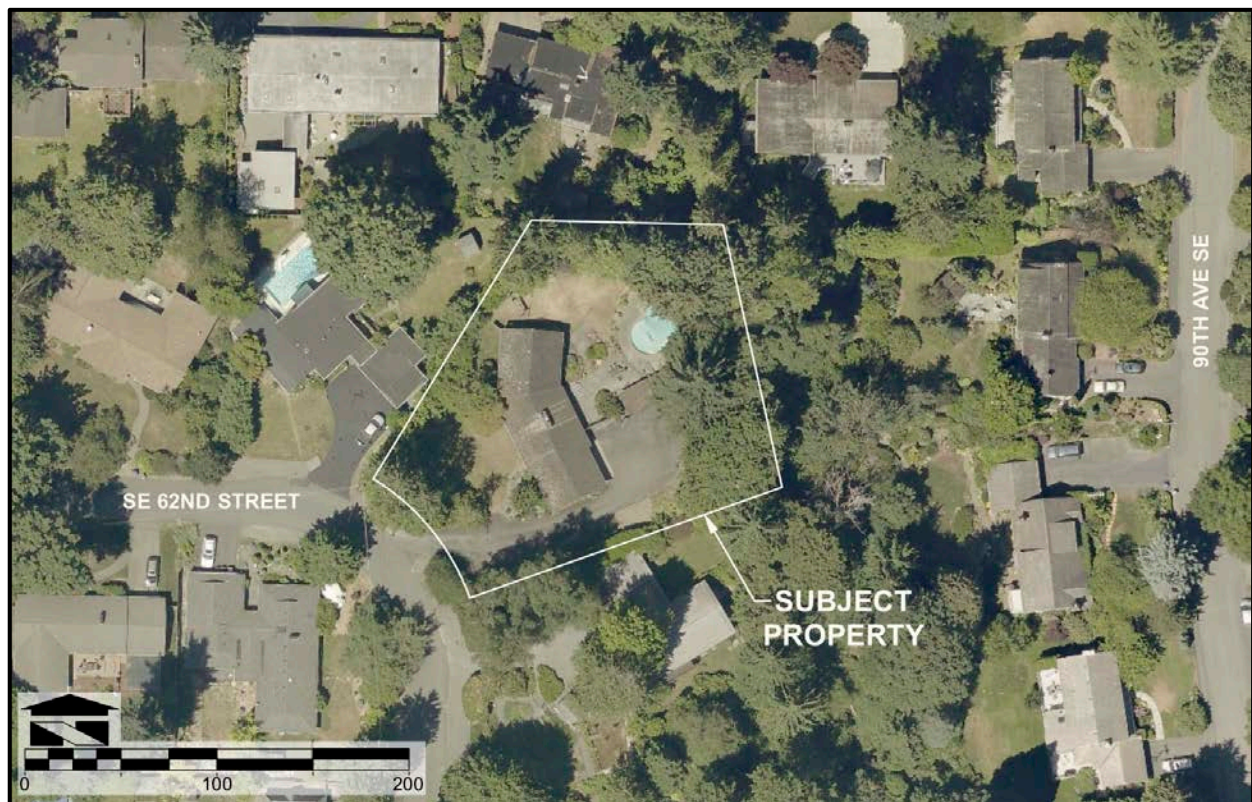
Figure 1: Aerial Overview of Subject Property

The subject property is a relatively level lot that slopes towards a shallow north-to-south oriented ravine in the eastern portion of the property. The level portion of the site is developed with a single-family residence and appurtenant structures/uses, including access/parking, storage sheds, ornamental landscaping, lawngrass, paved areas, and a pool. A seasonal stream channel and a 123 square-foot wetland were identified along the east property line. The stream originates from a large-diameter culvert located near the northeast property boundary, and enters another culvert near the southeast property boundary. The small wetland is supported by groundwater discharge at the toe of the ravine, along the face of an existing retaining wall. The wetland also receives hydrology from a hyporheic connection with Stream A.

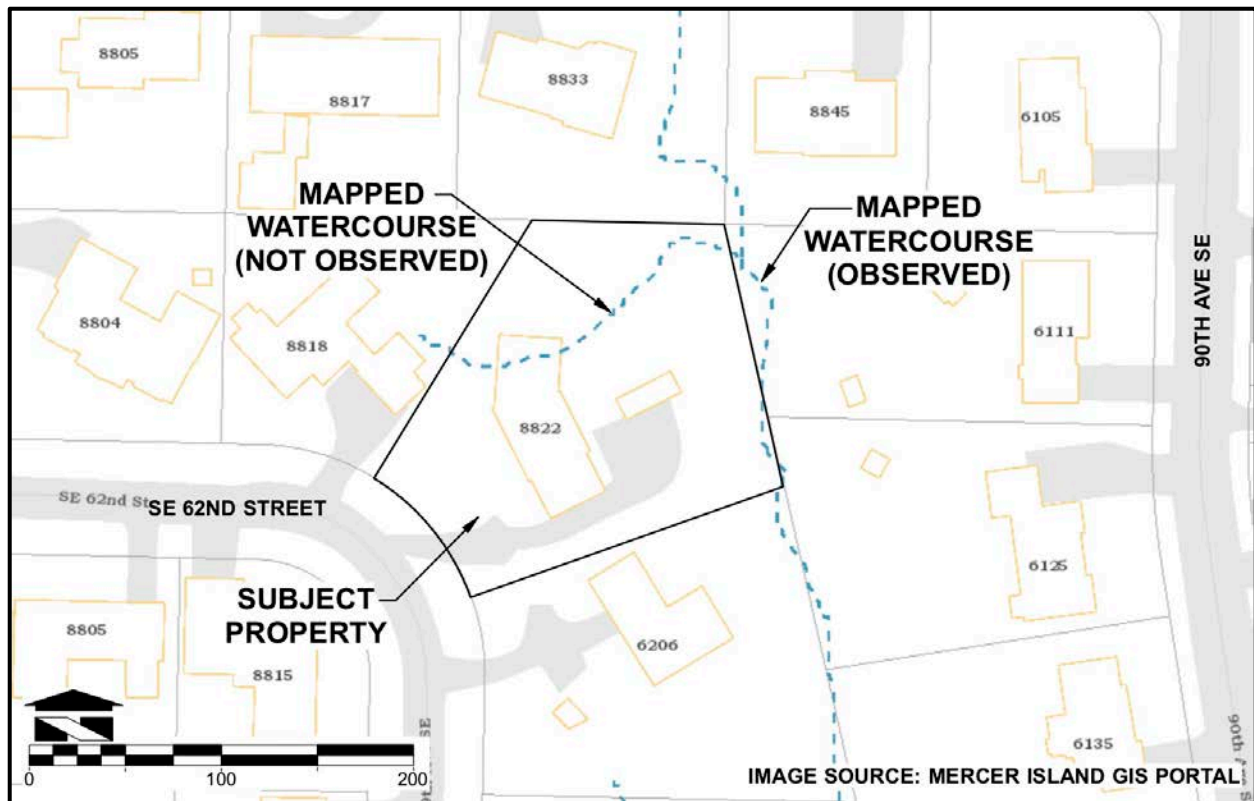
Figure 2: City-Mapped Watercourses

The City of Mercer Island Development Services Group relies on data compiled in the City of Mercer Island GIS Portal to approximate critical areas presence and locate stormwater features (among many other things). This resource was used by WRI staff prior to the site investigation, to determine potential critical areas on and in the vicinity of the subject property. This resource depicts two Type 3 watercourses within the boundaries of the subject property; Stream A, which flows through the aforementioned ravine along the east property line, and a tributary to Stream A,

which is shown passing through maintained lawn, the primary residence, and impervious surfaces in the northern portion of the site. Based on the developed condition of the site, the existence of the mapped Type 3 watercourse (flowing through the primary residence) was thought to be unlikely. Special care was taken during the site inspection to confirm or deny the presence of the mapped tributary. See Figure 2 below, which shows the location of City-mapped watercourses in the vicinity of the subject property.

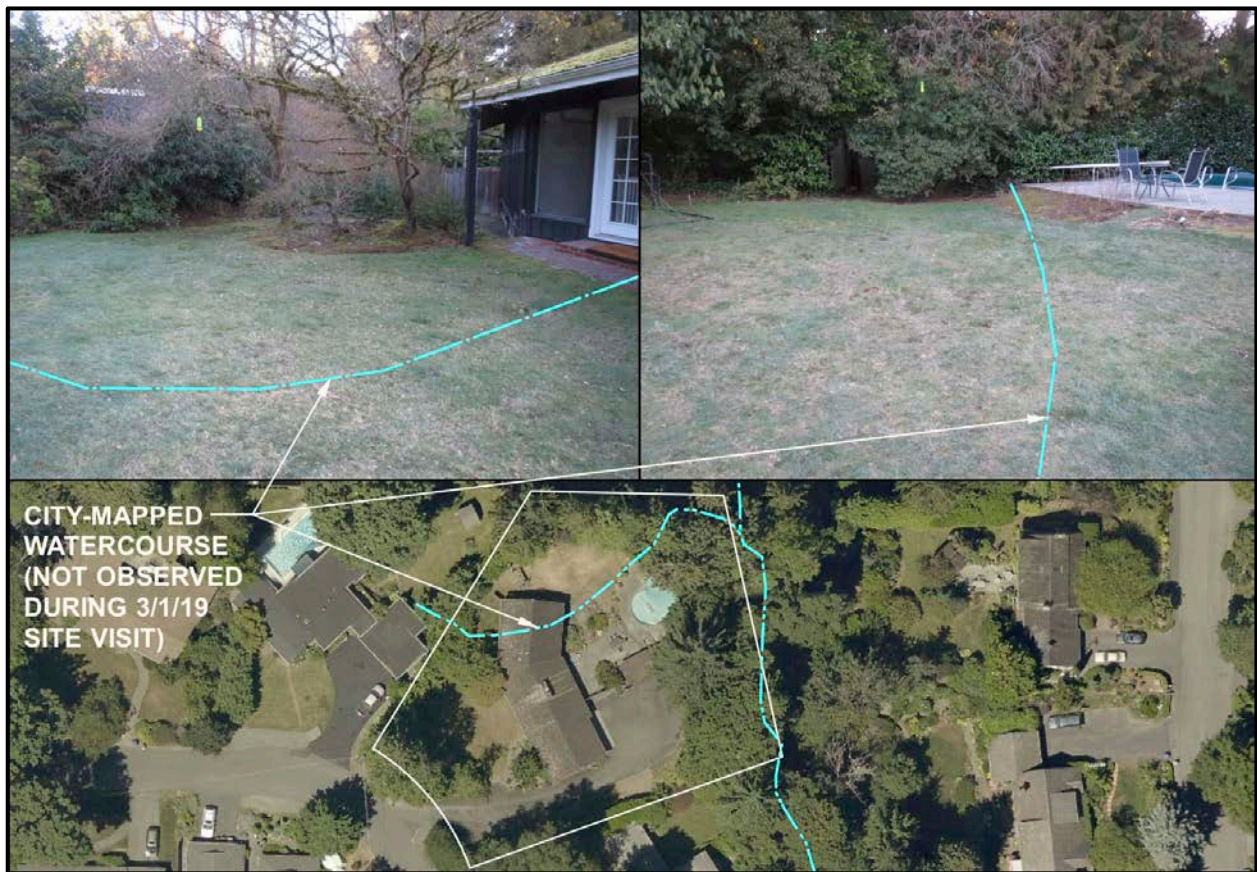
Figure 3: Site Photos of City-Mapped Watercourse

The mapped location of the tributary to Stream A was physically inspected on March 1, 2019. Best available science suggests that directly observed hydrology or evidence of recent surface flow support a stream presence determination. Evidence of flow includes defined bed and banks, scour marks, fine and coarse sediments deposited on existing vegetation, flattened vegetation in the direction of flow, and the presence of wet-tolerant vegetation.

Perennial streams in Puget Sound typically contain hydrology in early March. Given the absence of hydrology or indicators of surface flow along the entire path of the City-mapped watercourse during the March visit, WRI staff has determined that the mapped watercourse does not exist. The City’s map error should be corrected by removing the mapped tributary to Stream A. Figure 3 below shows site photos from the March visit, and provides visual evidence that the mapped stream does not exist. No additional discussion of the (non-existent) tributary to Stream A is included in this report.

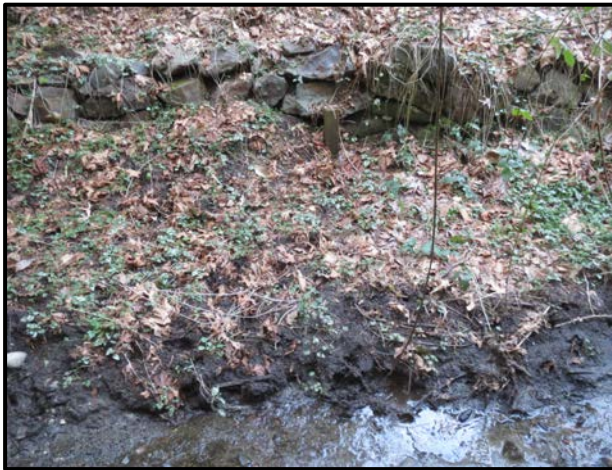
Figure 4: Facing East Towards Wetland A

Wetland A is 123 square feet in total area. The feature is located along the east property line of the subject property, on the left bank of Stream A. The feature forms from groundwater discharge at the toe of an existing retaining wall, and is also supported by the hyporheic zone associated with Stream A. Groundwater was observed in data site S-1 at the same elevation as the stream bed. Wetland A was rated as a slope wetland due to lack of evidence of overbank flooding. Vegetation was not flattened or otherwise marked, scour marks and recent or layered sediment deposits were not observed in the soil profile.

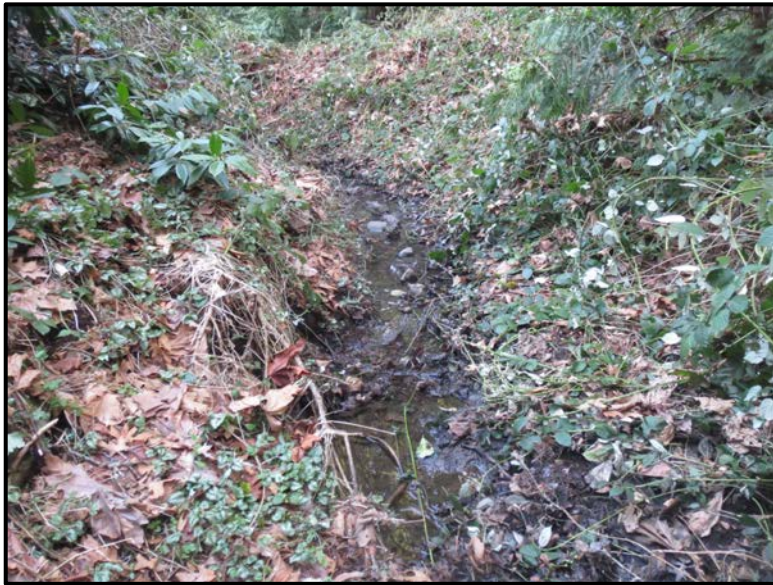
Figure 6: Facing South Along Stream A

The open channel of Stream A originates at the outlet of a large-diameter culvert located near the northeast corner of the subject property. The channel terminates where it enters another culvert located in the southeast corner of the subject property. The open channel consists of mixed cobble, bricks, and mud. The feature is an intermittent stream based on physical observation of a dry bed during the March site visit. Piped watercourses require 25-foot protective buffers, and Type 3 watercourses require 35-foot protective buffers. Based on comparison with the Mercer Island GIS Portal, it appears that Stream A outlets directly to Lake Washington on the east side of Mercer Island.

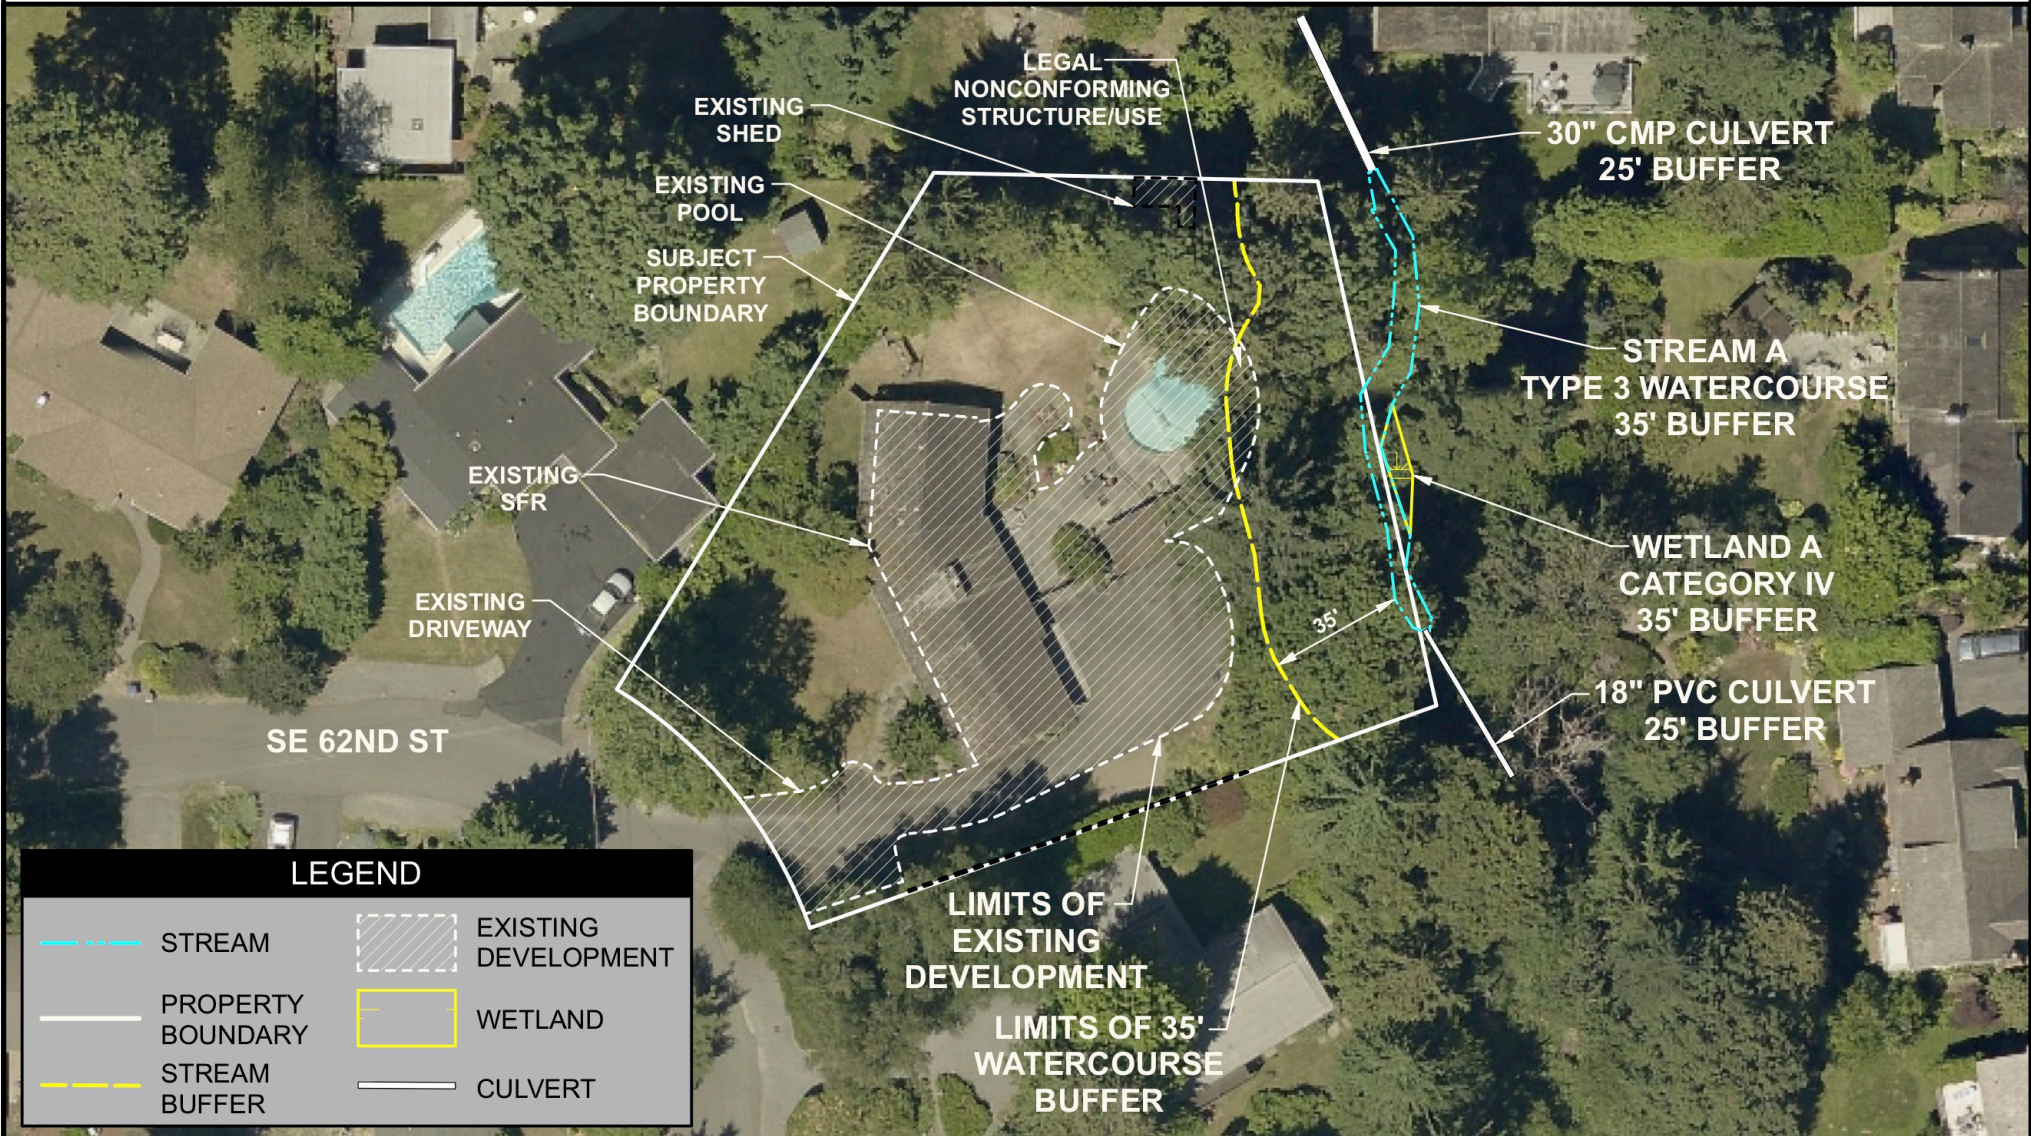
CRITICAL AREA STUDY MAP
HEADRICK GARAGE AND POOL ADDITION - 8822 SE 62ND ST
EXISTING CONDITIONS

WRI was contracted to delineate regulated features within and in the vicinity of the subject property. One wetland (Wetland A) was observed in the study area. One watercourse (Stream A) was observed. These features are depicted in the attached critical area study maps (See Appendix C). Wetland A is a small Category IV wetland that requires a 35-foot protective buffer. Stream A originates from a culvert and drains to a culvert, both of which are classified as piped watercourses. Piped watercourses require 25-foot protective buffers. The open channel is a Type 3 watercourse that requires a 35-foot protective buffer.

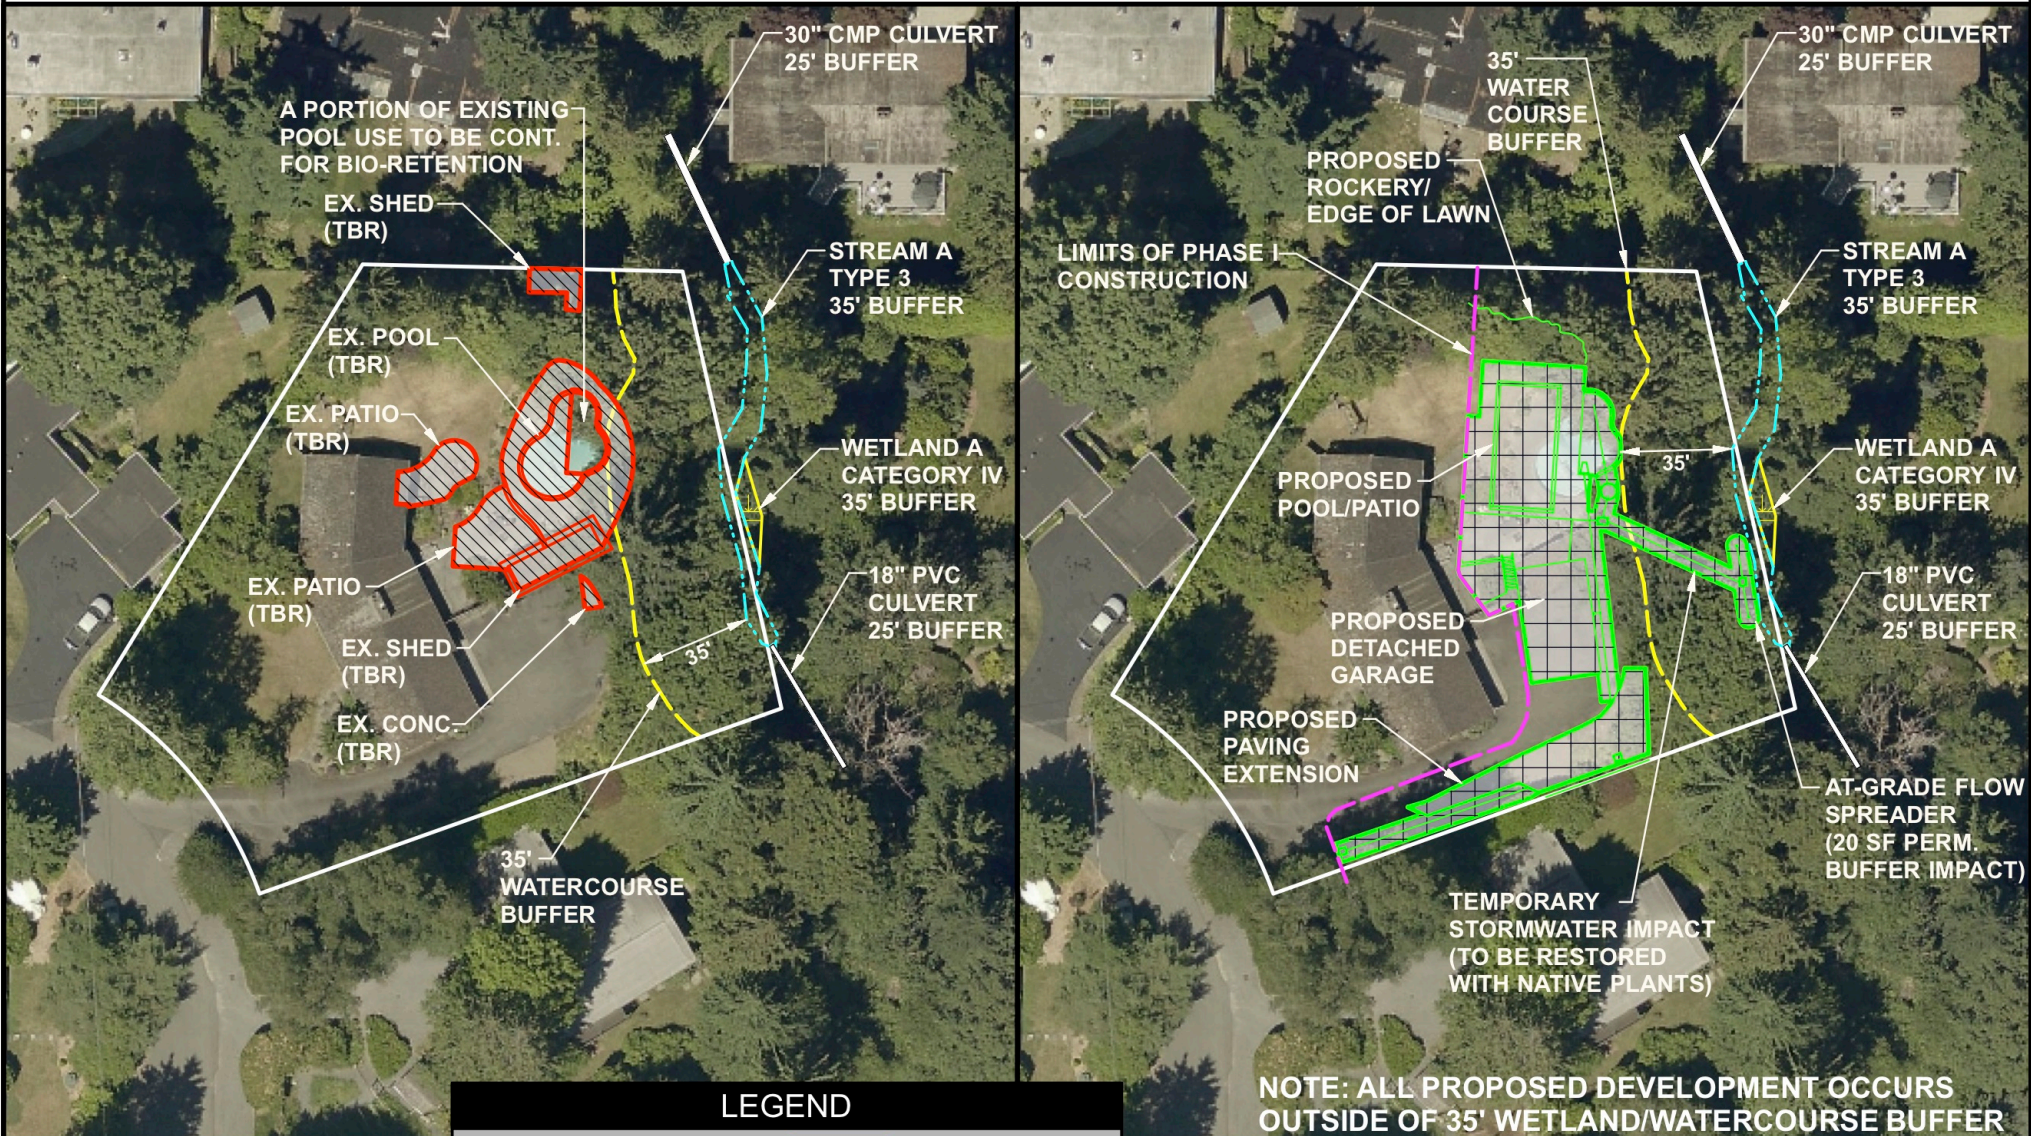
PROPOSED DEVELOPMENT

The proposed redevelopment will mostly occur outside of regulated critical areas and associated buffers. This project will create 27 square feet of new permanent buffer impact, and will remove 209 square feet of an existing non-conforming use (patio). Temporary buffer impacts will occur in an area consisting exclusively of undesirable non-native vegetation. In exchange for allowing project impacts, the applicant proposes to restore 209 square feet of nonconforming pool/patio, and to remove 378 square feet of invasive species and provide replacement with native trees and shrubs. Total mitigation includes 587 square feet of buffer enhancement.

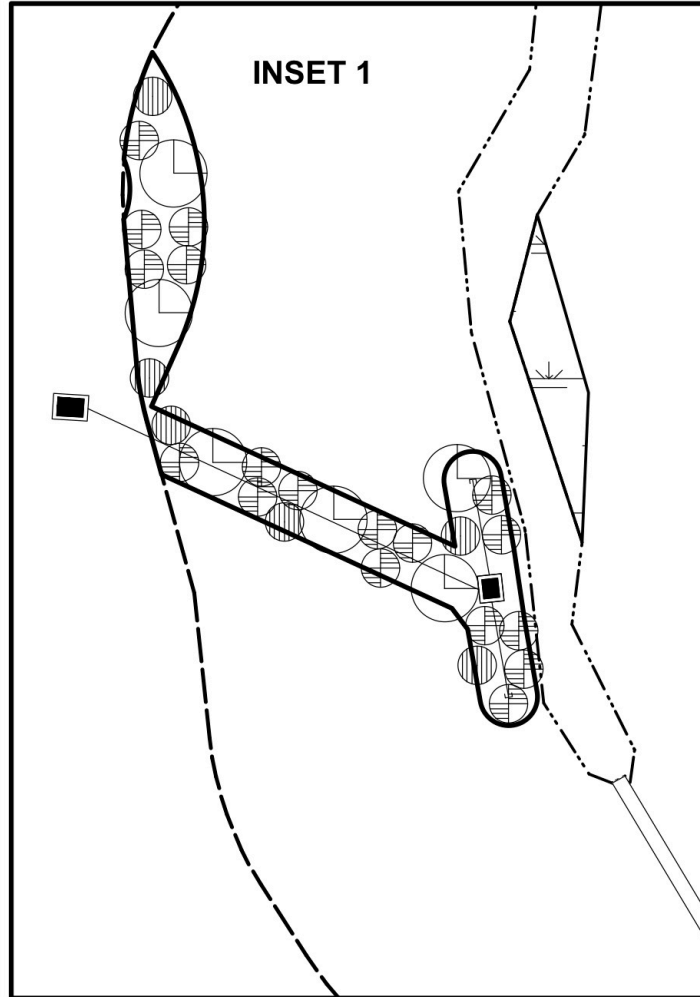
BUFFER RESTORATION PLAN

- WESTERN RED CEDAR
- SALMONBERRY
- VINE MAPLE

Most new development will occur outside of critical area buffers. Impacts to critical area buffers are limited to the removal of the nonconforming patio (209 square feet), and installation of a stormwater conveyance system (378 square feet). Permanent buffer impacts to the buffer include one catch basin (seven square feet of permanent impact) and a level spreader (20 square feet of permanent buffer impact). Vegetation within the temporary impact area is composed of exclusively undesirable species. The following were observed during a recent October 24, 2019 site visit: ornamental laurel, English holly, English ivy, Himalayan blackberry, common morning glory, and yellow archangel.
