September 24, 2019

## 7431 East Mercer Way, Wetland and Stream Reconnaissance Report

The Watershed Company Reference Number: 190911

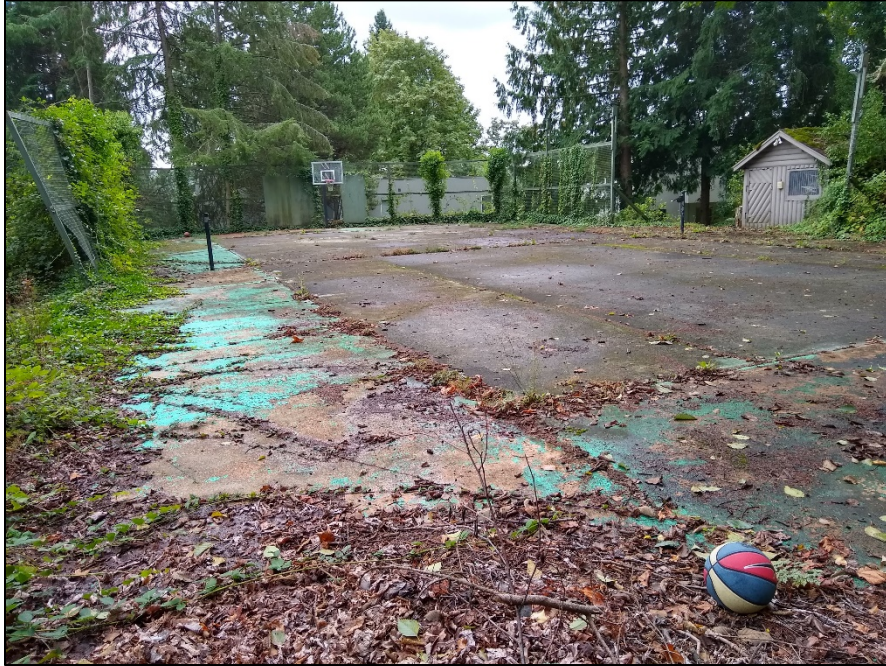
The property is developed with a tennis court and fencing, presumably as an amenity to the neighboring house. It appears to have been graded to create a flat terrace for the tennis court.

Photo 1. Tennis court occupies much of the property area.

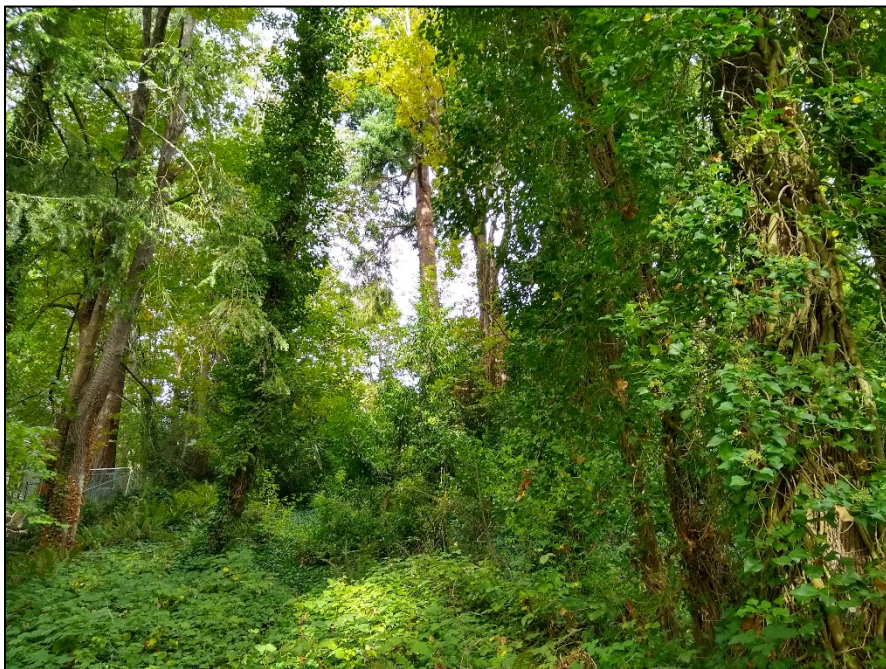
Vegetation on the property compose a non-wetland plant community and include the dominant species: big-leaf maple (*Acer macrophyllum*), western red cedar (*Thuja plicata*), red alder (*Alnus rubra*), western hemlock (*Tsuga heterophylla*), English holly (*Ilex aquifolium*), cherry laurel (*Prunus laurocerasus*), Himalayan blackberry (*Rubus armeniacus*), English ivy (*Hedera helix*). Additionally, a variety of non-wetland ornamental plants have been installed in landscaped areas.

Photo 2. Forest stand on the slope uphill from the tennis court, heavily covered in English ivy.

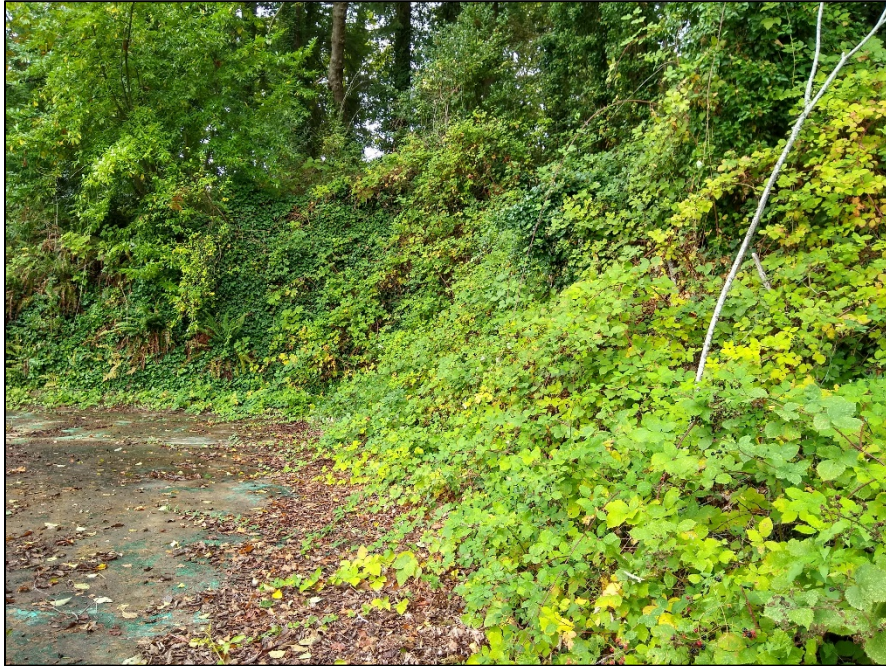
Soils exhibit a very dark grayish brown (2.5Y 3/2) clay loam surface layer, generally above an olive brown (2.5Y 4/4) sublayer. Some locations near the base of the cut slope contain clay loam soils with a depleted matrix (5Y 5/1) and minimal to absent redoximorphic features. These appear to be subsoils that were exposed during excavation for the tennis court and are very compact. No evidence of wetland hydrology was observed during the site visit.

Photo 3. Steep cut-slope excavated to create the terrace.

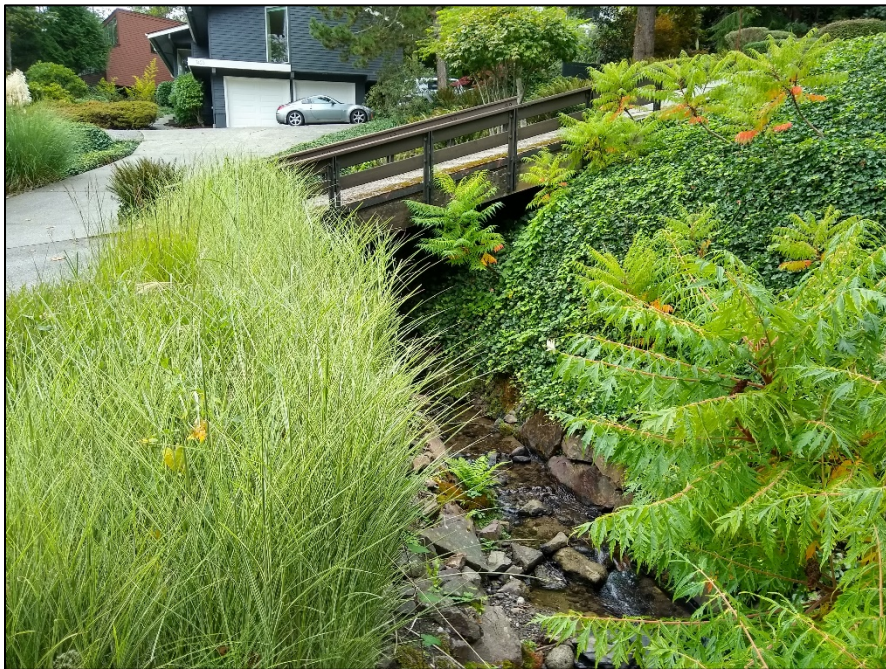
One stream, hereafter referred to as Stream A, was identified on the neighboring property to the south. Stream A is approximately two feet in width and confined within a narrow armored channel that conveys streamflow toward Lake Washington, to the east. The average stream gradient from the neighboring property to Lake Washington averages approximately 29% according to topographic data obtained from the Mercer Island GIS Portal. Gradients above 16% generally act as a natural barrier to fish passage, therefore, Stream A would not be considered fish bearing. Based on the amount of streamflow observed during the site visit, Stream A is assumed to be a perennial watercourse. No other streams were observed within, or potentially encumbering the subject property.

Photo 4. Stream A on the neighboring property.
