ARBORIST NOTES

SITE: Rudolf Property, Mercer Island, Washington

DATE: June 18, 2019

PURPOSE: Assess the air excavation for roots around the current driveway, provide evidence and professional guidance regarding the impact to tree # 122 and if tree removal will be required with planned excavation for the wall.

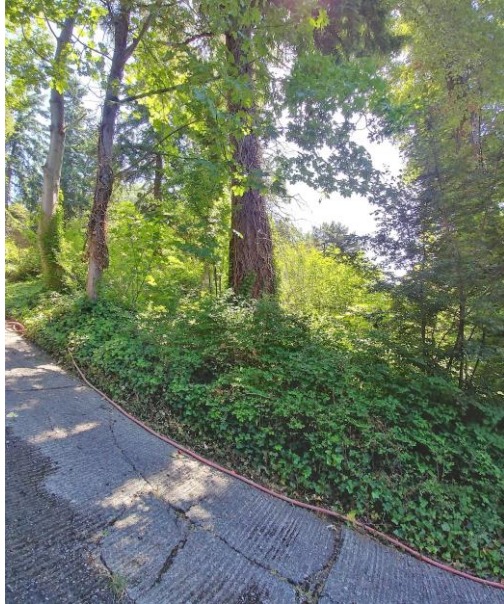
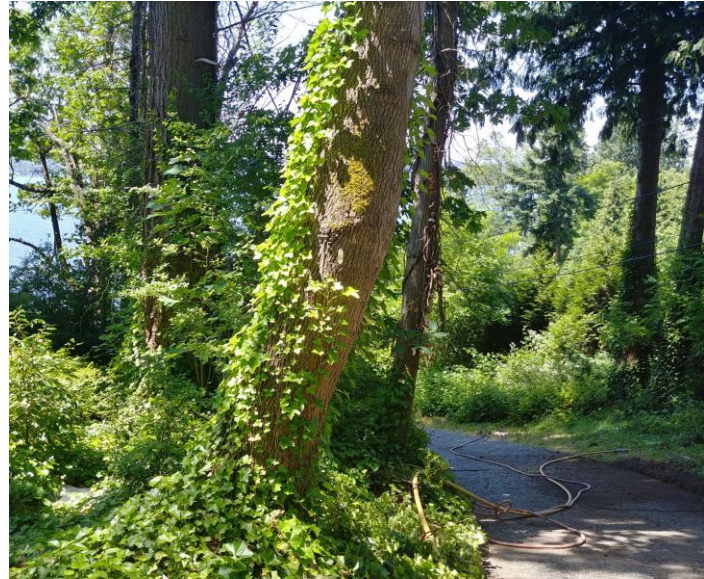
Photo 1 and 2. This is the Douglas fir tree #122 from the side with the two maple trees uphill and a perspective of the Douglas fir with the two maples closer to the driveway.

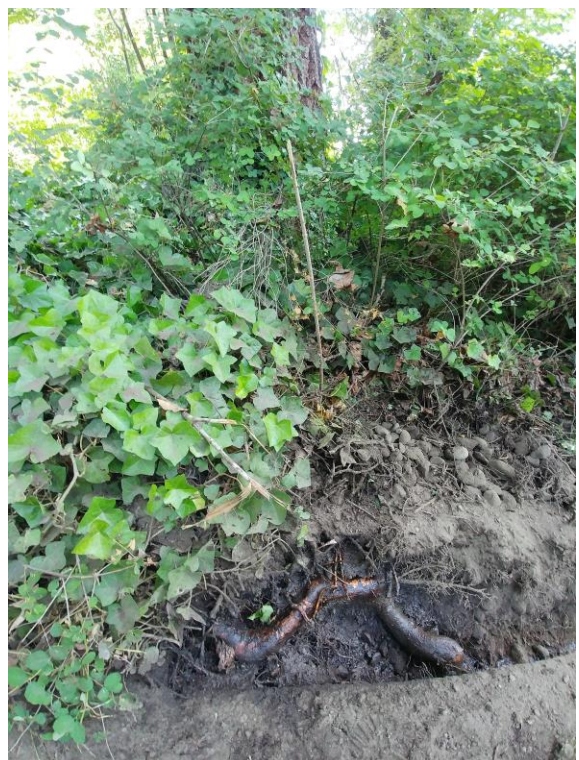
The second 20-foot long trench was excavated on the part of the driveway closest to the Douglas fir just 12 feet from the trunk. Roots from the ivy, snowberry, and blackberry vegetation were apparent in this trench (Photo 3). One 3.5-inch, unhealthy root from the maple #123 just 3 feet uphill was identified (Photo 3, Photo C). This root angled straight down into the soil when it encountered the driveway.

Photo 3 The Douglas fir tree behind the root found from the maple. This root is below the grade of the pavement and three feet long.

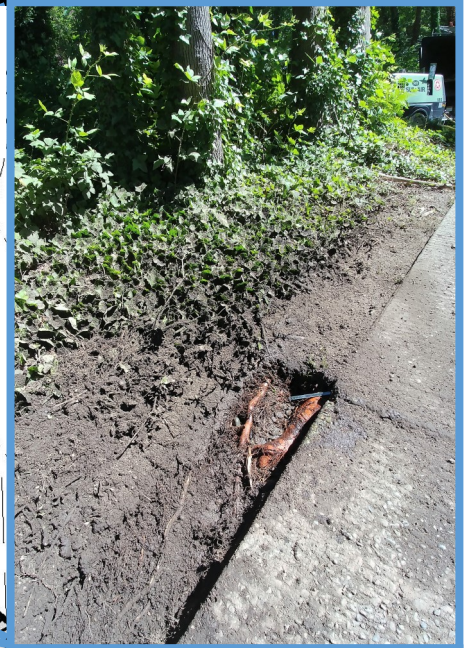
The first trench began at a pavement panel (Photo A on attached map) and was excavated about 40 feet along the edge of the driveway farther from the Douglas fir. Three large roots were found ranging from 2.5 to 4" in diameter. See the attached map, Photo A and B. These roots originate from tree #109 located 11 feet up the hill. When the roots met with the pavement, they ran parallel to the pavement with smaller roots running under the pavement causing the noticeable pavement cracking.

Photo B. Fourteen feet of roots
connected to Maple #109 up
the hill.

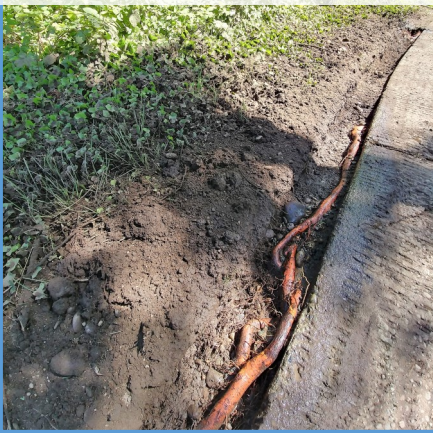
Photo C. Three foot long and 4
inch wide root from maple
#11 #123. Root dives deep into soil
and the trench is 10 feet from
the Douglas fir.

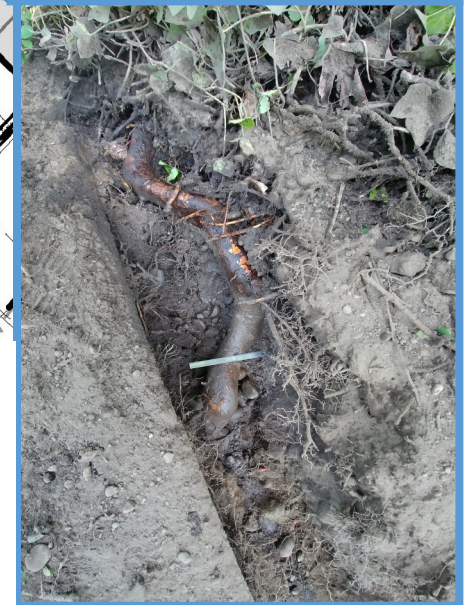
Rudolf Property Root Assessment
8255 West Mercer Way, Mercer Island, Washington
March 20, 2019

Air excavation of the soil was conducted to assess for root spread and depth of the Douglas fir tree near the area where the wall will be installed. Trenches were cut 12 inches wide and 18" deep on both sides of the existing driveway. Roots found within the excavation area were further uncovered until the source and direction of growth were determined. The attached map and photos identify the areas where the wall is planned, where soil excavation occurred, and where roots were found.
