**TECHNICAL MEMORANDUM**

June 25, 2021

To:	Mr. Harvey Kanter 12 Meadow Lane Mercer Island, WA 98040
From:	Kolten T. Kusters, M.S., PWS Wetland Scientist Raedeke Associates, Inc.  William Russack, B.S Wetland Technician Raedeke Associates, Inc.
RE:	Kanter Mercer Island – Stream Reconnaissance (RAI Project No. 2021-048-001)

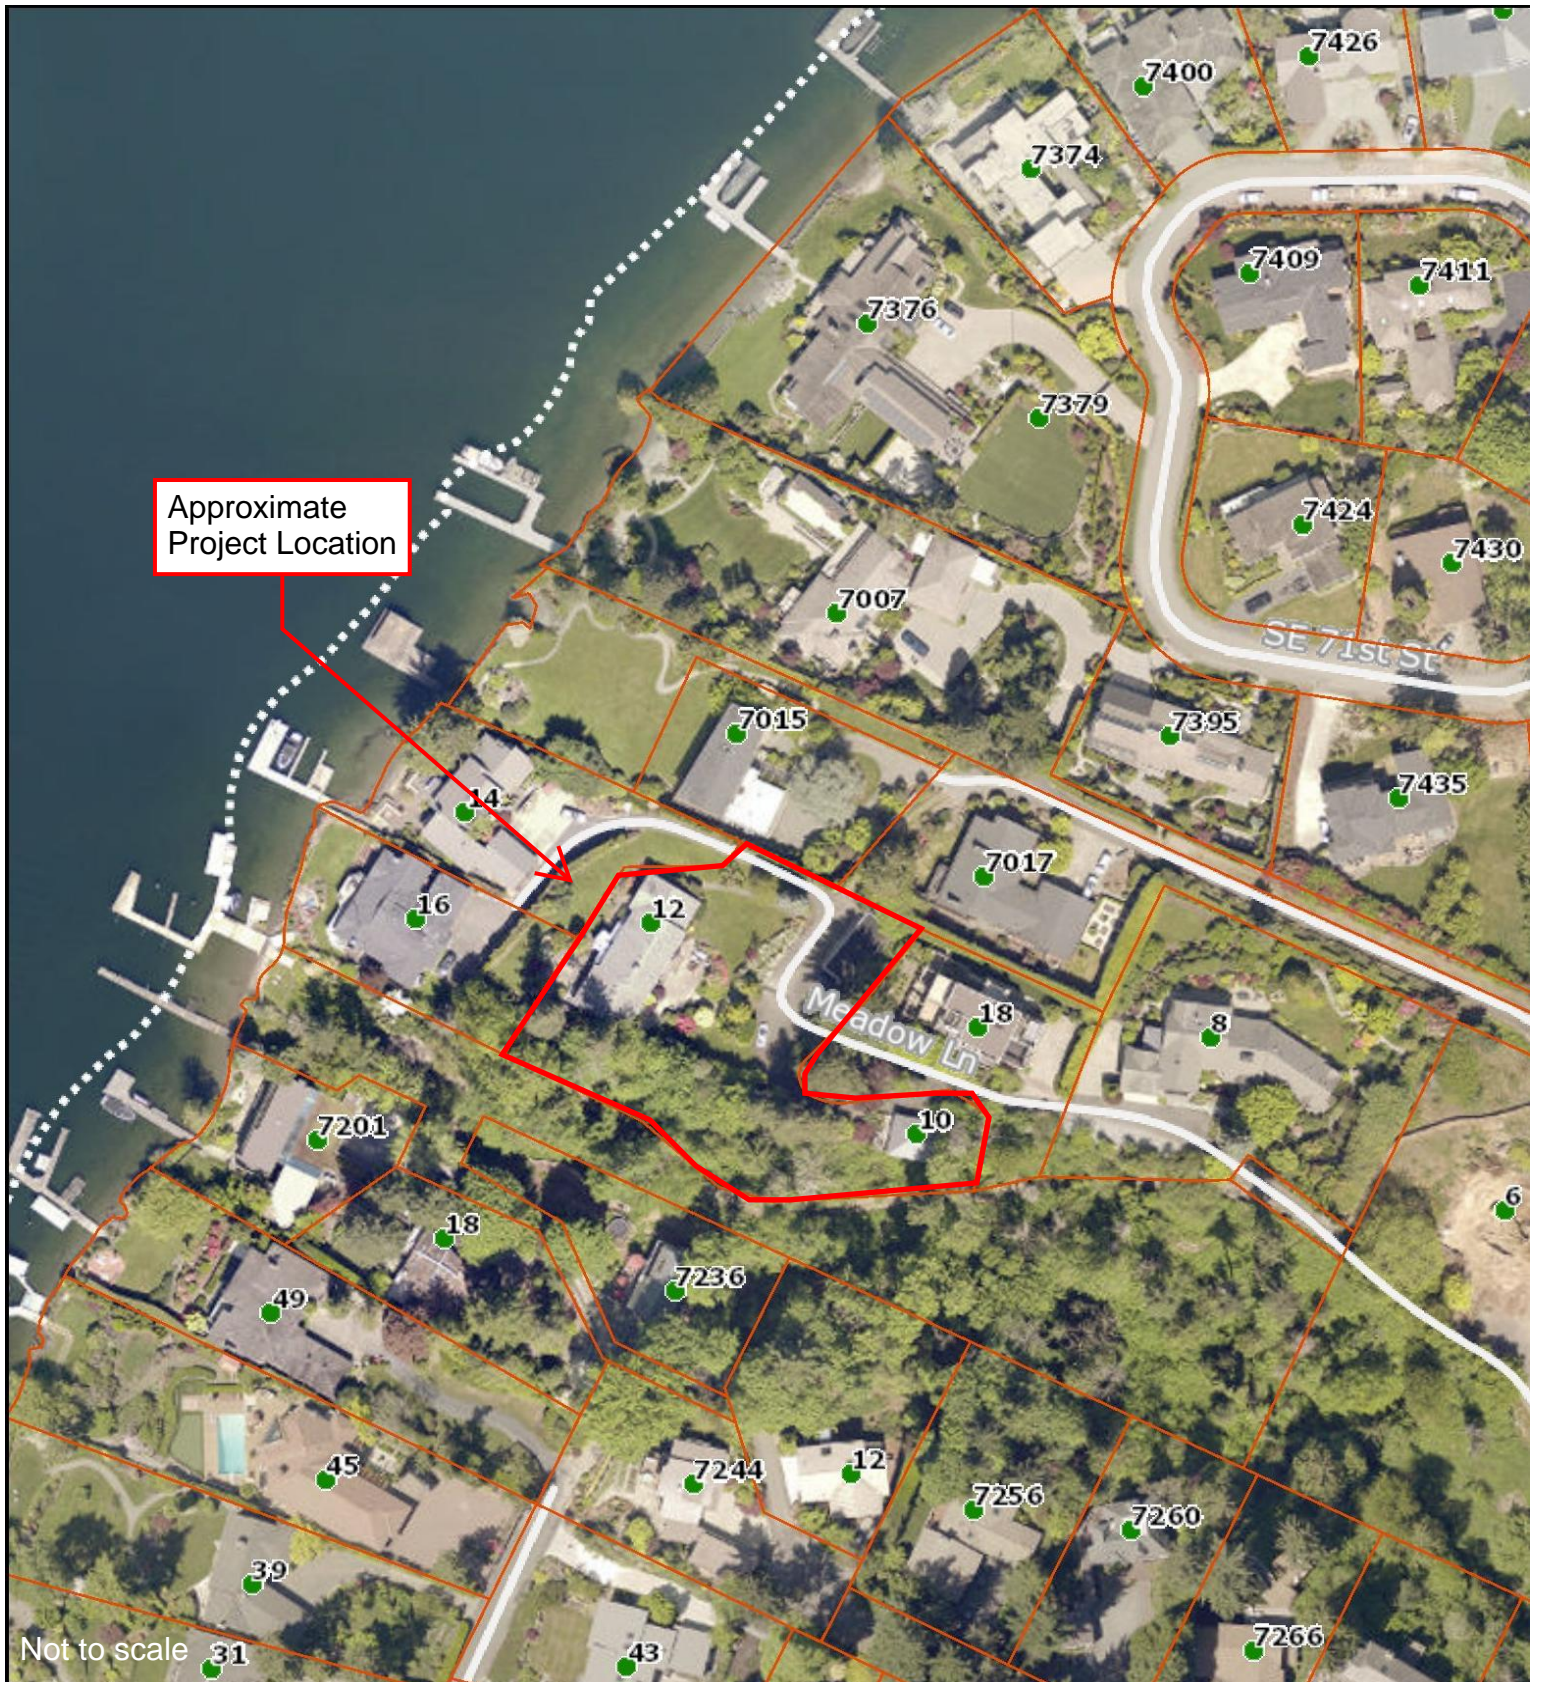
## FIGURE 2 - King County iMap Kanter Mercer Island 12 Meadow Lane, Mercer Island WA RAI PROJECT: 2021-048-001

The King County (2021) iMap did not show any streams located in the vicinity of the project site (Figure 2). The WDFW 2021 Salmonscape map depicted an intermittent stream course located south of Meadow Lane on the south edge of the project site in a right-of-way (Figure 3). Similarly, the WDNR (2021) water type map showed a fish bearing stream located along the south edge of the project (Figure 4). The City of Mercer Island (2021a) Information and Geographic Services watercourse layer depicted a Type F watercourse in the location of the southern stream (Figure 5).
