MORAN PROPERTY
CRITICAL AREAS REPORT, IMPACT ANALYSIS,
& MITIGATION PLAN
CITY OF MERCER ISLAND, WASHINGTON

April 11, 2022 (Revised January 5, 2023)

Report Summary

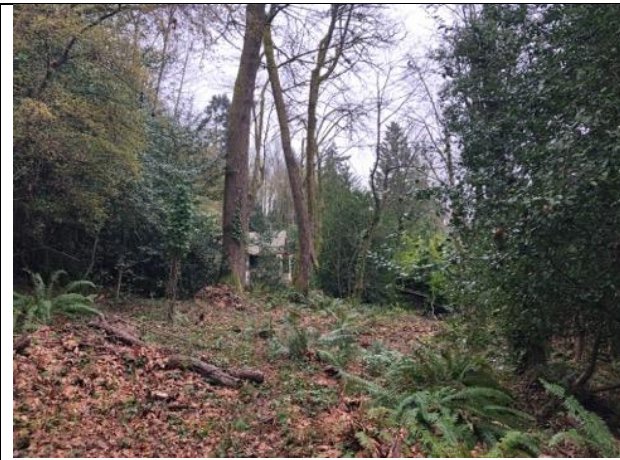
Photo 1. View of the central interior portion of the Moran property (looking south). Photo taken 3-17-22.

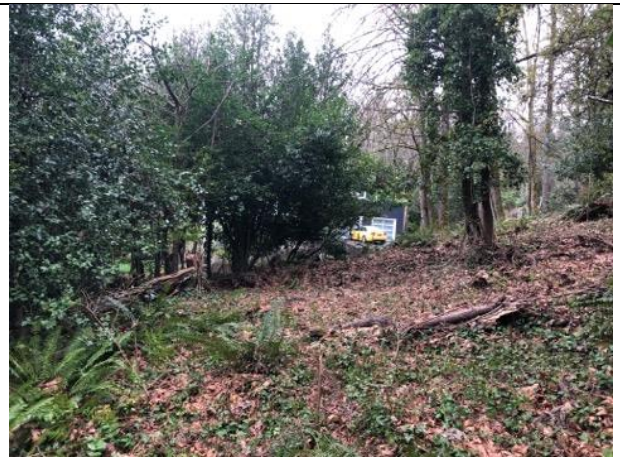
Photo 2. View of the central interior portion of the Moran property (looking north). Photo taken 3-17-22.

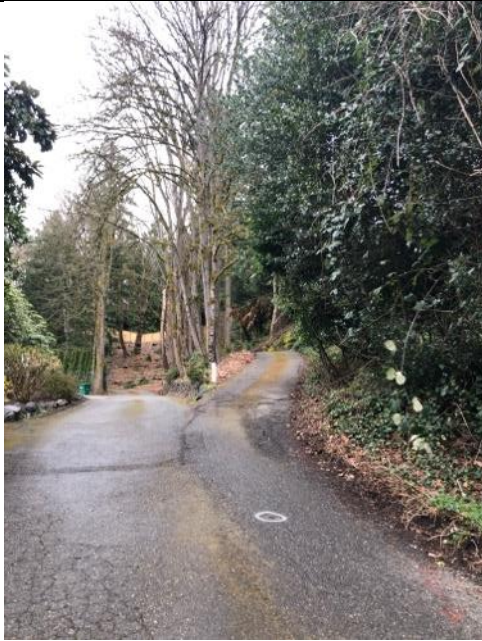
Photo 3. View of driveway access road at north end of Project Site which directs stormwater to Ditch 1/Wetland A.

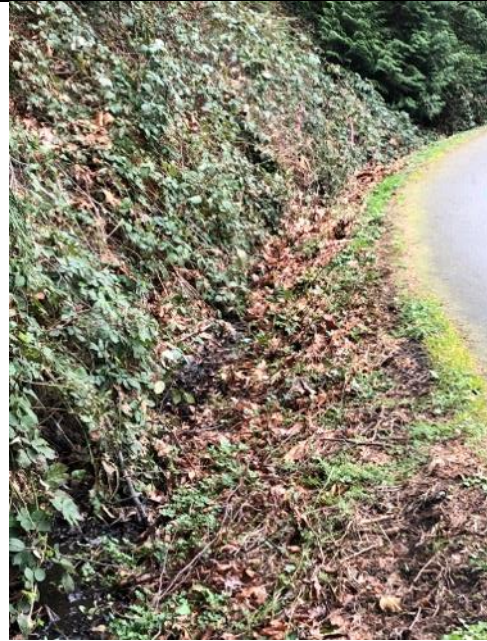
Wetland A is a 205 square feet, linear depressional wetland feature within the road embankment ditch (Ditch 1) along the east side of West Mercer Way (**Appendix A/Figure 6** and **Appendix B/Plan Sheet 1**). Wetland A occurs within the northern half of Ditch 1. This portion of Ditch 1 is somewhat wider and is the lowest point within Ditch 1. The area of Ditch 1 that met wetland conditions is also in closest proximity to the main source of hydrology to Ditch 1. Ditch 1/Wetland A receives seasonal stormwater runoff from the private driveway access road running northeast to southwest along the north side of the Project Site (**Photo 3**). Wetland A has a single emergent vegetation class dominated by giant horsetail (*Equisetum telmateia*) with minor components of English ivy, bittersweet nightshade (*Solanum dulcamara*), creeping buttercup (*Ranunculus repens*), Watson’s willowherb (*Epilobium watsonii*), and American speedwell (*Veronica americana*) (**Photo 4**).

Photo 4. View of Wetland A within Ditch 1, looking south. Photo taken 3-17-22.

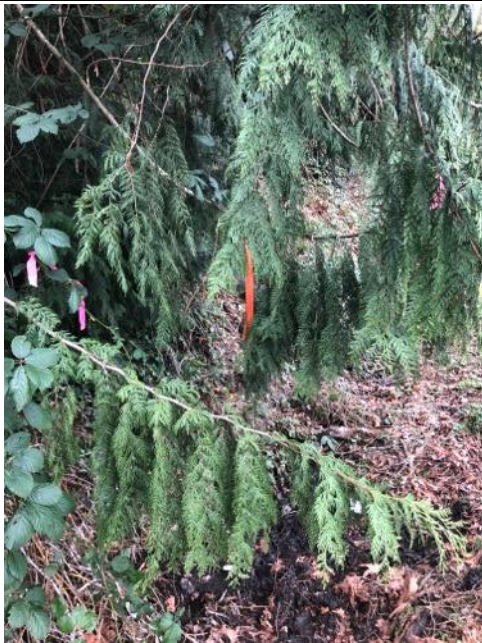
A soil pit was excavated within a representative portion of Wetland A (**Photo 5**) (**Appendix A/Figure 6** and **Appendix B/Plan Sheet 1**). Within sample plot (SP) 1 (**Photo 6**), the top 15 inches of soil consisted of a black (10YR 2/1) muck containing high organic content with lots of undecomposed leaves, branches mixed with fine mineral deposits (see also attached Wetland Determination Data Forms). Below 15 inches of the ground surface, soils were a dark gray (2.5Y 4/1) silty sandy muck with a likely mineral layer below; however, soils were too loose and saturated/flooded to excavate further. Soils within this sample plot met the Black Histic (A3) and likely also the Histic Epipedon (A2) hydric soil indicators.

Photo 5. View of soil pit 1 (SP-1) at north end of Ditch 1/Wetland A, looking south. Photo taken 3-17-22.

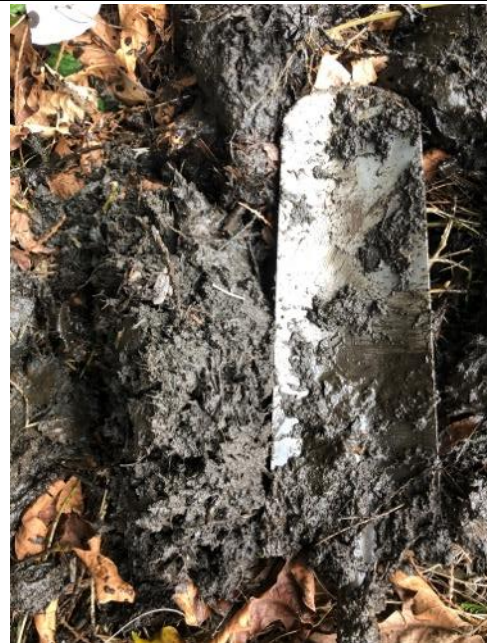
Photo 6. View of soil profile within Wetland A at SP-1. Photo taken 3-17-22.

Primary wetland hydrology indicators of high-water table (A2), saturation (A3), and hydrogen sulfide odor (C1) were encountered at SP-1. A secondary hydrology indicator (D2 – Geomorphic position) was also present within the sample plot. The main sources of hydrology to Wetland A are stormwater directed from the private access driveway at its north end as well as stormwater runoff from West Mercer Way with very minor groundwater discharge from the toe of slope along its east side. No seeps or springs were observed along the eastern uphill side slope; however, giant horsetails were observed growing 1-2 feet up from the eastern toe of slope. Wetland A occurs at the bottom of and is contained entirely within the lowest section of Ditch 1 (**Appendix A/Figure 6** and **Appendix B/Plan Sheet 1**). Wetland conditions do not extend the full length of Ditch 1. At the south end of Ditch 1 is an approximately 6-inch-wide overflow pipe conveying stormwater either south or west beyond the Study Area. The outlet of Ditch 1 is well beyond the boundary of Wetland A though during excessive periods of rain or winter storm events it is likely that Wetland A has intermittent overflow into the outlet of Ditch 1. As evidenced by surrounding topography, the impoundment of the road embankment, the intentional direction of stormwater, and the clear linear excavation made to create the drainage ditch for West Mercer Way, Wetland A is not a naturally occurring feature. Nor is there any evidence that historic wetland conditions existed in this location nor evidence of an historic source for wetland hydrology. If it were not for the construction of West Mercer Way along this hillslope, Ditch 1 and Wetland A would not exist. If it were not for a significant source of stormwater being directed into Wetland A, Ditch 1 would not contain wetland conditions. Additionally, though there was a minor indicator of groundwater discharge along the eastern edge of Wetland A and toe of slope where horsetails were growing, this is easily attributed to the steep and deep cut originally made in the hillside to form a flattened roadbed for West Mercer Way. It is natural that through the excavations that were made to the hillslope some amount of groundwater would be encountered at its current elevation.

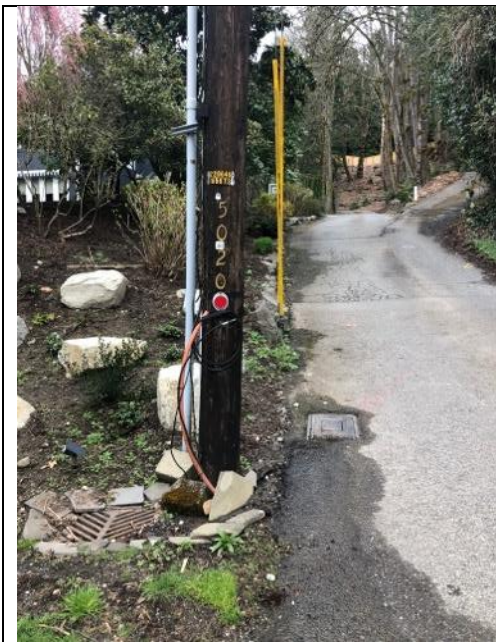
Photo 7. View of private access driveway on north end of Project Site where the piped watercourse is located as evidenced by the two drains. Looking east. Photo taken 3-17-22.

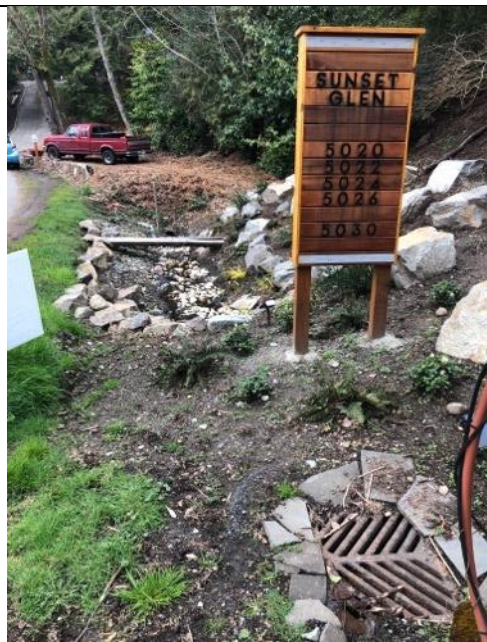
Photo 8. View of the drain grate and area where the piped watercourse connects with the open and possibly daylight section of the Type Ns stream, looking north. Photo taken 3-17-22.

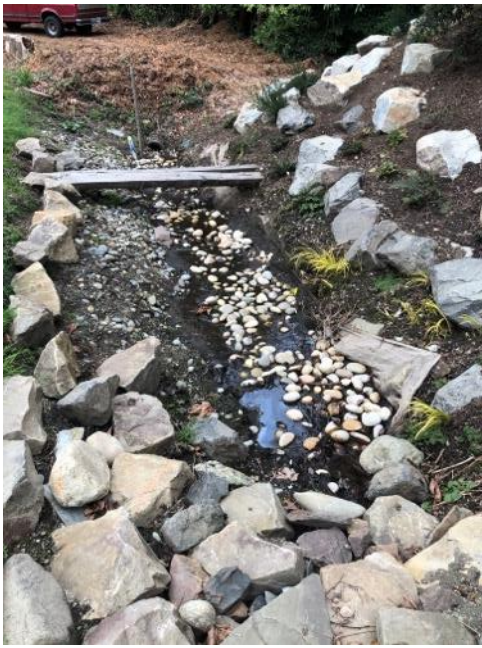
During the site investigation, this segment of open stream channel appeared to have received recent improvements. Fresh grading of sloped soils, composted mulch, and fresh river rock cobble and landscape boulders were observed throughout the side channels and surrounding buffer to the south and east (**Photos 7-9**). Erosion control fabric was also present within the channel indicating recent soil

Photo 9. View of the open or daylit section of the Type Ns stream including fresh side slope soils, grading, rock, erosion control fabric, and river rock within the bottom of the channel, looking north. Photo taken 3-17-22.

The channel side slopes of Stream 1 appear to have been re-graded and reinforced by large boulders. Erosion control fabric was also applied (Photo 9). Fresh gravel has also been applied to the bottom of the channel for stability of sediments and slowing of seasonal surface flow. The swale which contains Stream 1 is not deep nor steep and does not appear to be a safety hazard.

According to observations made during the site investigation of this critical areas study and impacts analysis, the current conditions in Stream 1 meet the standards and intent of MICC 19.07.180(C)(6)(c). Therefore, buffer reduction is proposed on **Appendix B/Plan Sheet 1**. Under this proposal, only a small section of the Type Ns watercourse buffer of Stream 1 and its BSBL overlap with the Project Site. This buffer and BSBL area is currently located within the private access driveway. No further development or site improvements are proposed in this small area on-site.

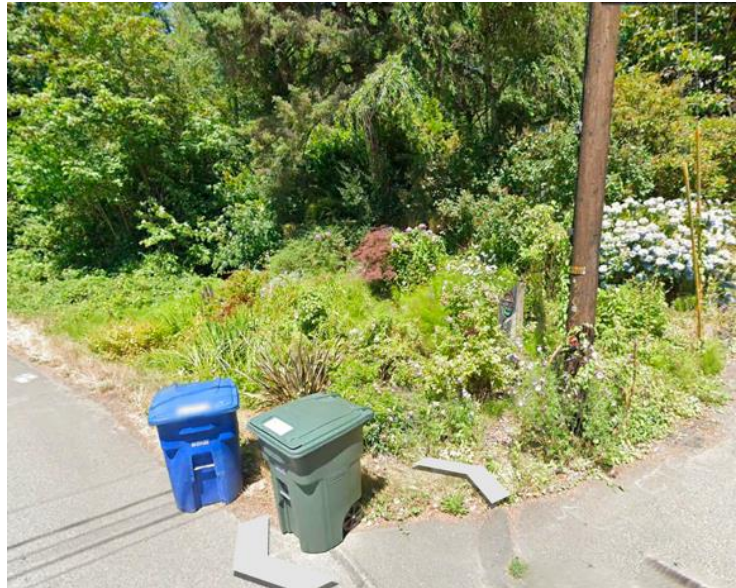
Photo 10. View of the same area as Photos 7-9 (prior to the 2022 growing season). Photo from Google Earth Street view.

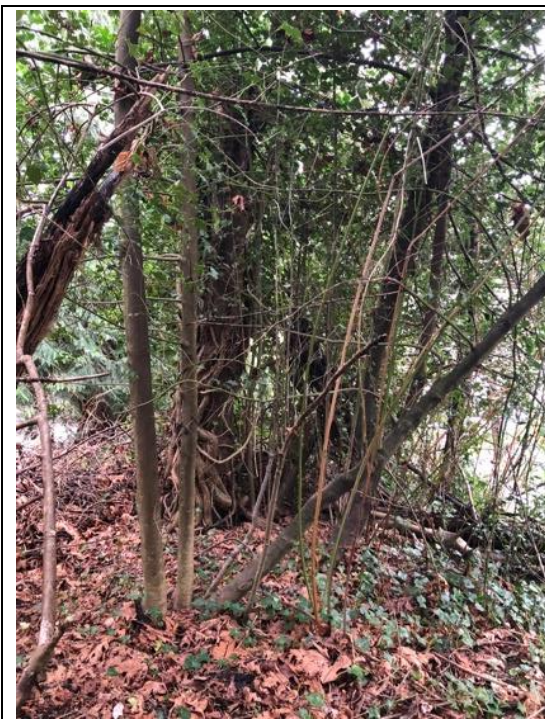
The existing on-site stream buffer and piped watercourse setback areas remain vegetated as the site is currently undeveloped (**Photos 13-14**) (**Appendix A/Figure 6**). The majority of the overlapping buffer and setback area is dominated by invasive species including English holly, cherry laurel, and English ivy. The portion of the buffer/setback area that comes onto the Moran property currently has few trees and little to no native vegetation. There is restoration potential within these areas through removal of invasive species and the planting of native vegetation.

Photo 13. View of north end of Ditch 1, looking south. Photo taken 3-17-22.

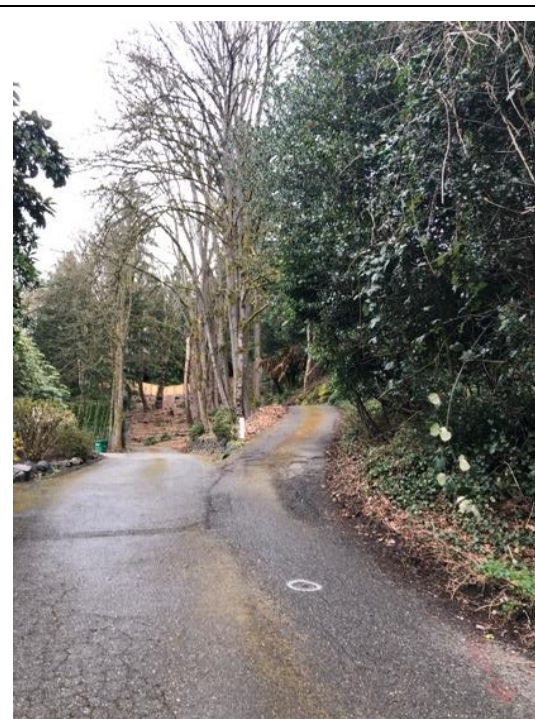
Photo 14. View of the south end of Ditch 1, (near outlet), looking north. Photo taken 3-17-22.

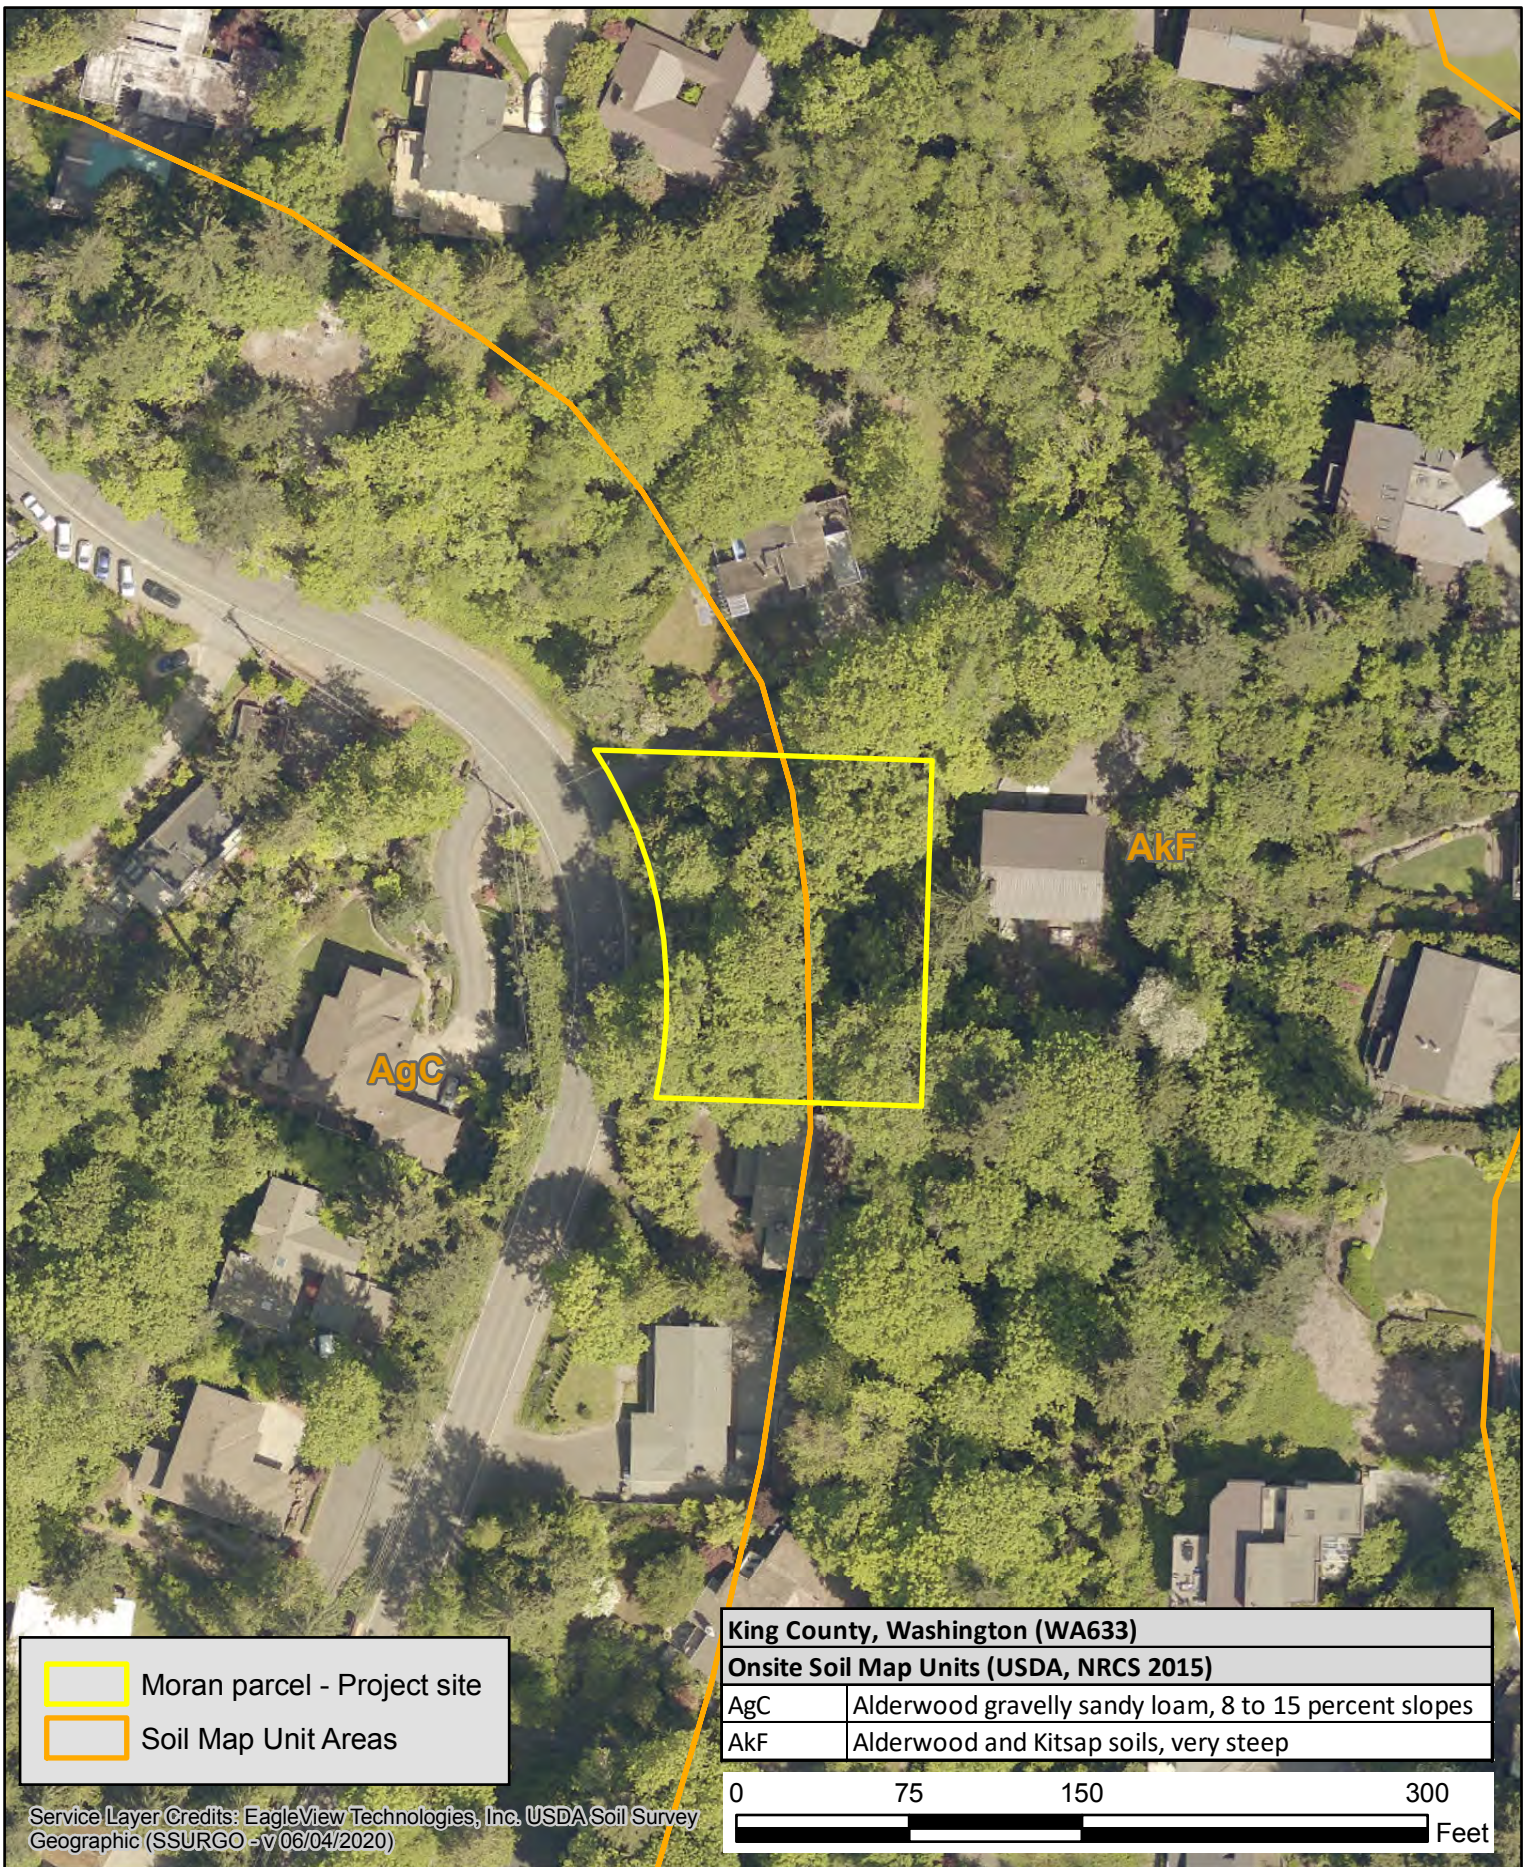
FIGURE 5: NRCS SOIL SURVEY
Moran Property, Mercer Island, WA

The National Resource Conservation Service (NRCS) soil survey indicates that the soils within the site are mapped as Alderwood gravelly sandy loam (8 to 15 percent slopes) (AgC) and very steep Alderwood and Kitsap soils (AkF) (NRCS 2022a) (**Appendix A/Figure 5**).
