Sewall Wetland Consulting, Inc.

RE: 5637 Mercer Way – *Revised* Critical Areas Report
SWC Job#14-206

This report describes our observations of any jurisdictional wetlands, streams and buffers on or within 200' of the proposed single family home located at 5637 East Mercer Way in the City of Mercer Island, Washington (the "site").

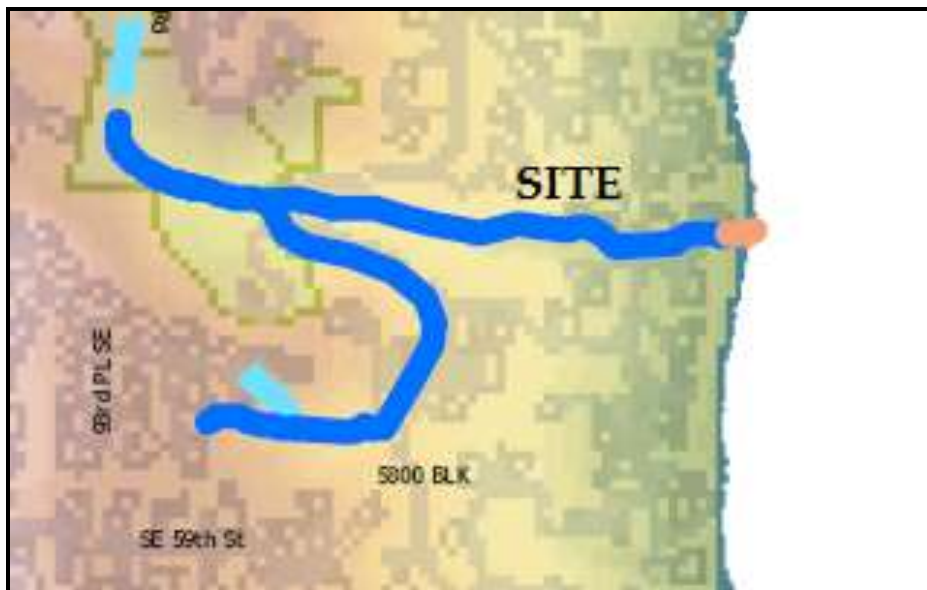
The City of Mercer Island stream inventory shows a perennial flowing non-fish bearing stream also known as a Type 2 watercourse with a 50' buffer.

Above: Mercer Island Stream Inventory of the site

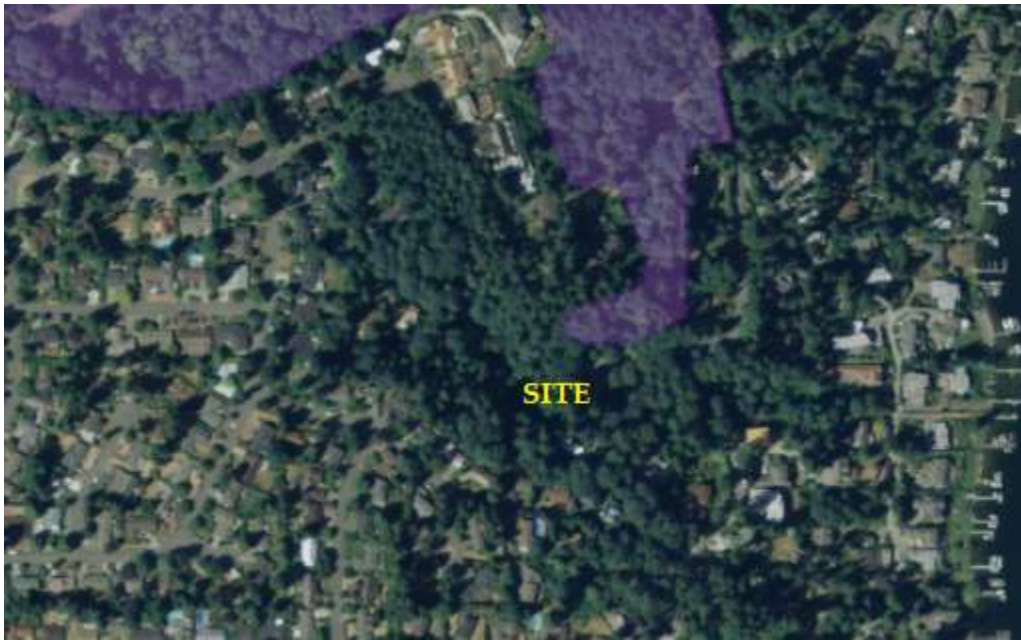
revealed no listed state or federal species utilizing the site. It does show and area to the north of the site as part of a “biodiversity corridor” (*purple shading*), which is a densely forested area with some steep slopes.

Above: WDFW Priority Habitat mapping of the area of the site.

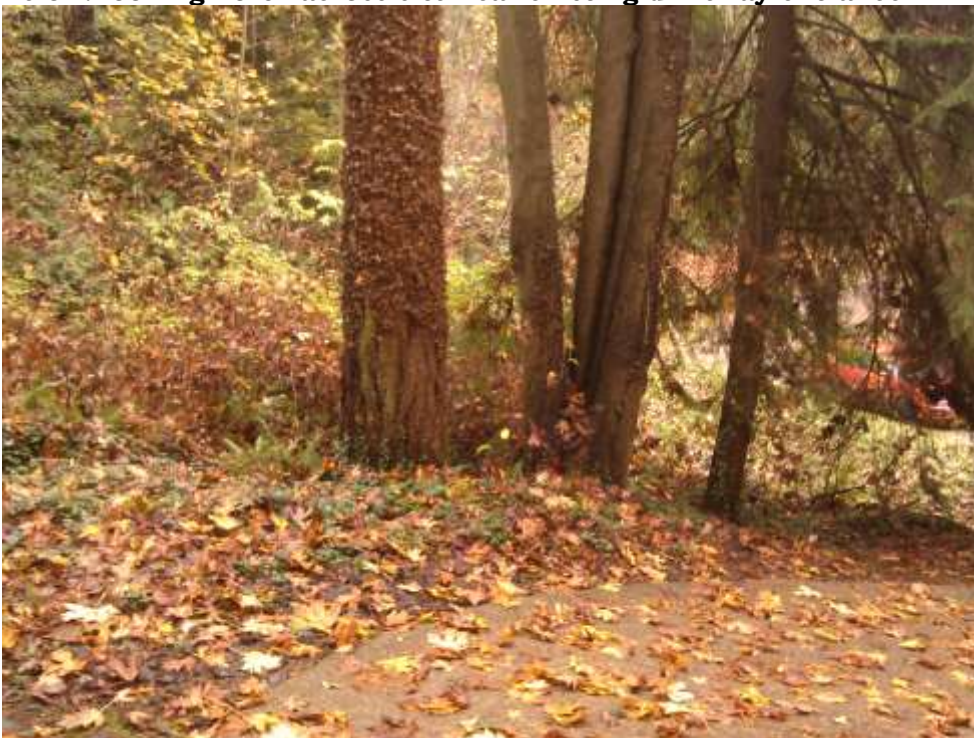
Below: looking north across site near existing driveway entrance
