Critical Areas Report

MERCER ISLAND SIMPSON PROJECT CITY OF MERCER ISLAND

May 2022

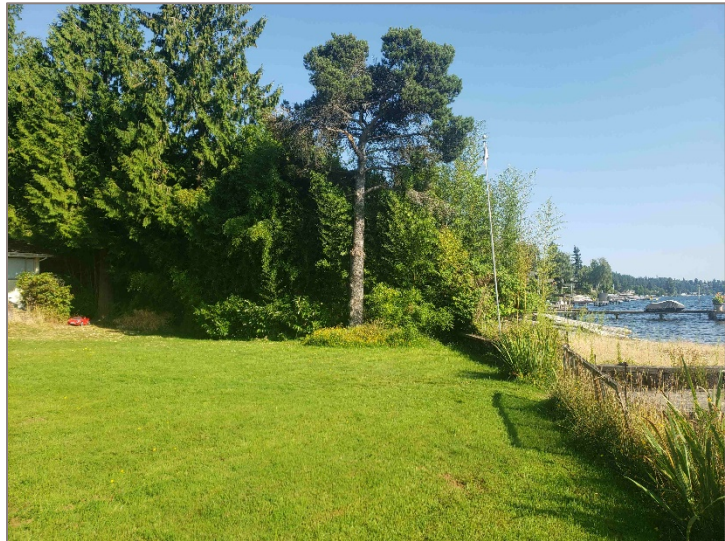
Title-page image: Existing maintained lawn along Lake Washington shoreline.

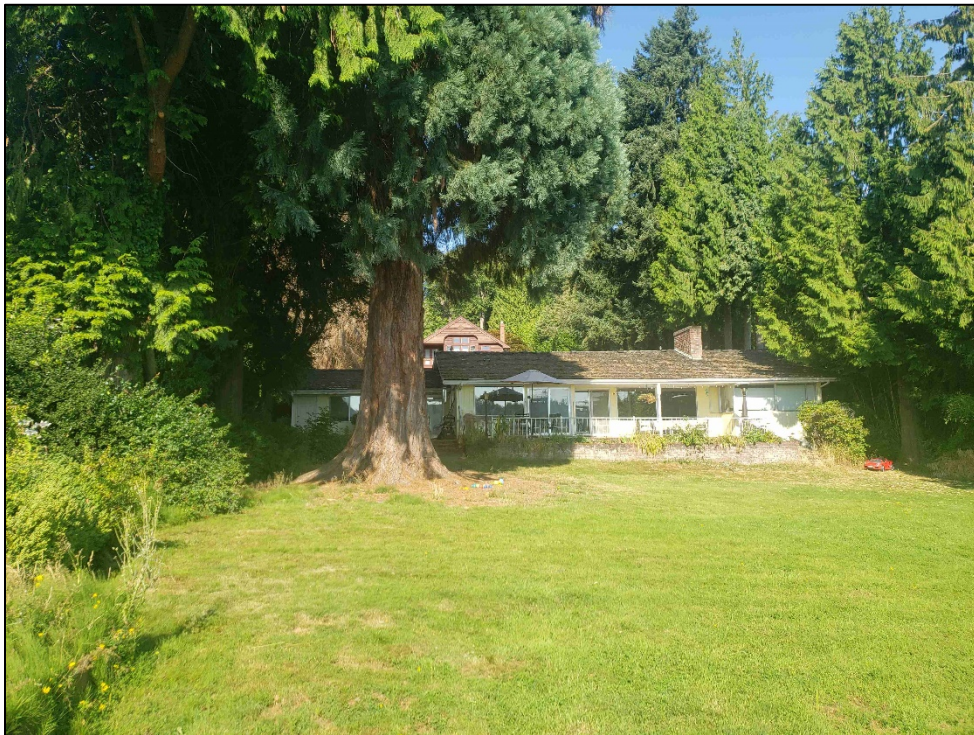
Figure 1. Subject property, existing residence, facing west

The subject property is approximately 0.47 acres in size and is developed with a single-family home, brick patio, associated driveway, dock, and a maintained yard (Figure 1). The northern property boundary is densely vegetated with western red cedar, shore pine, bamboo, rhododendrons, cherry laurel, and ornamental shrubs. The southern property boundary is vegetated with sedges, maintained ornamental shrubs, western red cedar, and coast redwood. The neighboring property to the north consists of a single-family home, landscaped areas, wooden walkways, a dock, and an extended yard that gradually slopes to the east toward the Lake Washington shoreline. Similarly, the subject property, the lawn is maintained up to a border of dense vegetation along the northern and southern property boundaries. Although both yards are regularly mowed, hydrophytic vegetation within the lawn, including obligate wetland plant species, persists on both properties. The slope wetland extends throughout the majority of both rear yards.

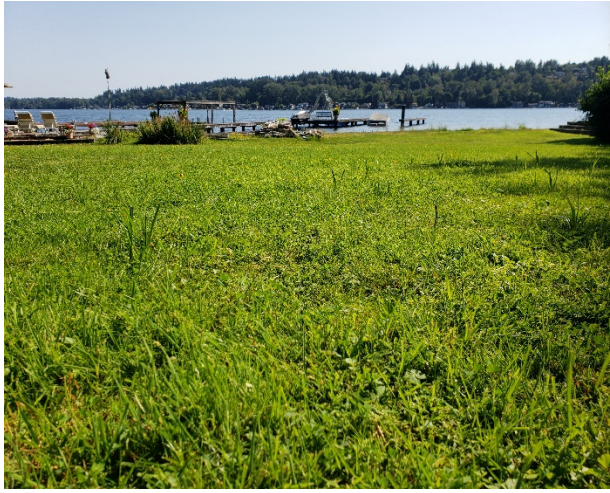
WETLAND A – Assessment Summary										
Location:	Lawn adjacent to Lake Washington shoreline on parcels #302405-9118 and -9003									
WRIA / Sub-basin:	Cedar-Sammamish River Watershed (WRIA 8) / Mercer Island Drainage Basin

2014 Western WA Ecology Rating:	Category IV								
	Buffer Width and Buffer Setback:	100 feet								
	Wetland Size:	Approx. 0.44 acres								
	Cowardin Classification(s):	Palustrine Emergent								
	HGM Classification(s):	Slope								
	Wetland Data Sheet(s):	DP-1, DP-2, DP-3, DP-5								
	Upland Data Sheet (s):	DP-4, DP-6								
	Flag Color:	Pink- and black-striped								
	Flag Numbers:	A-1 to A-16								
	Vegetation	Tree stratum: <i>Thuja plicata</i> Shrub stratum: <i>Physocarpus capitatus, Rubus spectabilis,</i> Herb stratum: <i>Scirpus microcarpus, Juncus effusus, Athyrium felix-femina, Iris pseudacorus</i>								
Soils	Soil survey: Kitsap silt loam, 2 to 8 percent slopes. Field data: Sandy Redox (S5), Depleted Matrix (F3), Sandy Gleyed Matrix (S4)

Hydrology	Source: Lake Washington, High Water Table Field data: Saturation (A3), Geomorphic Position (D2), FAC-Neutral Test (D5)									
Wetland Functions										
	Improving Water Quality			Hydrologic			Habitat			
Site Potential	H	M	<u>L</u>	H	M	<u>L</u>	H	M	<u>L</u>	
Landscape Potential	H	<u>M</u>	L	H	<u>M</u>	L	H	<u>M</u>	L	
Value	<u>H</u>	M	L	H	M	<u>L</u>	H	<u>M</u>	L	TOTAL
Score Based on Ratings	6			4			5			15
Description and Comments										
Wetland A is a slope wetland located on two maintained lawns along the Lake Washington shoreline.

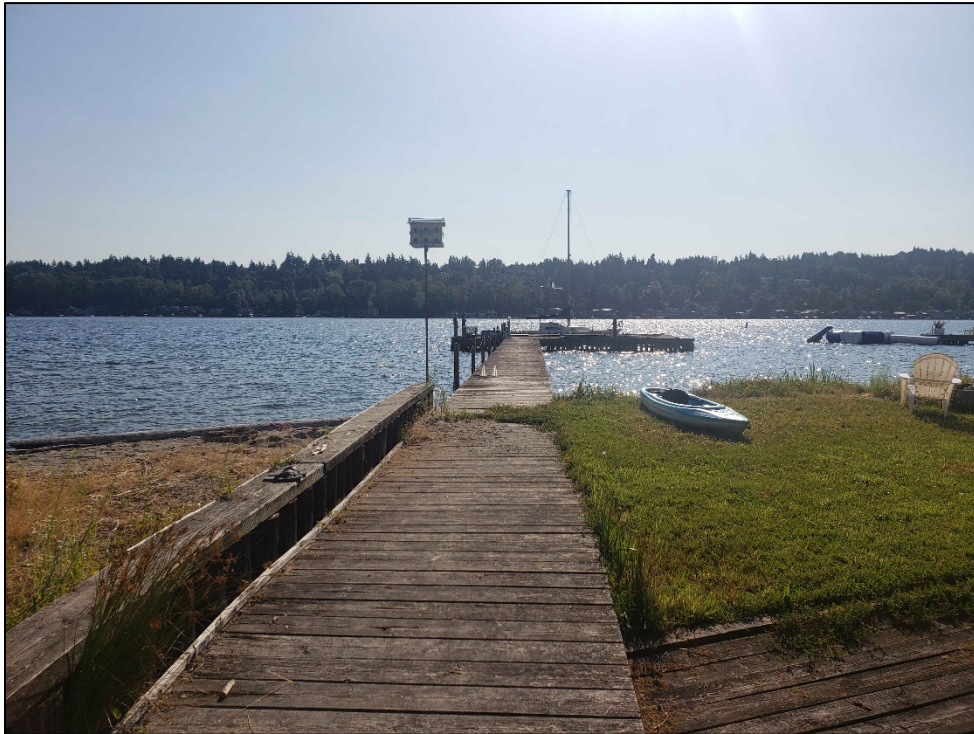
Figure 2. View of Lake Washington shoreline, the maintained lawn, and wooden boardwalk and pier.

The subject property is located along the Lake Washington shoreline. The shoreline consists of beach gravels that transition to maintained lawn. A small timber bulkhead is located north of a wood-decked boardwalk and pier (Figure 2). The majority of the riparian vegetation is a maintained extension of the backyard, with the exception of some untrimmed yellow flag iris, tall horsetail, sedges, soft rush, birds foot trefoil, and Japanese knotweed.

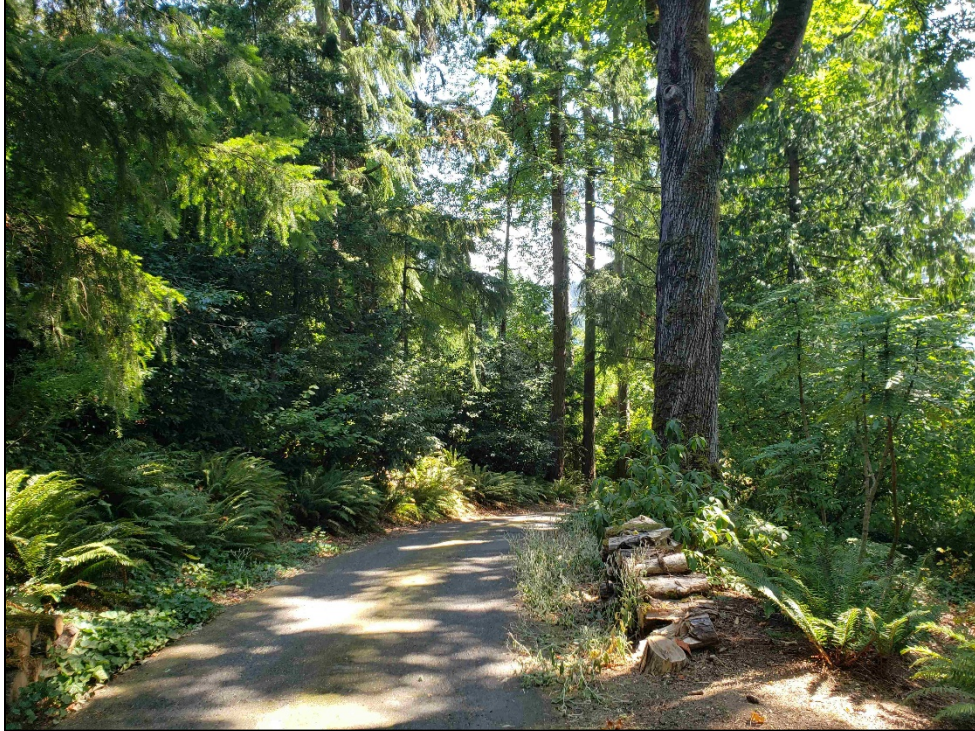
Figure 3. Existing upland conditions along access drive

Areas outside of observed wetlands do not meet criteria for wetland hydrophytic vegetation, hydric soils, and/or wetland hydrology. Non-wetland areas are located west of the maintained lawns, including the residential homes, paved driveways, and forested slopes. Vegetation includes giant sequoia, Douglas-fir, big-leaf maple, rhododendrons, cherry laurel, western sword fern, English ivy, Japanese knotweed, and other ornamental species (Figure 3).

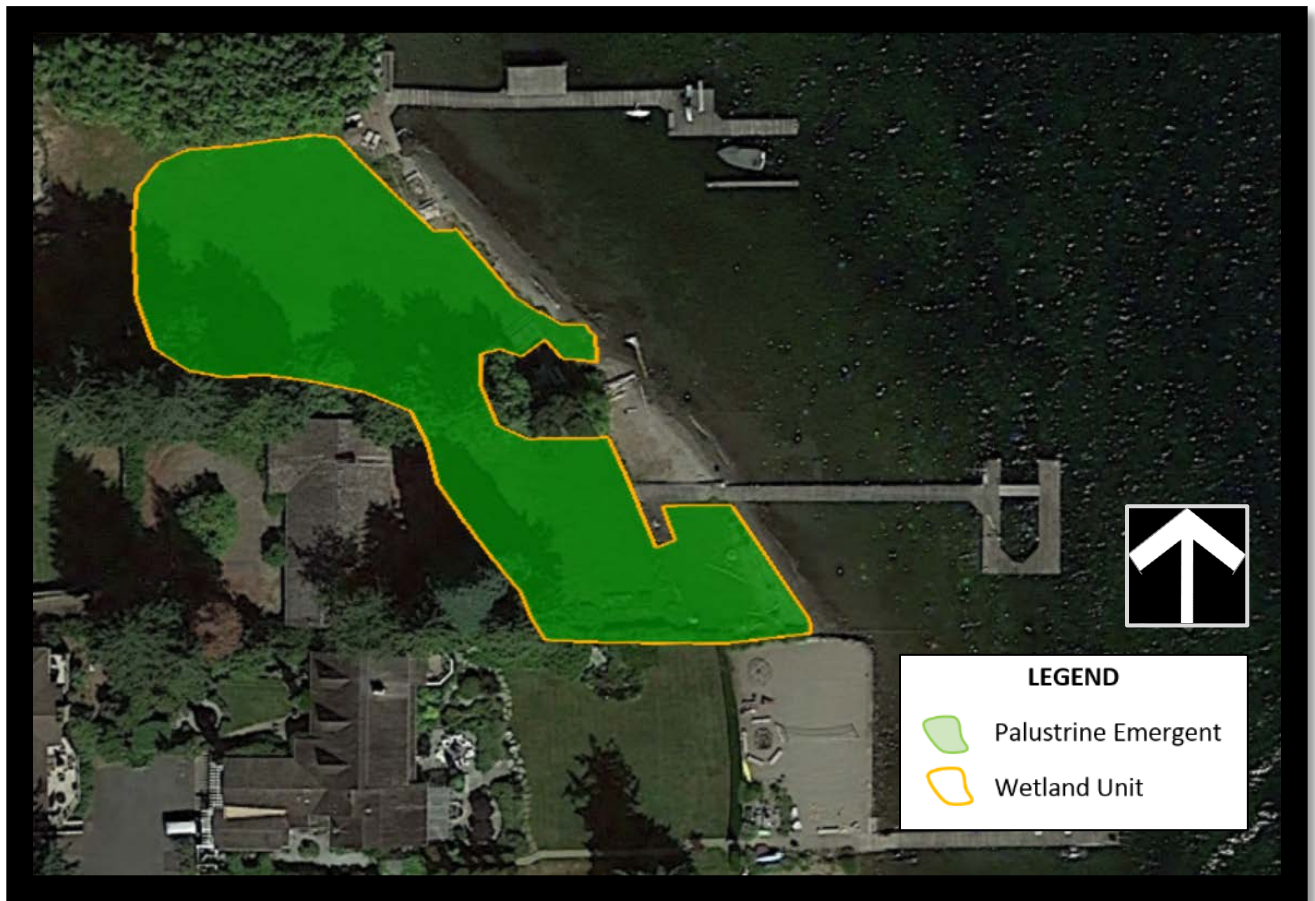
Figure 1. Cowardin plant classes – H1.1, H1.4

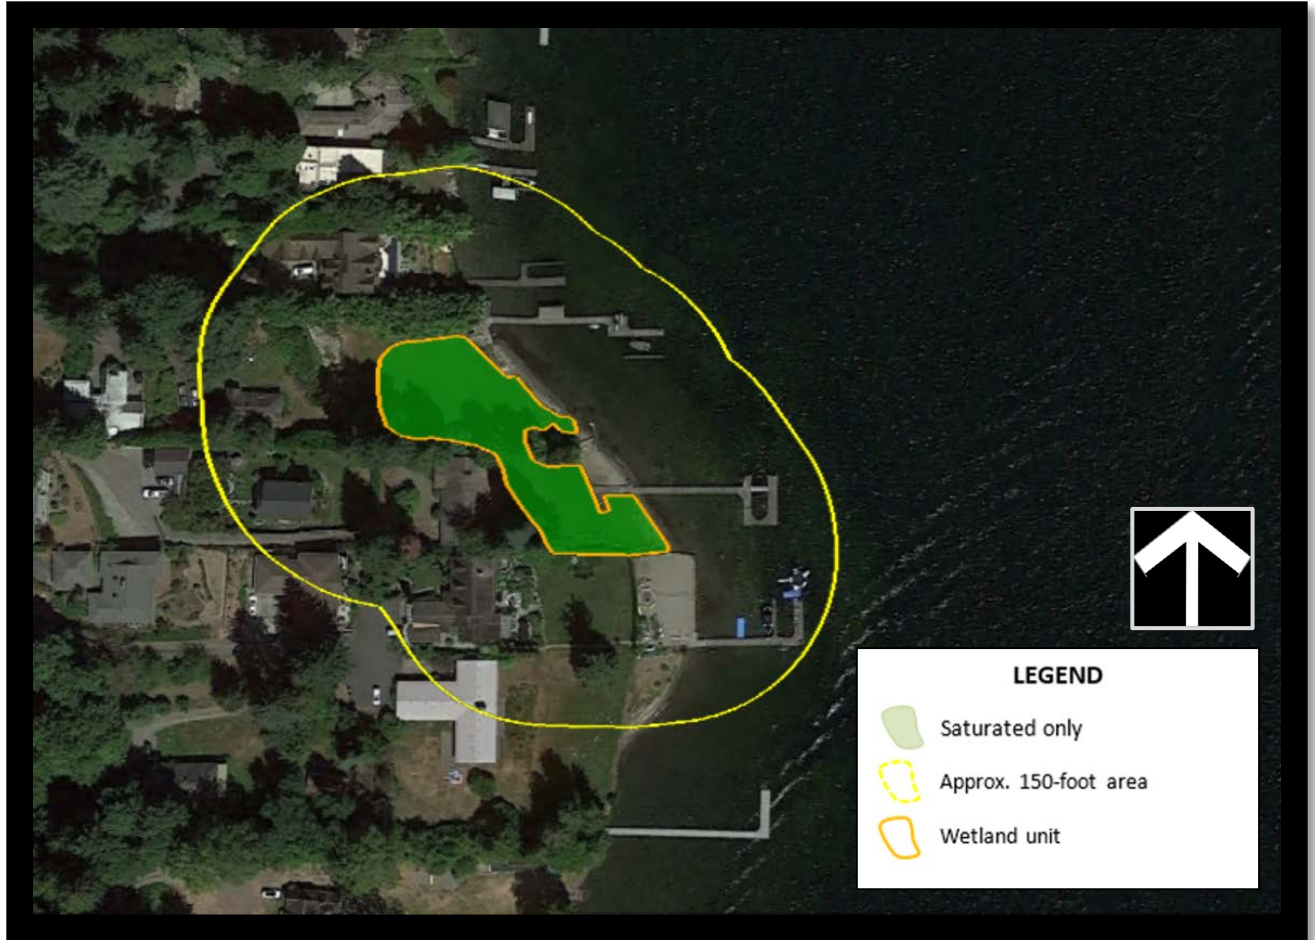
Figure 2. Hydroperiods and 150-foot area – H1.2, S2.1, S5.1

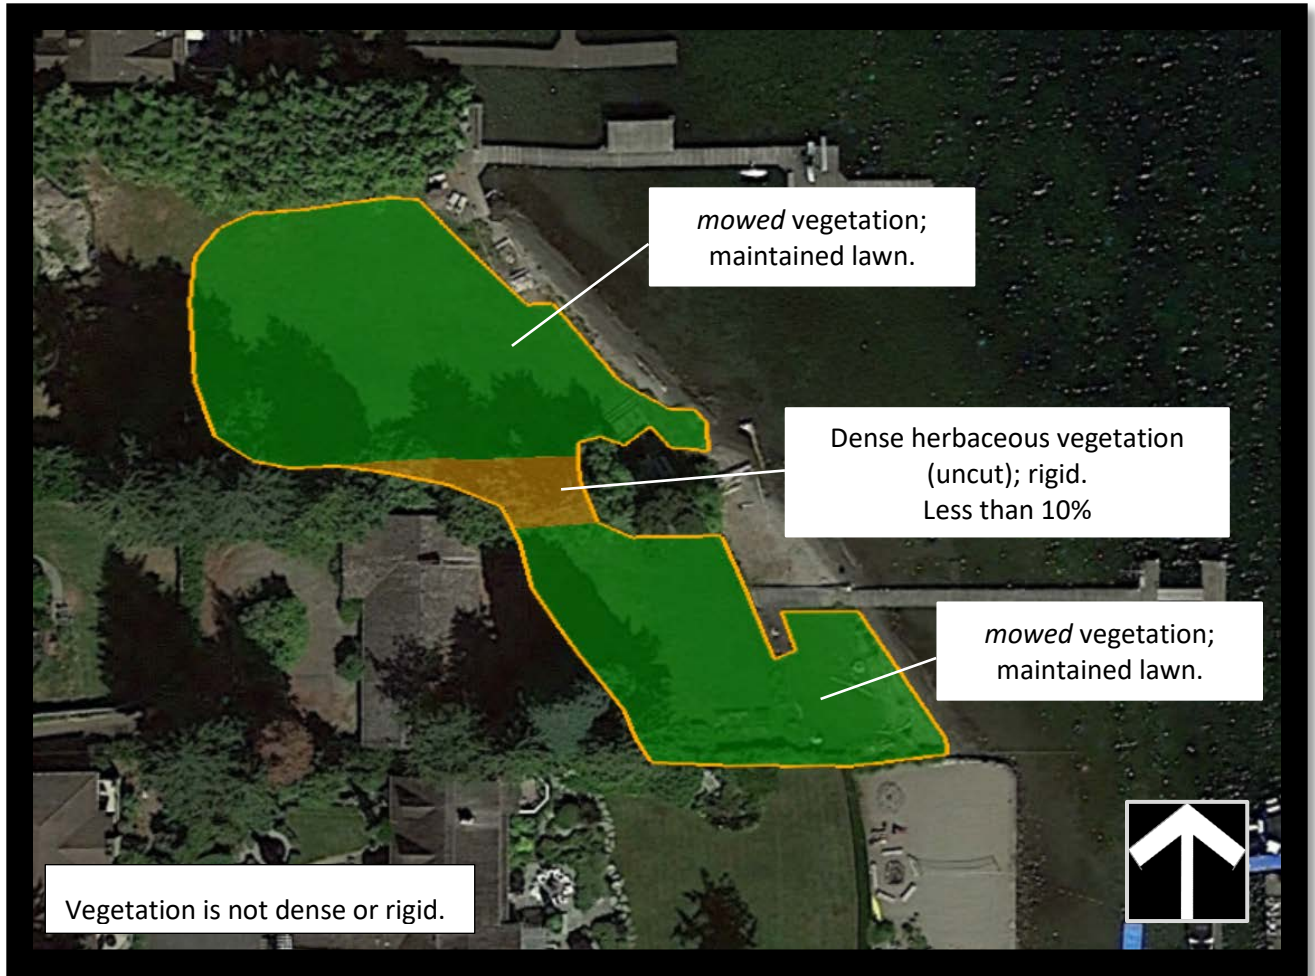
Figure 3. Plant cover of dense and rigid trees, shrubs, and herbaceous plants – S1.3, S4.1
