**GEOTECHNICAL ENGINEERING  
REPORT ADDENDUM**  
Buttenwieser/Wiley Residence  
6838 96th Avenue SE  
Mercer Island, Washington

Project No. 200631 • April 26, 2022 (Revised August 16, 2022)

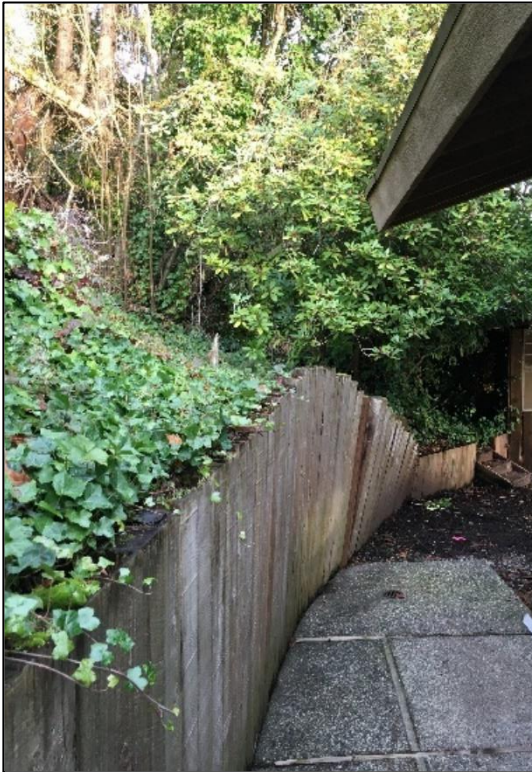
**Photograph 1.** Looking northeast at the existing yielding wall northwest of the existing residence.

Please refer to the Photographs 1 and 2 for representative examples of the extent and magnitude of observed yielding and the conditions of the aforementioned tree.

We did not observe tension cracks or noticeable, well-delineated ground subsidence associated with the yielding condition of the wall, nor did the topographic survey performed for the Project capture any localized subsidence at this location. In our opinion, the cause of the yielding is localized surficial slope movement that reflects the age and decay of the railroad tie timbers and/or that the wall was not designed/engineered for the earth pressures it has been exposed to. In our opinion, the slope movement likely extends upslope a distance on the order of inches to a few feet.

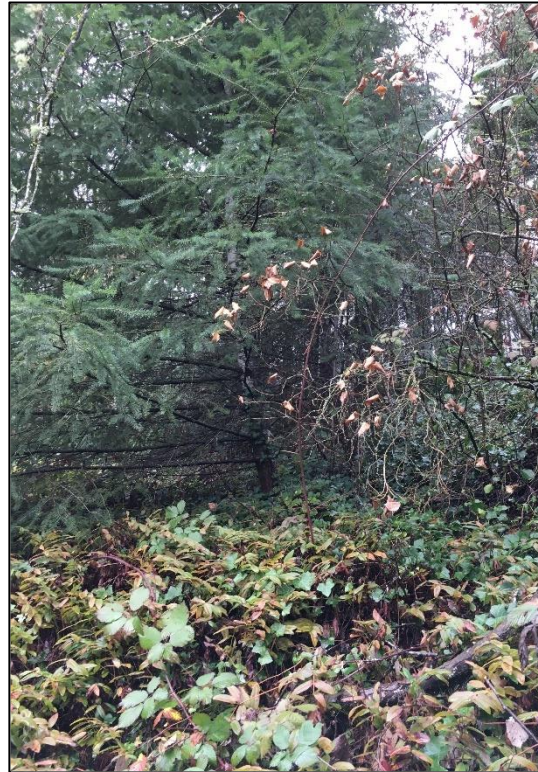
**Photograph 2.** Looking upslope at a conifer with slightly curved trunk northwest of the existing residence.

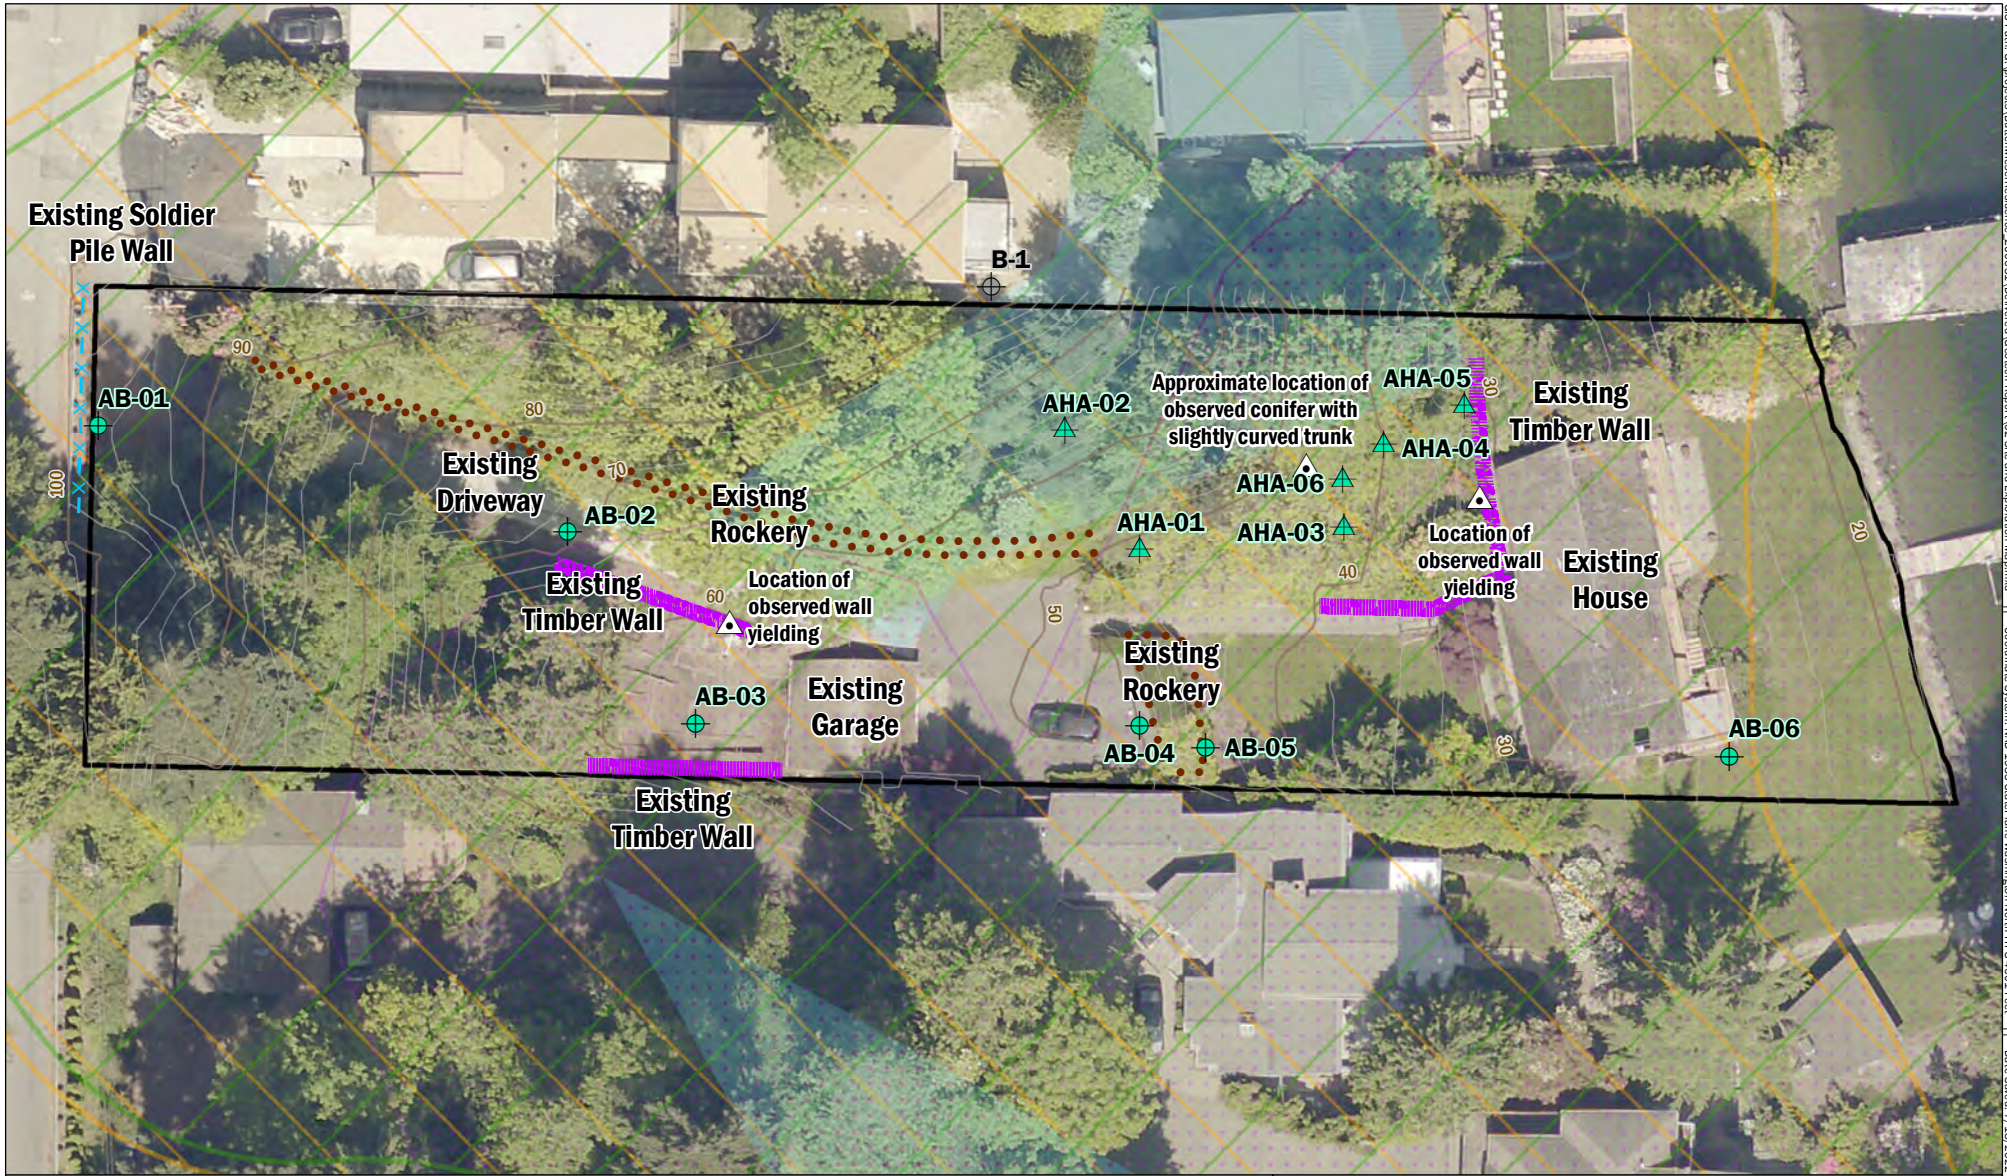
FIGURE NO.  
**1**

- Explorations**
- Hand Auger (Aspect)
  - Boring (Aspect)
  - Boring (Cascade Group LLC)

On July 8, 2022, Aspect advanced a series of hand augers (AHA-01 through AHA-06) on the Site slope northwest of the residence to better quantify the thickness of colluvium on the slope. These logs are included as Appendix D and the results are incorporated into our analyses, conclusions, and recommendations.

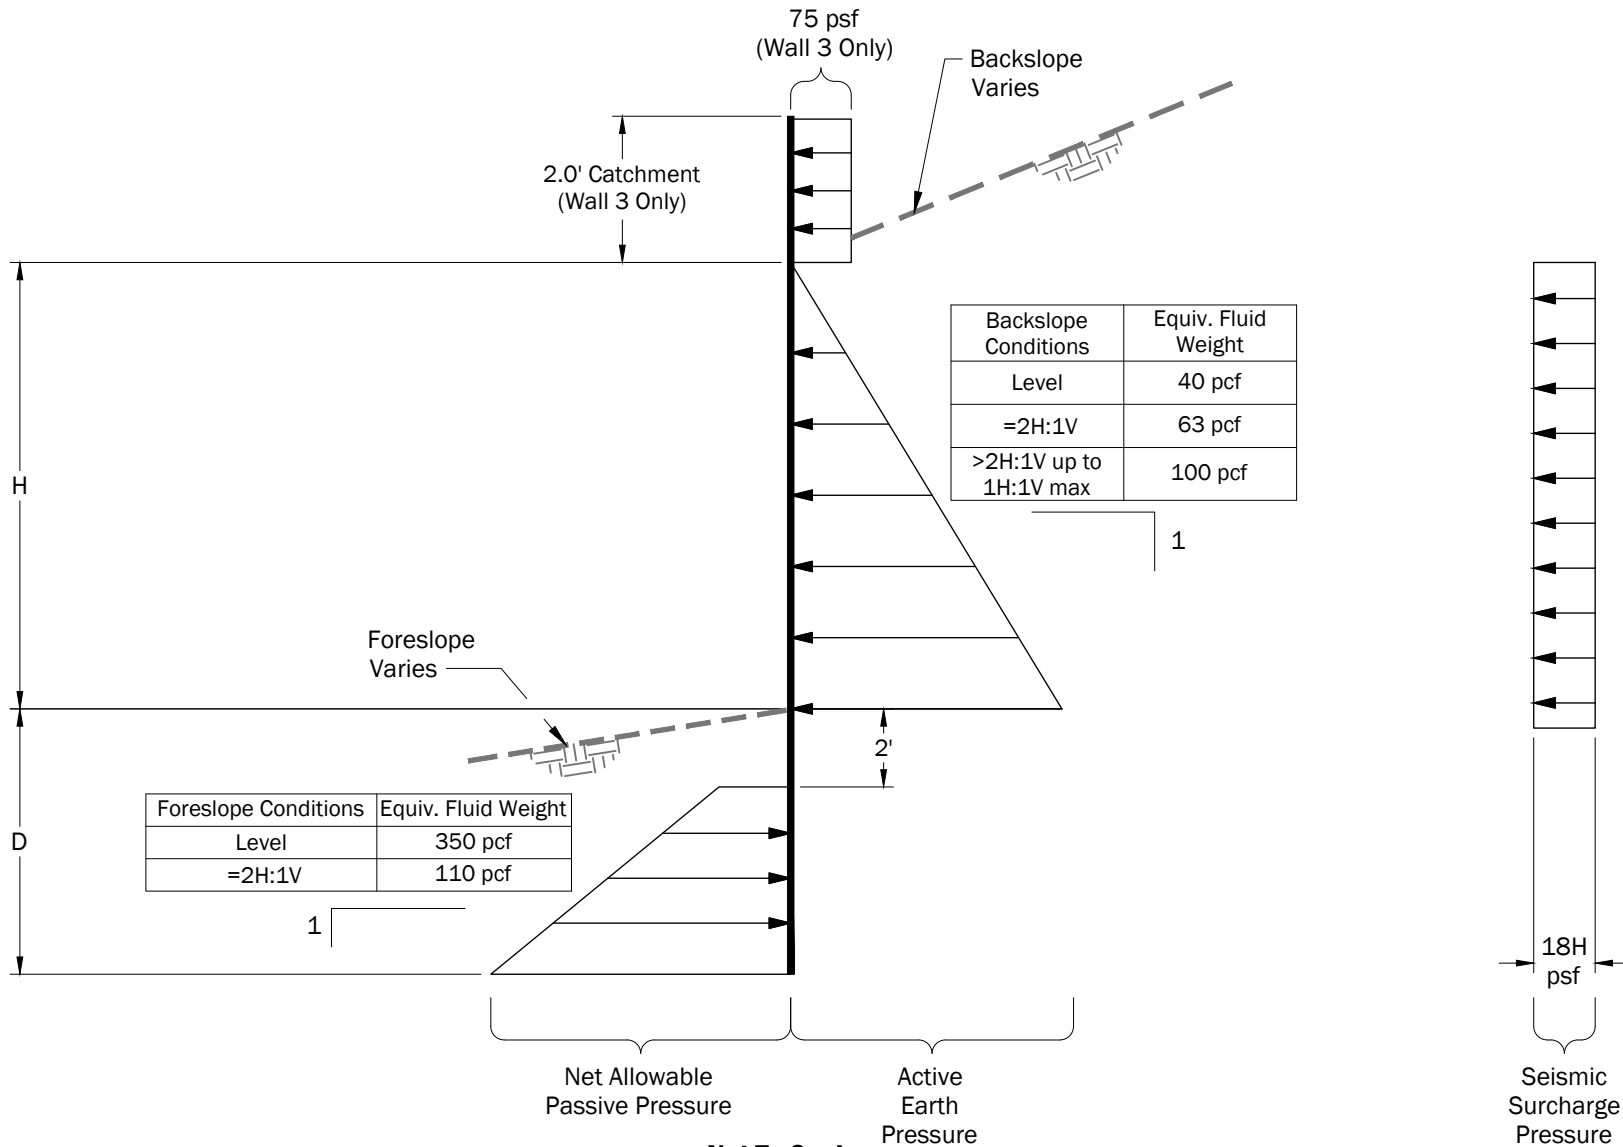
1. Linear interpolation can be used for backslope/foreslope conditions between level and 2H:1V.
2. Active/apparent earth pressure and surcharge act over the pile center-to-center spacing above the base of the excavation.
3. Passive earth pressure acts over 3 times the soldier pile shaft diameter, or the soldier pile center-to-center spacing, whichever is less.
4. Passive earth pressure includes a factor of safety of 1.5.

Lateral earth pressures acting on earth retaining systems with assumed geometries for active, at-rest, and seismic conditions are shown below in Table 1. These values assume that new walls will primarily retain existing fill deposits at an approximately vertical interface. These values also assume that existing fill deposits will provide passive support in front of the structures. To invoke active earth pressure conditions, a wall must be capable of yielding laterally at least  $0.001$  to  $0.002H$ , where  $H$  is the exposed height of the wall; otherwise, at-rest conditions should be assumed.

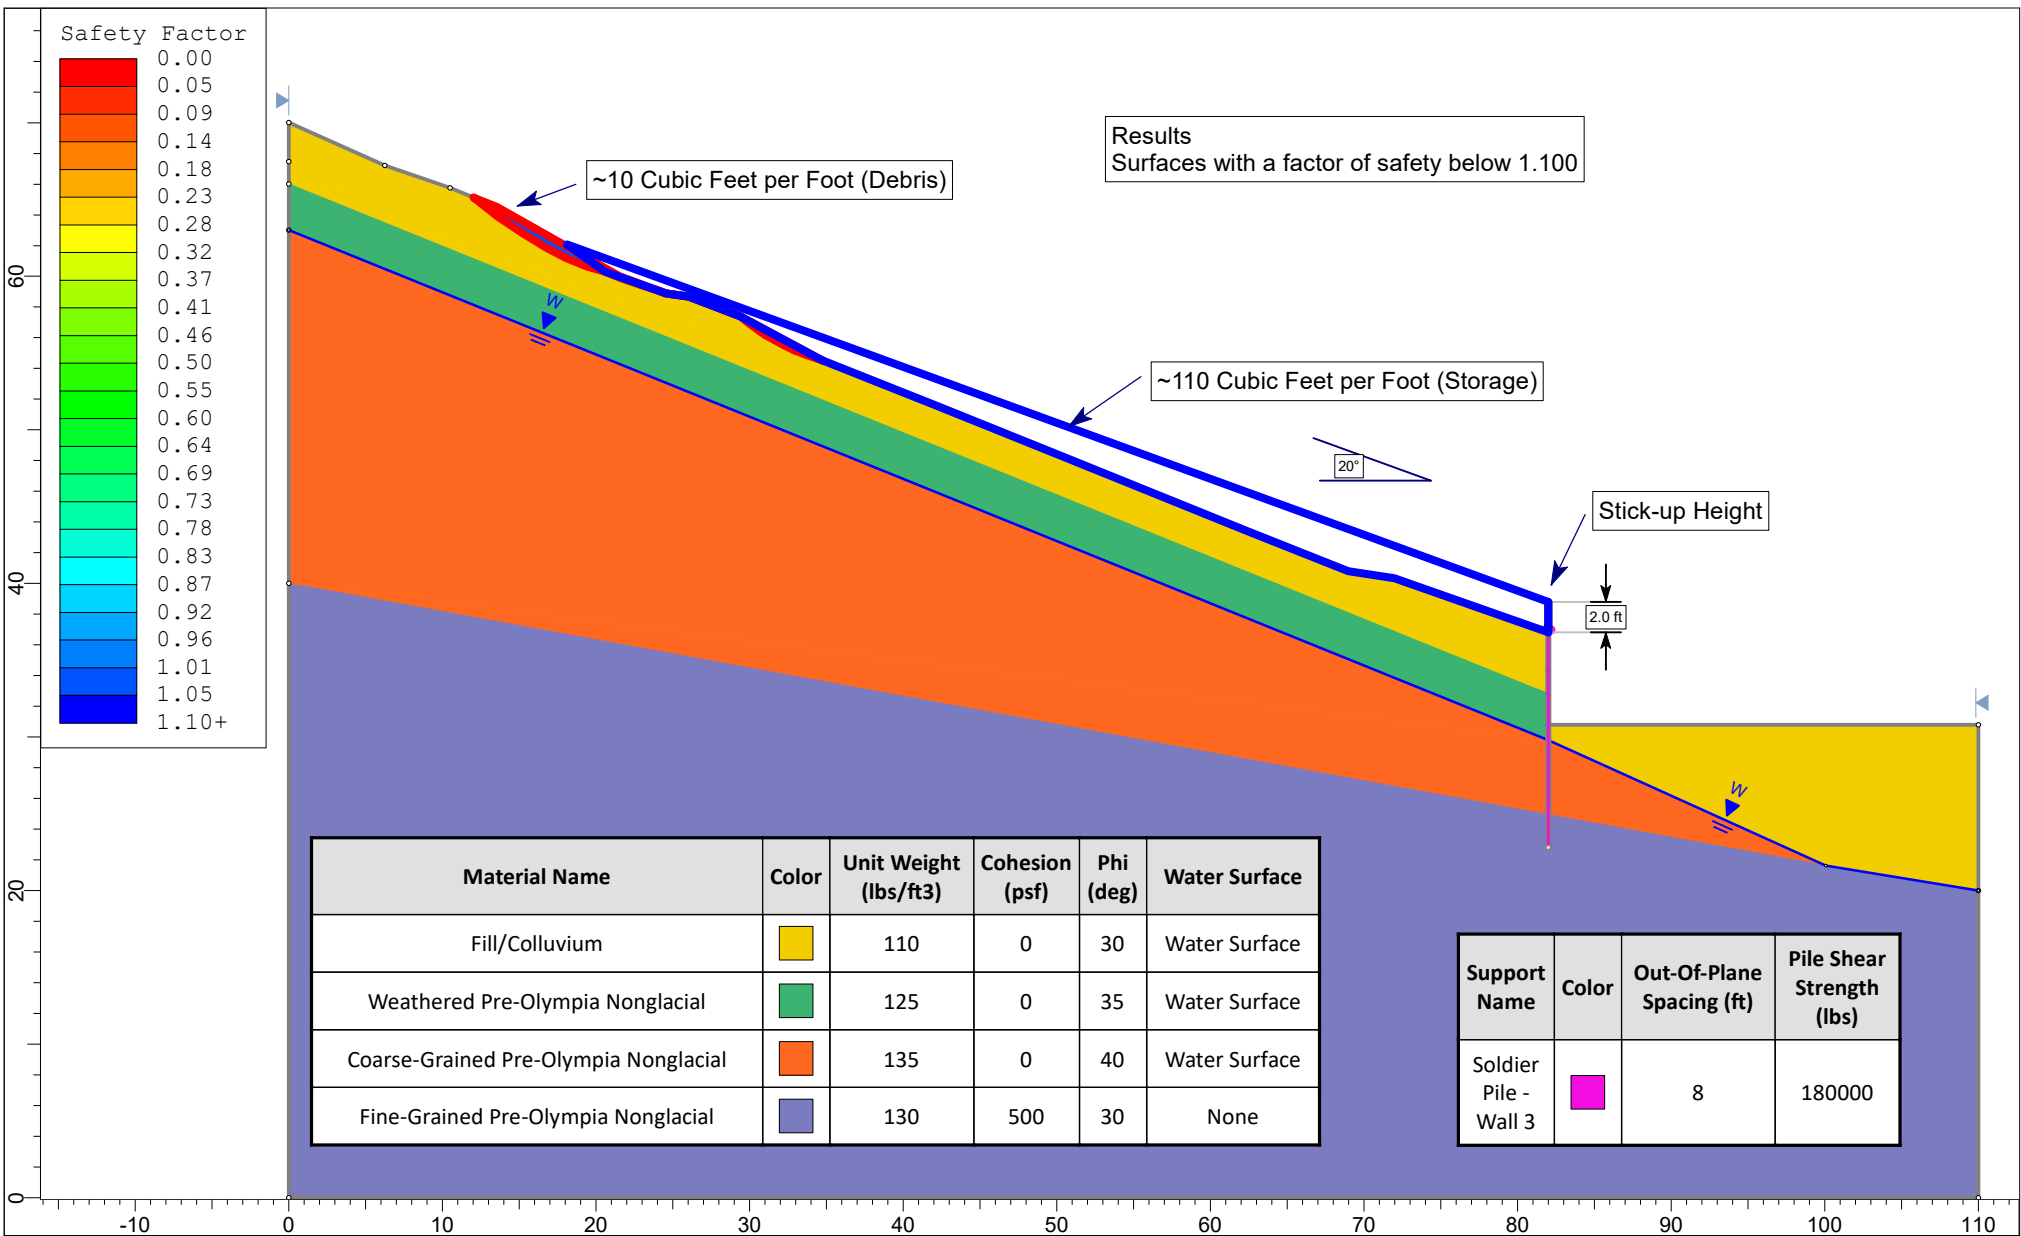
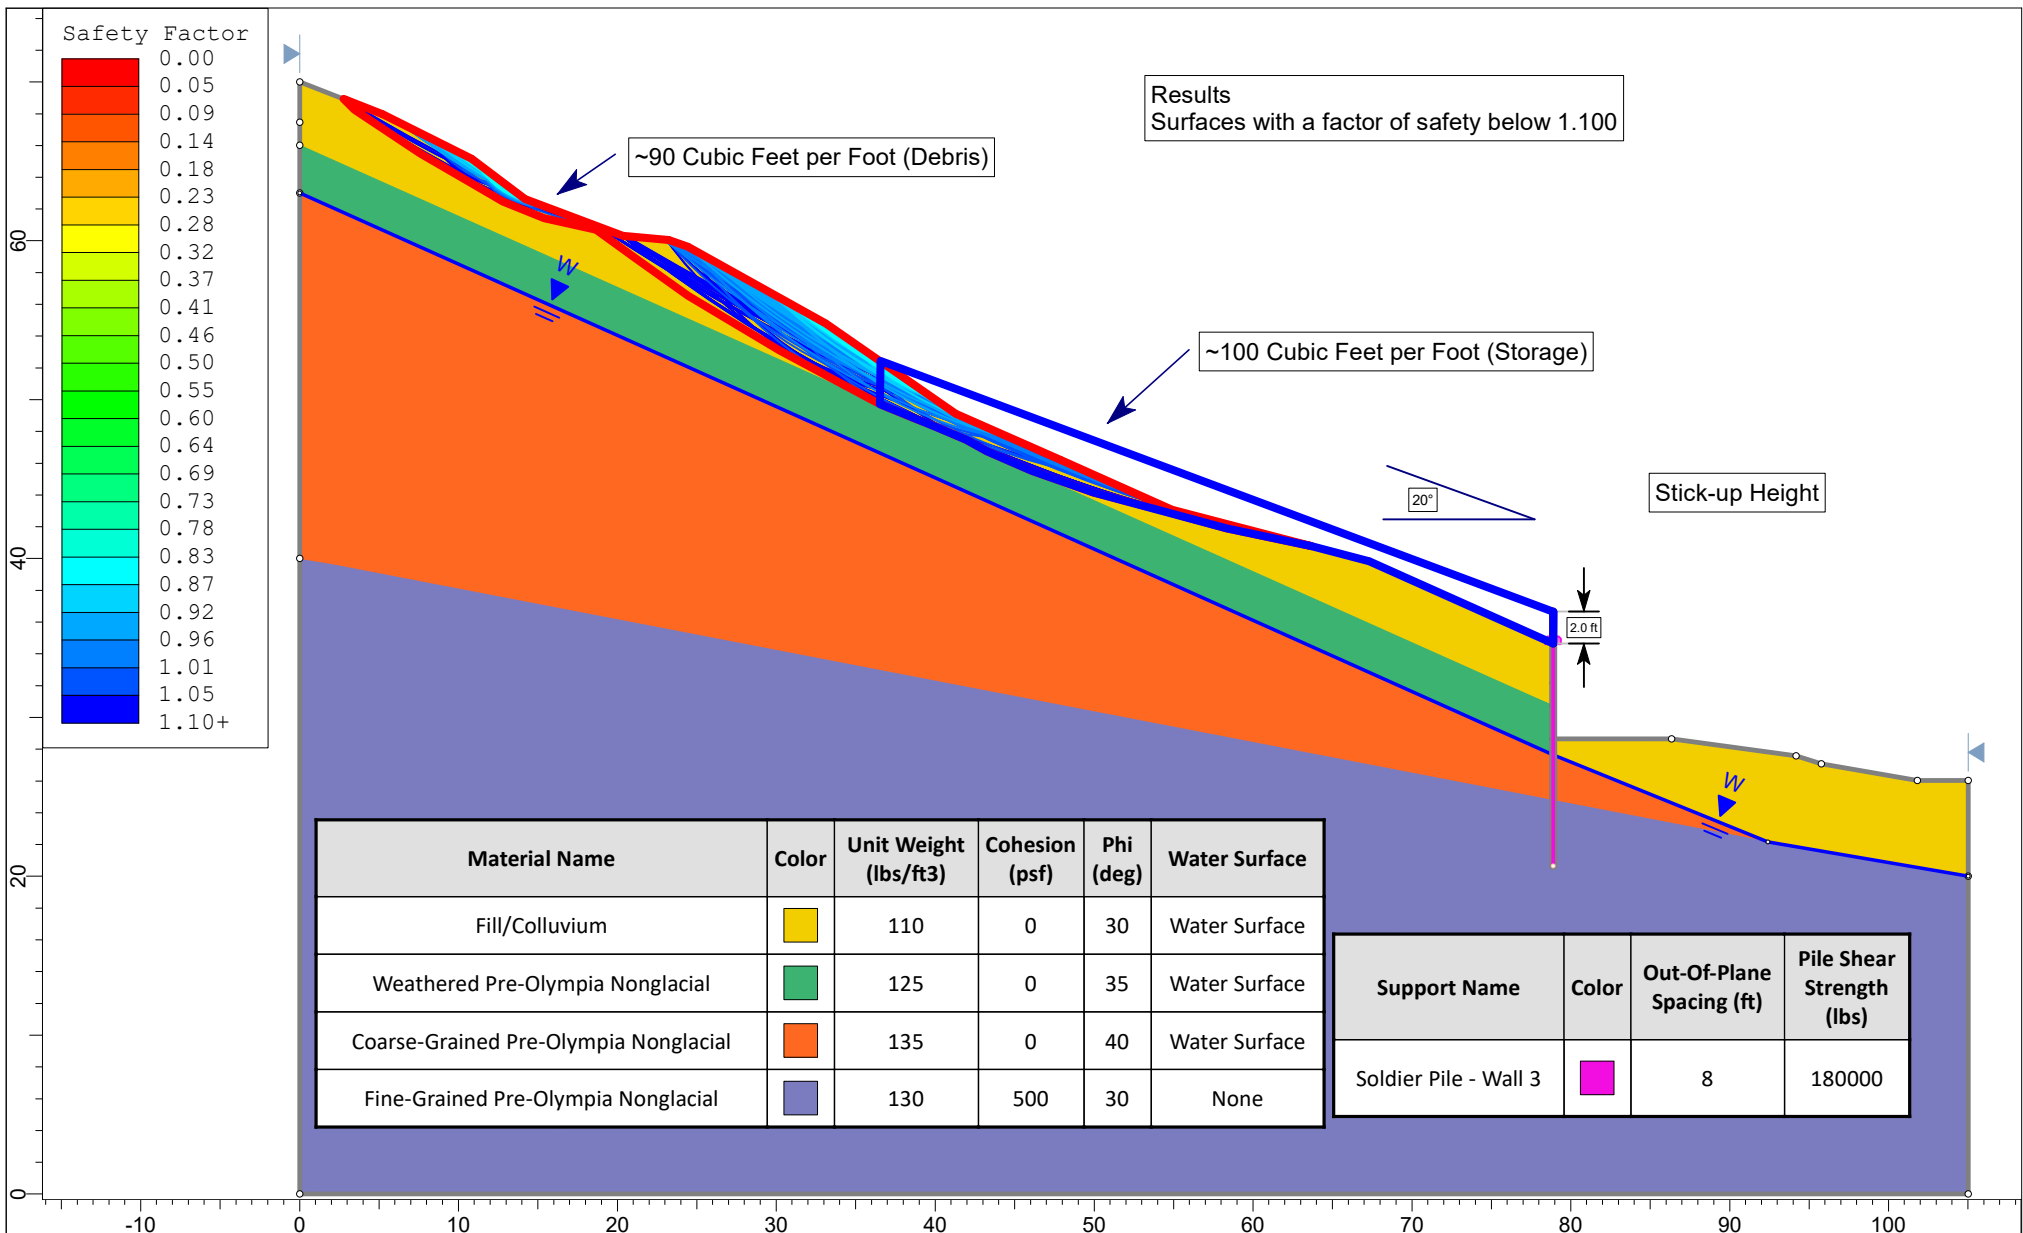
### **Retaining Wall Catchment Calculations**

- Search Grid
- Search Limits
- Modeled Groundwater Level
- Boring Location and Depth

We performed stability analyses of the shallow landslide hazard to identify whether a catchment feature should be provided on the proposed soldier pile wall located at the base of the ECA steep slope north of the main residence (Wall 3). We analyzed sections C-C,' D-D,' and E-E' (refer to Appendices E and F) and found that section E-E' governed our catchment recommendations.

Based on our interpretation of the failure surfaces and ranges in calculated factors of safety, it is our opinion that a unit volume of slide debris expected to mobilize during a characteristic shallow slide is approximately 90 cubic feet per foot of slope width. Assuming the slide debris will come to rest at the base of the slope with a residual backslope of approximately 20 degrees, we recommend a minimum extra stick-up height for debris catchment of 2.0 feet above existing grade at the top back of the wall. These calculations are represented graphically in Appendix F.
