Subject: Geotechnical Report

Proposed Additions and Alterations

7244 North Mercer Way, Mercer Island, Washington

GEOTECHNICAL REPORT PROPOSED ADDITIONS AND ALTERATIONS 7244 NORTH MERCER WAY MERCER ISLAND, WASHINGTON

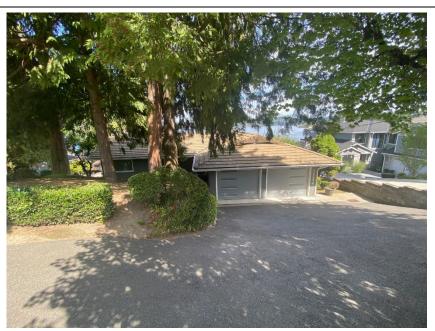
Plate 1. View of the west side of the existing residence and garage at the site, looking east from North Mercer Way.

Based on review of the project topographic survey, the site gradient generally slopes down from the northwest property corner towards the east at an average gradient of about 18 percent. However, the concrete driveway west of the house is at about 30 percent gradient (see topographic contours on *Figure 2*). Total vertical relief across the site is on the order of about 30 feet. Current site conditions are shown on Plates 1 and 2 on the following page.

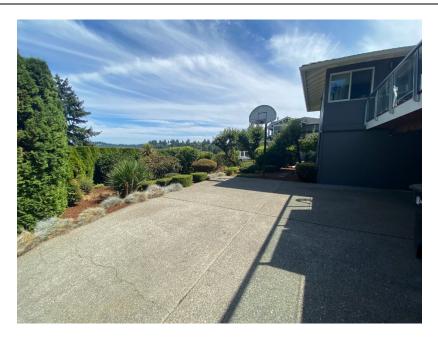
Plate 2. View of the landscaping and concrete paving area on east side of the subject site, looking south.

We also evaluated the existing building and observed no signs of apparent cracks or vertical settlement on the existing foundation walls. We did observe some minor cracking in the concrete paving surface on the east side of the site, but in our opinion it is likely the result of improper fill placement under the concrete and not the result of instability. In our opinion, the site is globally stable in its current condition and the existing development has been stable in its current configuration.

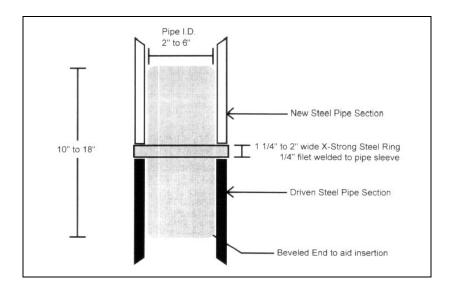
6. Piles shall be driven in nominal sections and connected with compression fitted sleeve couplers (see detail below – Courtesy of McDowell Pile King, Kent, WA). We discourage welding of pipe joints, particularly when galvanized pipe is used, as we have frequently observed welds broken during driving.

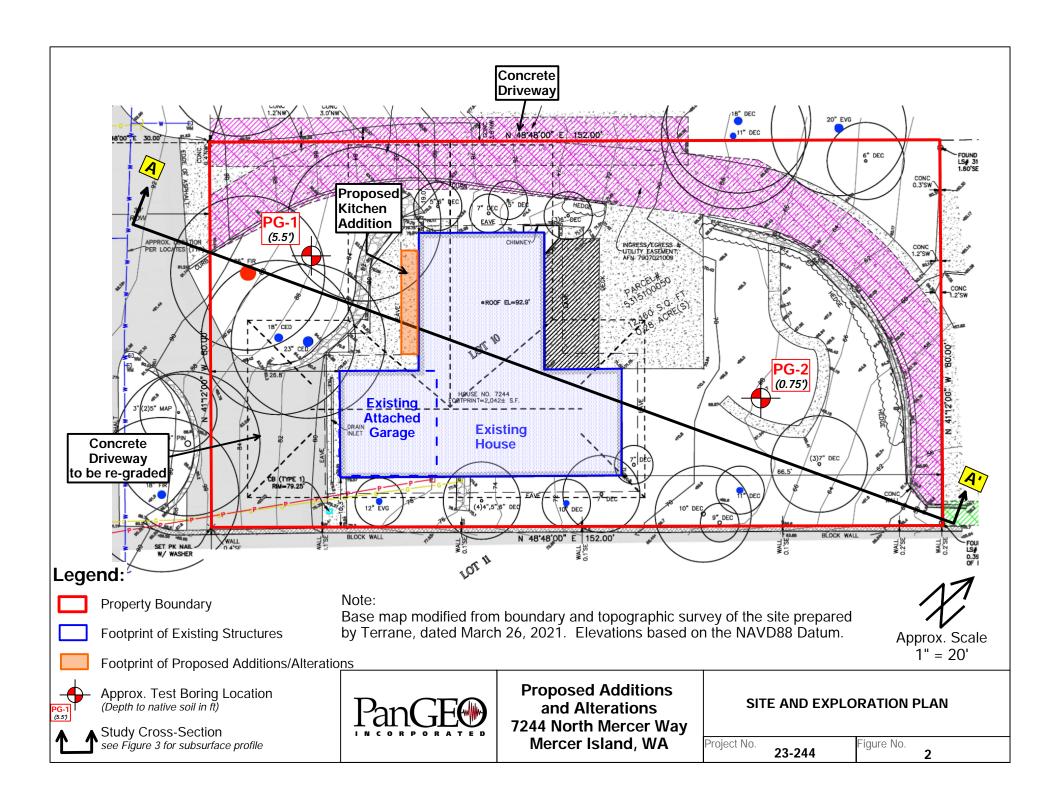
Two test borings (PG-1 and PG-2) were advanced at the site on August 22, 2023 using a hand-portable limited access drill rig owned and operated by CN Drilling of Seattle, Washington. Test borings PG-1 and PG-2 were drilled to maximum depths of about 14 feet and 9 feet below existing grades, respectively. The approximate boring locations were determined relative to existing features and are shown on the attached *Figure 2*.

The subject site is an approximately 12,160 square foot lot located at 7244 North Mercer Way in Mercer Island, Washington, approximately as shown on the attached *Figure 1, Vicinity Map*. The site is rectangular in shape, and is bound by North Mercer Way to the west, and by single-family residential lots in the other directions. The site is currently developed with a one-story residence with one level of daylight basement. An attached garage is located at the southwestern corner of the site. A concrete driveway provides access to the attached garage from North Mercer Way to the west. Additionally, the northern portion of the site contains an existing concrete right-of-way, which provides access to the adjacent properties to the north and east. The layout of the site is shown on *Figure 2, Site and Exploration Plan*.

Based on the site topographic survey and subsurface conditions encountered in the test borings, we developed a generalized subsurface profile A-A' at the approximate location shown on *Figure 2*. The subsurface profile is attached as *Figure 3*.
