Altmann Oliver Associates, LLC

Environmental
Planning &
Landscape
Architecture

**SUBJECT: Wetland Reconnaissance for 6333 – 77th Ave. SE
Parcel 409710-0010, Mercer Island, WA**

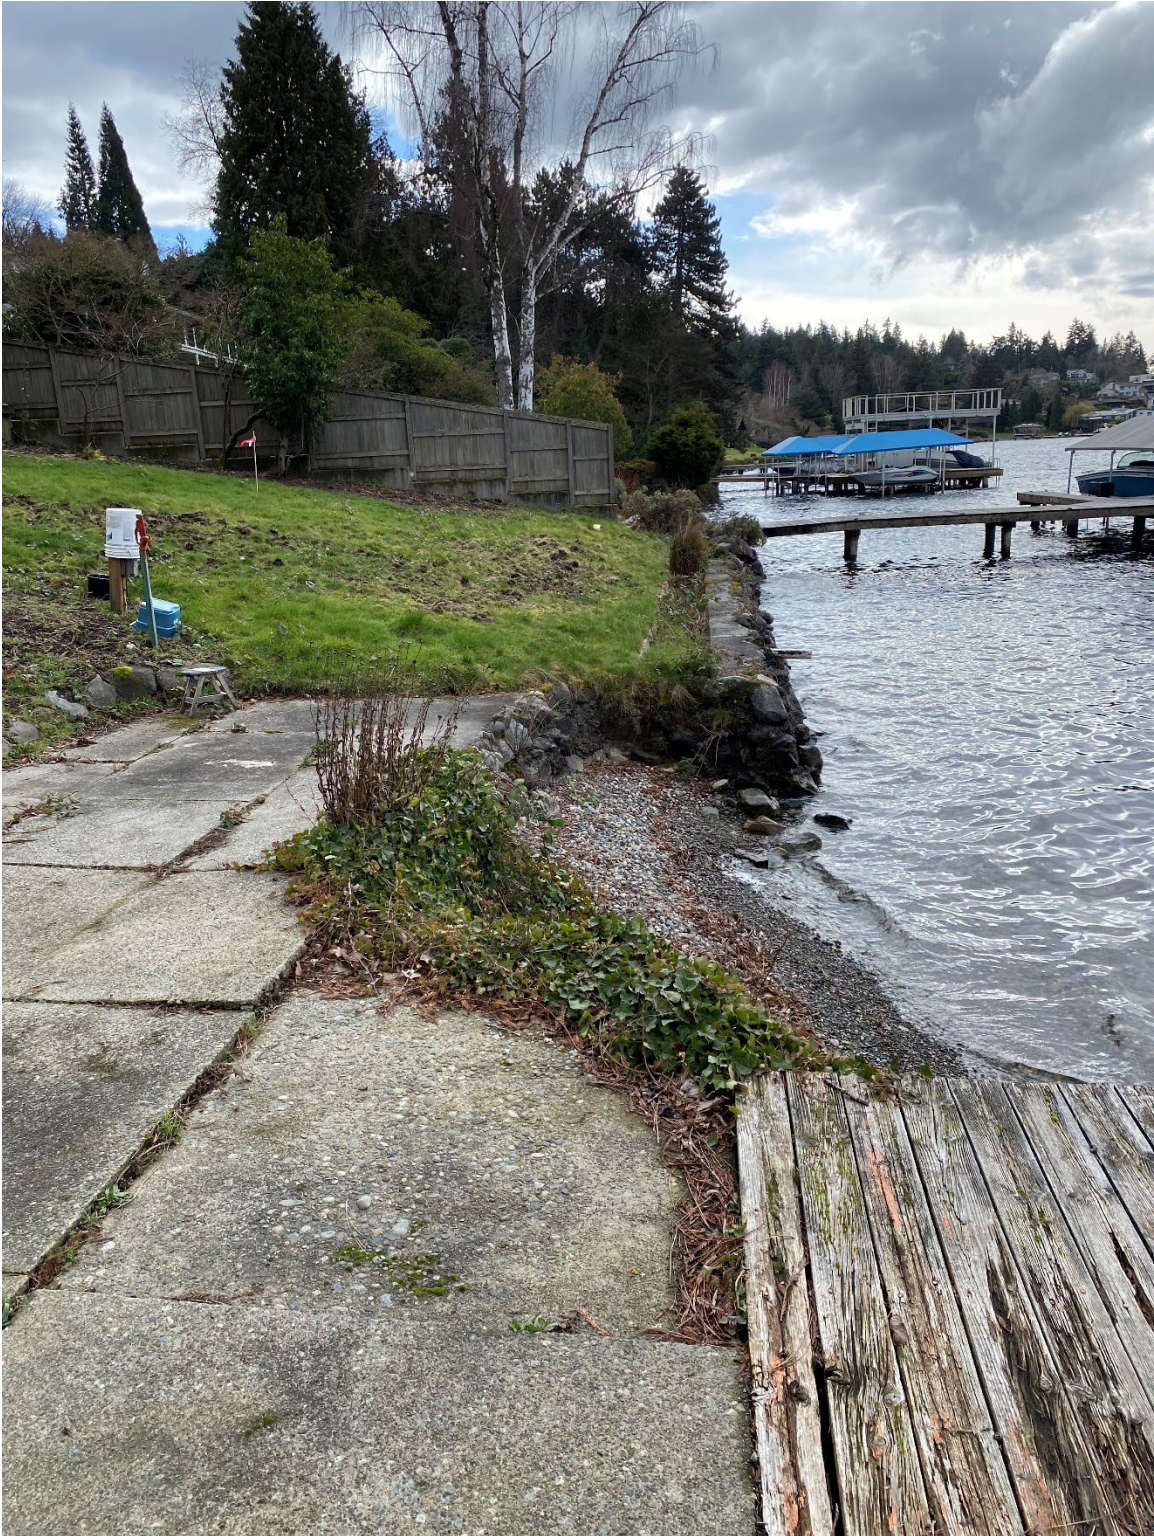
The site is currently entirely developed with a single-family residence and associated maintained yard. A rock wall is located along the entire shoreline except for a small gravel beach in the northwest portion of the property in the vicinity of an existing dock.

No intact native plant communities are located on the site and no vegetation was observed below the rock wall within the lake. Plant species on the property are generally limited to scattered ornamental tree and shrub plantings and mowed grass, Himalayan blackberry (*Rubus armeniacus*) and English ivy (*Hedera helix*) to the water's edge. No definitive hydrophytic plant communities were observed on or adjacent to the property.

Typical view of shoreline looking south.

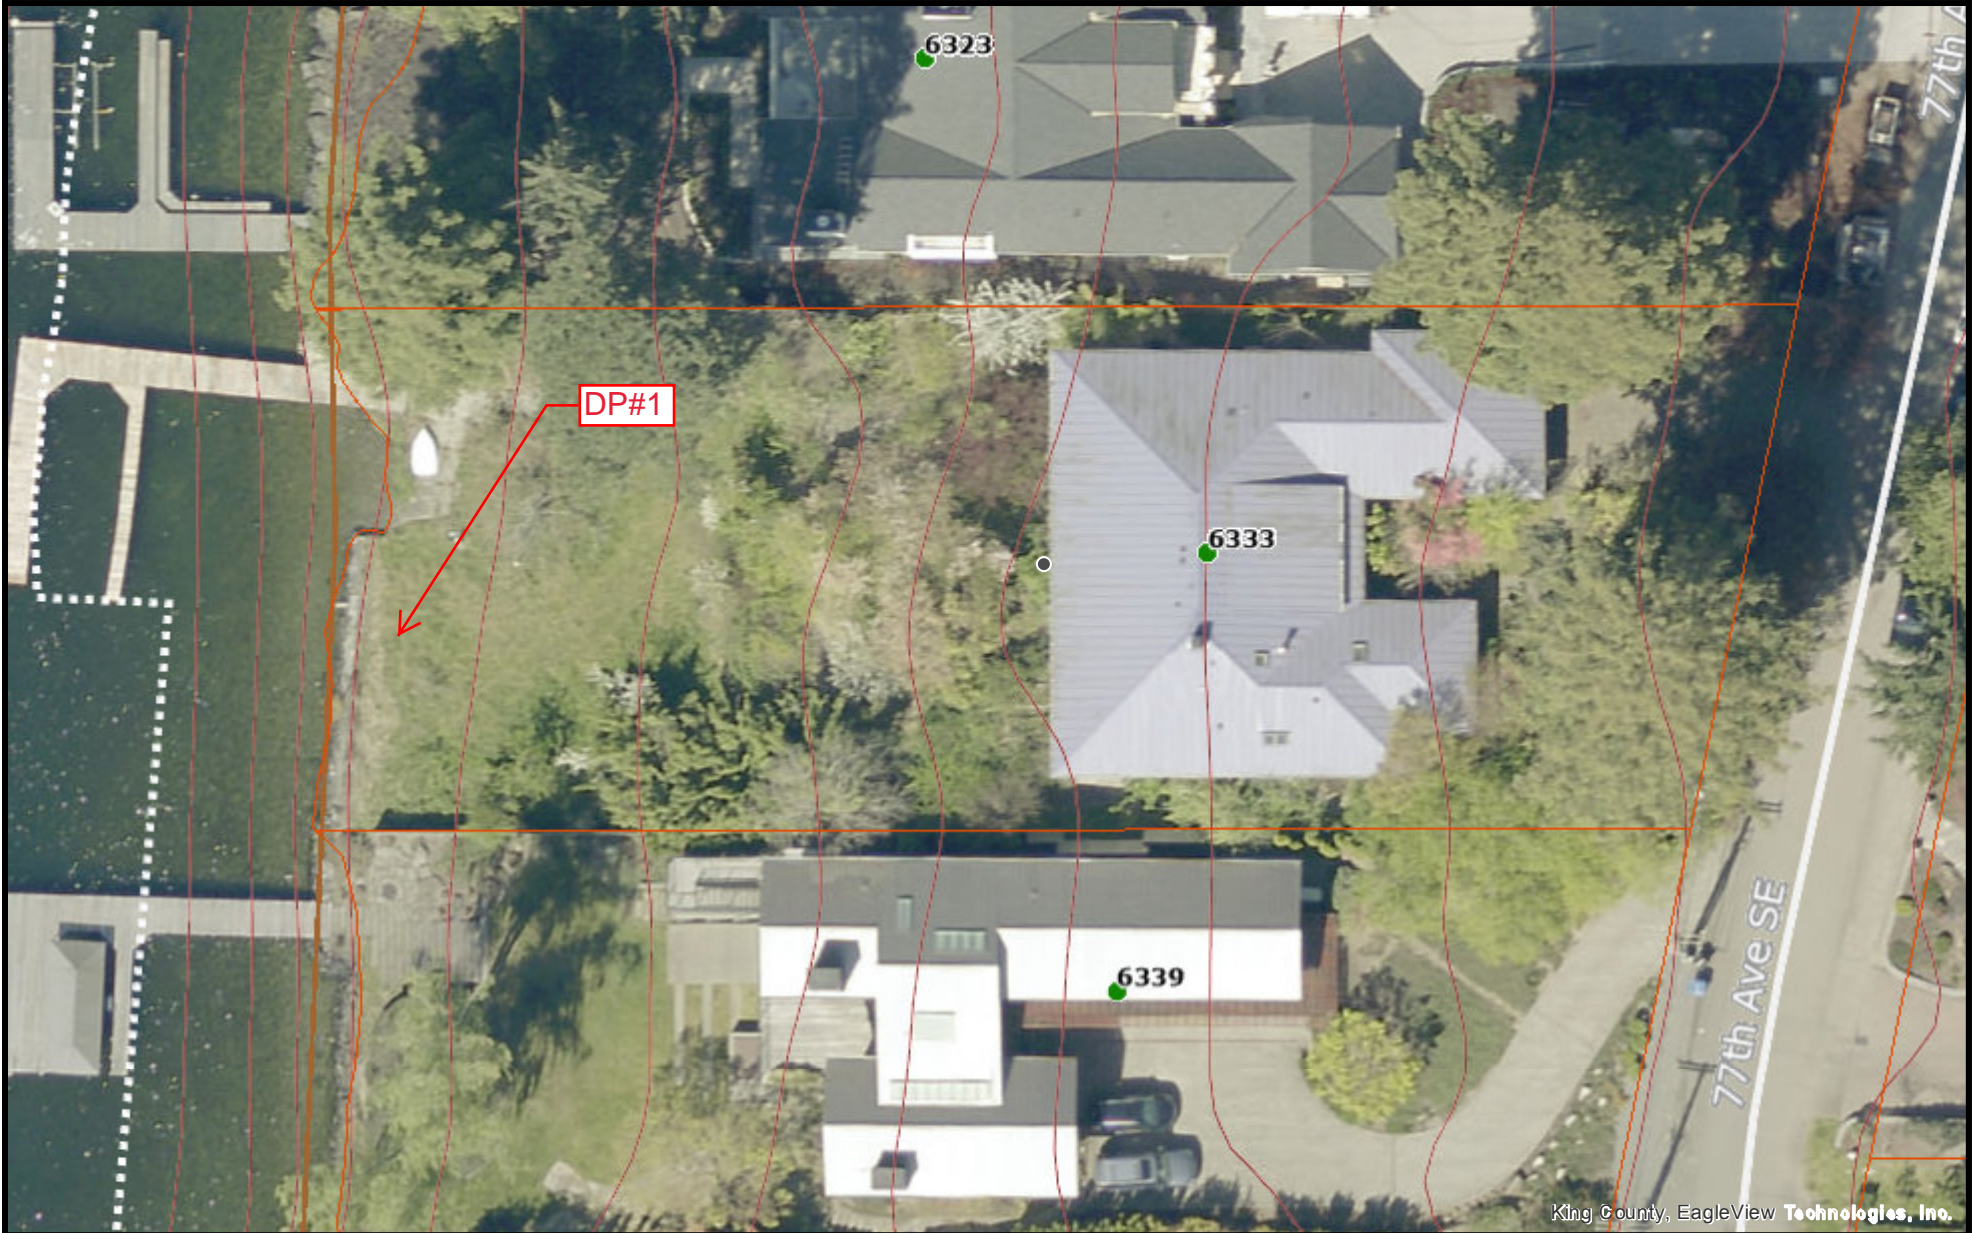
Datasheet Map

Hydrophytic Vegetation Present?	Yes <input type="checkbox"/> No <input type="checkbox"/>	Is the Sampled Area within a Wetland?	Yes <input type="checkbox"/> No <input checked="" type="checkbox"/>
Hydric Soil Present?	Yes <input type="checkbox"/> No <input checked="" type="checkbox"/>		Yes <input type="checkbox"/> No <input checked="" type="checkbox"/>
Wetland Hydrology Present?	Yes <input type="checkbox"/> No <input checked="" type="checkbox"/>		
Remarks: Upland Plot, see map for location.
