RE: Dhaliwal/Klar residence results from air-spade root inspections
7024 SE 20th Mercer Island, WA.

On 3/31/23, ArboristsNW LLC excavated areas of possible root encroachment on two exceptional trees. The air-spade method was used to expose the areas of proposed encroachment. Trees 1 & 4 were the target root systems. Pictures and a site drawing are included below.

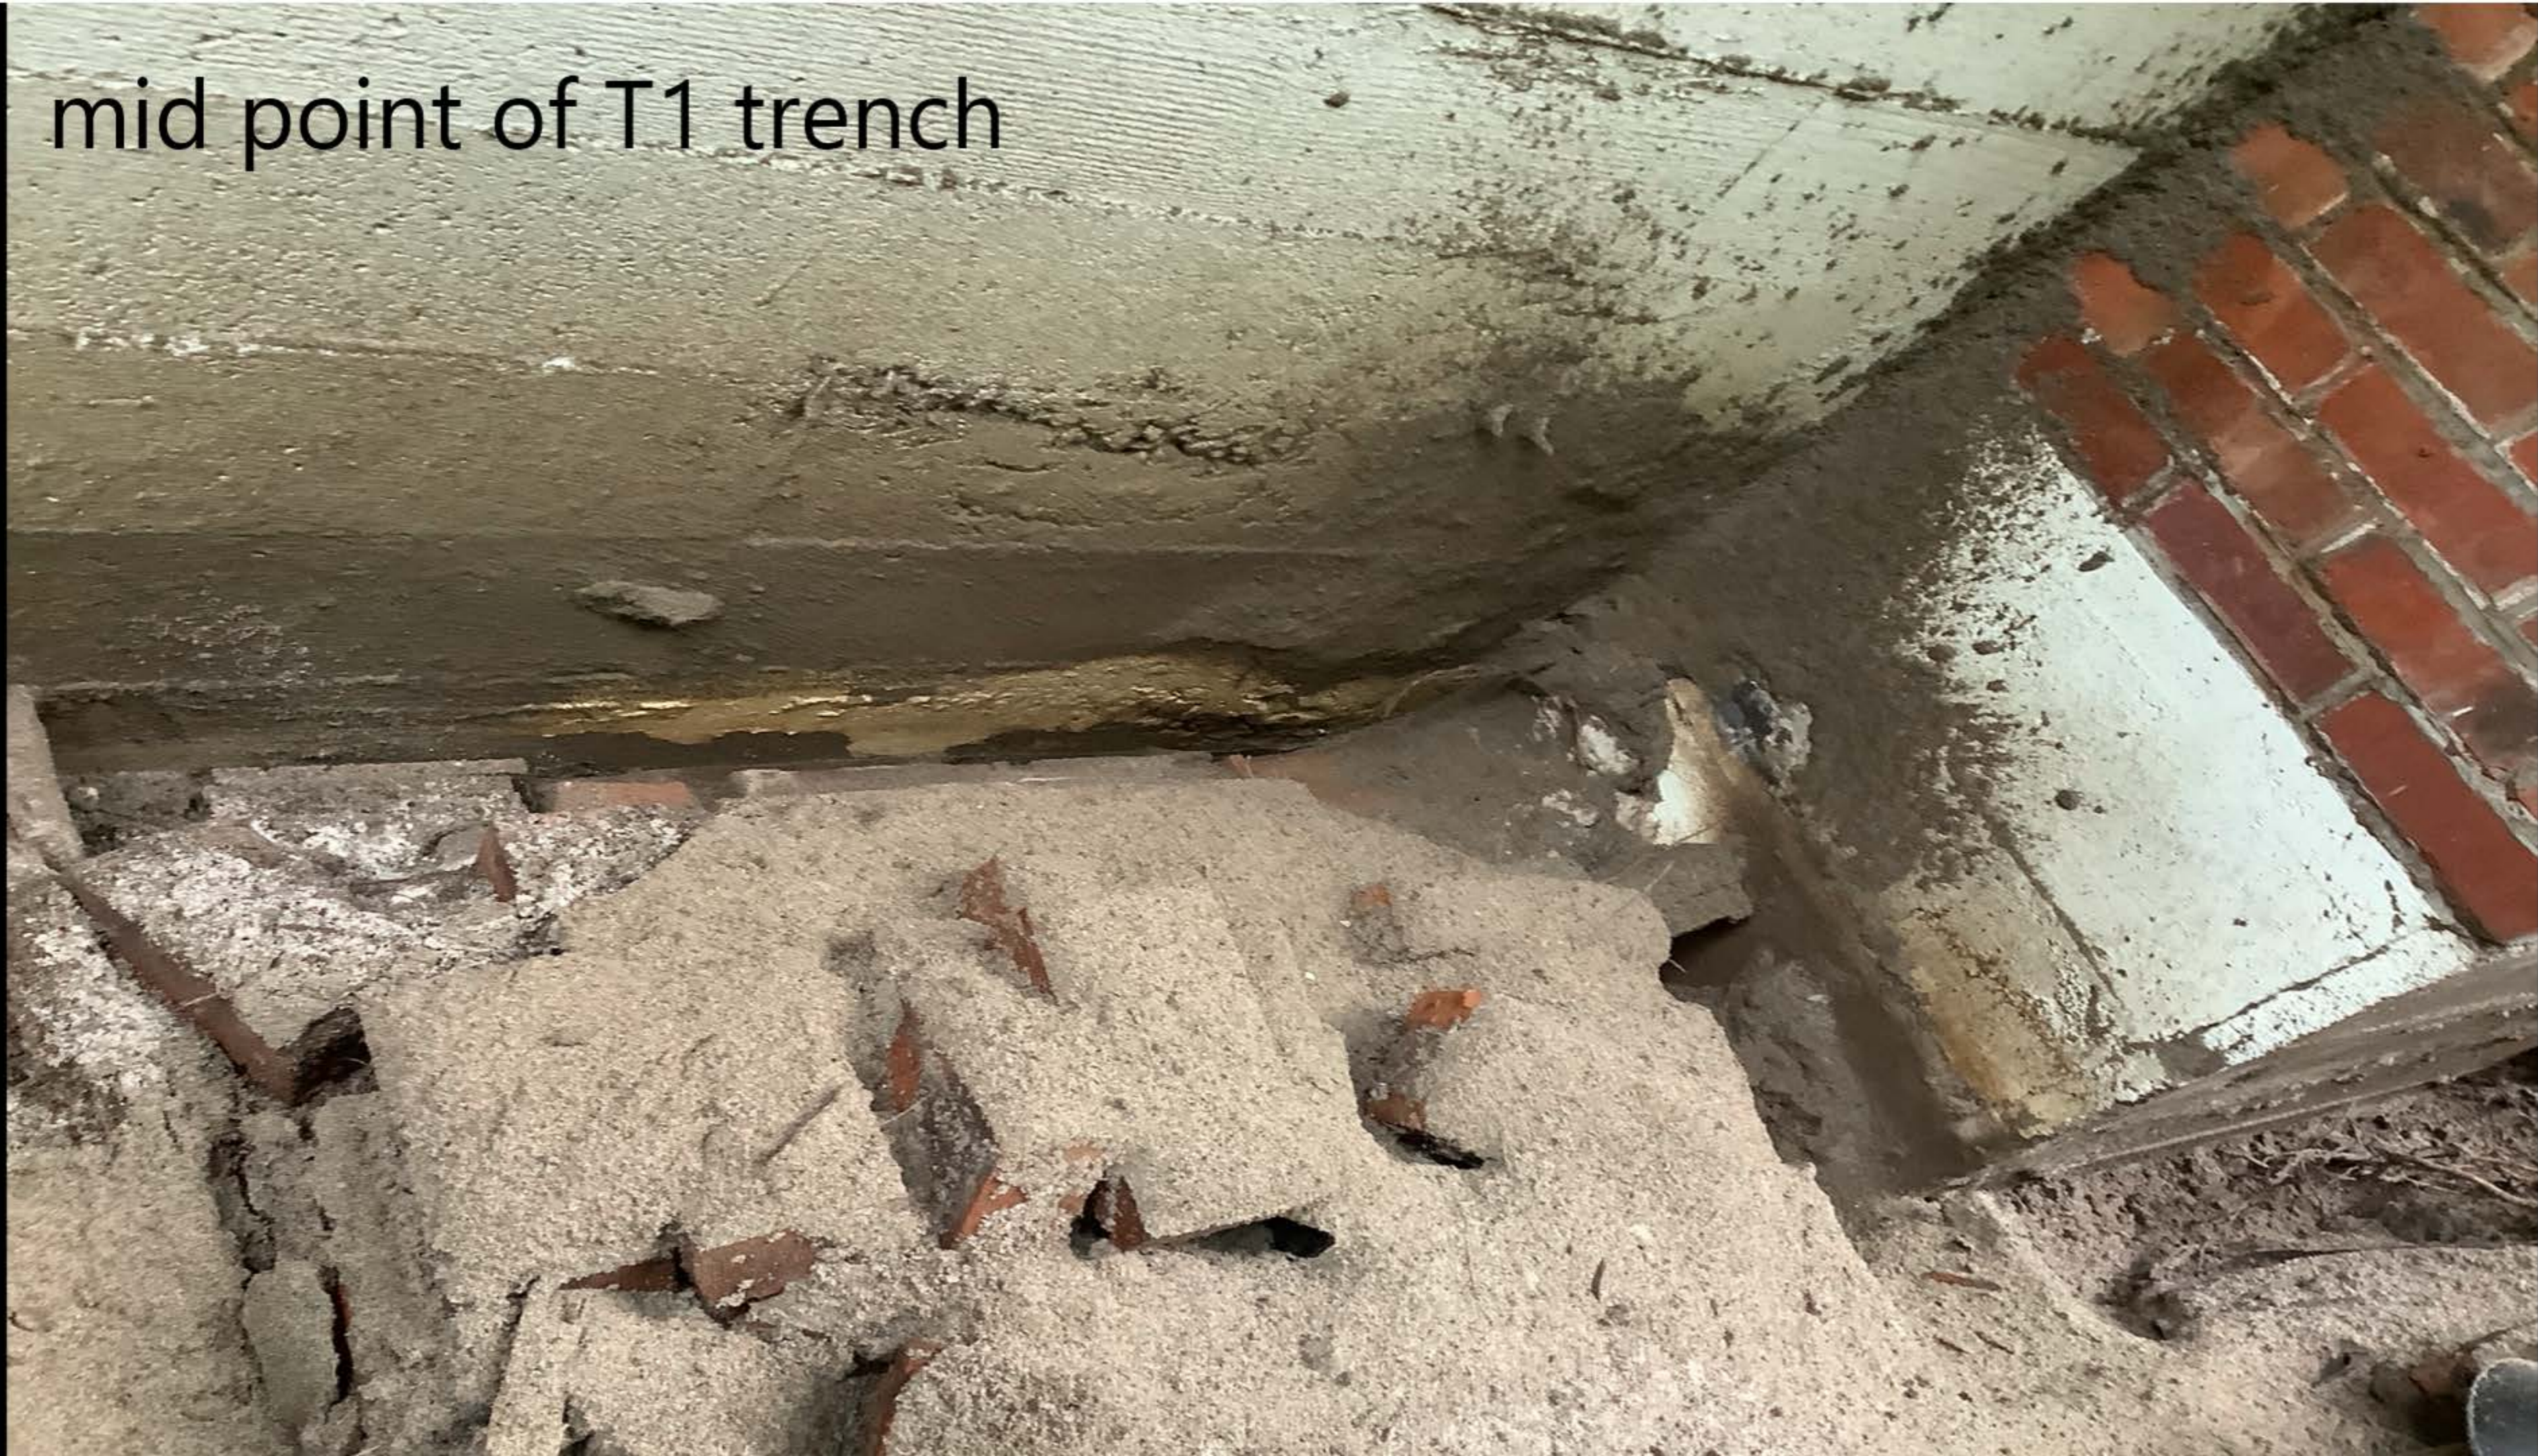
Tree #1, An exceptional Western Red Cedar, I had stated earlier that the existing foundation would have restricted the roots of T 1 from extending to their full extent and would have been stopped at the edge of the concrete. In fact, after making an 18" deep trench with the air spade, no roots were found at all. It appears from the soil in the trench next to the existing foundation that the soil was a fill, and any roots had been cut/rerouted some time ago a foot or more from the existing cement. As such, with the design of your building as is, construction will not affect the tree's health. What will need to be done is the placing of a 5-6" deep layer of mulch over the root place as drawn and then covered by plywood or expanded metal for the duration of construction.

mid point of T1 trench

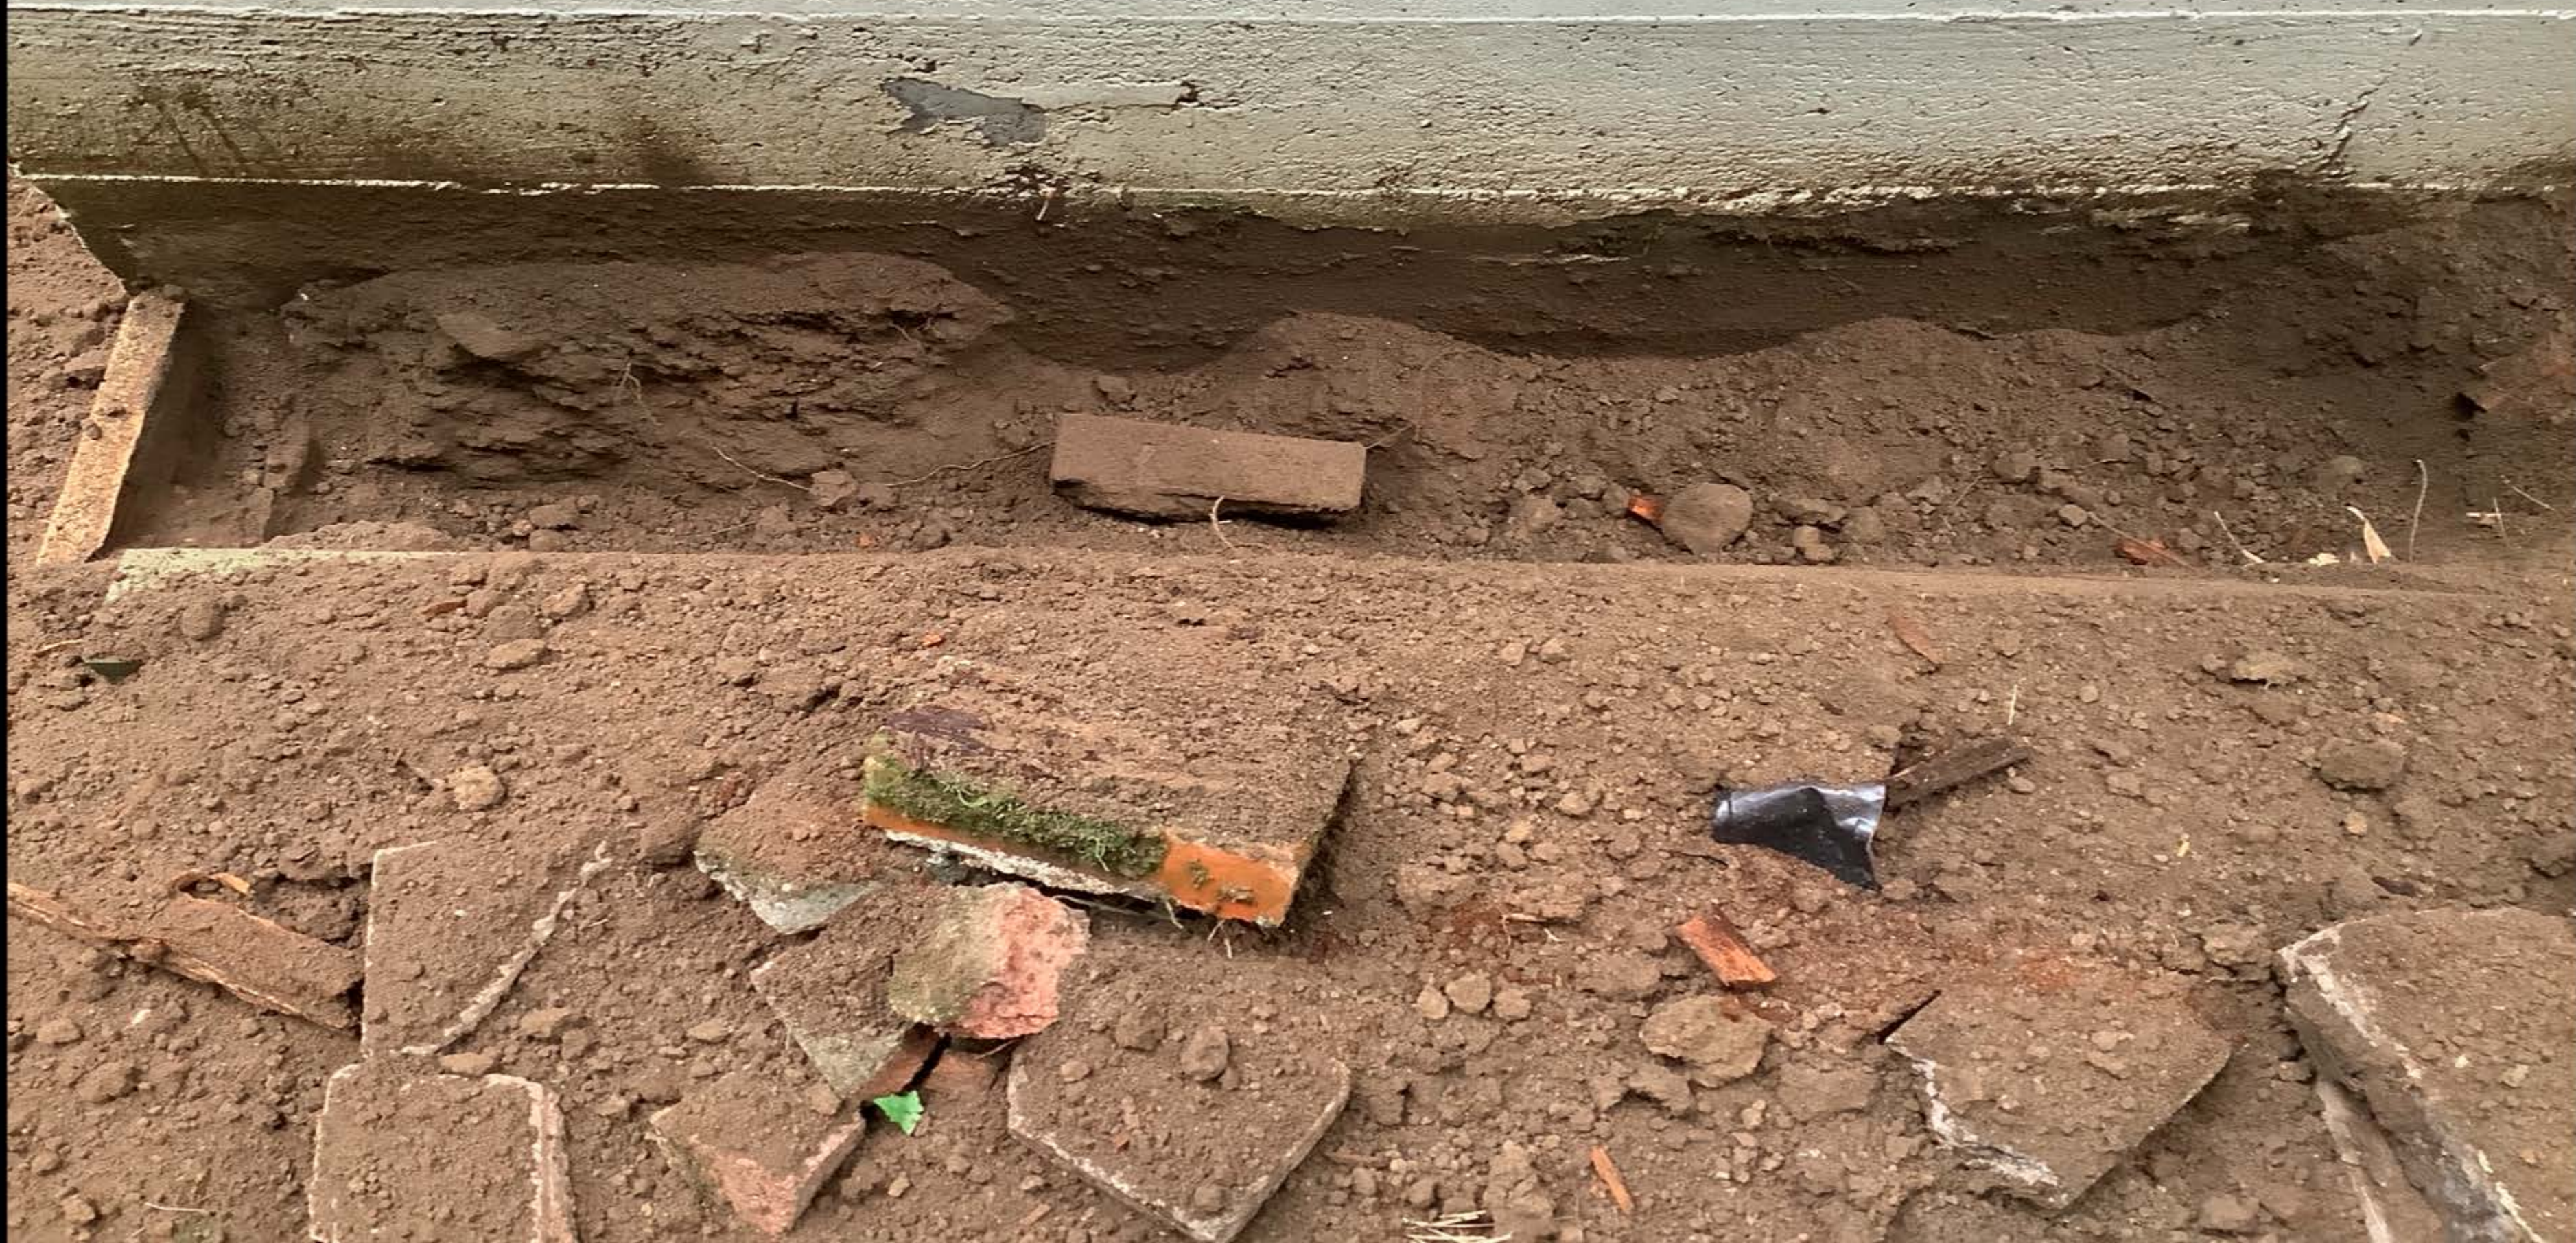
North end of trench T 1

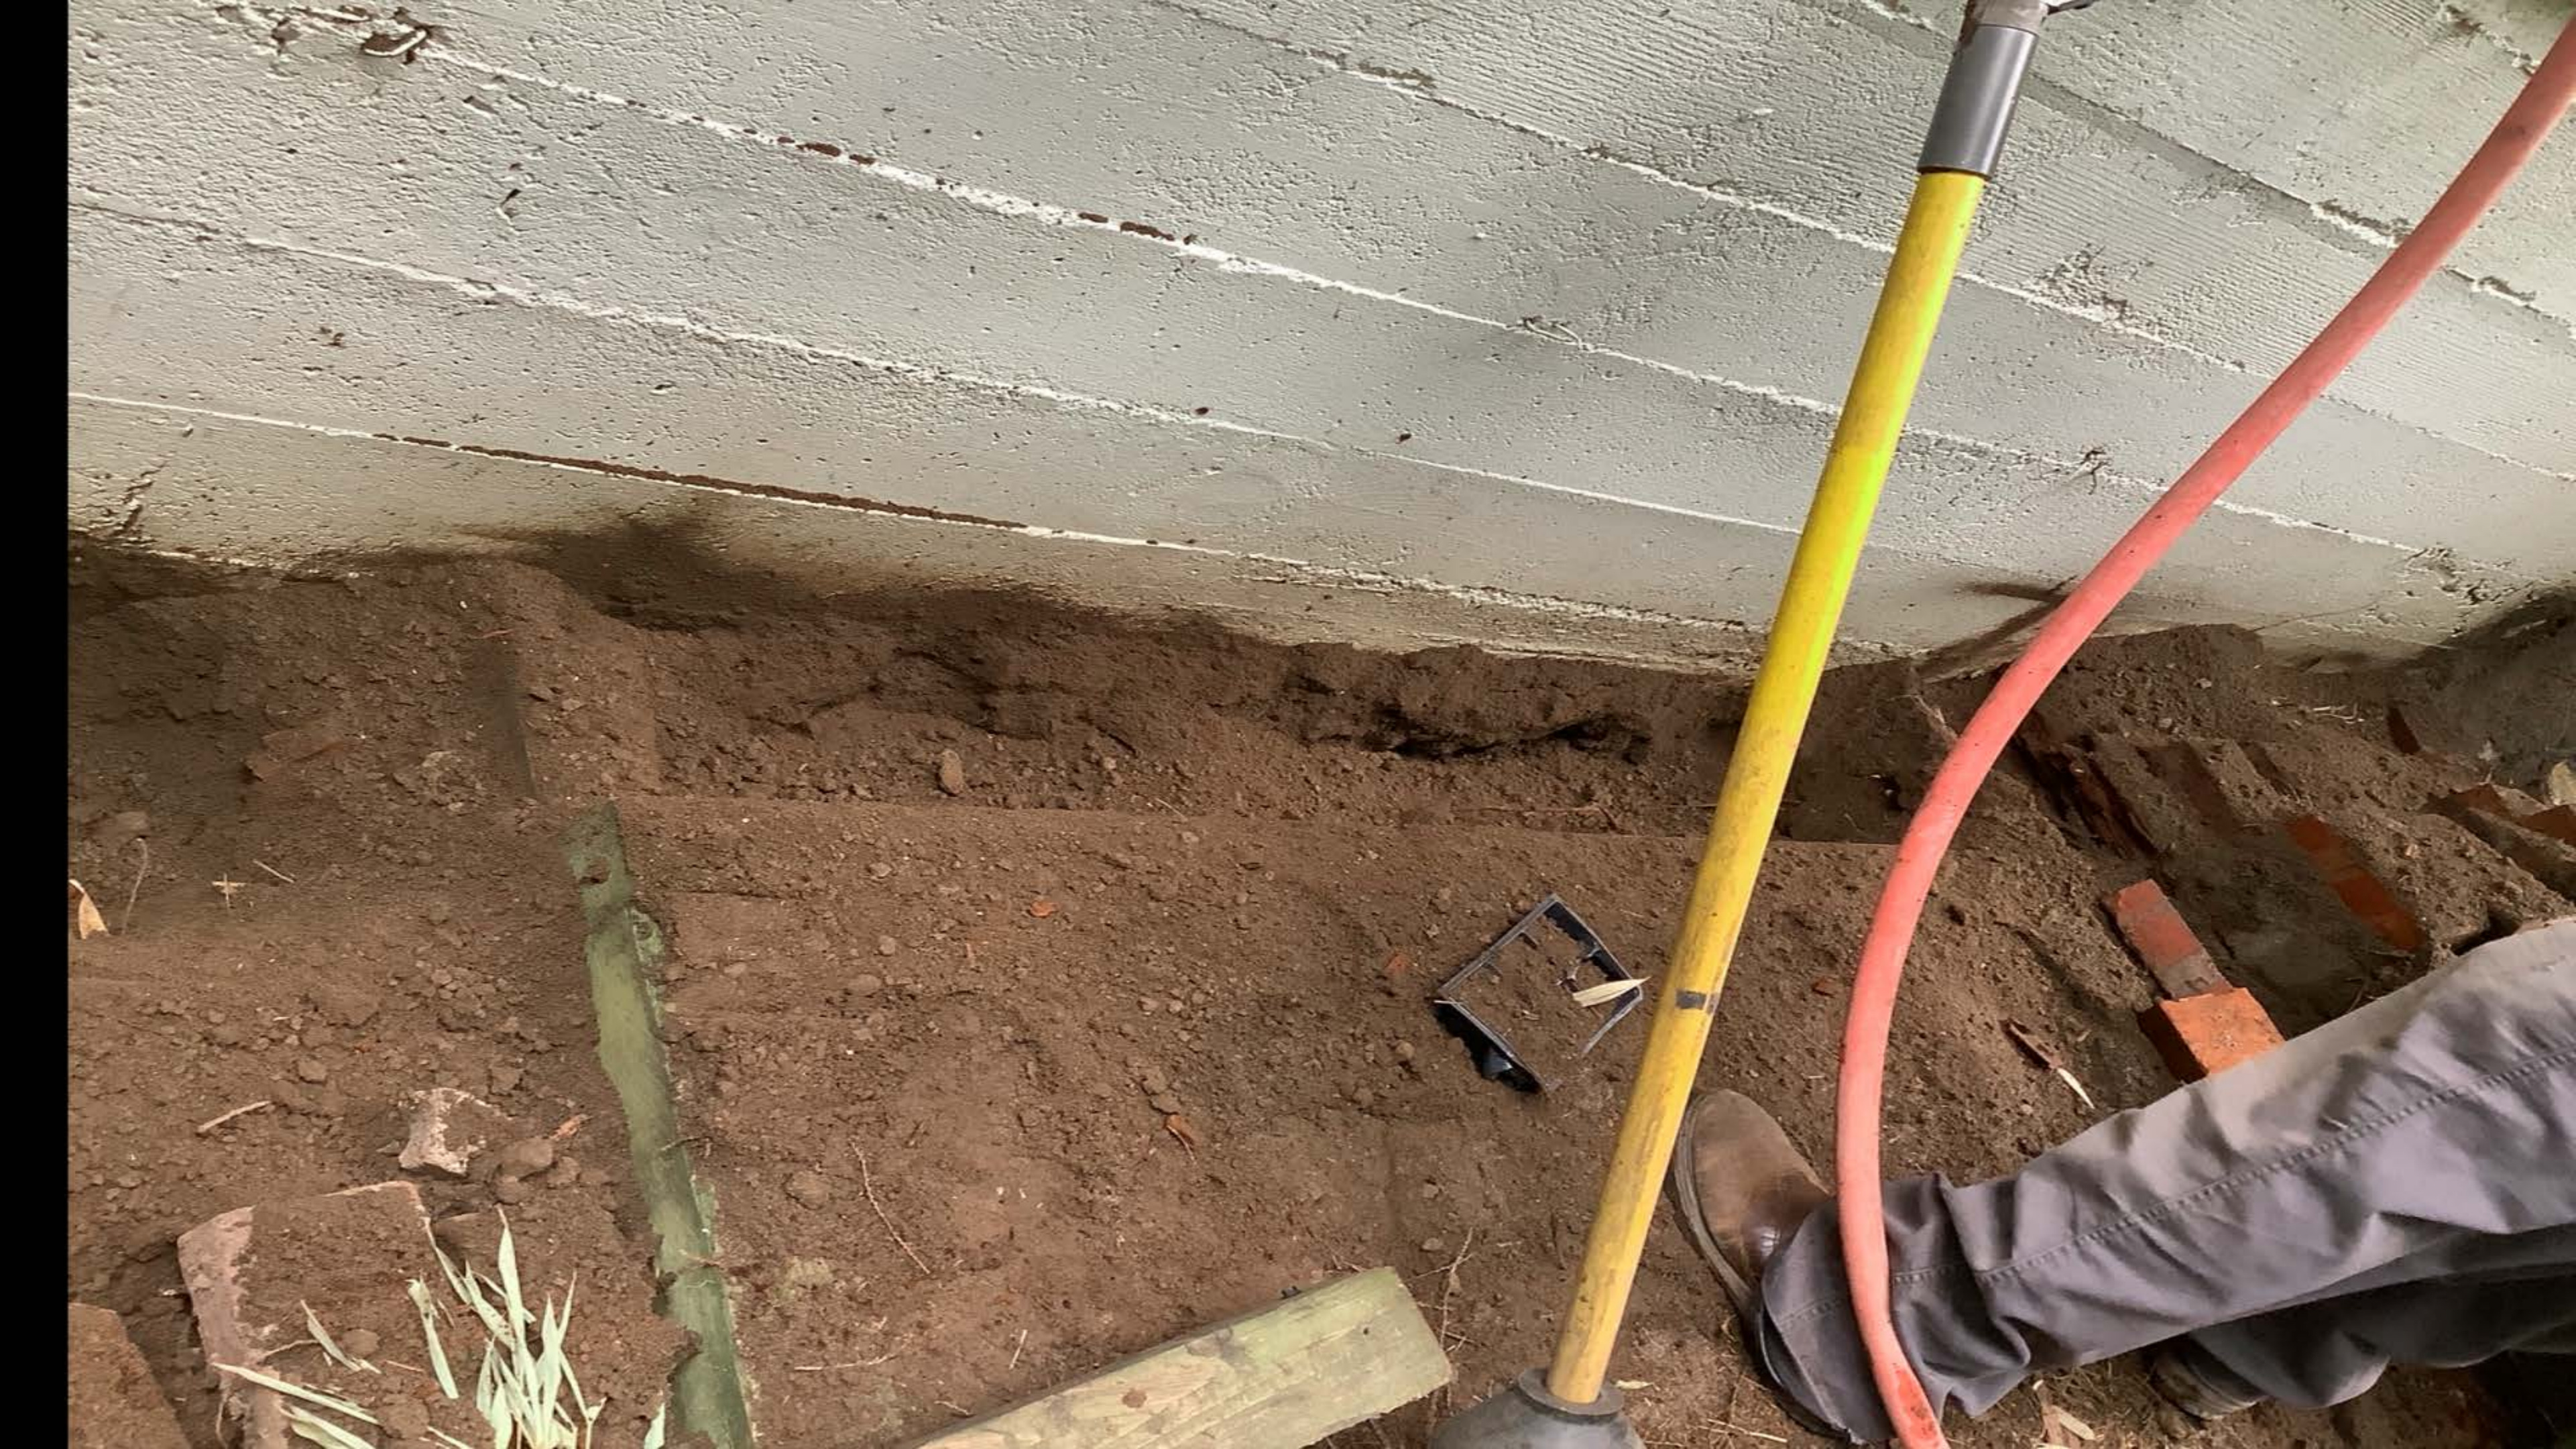
Point 1 trench

T #4, An exceptional Western Red Cedar. Findings for the 3 locations needed for pillars to keep the proposed deck off the surface; no roots were found around point #1 on the included site map. A 6-7" wide and 18" deep trench was made for this observation. In the point #2 area, roots were exposed but found to be no bigger than 3/8" and few in number with a liberal spacing. One root 1.5-2" was located north of a pillar location and will not be affected. It is my opinion that it is possible to expose more of the roots that were found and that this will allow for the careful flexing of the roots out of the way of the proposed pillar locations. The root plate, as shown on the site drawings, is to be covered in that 5-6" of mulch and covered as T #1, again for the project's life.

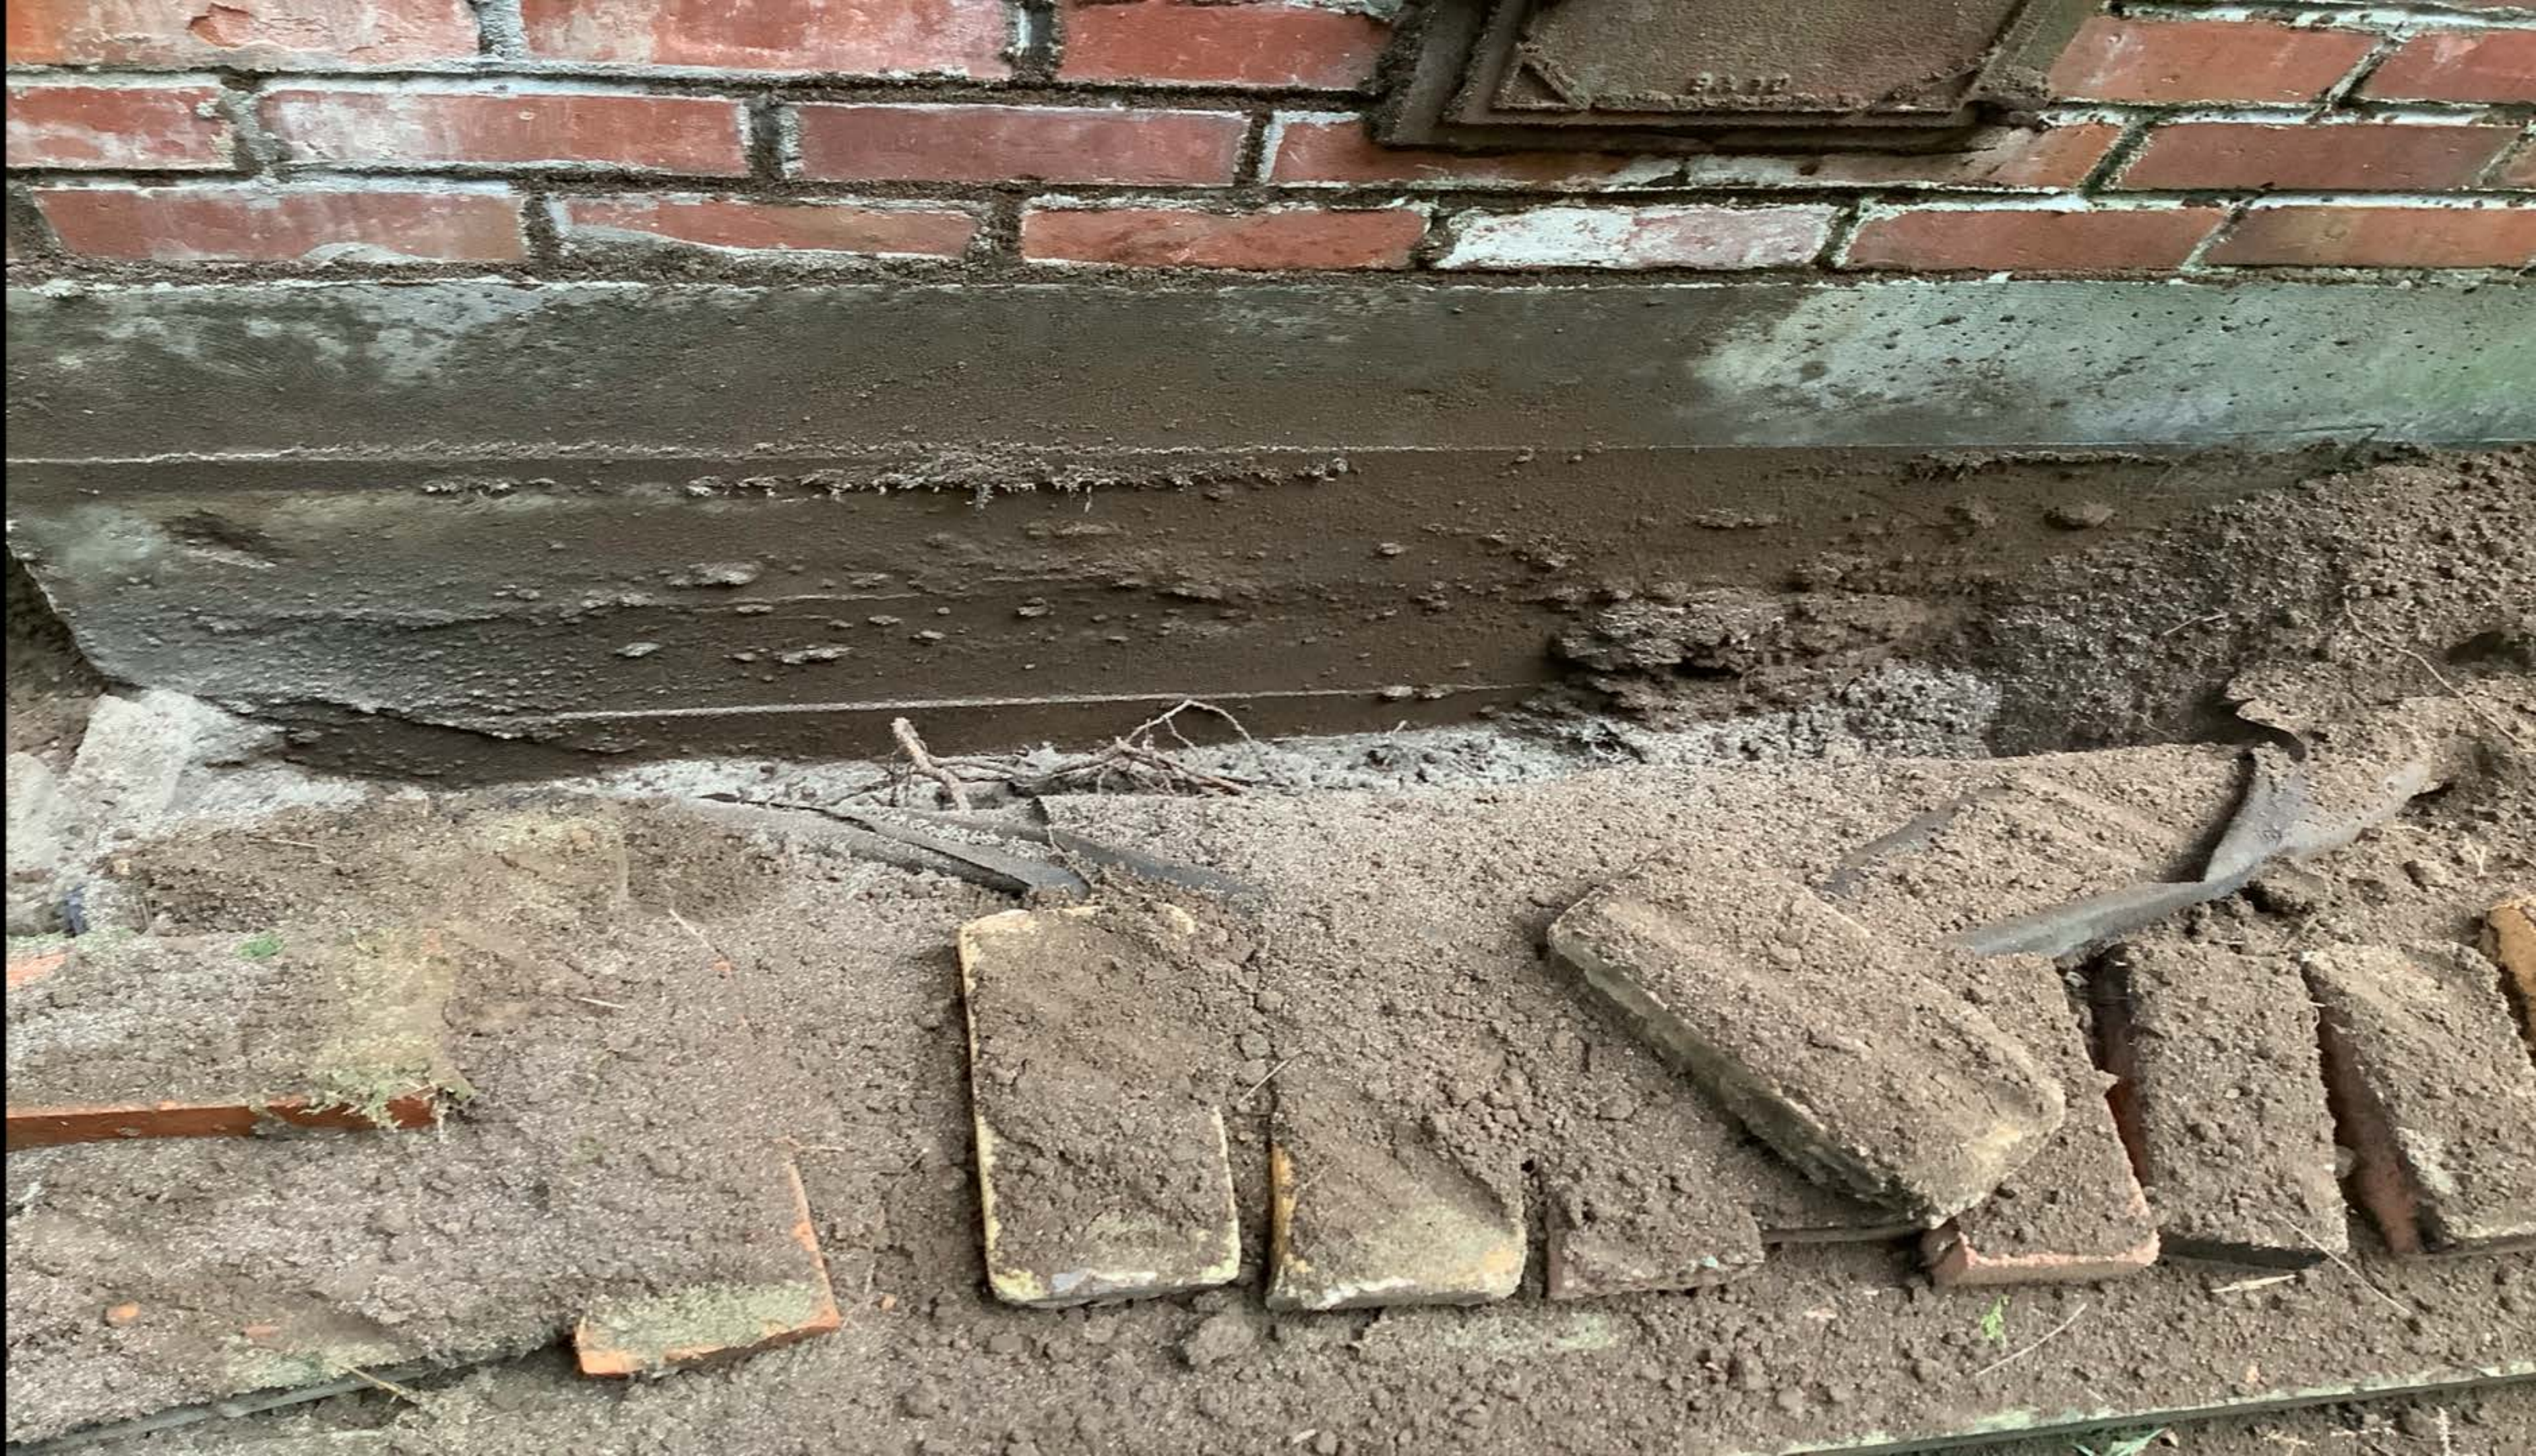
Point 2 trench

1.5-2" root

Project arborist to be on site for the placement of tree protection measures installation and during deck pillar placement.

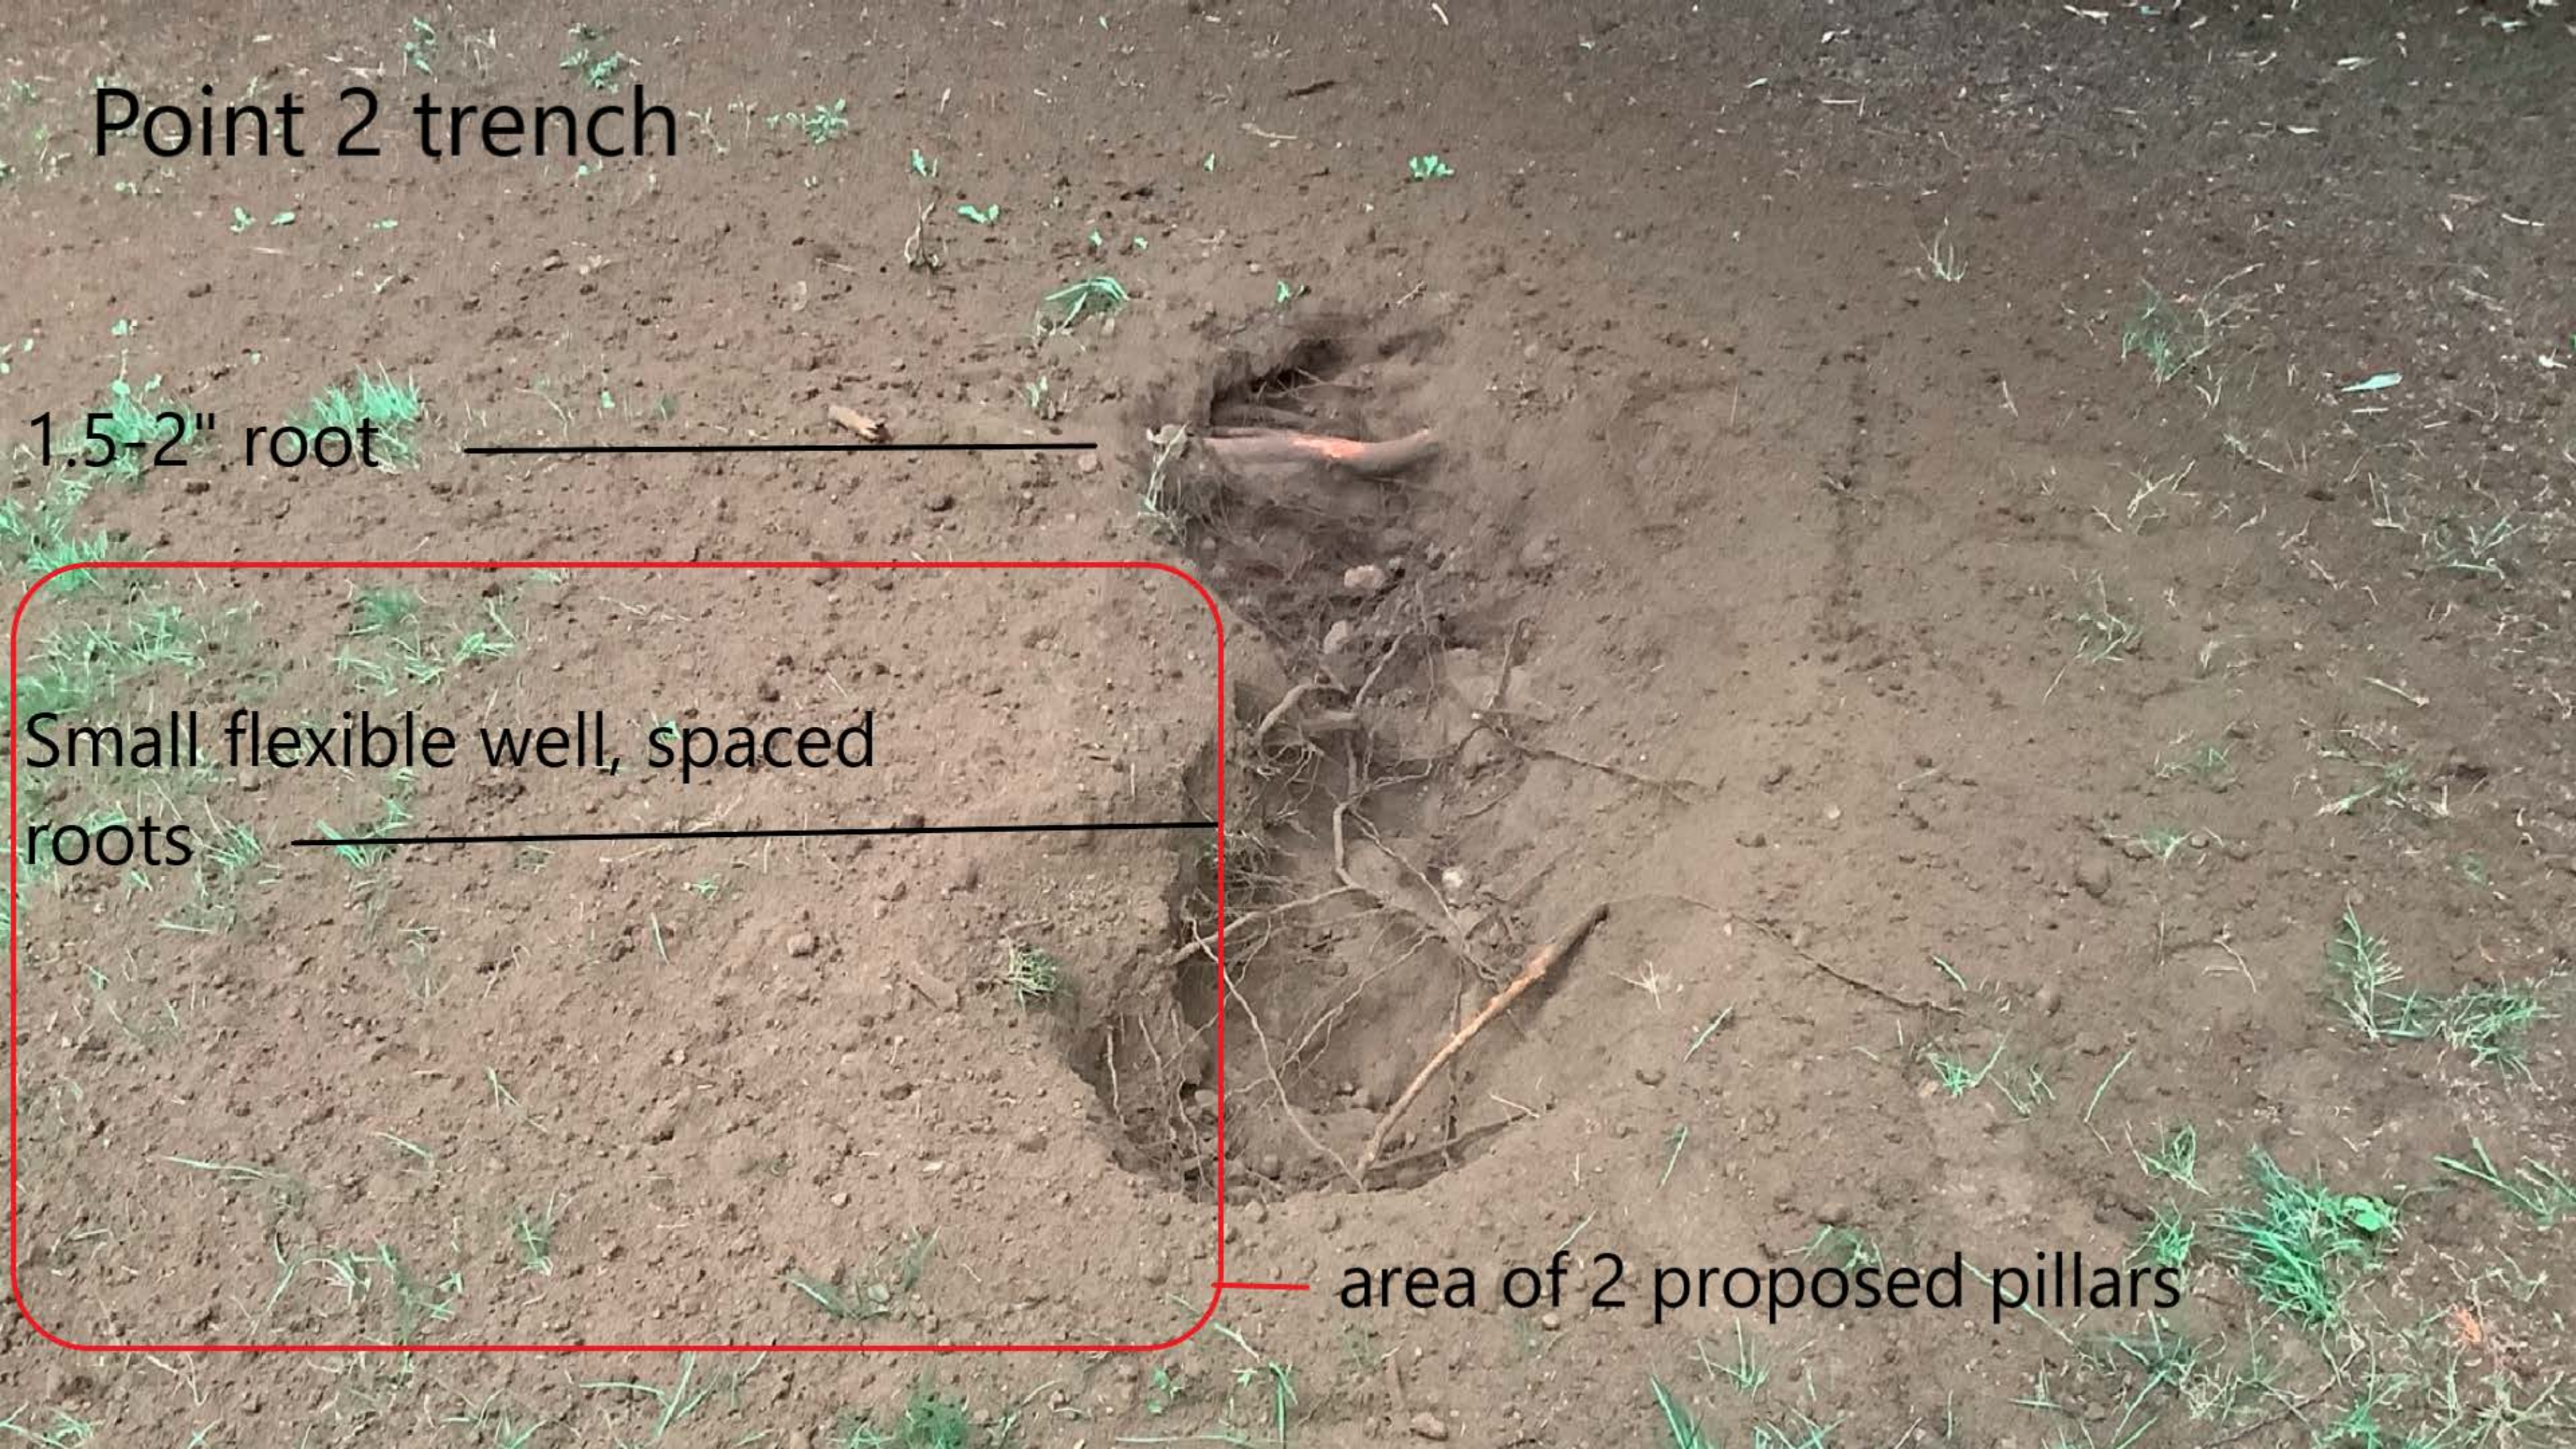
Small flexible well, spaced roots

area of 2 proposed pillars
