**Stormwater Drainage Report  
4216 83<sup>rd</sup> Avenue SE  
Mercer Island, Washington  
KC Tax Parcel #362650-0065  
Permit #: XXXX-XXX**

### **Section 1: Project Narrative:**

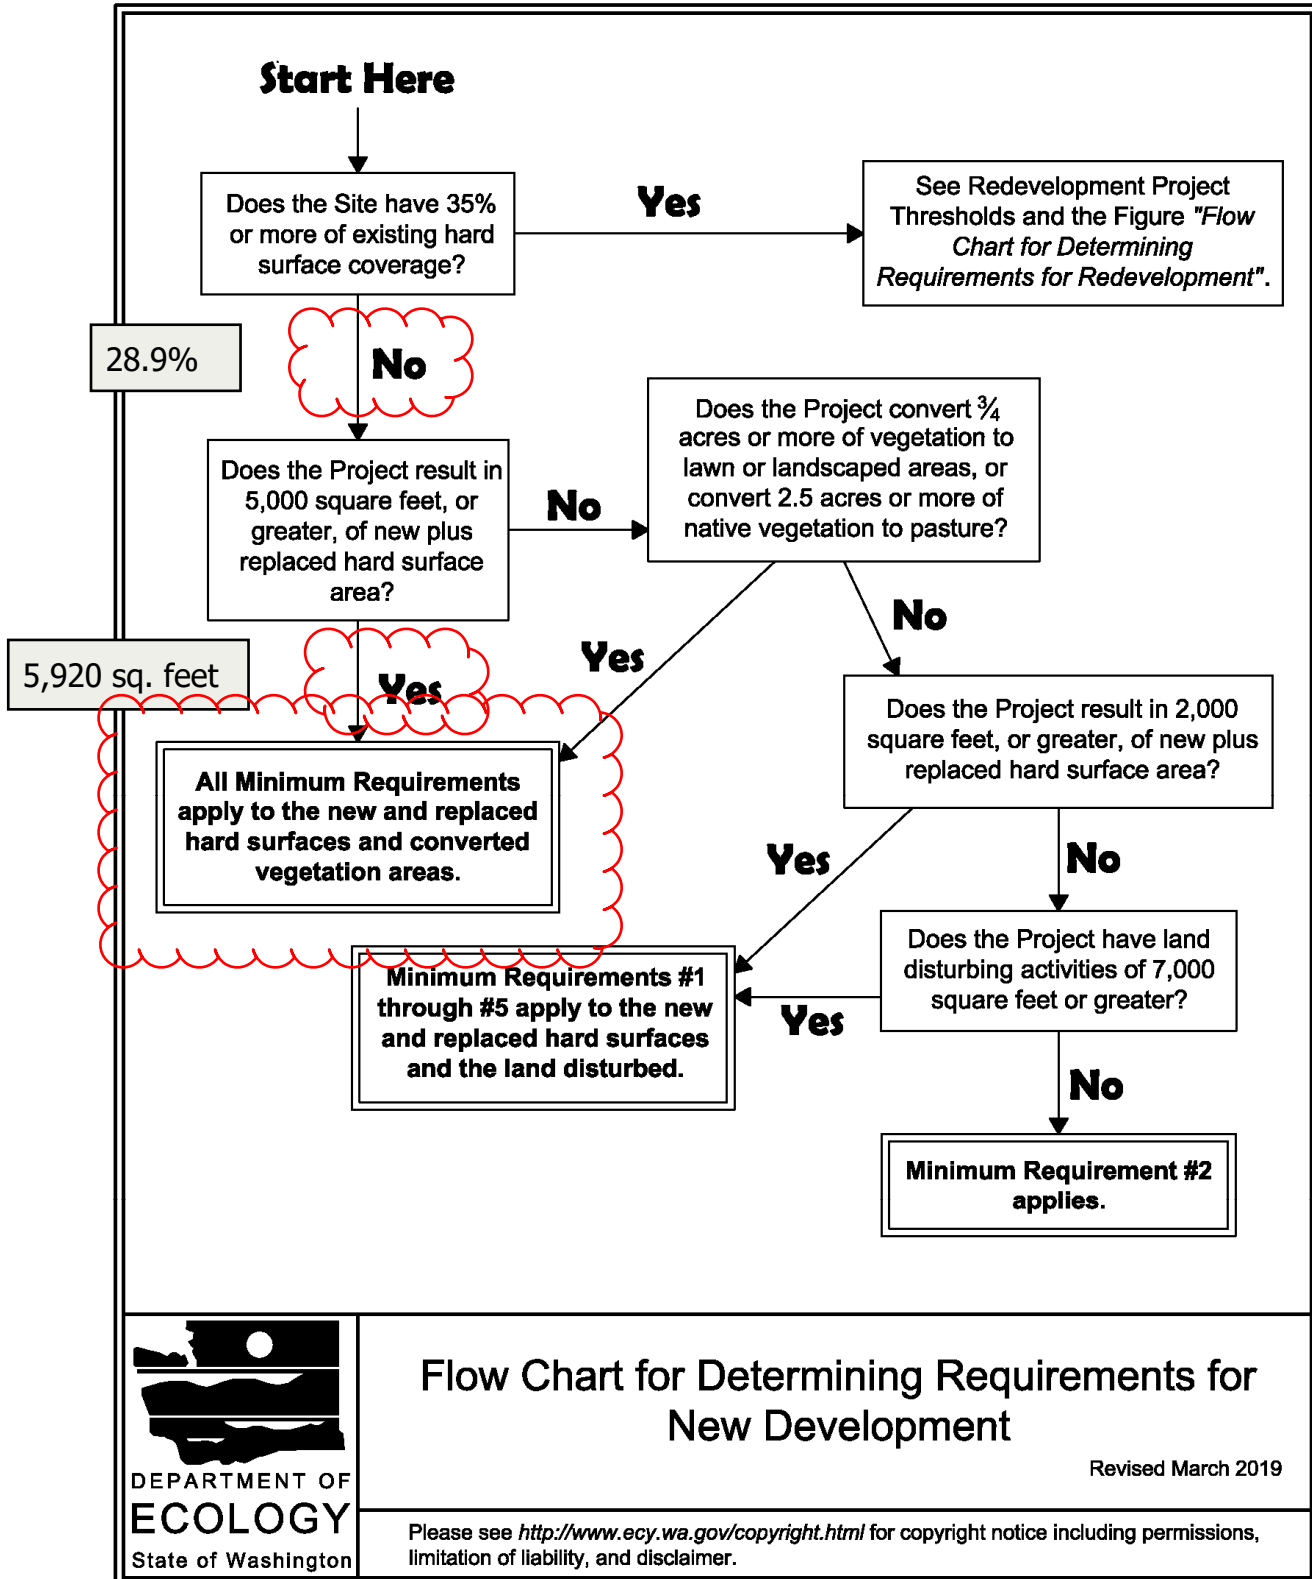
**Figure I-3.1: Flow Chart for Determining Requirements for New Development**

**Flow Chart for Determining Requirements for New Development**
