# TECHNICAL MEMORANDUM

Date: October 21, 2020  
To: Subu Sankra Subramanan & Sellapriya Ramaiyah  
From: Ryan Kahlo, PWS, Senior Ecologist  
Project Name: Mercer Island Ramaiyah  
Project Number: 200832

## Subject: 7466 E. Mercer Way Critical Areas Evaluation

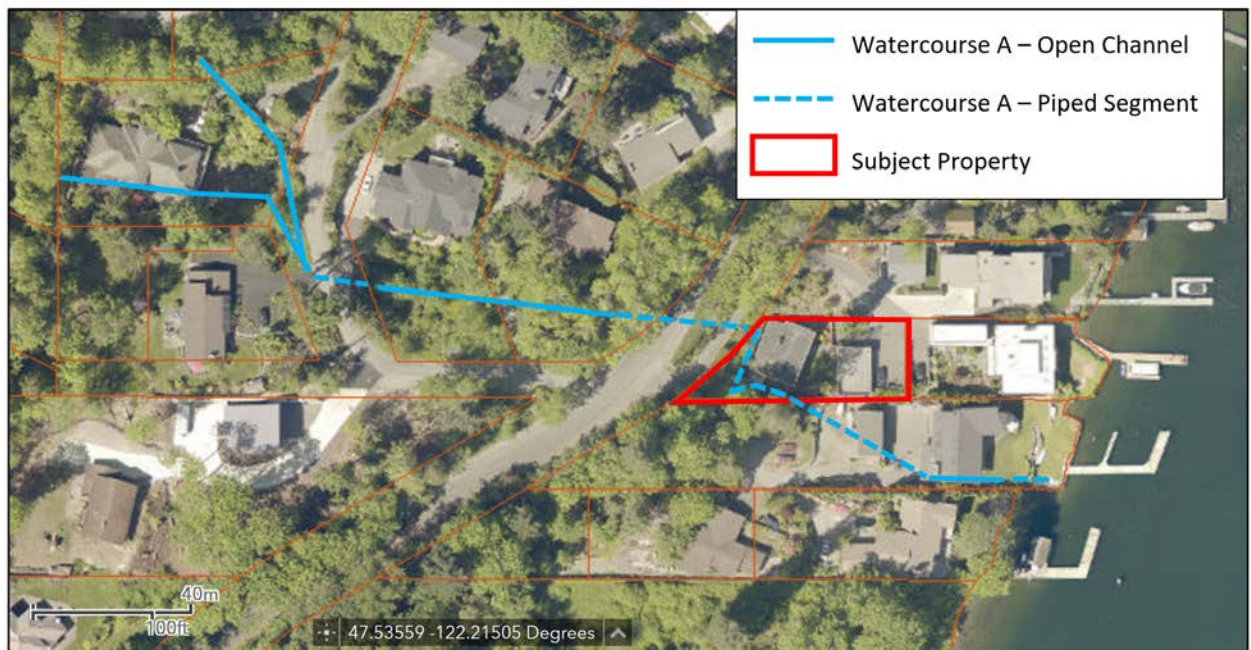
Watercourse A originates from two tributaries located in wetlands approximately 600 feet northwest of the subject property on Parcel #2579500190. Watercourse A flows southeast towards the subject property alternating open channel and piped segments before being piped beneath E. Mercer Way and the access drive serving the subject and neighboring properties. As the watercourse is conveyed beneath E. Mercer Way, the flow is combined with untreated stormwater runoff from the road. Watercourse A is then piped in a southwestern direction at the base of a steep slope immediately west of

the subject residence before continuing southeast towards the southern property boundary. Watercourse A continues as a piped watercourse towards the southeast, eventually daylighting and flowing east along the southern property line on Parcel #3024059114, where it discharges into Lake Washington approximately 150 feet southeast of the subject property. I did not observe an open channel segment immediately south of the subject property as depicted on the City GIS map; the open channel begins immediately south of the primary residence on Parcel #3024059114 (Figure 1).

Figure 1. Approximate location of Watercourse A

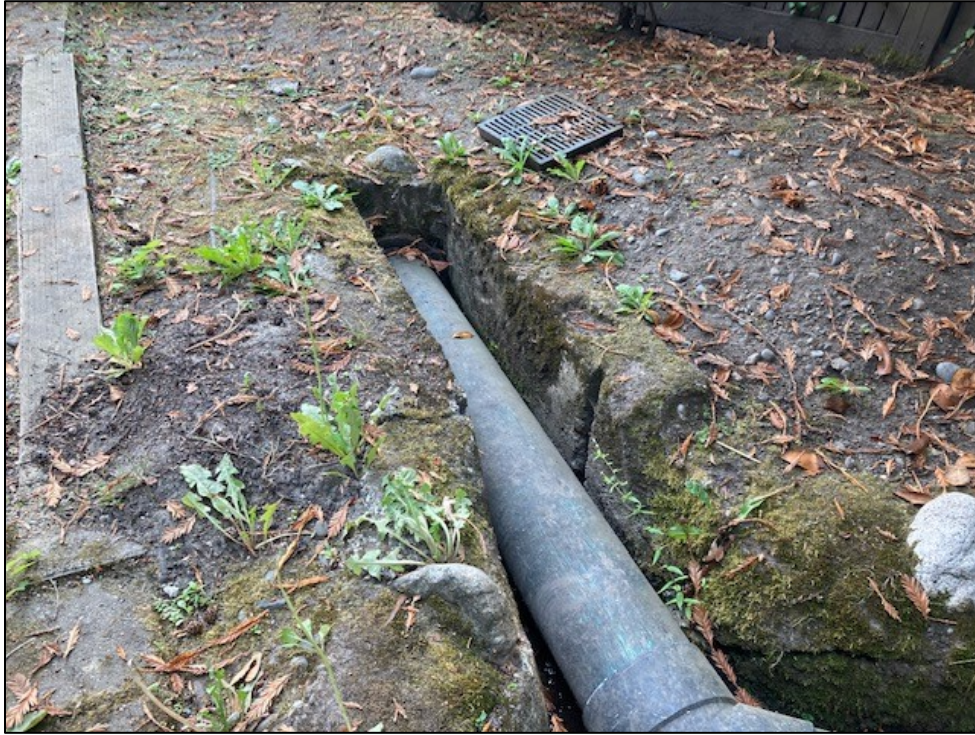
During the inspection, I evaluated the on-site watercourse characteristics and visually observed areas farther upstream to the extent feasible from publicly accessible areas. I have confirmed that a piped watercourse (Watercourse A) is located on the subject property (Figure 1). While Watercourse A conveys stormwater during rain events, it also conveys natural flows and is, therefore, regulated as a watercourse under Mercer Island City Code (MICC). Upstream and downstream segments of Watercourse A were flowing at the time of the inspection, which occurred during a prolonged dry period with no measurable rainfall.

Figure 2. Watercourse A on the subject property, facing southeast (9/11/20)

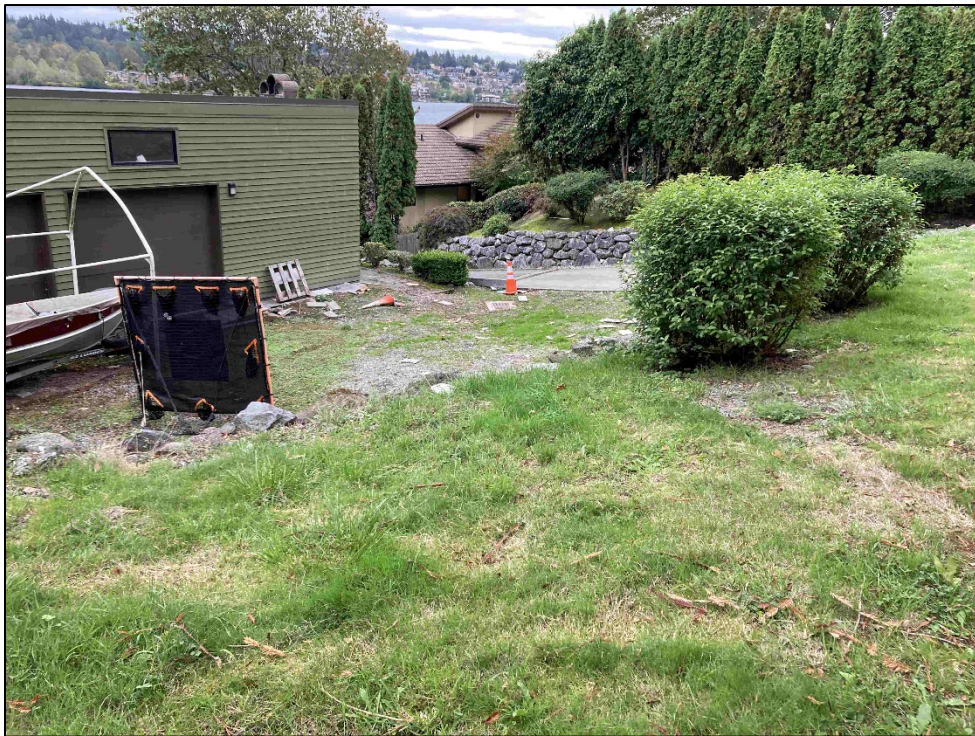
Figure 3. Location where open channel segment of Watercourse A is mapped south of subject property, facing southeast (10/16/20).

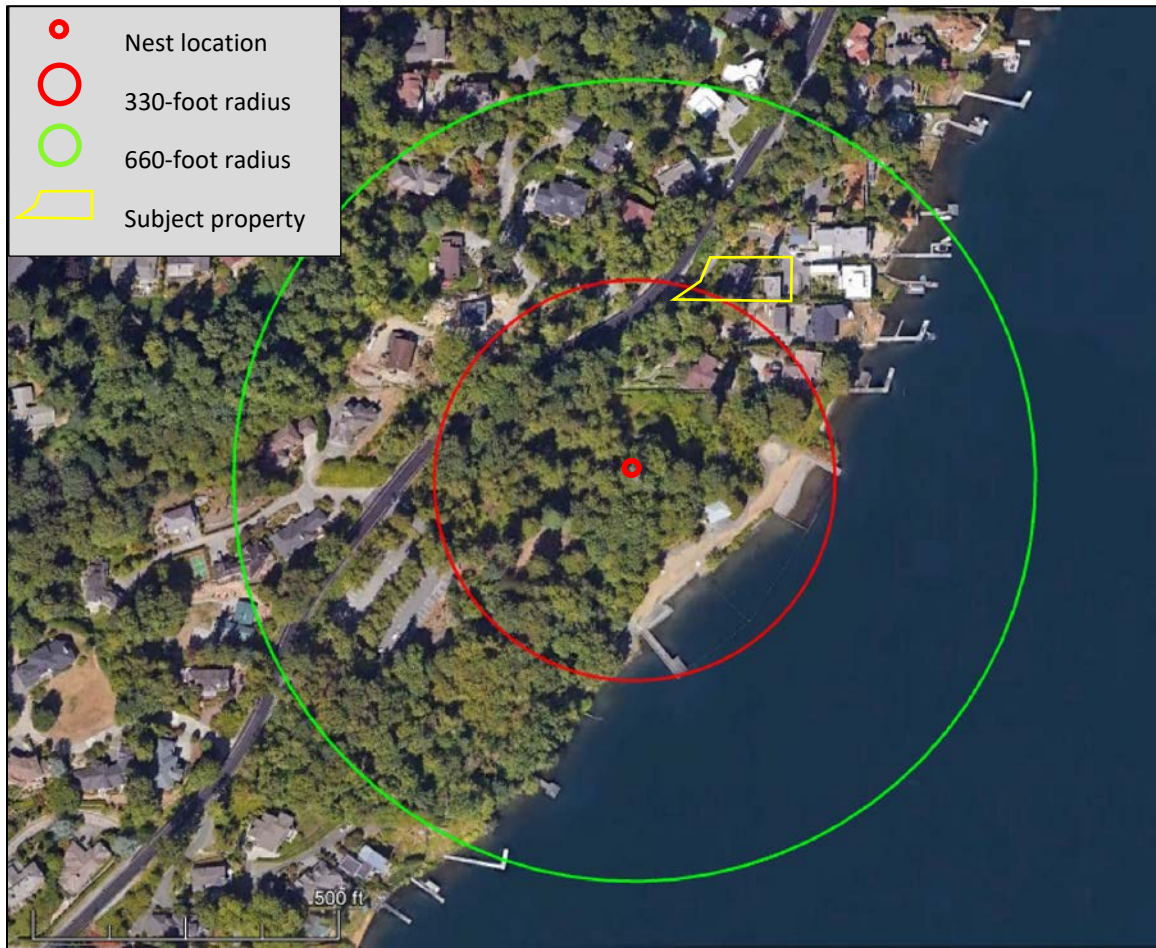
No wetlands or fish and wildlife habitat conservation areas were observed on-site or within the immediate vicinity. A bald eagle nest was verified in Clarke Beach Park approximately 325 feet southwest of the subject property. Bald eagle nests are classified as a fish and wildlife habitat conservation area under MICC. The nest, which is located on top of a western hemlock tree in relatively poor health, is visible from the subject property. The precise location was verified in the Park and recorded (Figure 4).

Figure 4. Bald eagle nest location relative to subject property.

The construction of a new single-family residence on the subject property will avoid all direct impacts to bald eagle habitat. Indirect effects, including visual and auditory disturbance, will be minor. By adhering to the timing restrictions identified by USFWS, when nests are at their most vulnerable (January through April), the project will minimize potential adverse effects to nesting bald eagles.

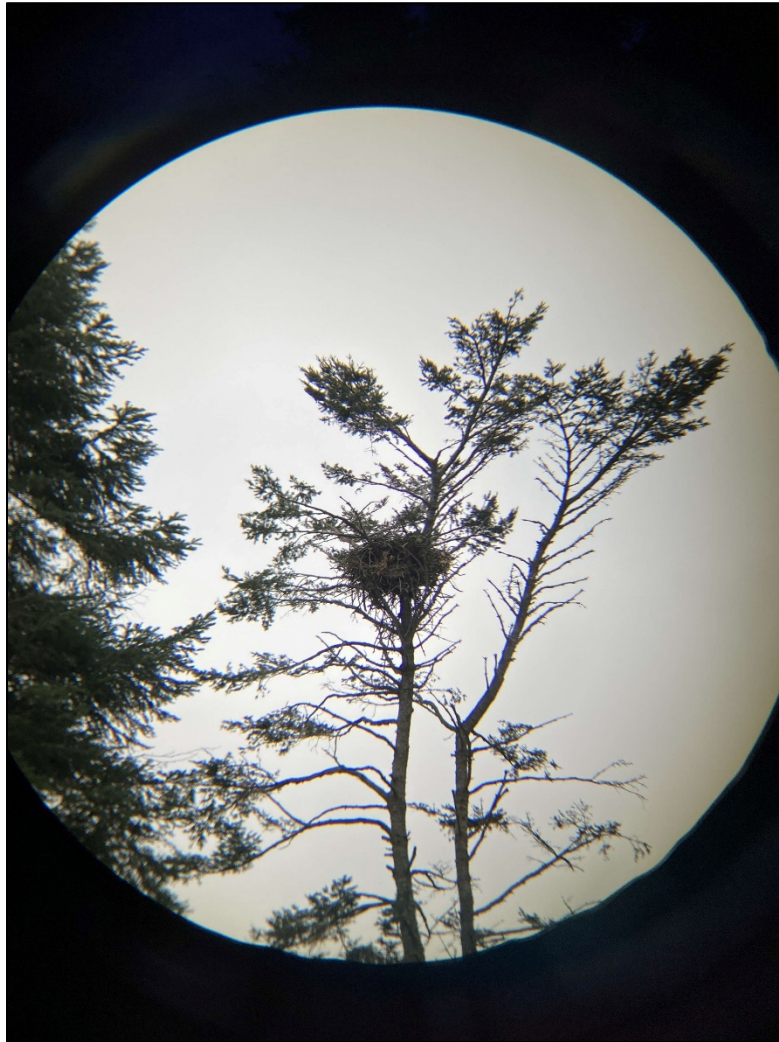
Figure 5. Bald eagle nest viewed through spotting scope from subject property (10/16/20).

A bald eagle (*Haliaeetus leucocephalus*) nest has been confirmed approximately 325 feet southwest of the subject property and approximately 350 southwest of the existing residence. Active use of the nest was not confirmed during the October 16, 2020, site inspection, and no eagles were observed. However, the site

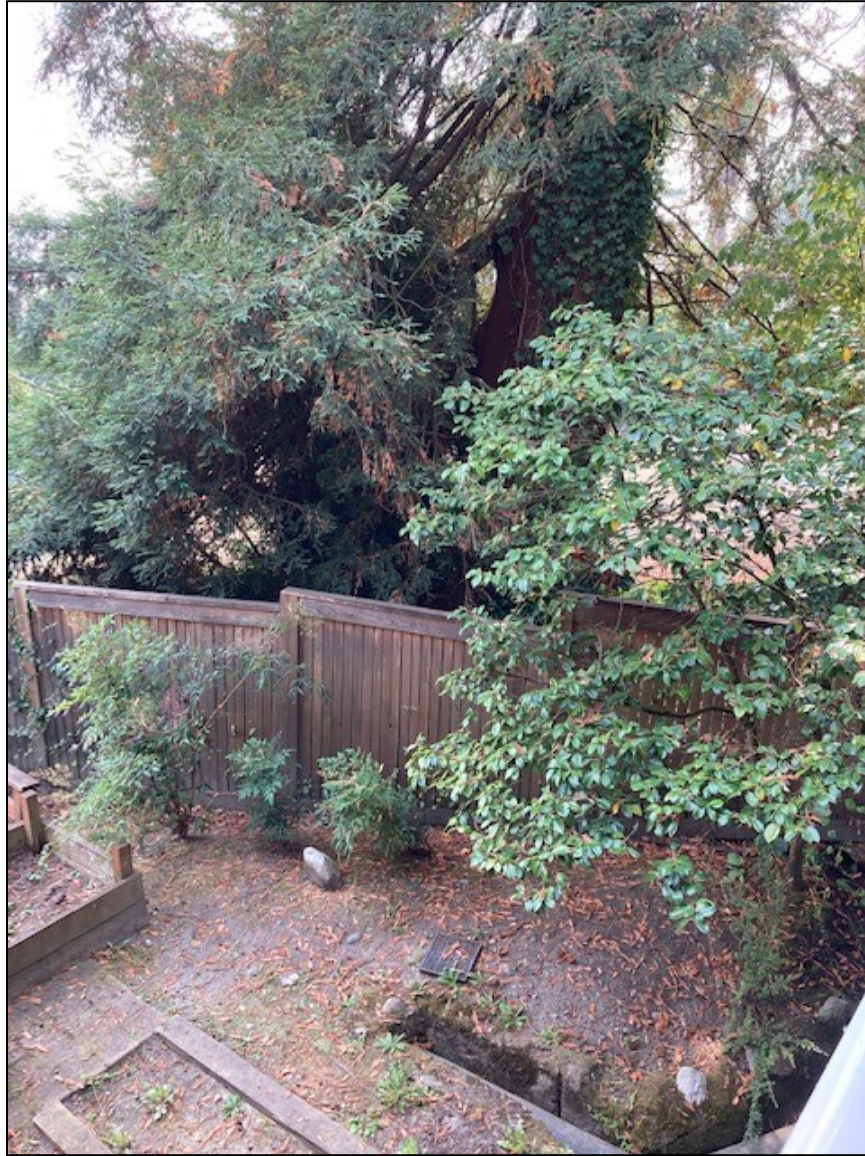
The piped segment of Watercourse A is located beneath the canopy of and within the critical root zone of an old-growth California redwood tree (*Sequoia sempervirens*) on the adjacent property to the south (Parcel #3024059114) (Figure 6). Based on visual estimates from the subject property, the redwood tree has a diameter at breast height of greater than 60 inches. Daylighting Watercourse A would necessitate the removal of this tree. The City prioritizes the retention of exceptional trees, and a redwood tree of this size and age is generally irreplaceable. The removal of the tree would represent an unnecessary risk of environmental damage due to the irreplaceable loss of habitat, soil stability, and evapotranspiration functions provided by this rare, old-growth tree, which conflicts with the requirements of MICC 19.07.180.C.6.d.ii. The environmental benefit of daylighting this short watercourse segment would not compensate for the loss of this tree, and it is not possible to completely mitigate the loss of this tree. Additionally, the redwood tree is not located on the subject property, meaning its removal would cause an additional impact on a neighboring property, which is in conflict with the requirements of MICC 19.07.180.C.6.c.ii. Daylighting Watercourse A would also create a watercourse buffer on the adjacent property where none currently exists, which conflicts with the same provision.

Figure 6. Watercourse A with old-growth redwood tree in background, facing southeast (9/11/20)

Based on the environmental damage resulting from the removal of an old-growth redwood tree, both on the subject property and the adjacent property, as well as the additional buffer encumbrance daylighting Watercourse A would create on the neighboring property, it is our opinion that daylighting Watercourse A is not feasible or environmentally beneficial at this location. Therefore, in accordance with MICC 19.07.180.C.6.d, a 10-foot setback should be required for Watercourse A.
