PRELIMINARY GEOTECHNICAL REPORT

Ramaiyah Residence

7466 E. Mercer Way
Mercer Island, Washington
Parcel Number: 2579500136

Project No. A-1562

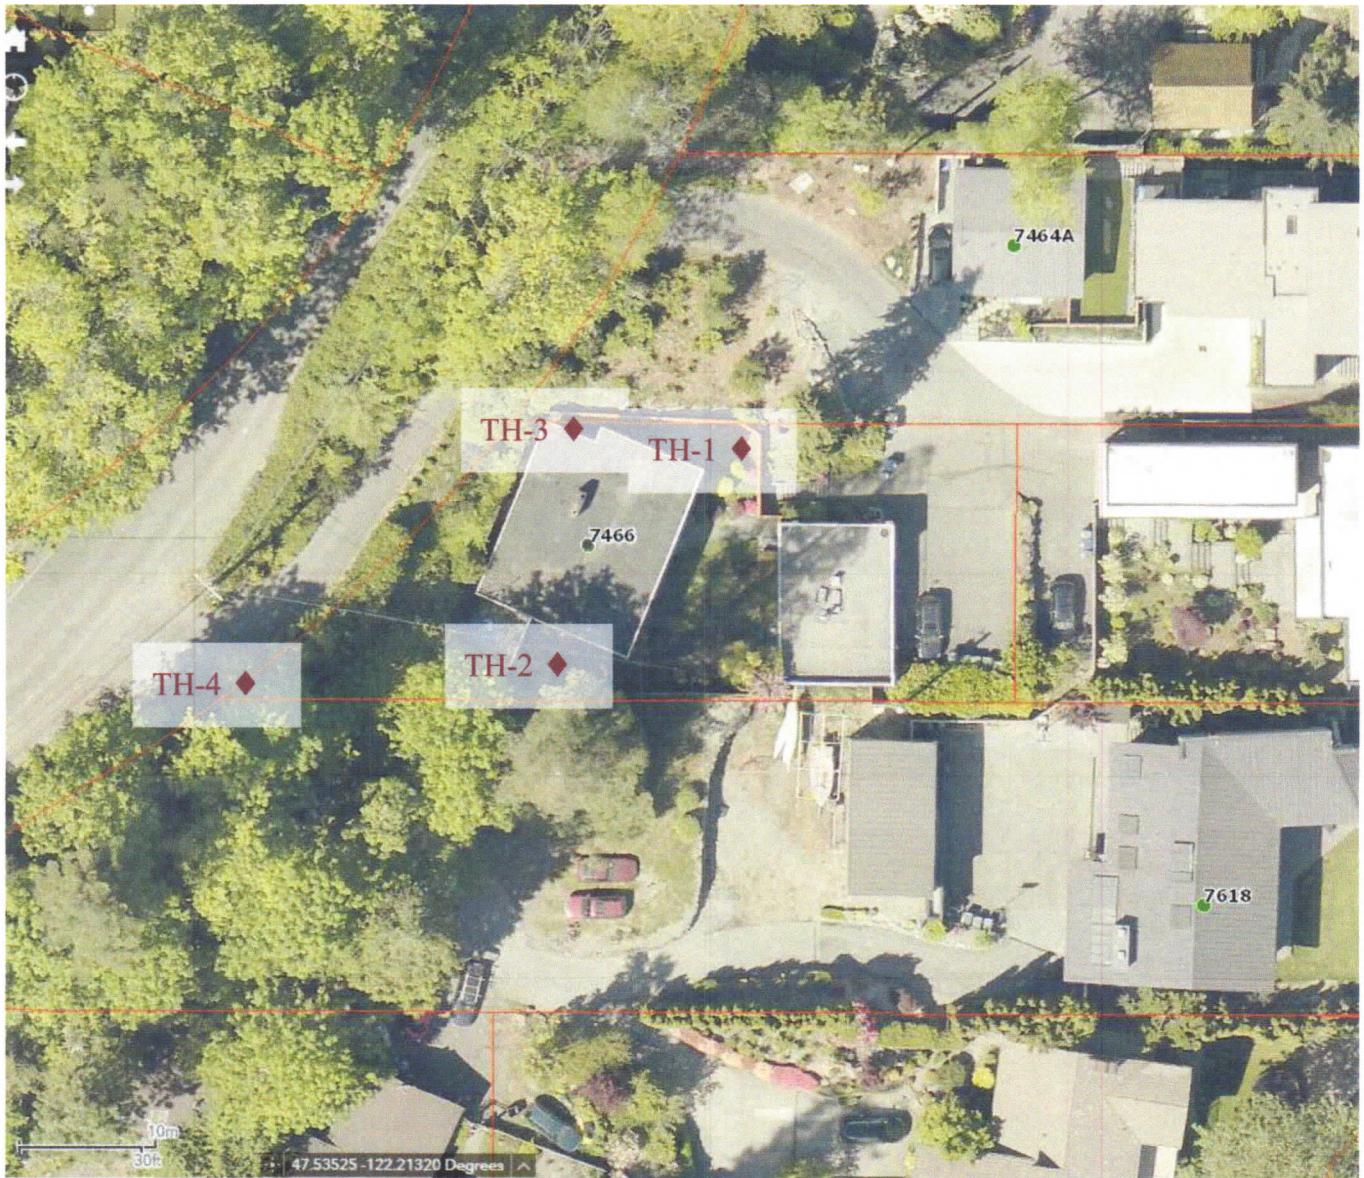
Figure 2

KEY:
 APPROXIMATE LOCATION OF TEST HOLE TH-1 ◆

The subject site area is an irregular shaped residential parcel located at 7466 East Mercer Way in the Clarke Beach area of Mercer Island, Washington. The subject site is currently occupied with a single-family residence located in the eastern central (downhill) portion of the site. A detached garage is located along the sites’ eastern property line. A driveway switchbacks down the western end of the site to the detached garage located along the east end of the site. The site is bordered with residential lots to the north, east, and south, and by East Mercer Way to the west. The location of the site is shown on the Site Vicinity Map provided in Figure 1. The current site layout is shown on the Exploration Location Plan provided in Figure 2.

Figures A-1 through A-3 present more detailed descriptions of the subsurface conditions encountered in the test holes. The approximate test hole locations are shown on the Exploration Location Plan provided in Figure 2.

On June 29, 2020 we explored subsurface conditions at the site by advancing four hand-augured test holes to a maximum depth of 7.0 feet below surface grades. The approximate test hole locations are shown on the Exploration Location Plan provided in Figure 2.
