March 5, 2024

AOA-7371

SUBJECT: **Wetland and Stream Reconnaissance for 8020 – SE 57th St.
Parcel 294890-0082, Mercer Island, WA**

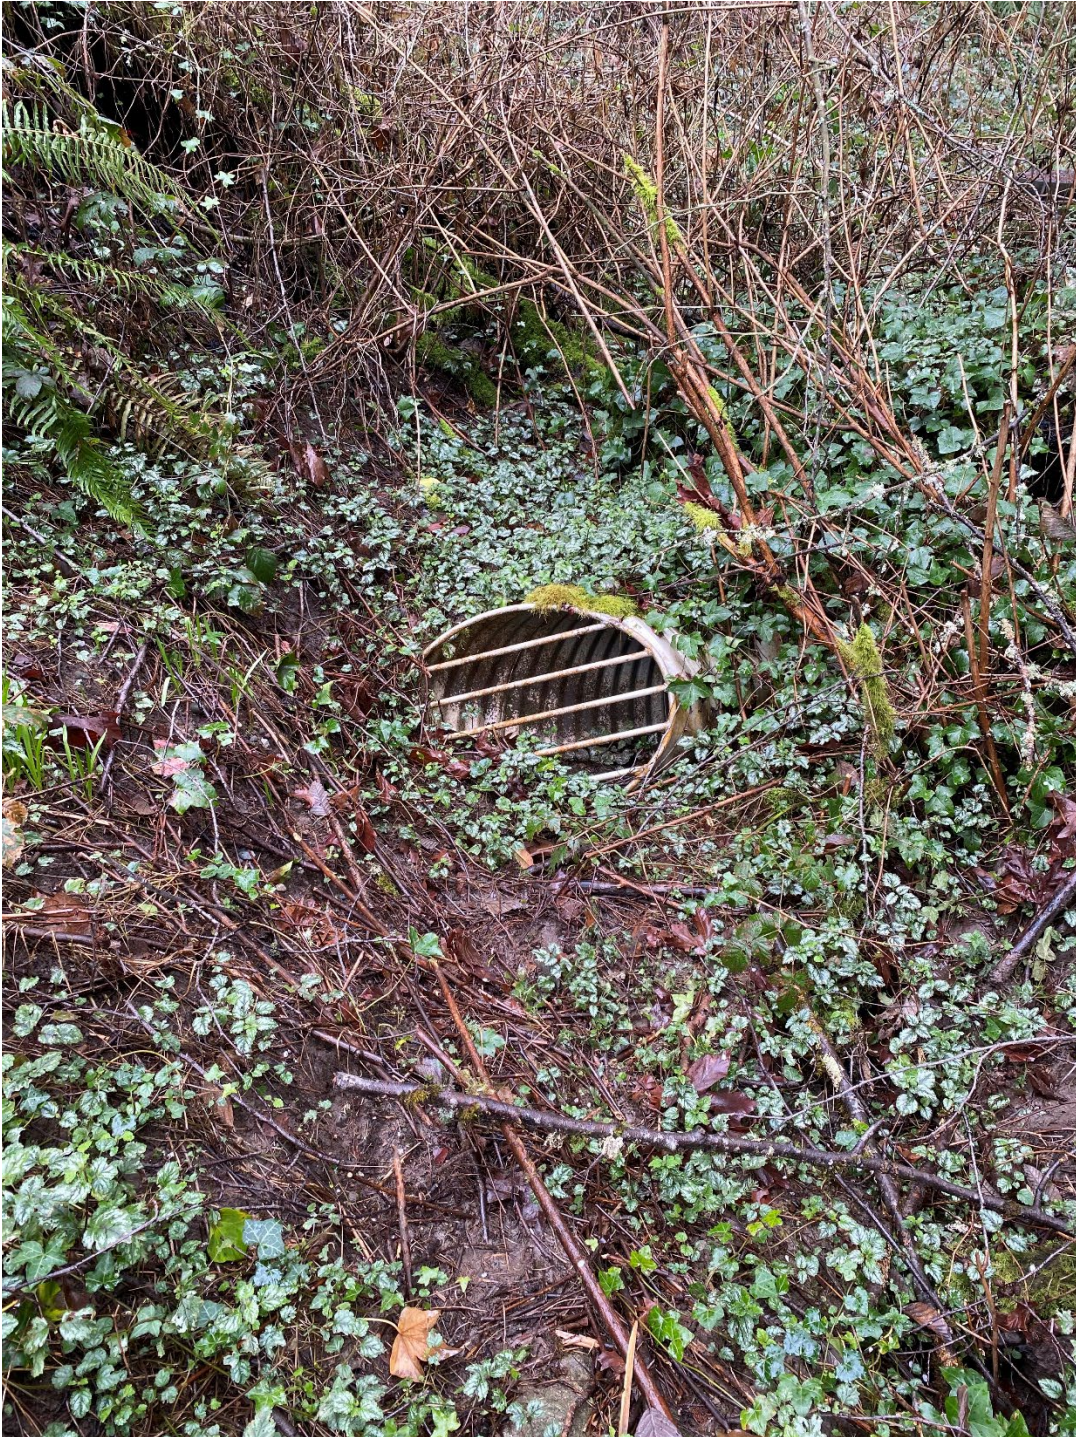
Although no wetlands or surface channels were observed within the off-site ravine, one piped watercourse appears to be located beneath the bottom of the off-site ravine. Piped watercourses require a standard 45-foot structure setback from the centerline of the pipe per MIMC 19.07.180.C.6.b.

View of culvert at bottom of ravine. Note no surface channel or flow entering culvert. Running water could be clearly heard beneath the surface within likely piped watercourse.

It is my recommendation that the 45-foot standard structure setback from the piped watercourse be added to any future development application drawings.
