**CRITICAL AREA STUDY**

**MITIGATION PLAN**

**NFH – 8000 SE 20<sup>th</sup> Street SFR**  
**Mercer Island, WA**

First Submittal: August 9, 2016  
**Revision 1: February 13, 2017**

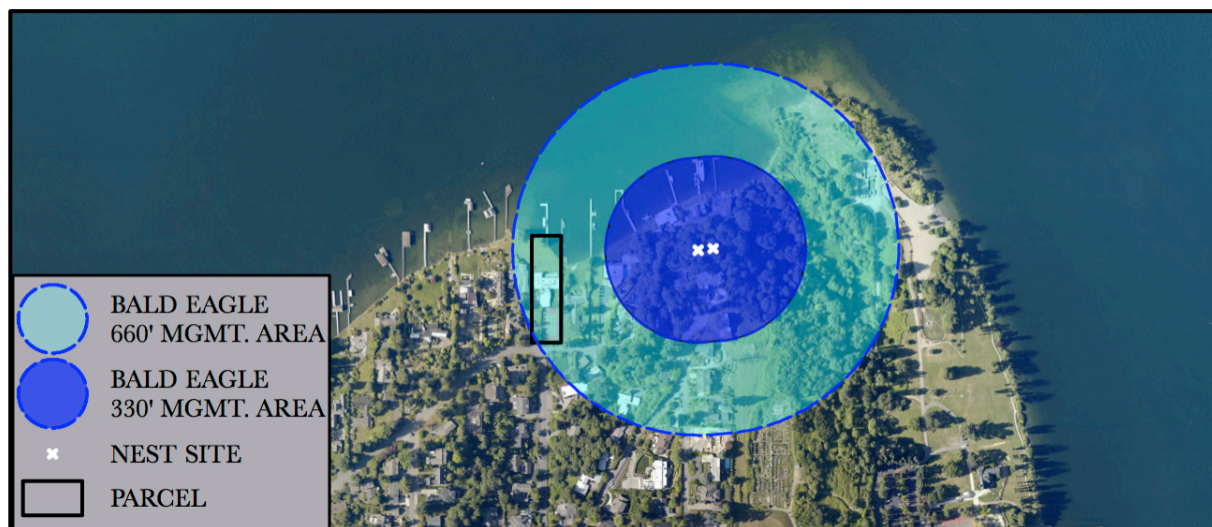
Figure 4: USFWS Eagle Disturbance Thresholds (image source: King County GIS)

The proposed project occurs between 485 and 700 feet from the known nest locations (based on the City of Mercer Island IGS map titled *Properties Affected by Bald Eagles - 4/26/16*). See Figure 4 below. The project is scheduled to take between 10 and 24 months to complete. Work is proposed through up to two nesting seasons. Based on email communication with USFWS staff Mark Miller (USFWS Washington Wildlife Office), no permit is required for this project. Furthermore, no avoidance/minimization measures are required by USFWS. Documentation of

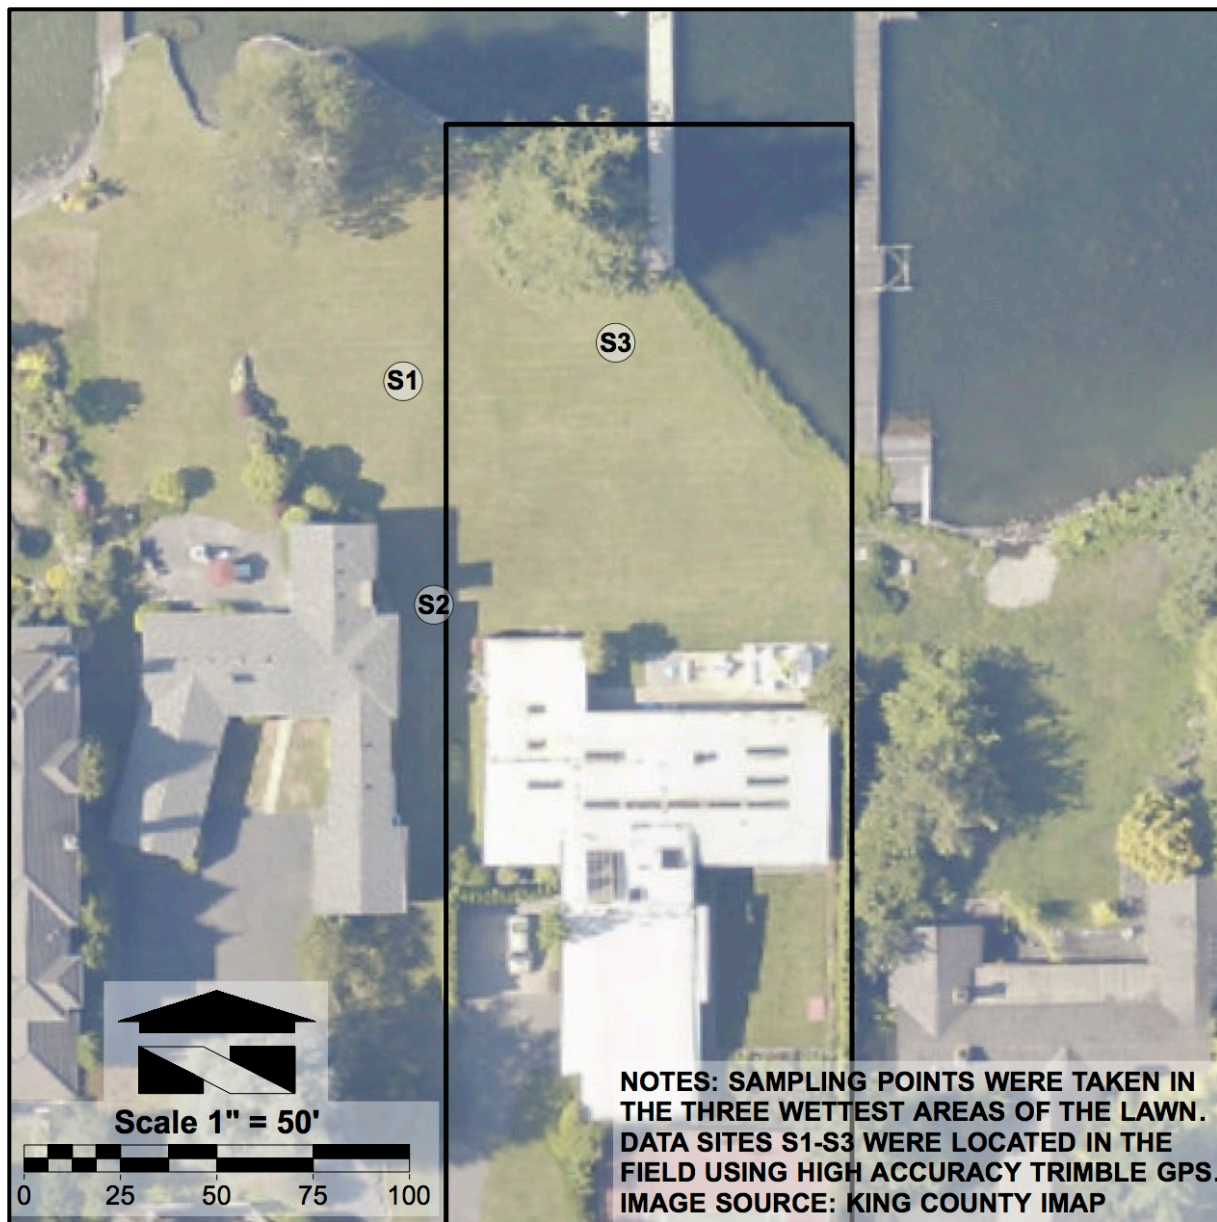
Figure 5: Data Plot Locations

The third-party reviewer hired by the City of Mercer Island for this project (ESA) conducted a site visit on November 23, 2016, to aid in review of the applicant's proposal. ESA staff drafted a review letter (date: 12.7.16, subject line: Proposed NFH Single Family Residence (CA016-002) – Environmental Review) noting areas to the west, northwest, and north of the existing residence with soils saturated to the surface. The letter requests additional documentation of existing conditions, including formal data plots, and a map that indicates data plot locations. Formal Corps Wetland Determination Data Forms are provided (S1-S3) as Appendix B. Data plot locations are depicted in Figure 5 below.

Wetland Resources staff (Scott Brainard, Niels Pedersen) conducted a site visit on December 15, 2016 to document soil, vegetation, and hydrologic conditions within the lawn area. In response to the concerns expressed by ESA staff, formal data plot locations were selected in the three wettest areas of the site; in localized minor depressions where soils exhibited the greatest compression-and-rebound effect underfoot. These areas are depicted in Figure 5 below. Data points were located in the field using high-accuracy Trimble GPS, and are overlaid on a geo-referenced aerial image of the subject property (Figure 5). GPS point accuracy was very high; 60% of all GPS positions were accurate to 5-15 centimeters.

Sample points S1-S3 were consistently moist in the upper part (from the surface to 4-8 inches below the mineral soil surface) and dry below. Soils were not saturated during the site visit. No water table was observed beneath the moist areas. Photos were taken at each soil pit approximately 10 minutes after excavation. See *Appendix C - Sample Point Photos*. No indicators of wetland hydrology were observed during the December site visit within any of the three sample pits.

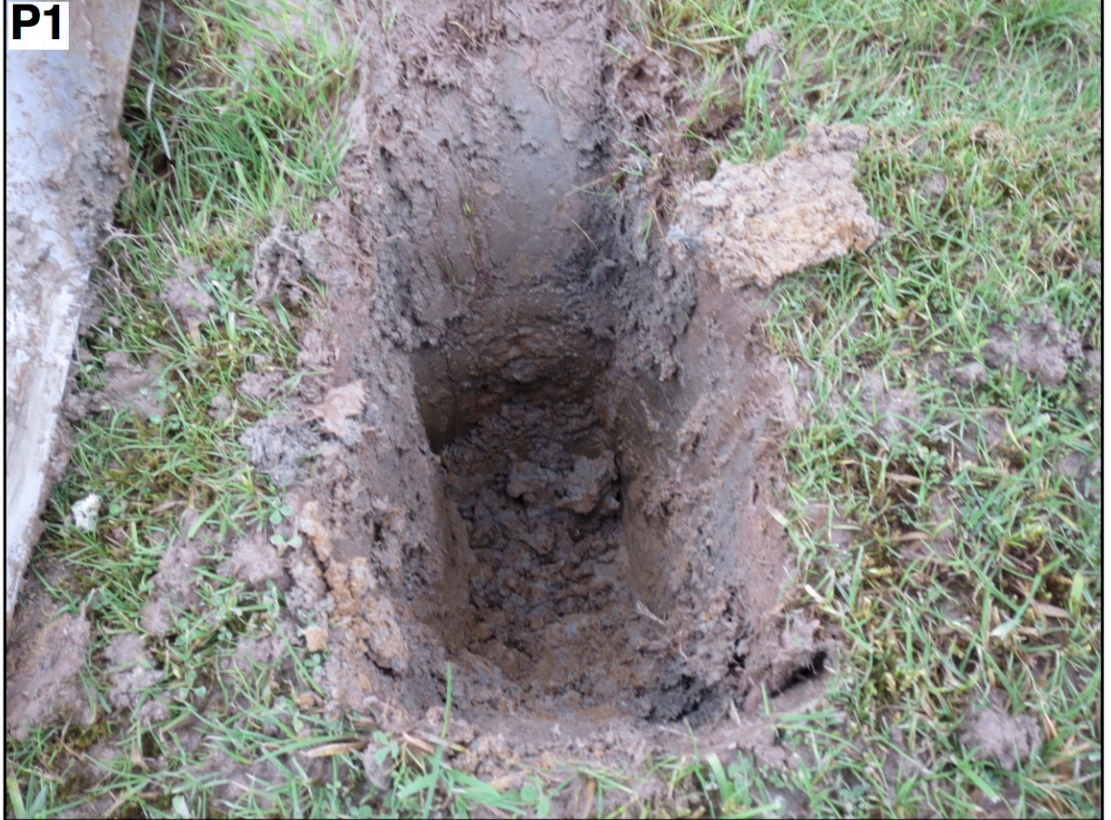
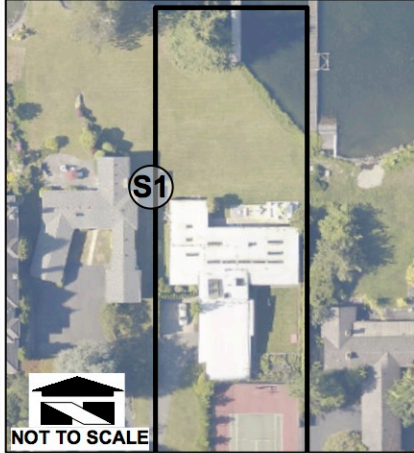
**Sample Point S-1**

Depth (inches)	Matrix		Redox Features			Loc <sup>2</sup>	Texture	Remarks
	Color (moist)	%	Color (moist)	%	Type <sup>1</sup>			
0-4	2.5Y 3/2	95	10YR 4/6	5	C	M	sandy loam	moist, fine-grain
4-15	10Y 5/1	70	10YR 4/6	30	C	M	sandy loam	dry

Remarks:  
 S-1 is likely below the historic OHWM of Lake Washington. It is the assertion of the investigators that observed hydric soil indicators represent historic conditions. If indicators of wetland hydrology were present, it could be assumed that hydric soil indicators are contemporary; their absence during the wet season supports a relict indicator determination.

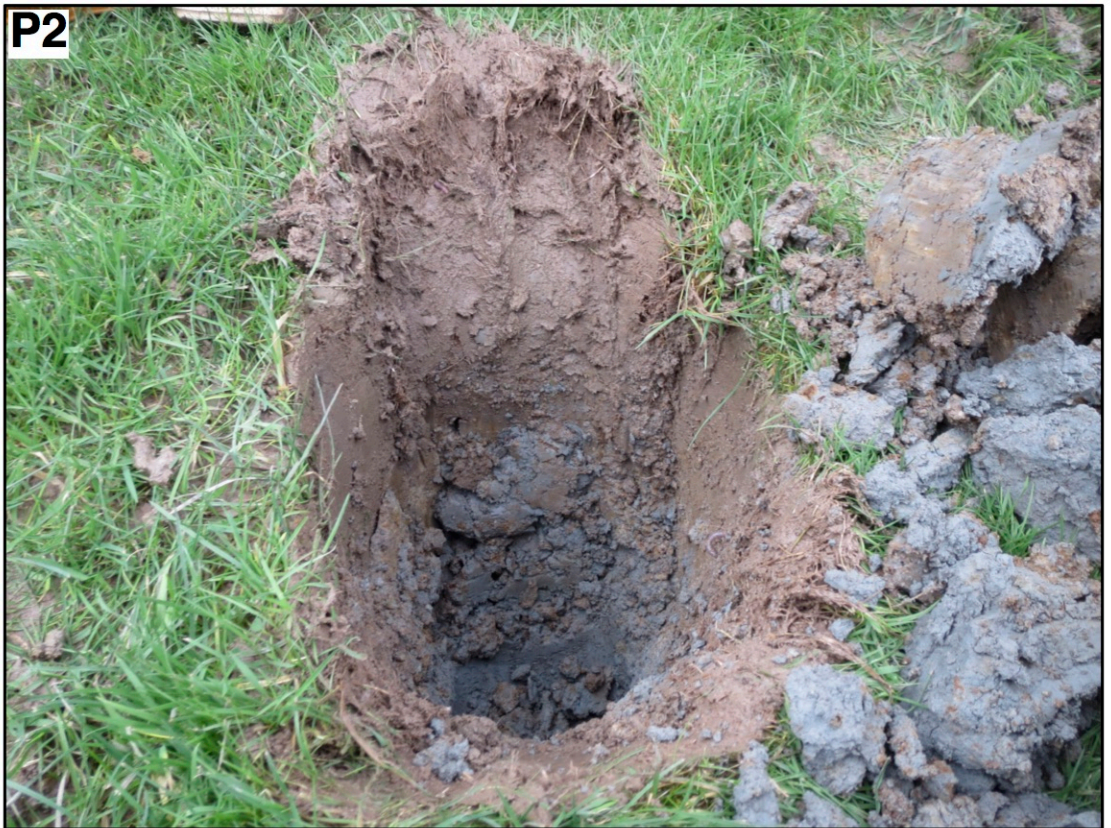
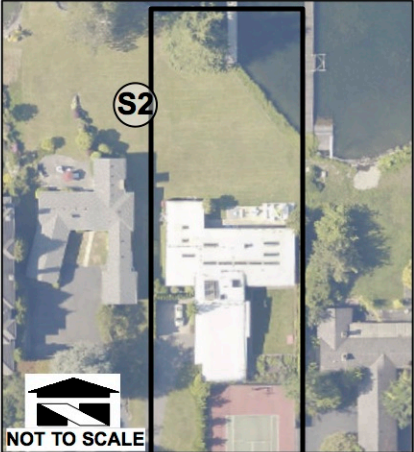
**Sample Point S-2**

Depth (inches)	Matrix		Redox Features			Loc <sup>2</sup>	Texture	Remarks
	Color (moist)	%	Color (moist)	%	Type <sup>1</sup>			
0-8	2.5Y 3/2	85	10YR 4/6	15	C	M	silt loam	Moist, gravelly
8-15	5Y 4/1	85	10YR 4/6	15	C	M	silt loam	Dry, not gravelly

Remarks:  
 S-2 is likely below the historic OHWM of Lake Washington. It is the assertion of the investigators that observed hydric soil indicators represent historic conditions. If indicators of wetland hydrology were present, it could be assumed that hydric soil indicators are contemporary; their absence during the wet season supports a relict indicator determination.

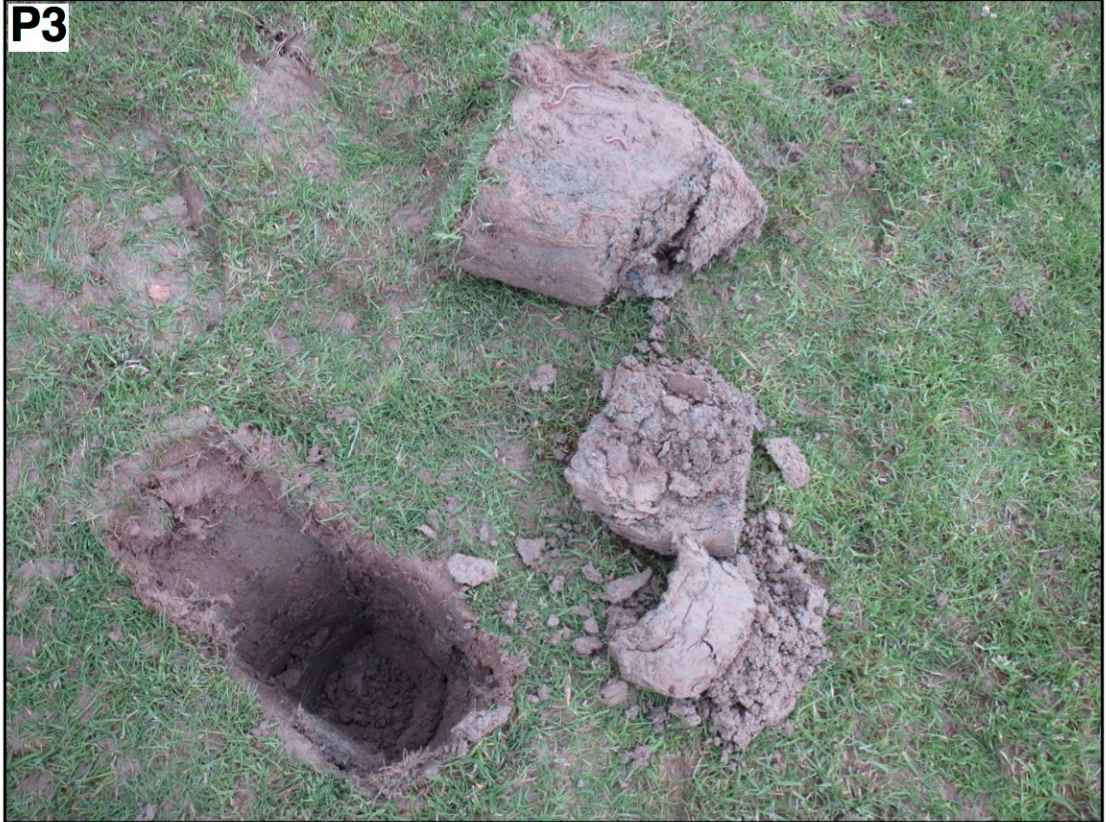
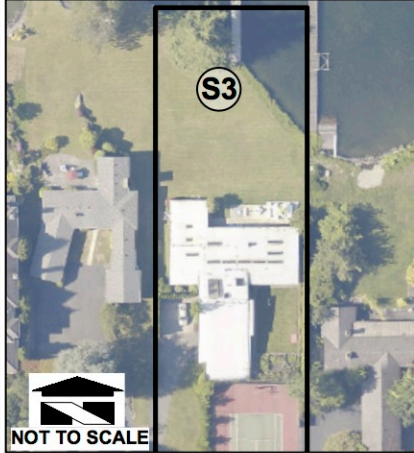
**Sample Point S-3**

Depth (inches)	Matrix		Redox Features			Loc <sup>2</sup>	Texture	Remarks
	Color (moist)	%	Color (moist)	%	Type <sup>1</sup>			
0-15	2.5Y 4/1	90	10YR 4/4	10	C	M, PL	sandy loam	moist in upper part

Remarks:  
 S-3 is likely below the historic OHWM of Lake Washington. It is the assertion of the investigators that observed hydric soil indicators represent historic conditions. If indicators of wetland hydrology were present, it could be assumed that hydric soil indicators are contemporary; their absence during the wet season supports a relict indicator determination.

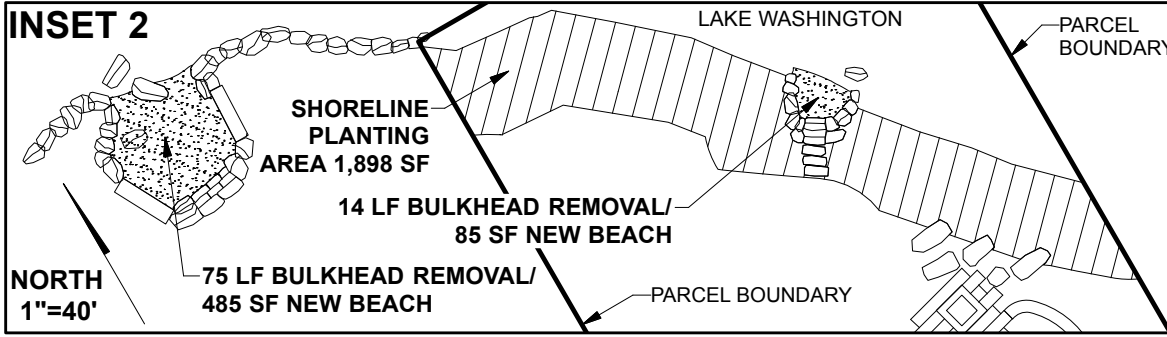
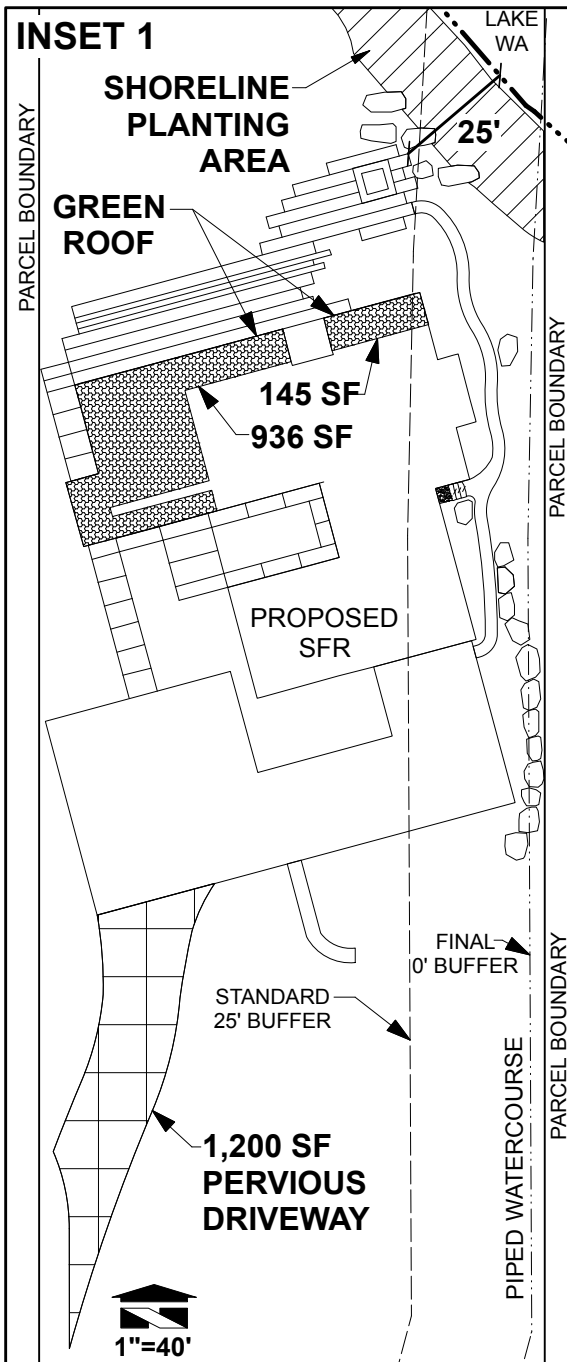
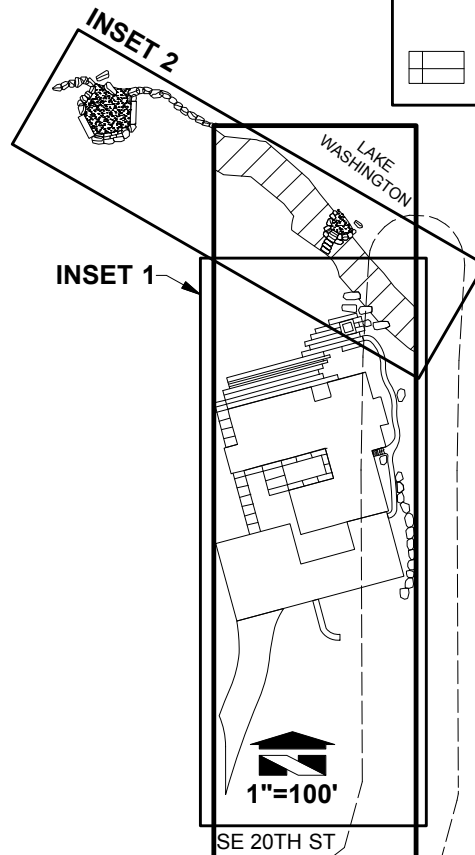
### PROPOSED ECOLOGICAL IMPROVEMENTS

**NOTE: APPLICANT PROPOSES TO REDUCED THE STANDARD 25' PIPED WATERCOURSE BUFFER TO 0 FEET**

ECOLOGICAL IMPROVEMENTS	
TYPE	QTY.
GREEN ROOF	1,081 SF
PERVIOUS DRIVEWAY	1,200 SF
BULKHEAD REMOVAL	89 LF
SAND BEACH	570 SF
SHORELINE PLANTING	1,898 SF

BUFFER REDUCTION SUMMARY	
REDUCTION AREA (SF)	GROUNDCOVER TYPE
2,871	MAINTAINED LAWN
4,847	IMPERVIOUS (EX. SFR, TENNIS CT.)
591	OPEN WATER (LAKE WA)
373	ORNAMENTAL SHRUBS
639	VEGETABLE GARDEN

- to construct a green roof totaling 1,081 square feet,
- to install pervious driveway totaling 1,200 square feet,
- to remove 89 lineal feet of existing bulkhead, and
- to construct 570 square feet of sandy beach.
