**Sewall Wetland Consulting, Inc.**

RE: 5637 Mercer Way – *Revised* Critical Areas Report  
SWC Job#14-206

## **1.0 INTRODUCTION**

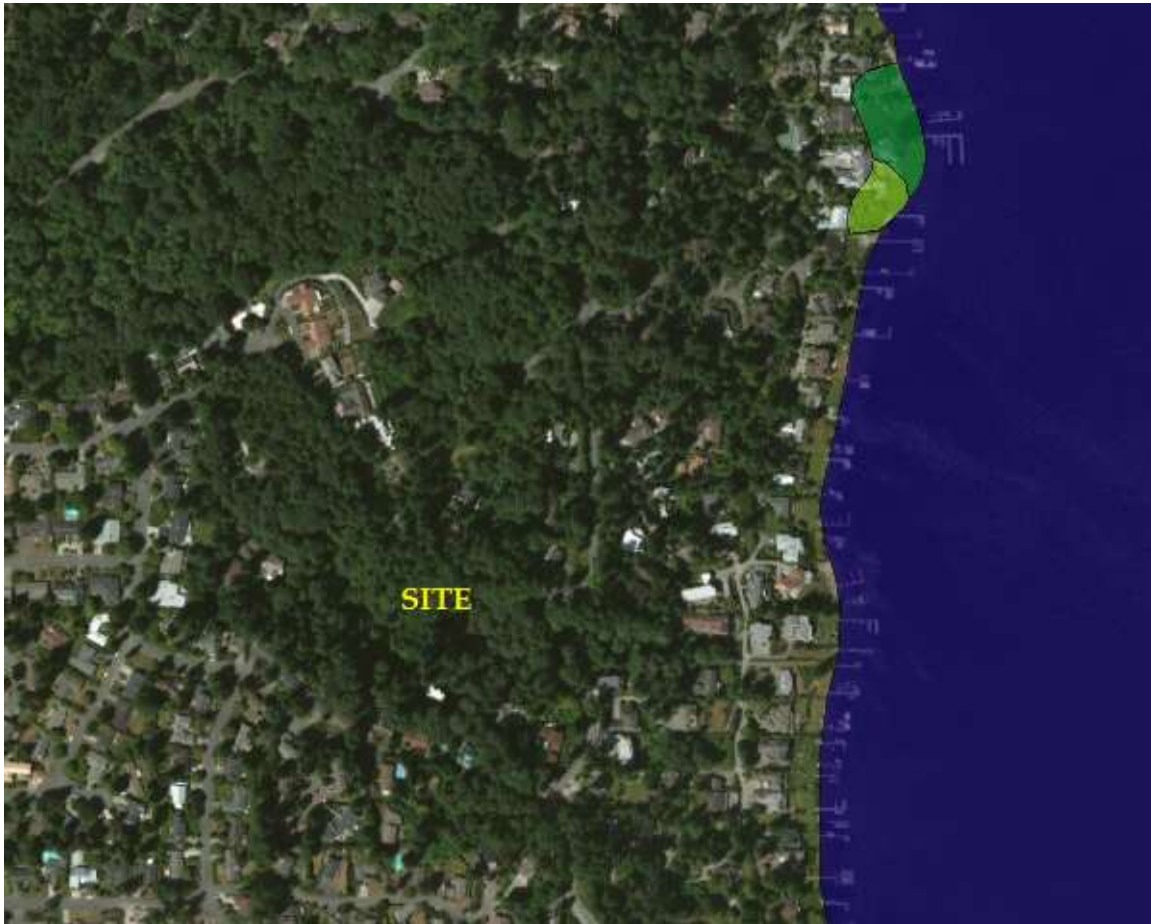
There are no wetlands mapped on or near the site on the NWI mapping for area of the site.

*Above: NWI Map of the study area*

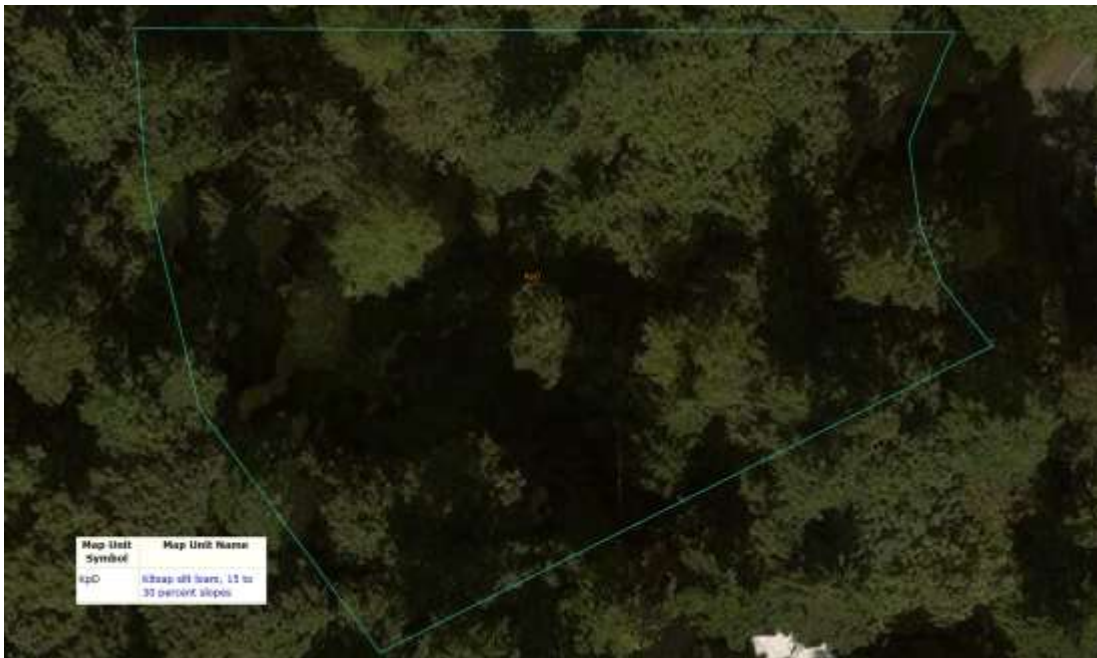
According to data on file with the NRCS Soil Survey, the site as mapped as Kitsap silt loam 15%-30% slopes. Kitsap soils are a moderately well-drained soils formed in lacustrine deposits. Kitsap soils are not considered "hydric" soils according to the publication Hydric Soils of the United States (USDA NTCHS Pub No.1491, 1991).

*Above: NRCS Soil map of the study area.*

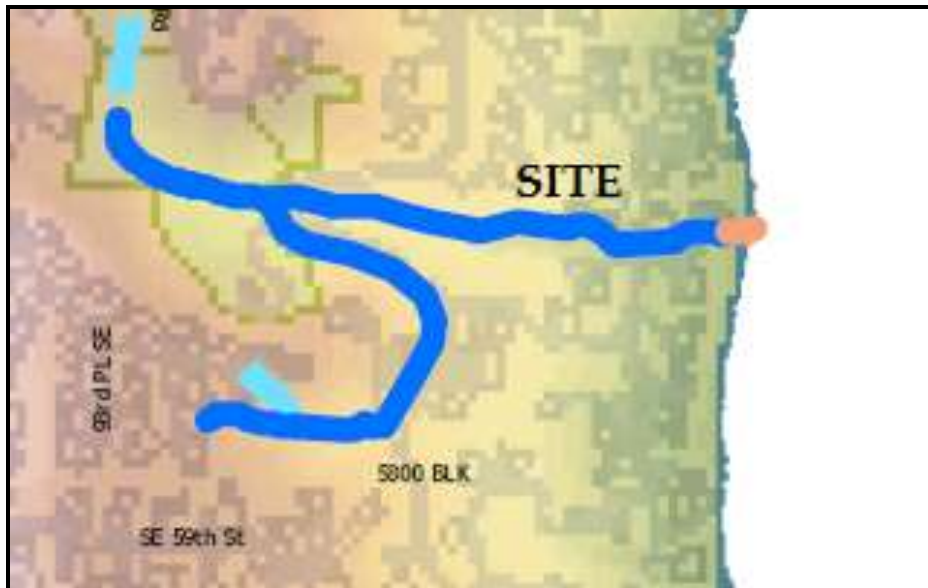
The City of Mercer Island stream inventory shows a perennial flowing non-fish bearing stream also known as a Type 2 watercourse with a 50' buffer.

*Above: Mercer Island Stream Inventory of the site*

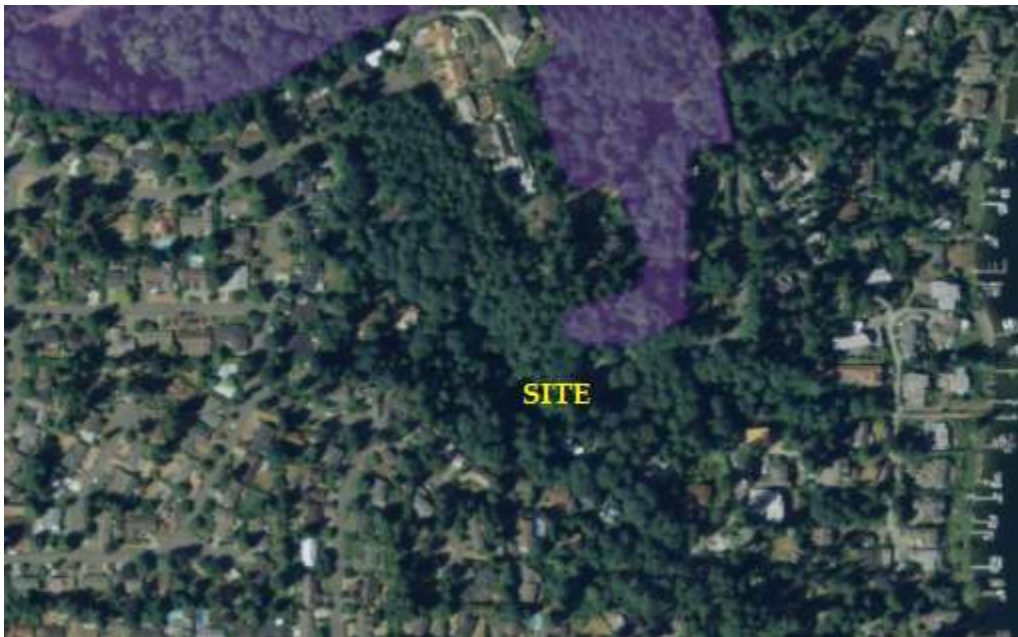
A review of the site revealed no state or federally listed species on or near the site. A review of the Washington State Department of Fish and Wildlife Priority Mapping system was conducted for the site. This mapping identifies state listed species as well as areas considered by WDFW to be "priority habitats". The mapping of the area of the site revealed no listed state or federal species utilizing the site. It does show an area to the north of the site as part of a "biodiversity corridor" (*purple shading*), which is a densely forested area with some steep slopes.

*Above: WDFW Priority Habitat mapping of the area of the site.*

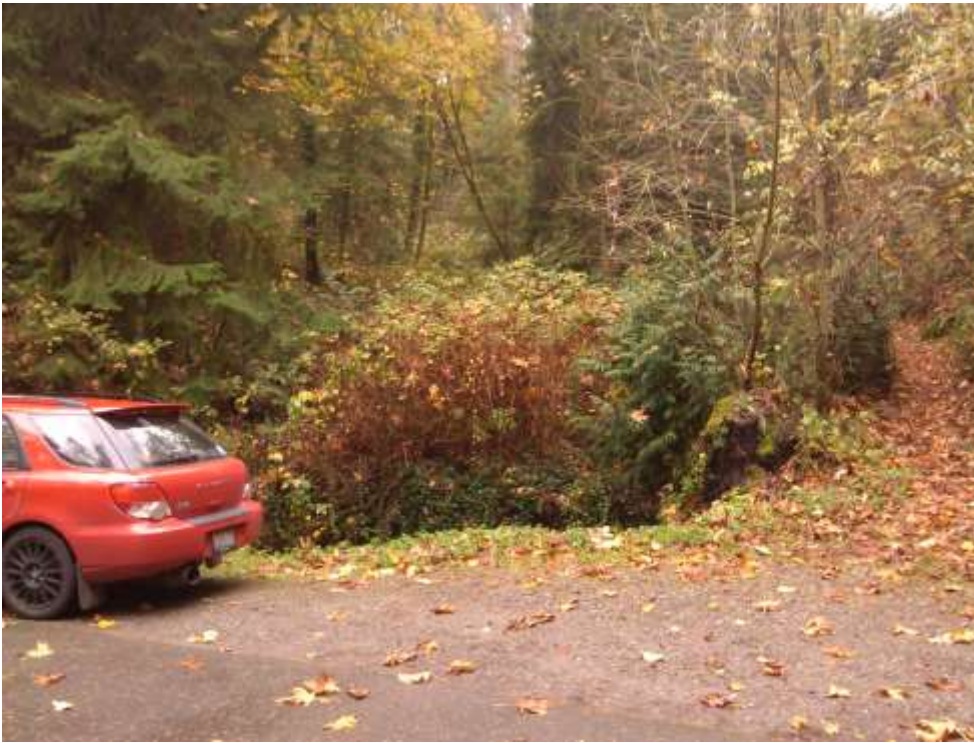
**Above: Site as viewed from Mercer Way**

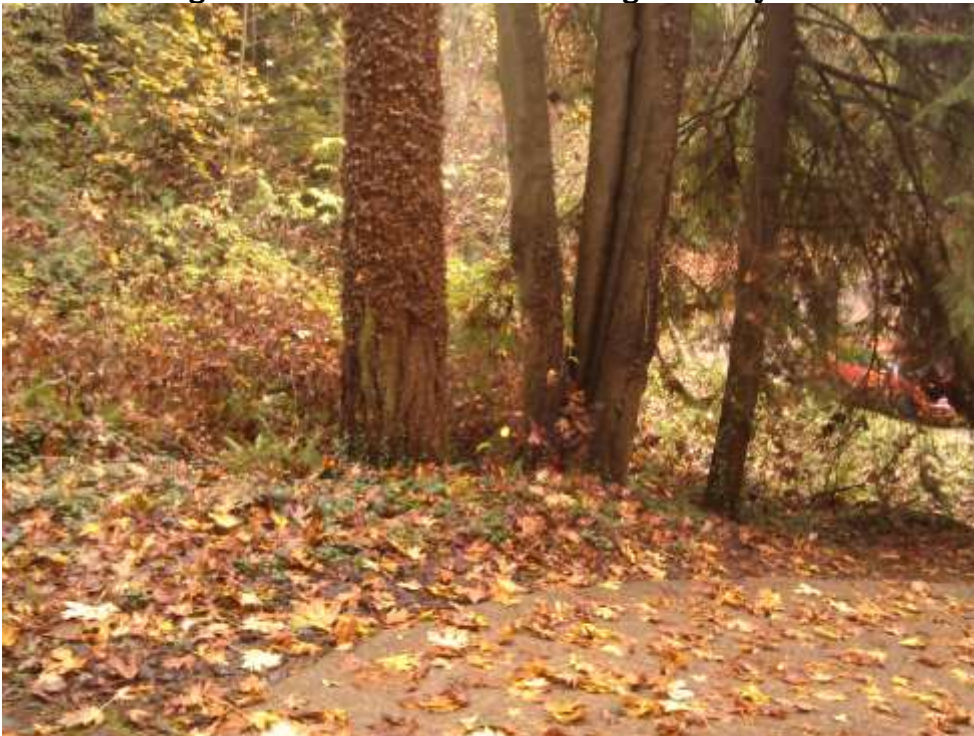
**Below: looking north across site near existing driveway entrance**

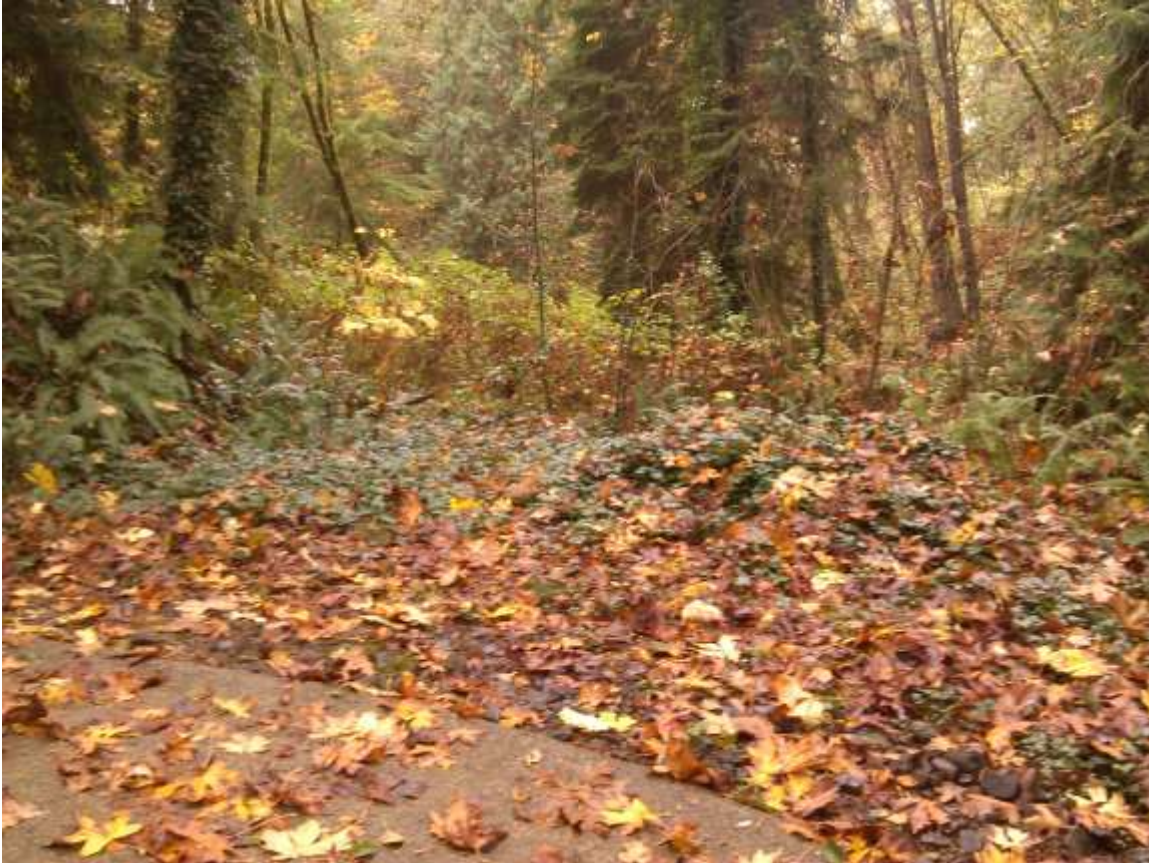
In addition to the fill of wetland for the foundation, a minor amount of fill will occur from the proposed driveway. The driveway will be located over the current location of the quarry spall driveway that exists on the site, further reducing impacts.

**Above: Existing quarry spill access driveway which leads to proposed building site**
