PIPED WATERCOURSE BUFFER ENHANCEMENT PLAN

FOR PROPOSED BUFFER AVERAGING
NIEDERMAN SFR

6800 - 96TH AVENUE SE
MERCER ISLAND, WA

MARCH 20, 2017

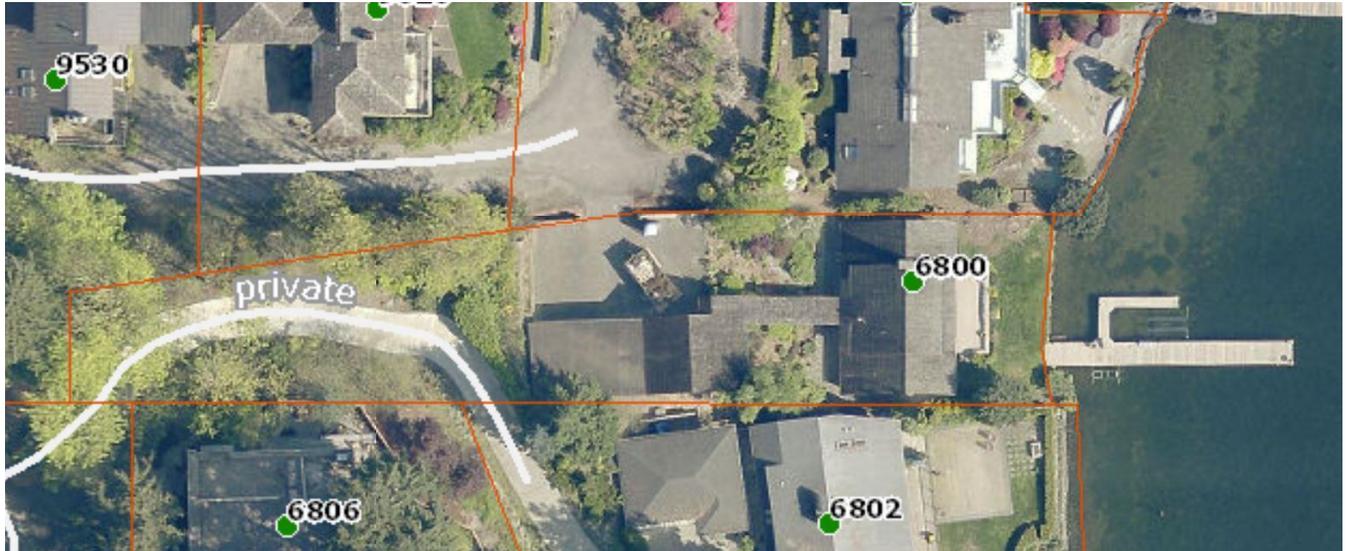
Figure 1. Aerial photograph (City of Mercer Island)

The Niederman family proposes to build a 2,000 square foot multi-level addition to their existing 1,800 square foot home located at 6800 - 96th Ave SE, shown in the aerial photograph in Figure 1. As can be seen, most of the site, including most of the buffer, is developed.

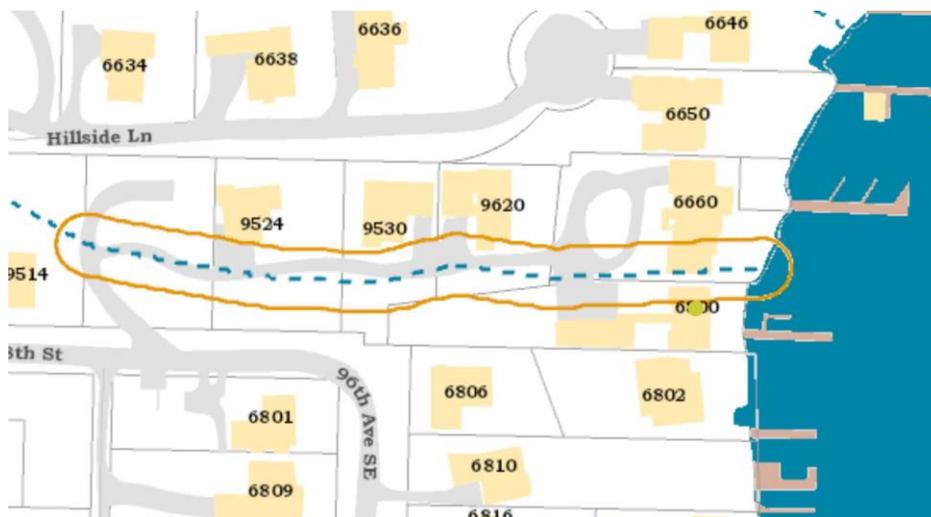
Figure 2. City of Mercer Island piped watercourse map

A piped watercourse is present on the property to the north as shown in Figure 2; the pipes pass beneath the residence on the neighboring lot to the north, and the buffer extends onto the Niederman parcel, as shown on the City of Mercer Island’s online map, shown in Figure 2. The proposed addition will result in 121 square feet of encroachment into this piped watercourse buffer. This report presents a plan to mitigate for these impacts.

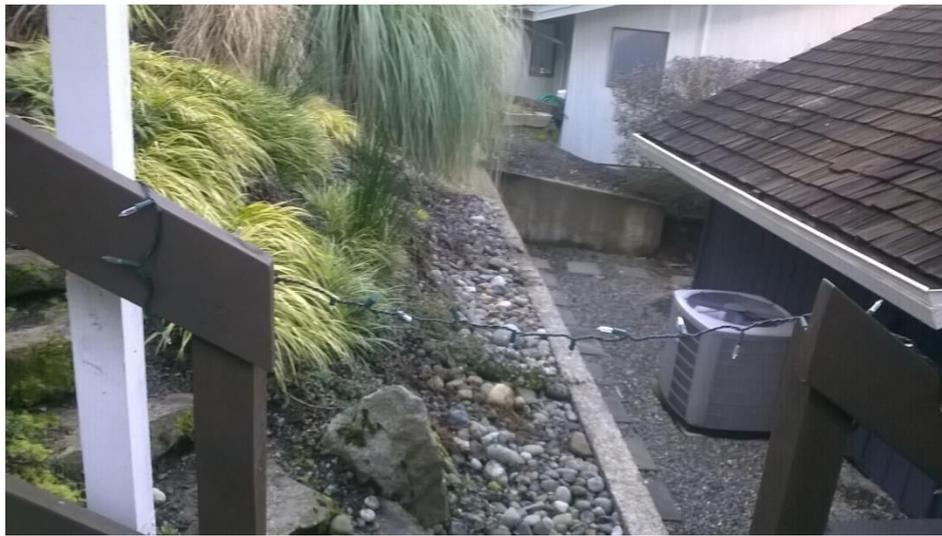
Figure 3. Area of proposed new watercourse buffer impacts. The proposed addition would extend 3 feet beyond the existing concrete retaining wall.

As noted above, this proposal will result in an incidental increase of 121 square feet of encroachment into the piped watercourse buffer (see attached site plan). A photograph showing the existing conditions within this proposed impact area is provided in Figure 3.

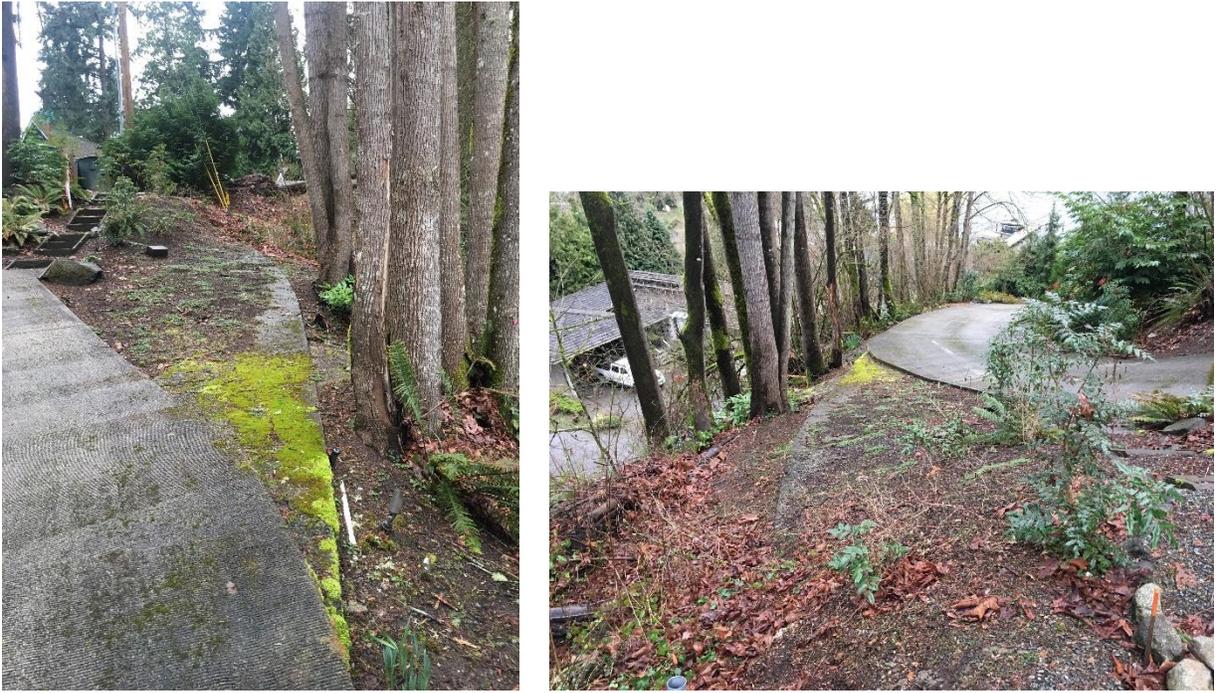
Figure 4. Photos of existing condition of compensation area

The goal of the mitigation plan is to compensate for loss of ecological functions resulting from creation of impervious surface within a piped watercourse buffer. Mitigation for these impacts will involve removing 124 square feet of impervious surface, i.e. a parking pad, located on the western portion of the site; the surface material will be removed and replaced with natural soil. The existing condition of the compensation area is shown in Figure 4. This restoration area will be enhanced, and an additional 401 square foot area adjacent to the standard buffer will be added to the standard 25-foot buffer to compensate for the proposed buffer impacts, as summarized in Figure 5. The proposal will result in a greater than 1:4 reduction:compensation ratio.

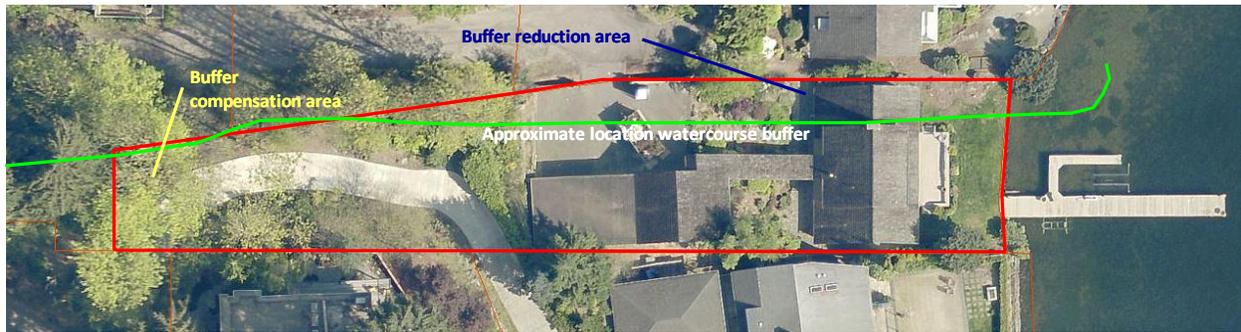
Figure 5. Overview of proposed buffer averaging

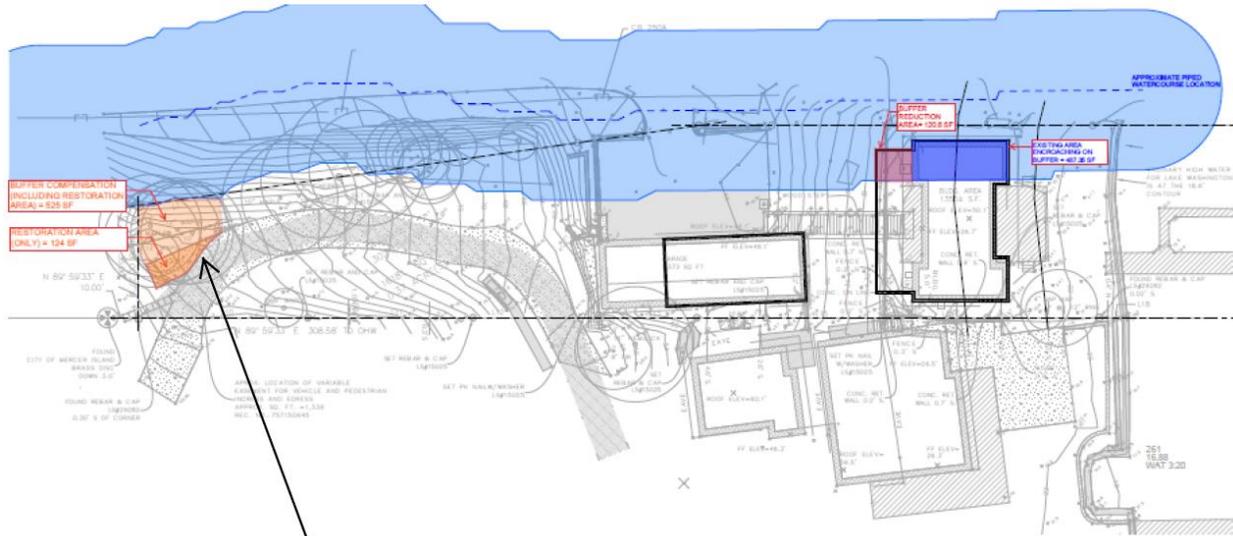
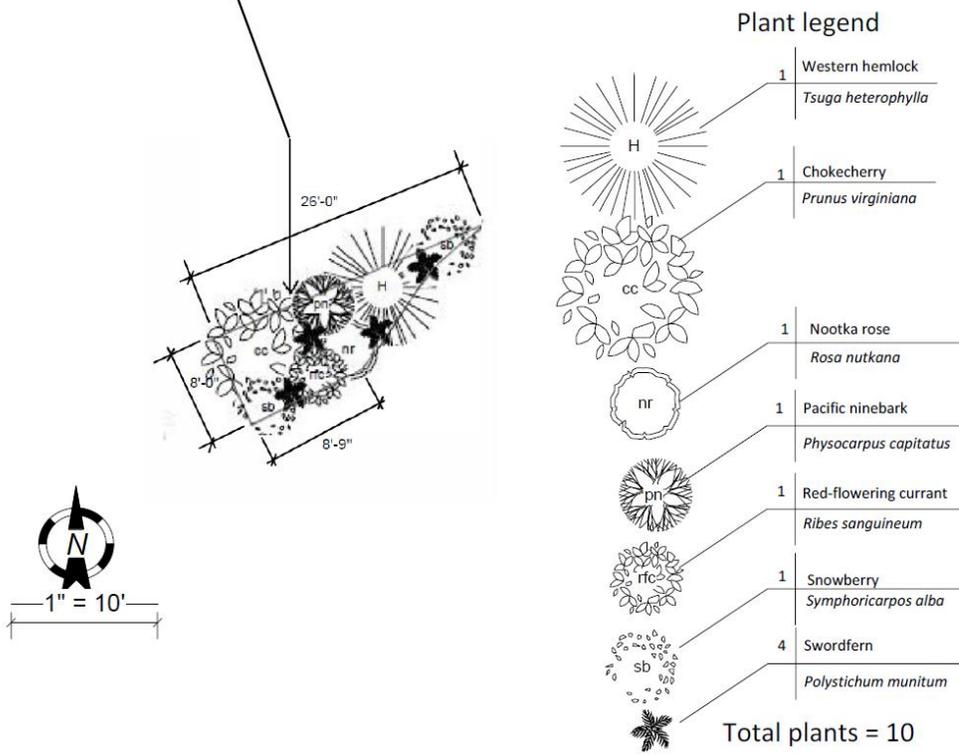
Figure 6: Planting Plan

Construction limits will be marked during project construction to protect the area from intrusion with equipment. The existing parking pad will be excavated to a depth of at least 6 inches below the concrete and any underlying material and the material properly disposed of; topsoil and compost will be installed within this area to bring it to a minimum of 6 inches above grade to allow for eventual soil settling and to avoid creation of a depression that could retain water, and the area will be planted with native vegetation. Non-native vegetation in the balance of the enhancement area will be grubbed entirely out. A total of 2 trees, 4 shrubs and 4 swordferns will be planted within the enhancement area, as shown in Figure 6. The enhancement area will be mulched to a depth of four inches. A temporary irrigation system will be installed to ensure the success of the plantings.
