**Critical Area Study
and
Stream Buffer Functional Assessment
of the**

Valentin Property
4346 E. Mercer Island Way
Mercer Island, WA 98046

Dated:
February 21, 2017

Prepared by:
Jeffery S. Jones, Professional Wetland Scientist

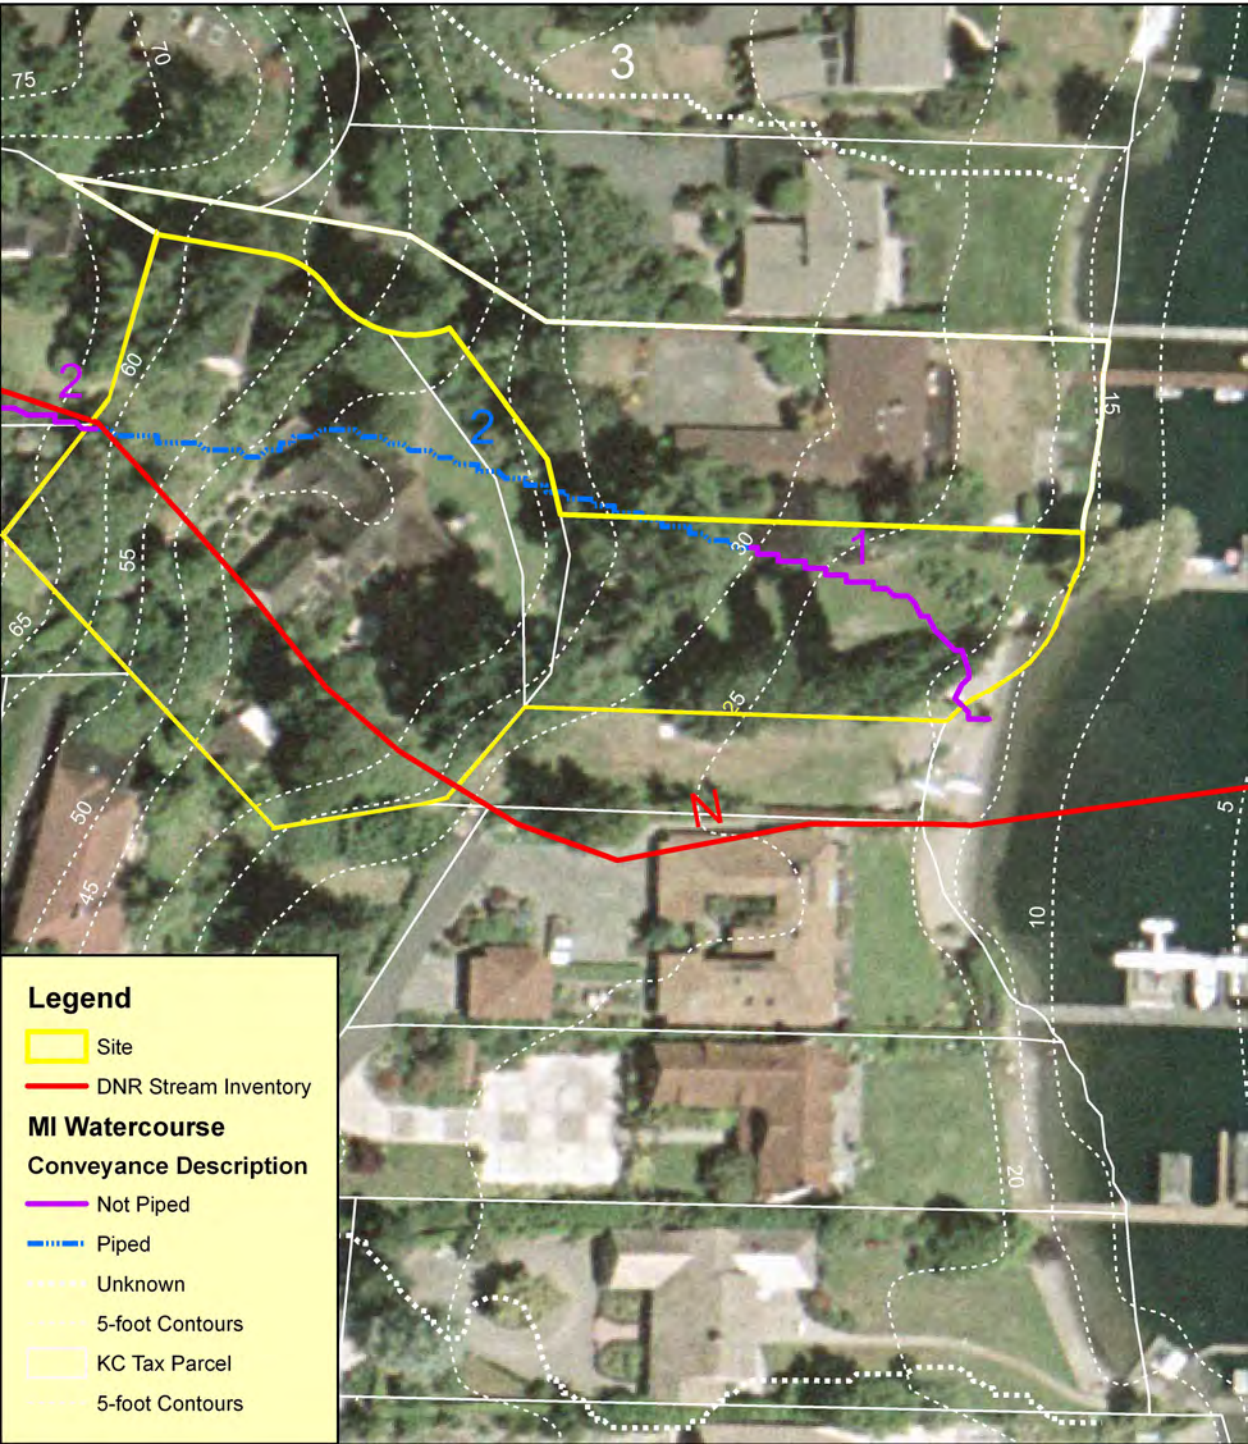
The Mercer Island stream inventory identifies a stream on the subject parcel (see attached Figure 3). The stream is an open two-foot wide eroded trench, from the 12” concrete pipe outfall to the lake, approximately 65 feet. This was not the natural location of a stream, but was previously channelized, meaning the final section was trenched.

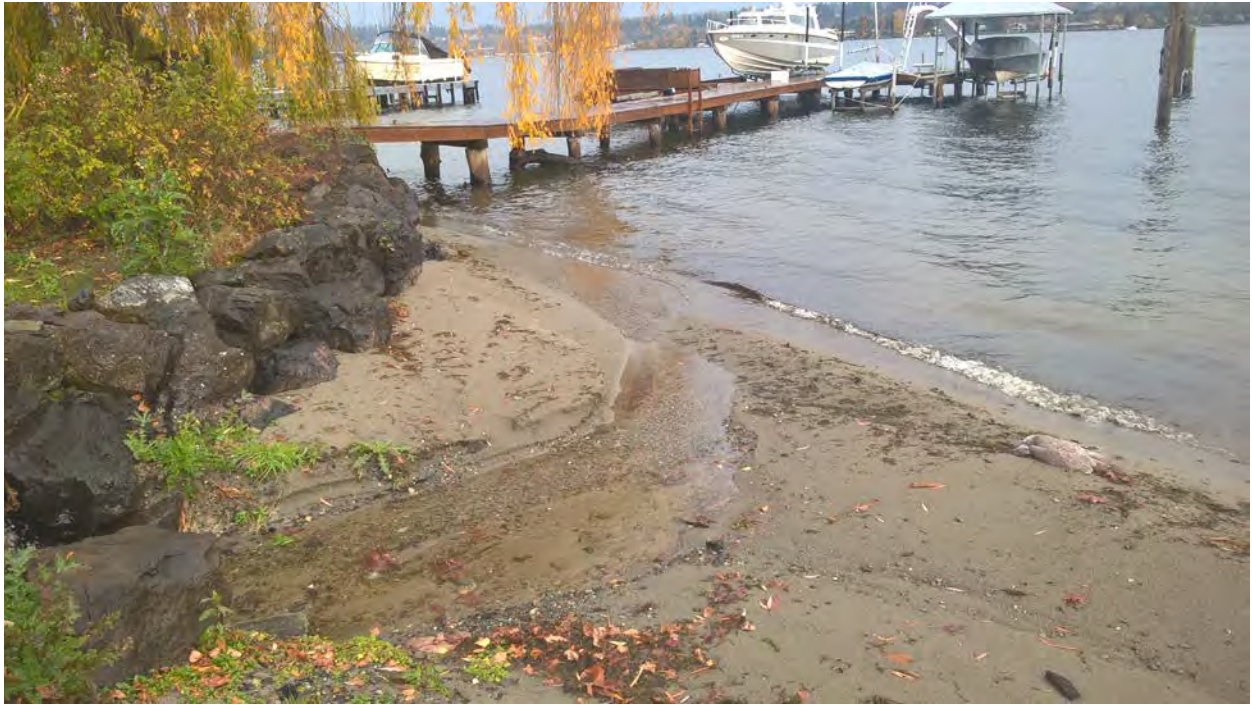
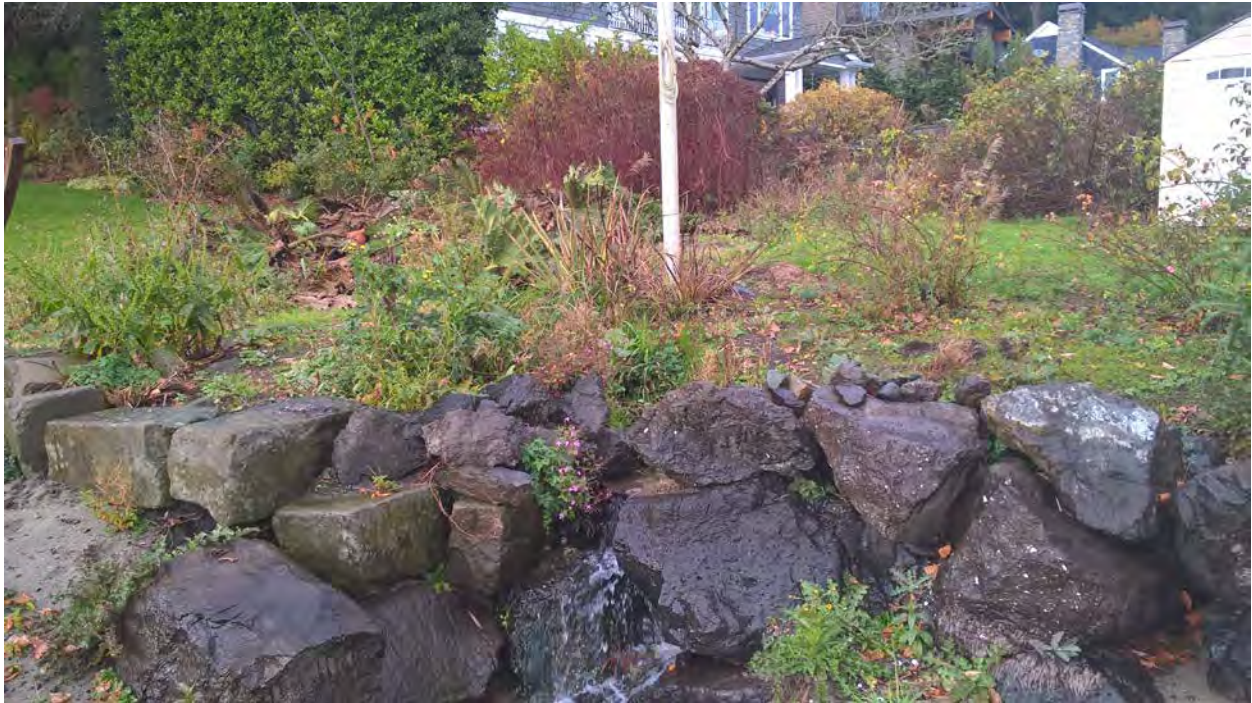
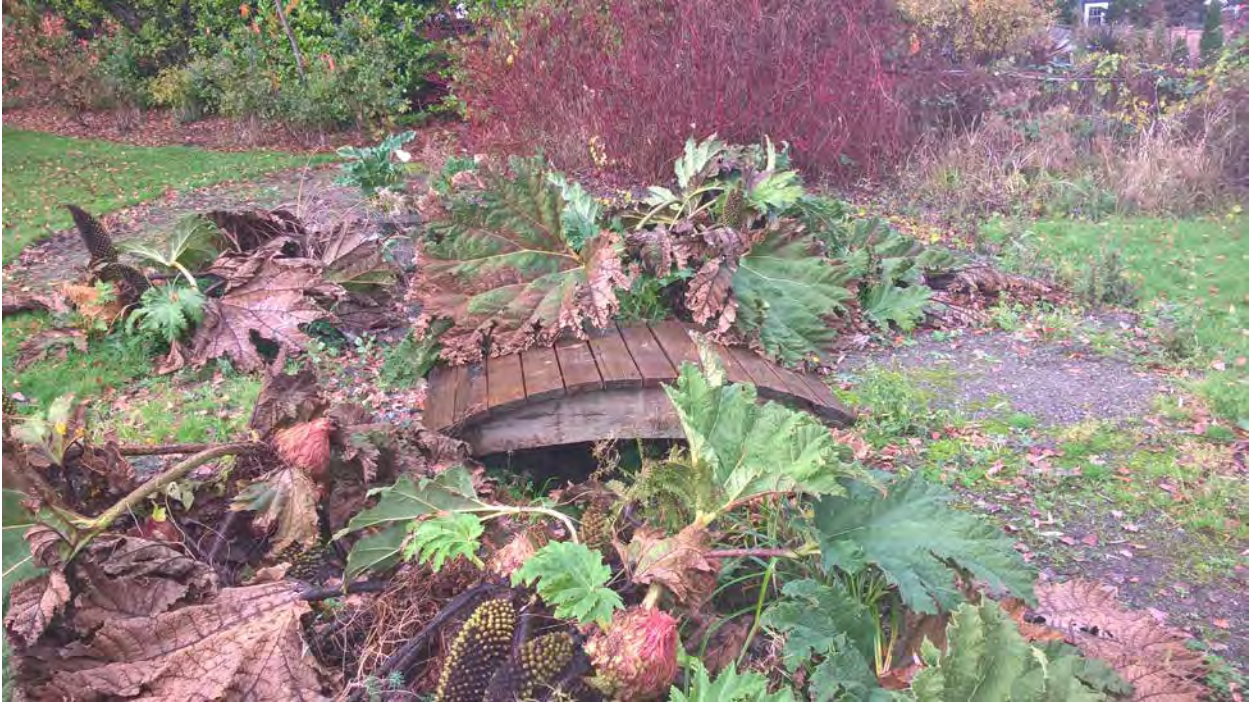
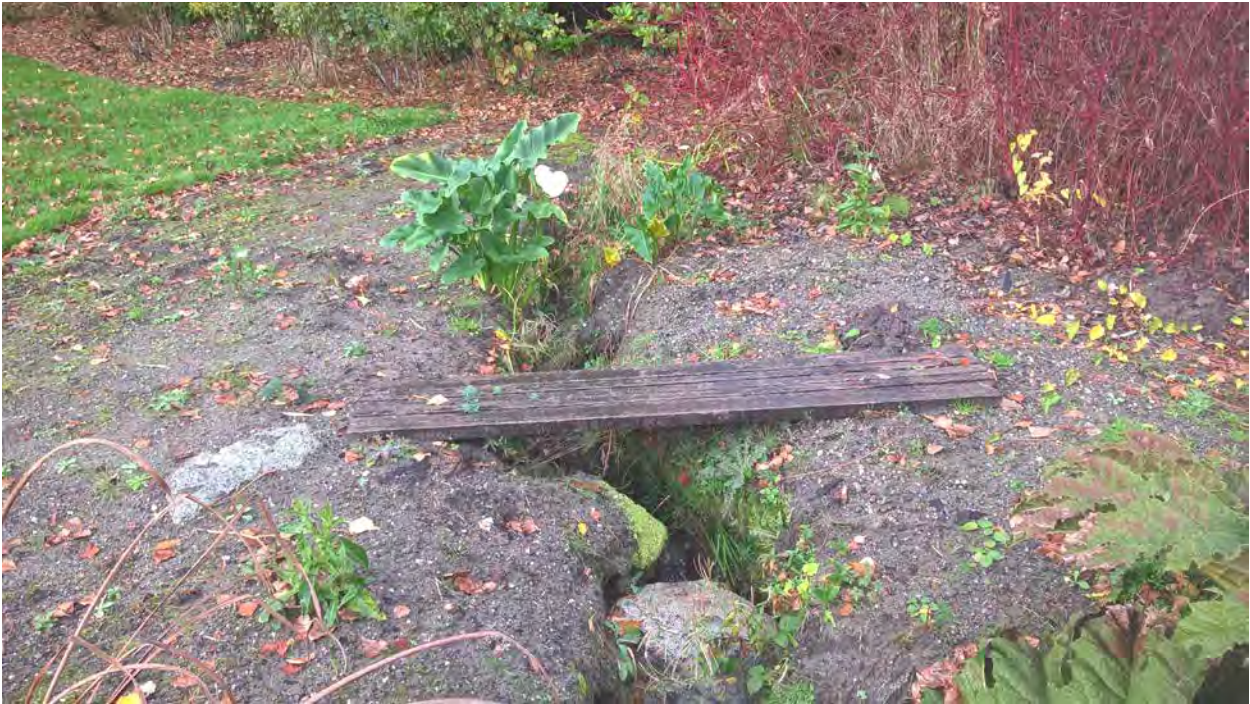
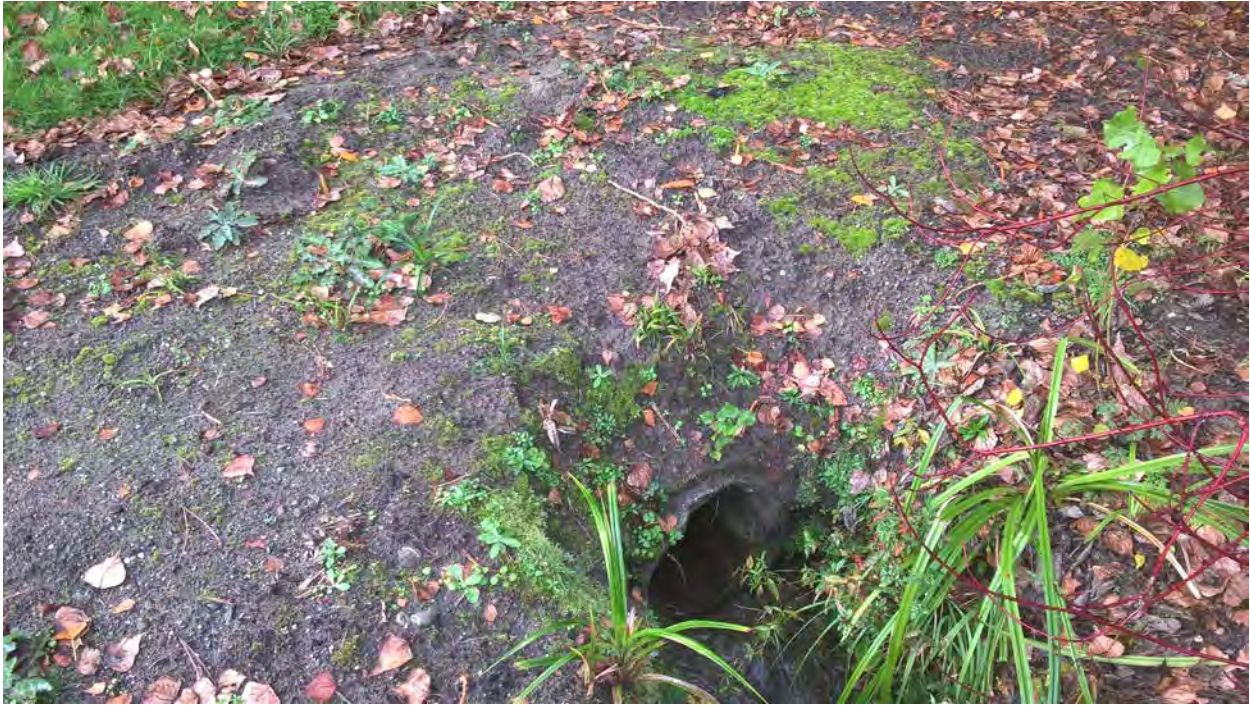
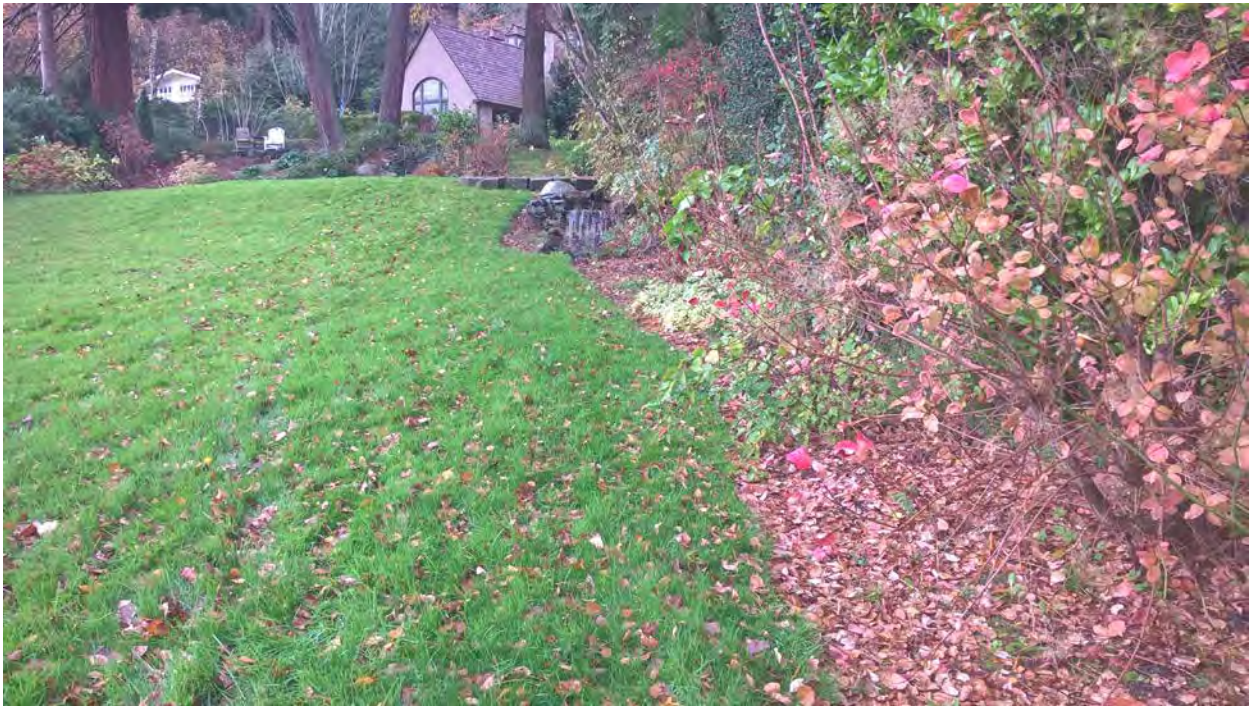
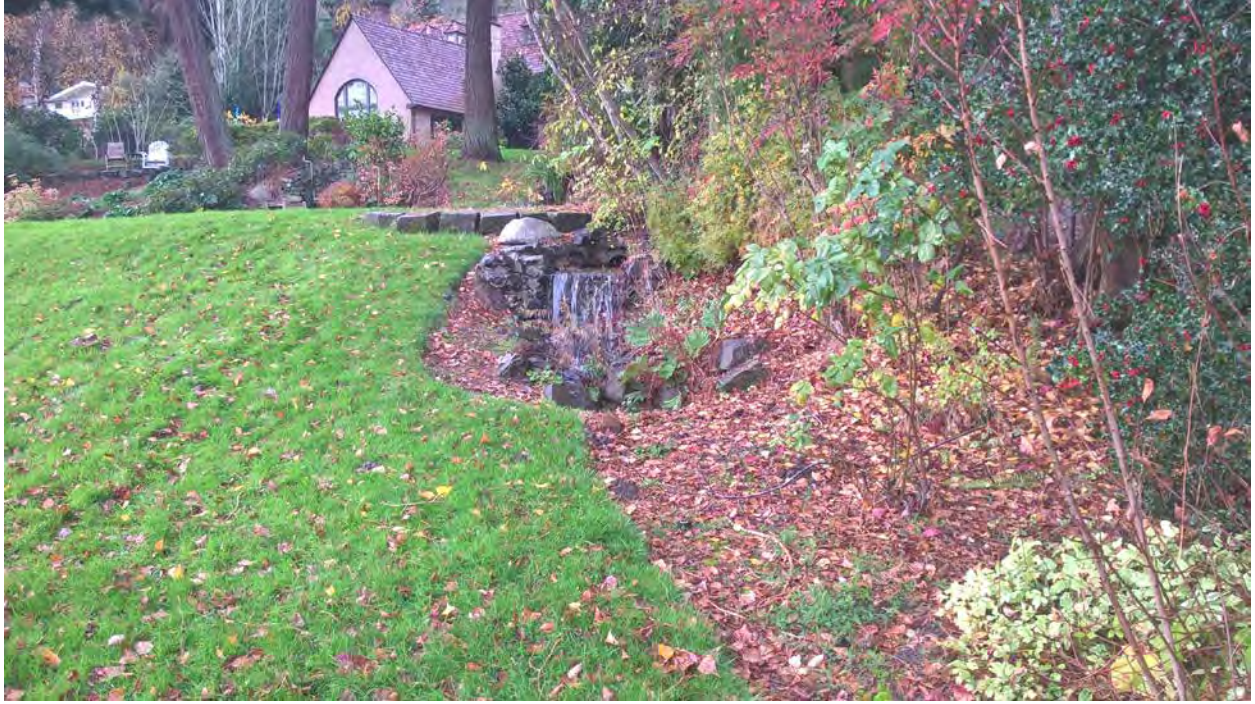
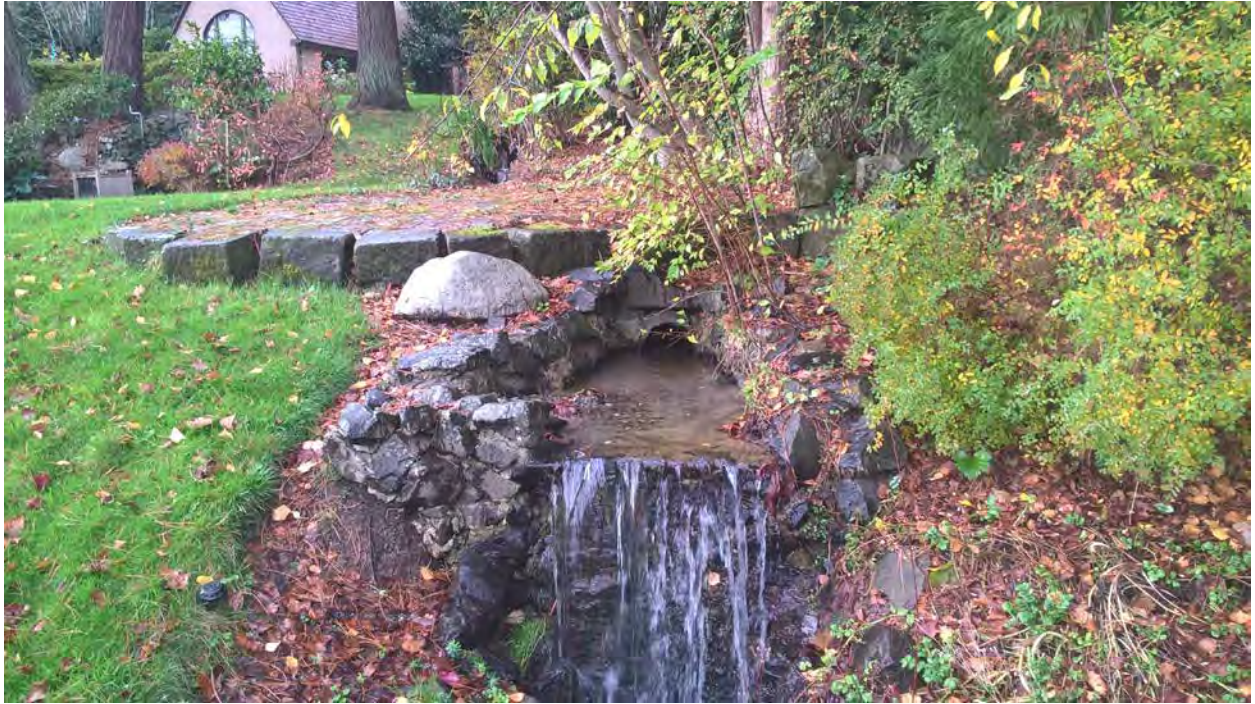
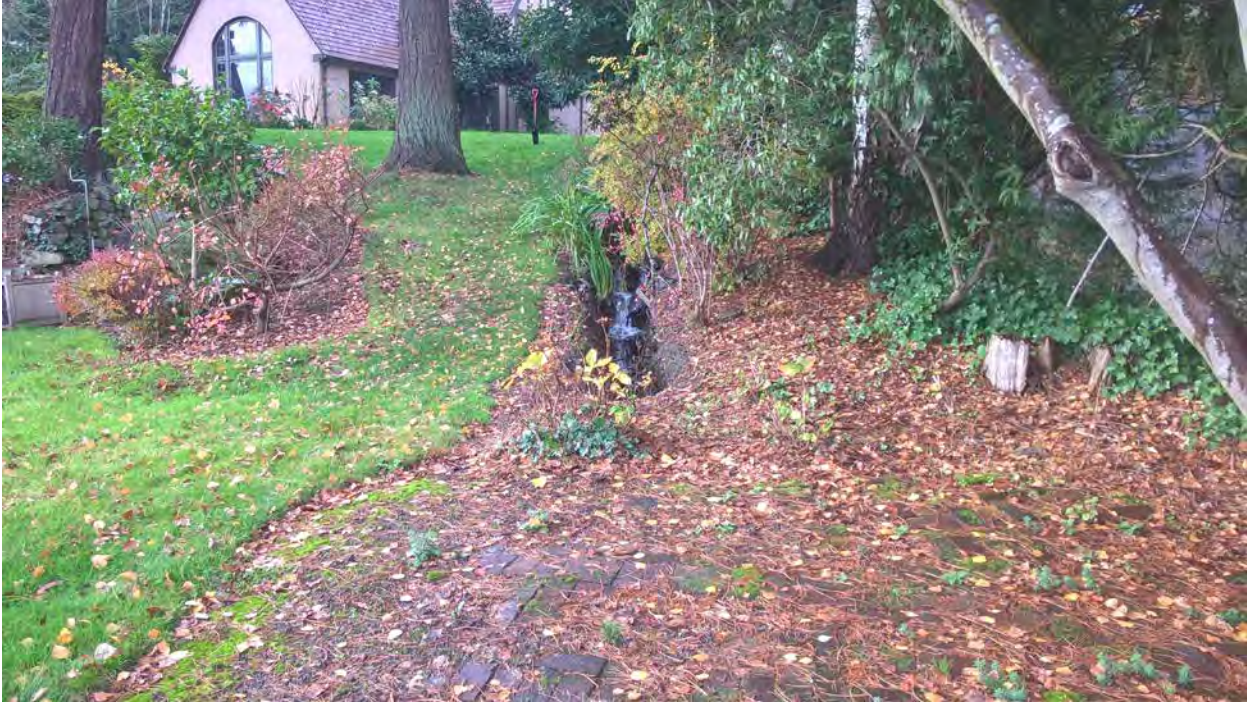
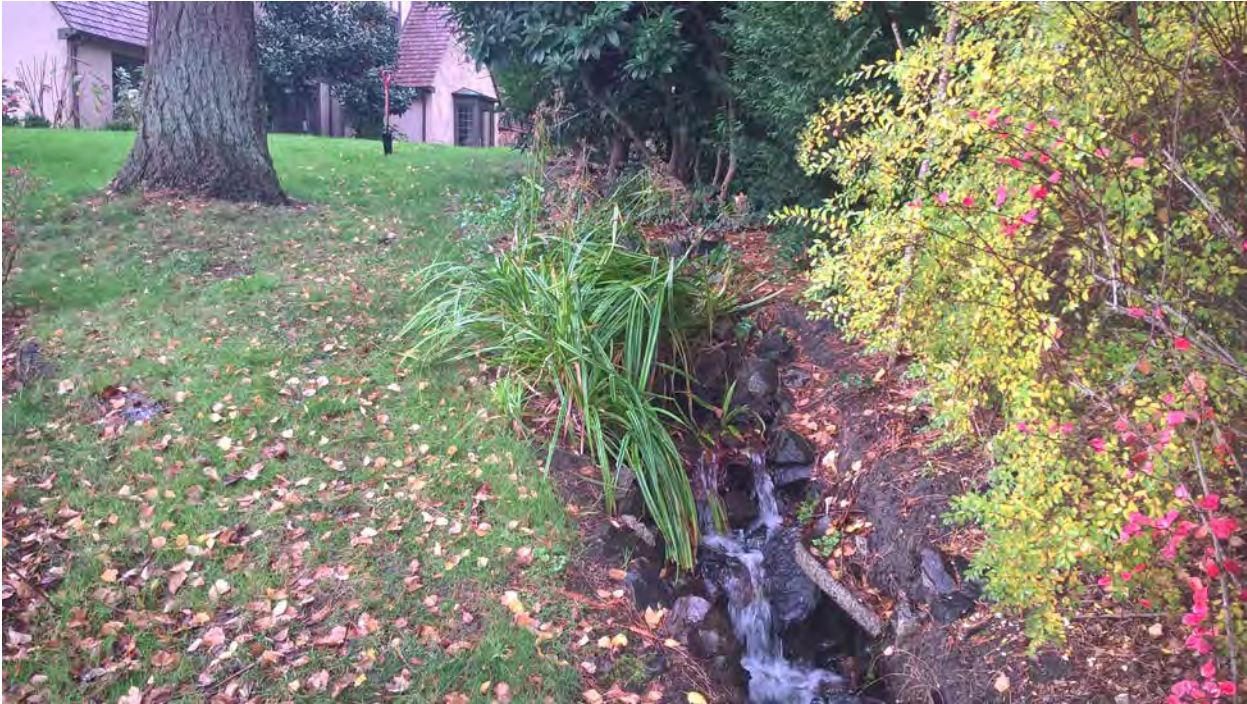
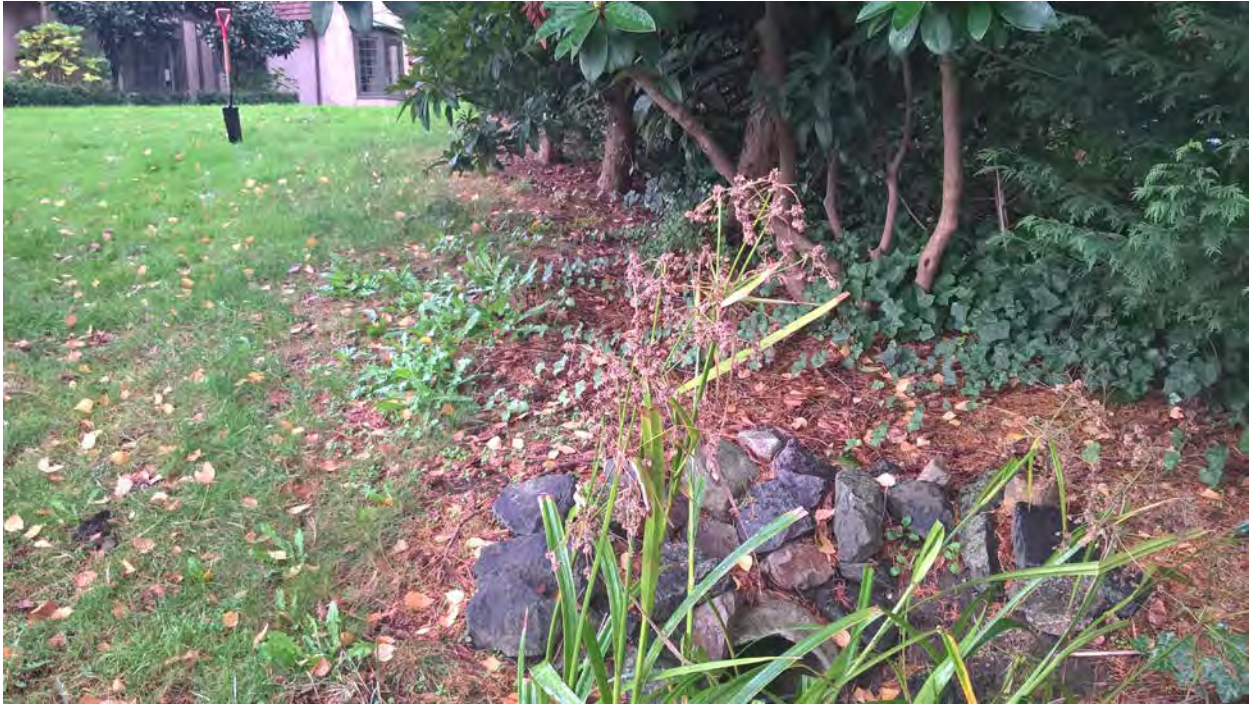
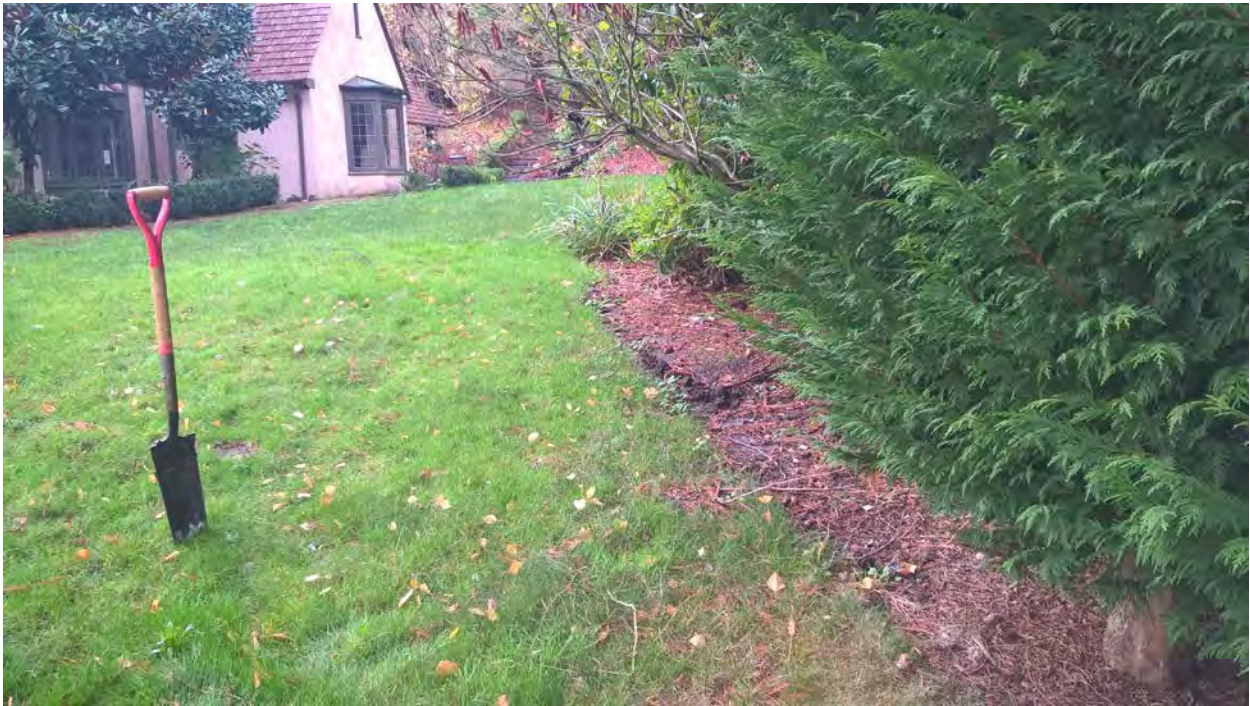
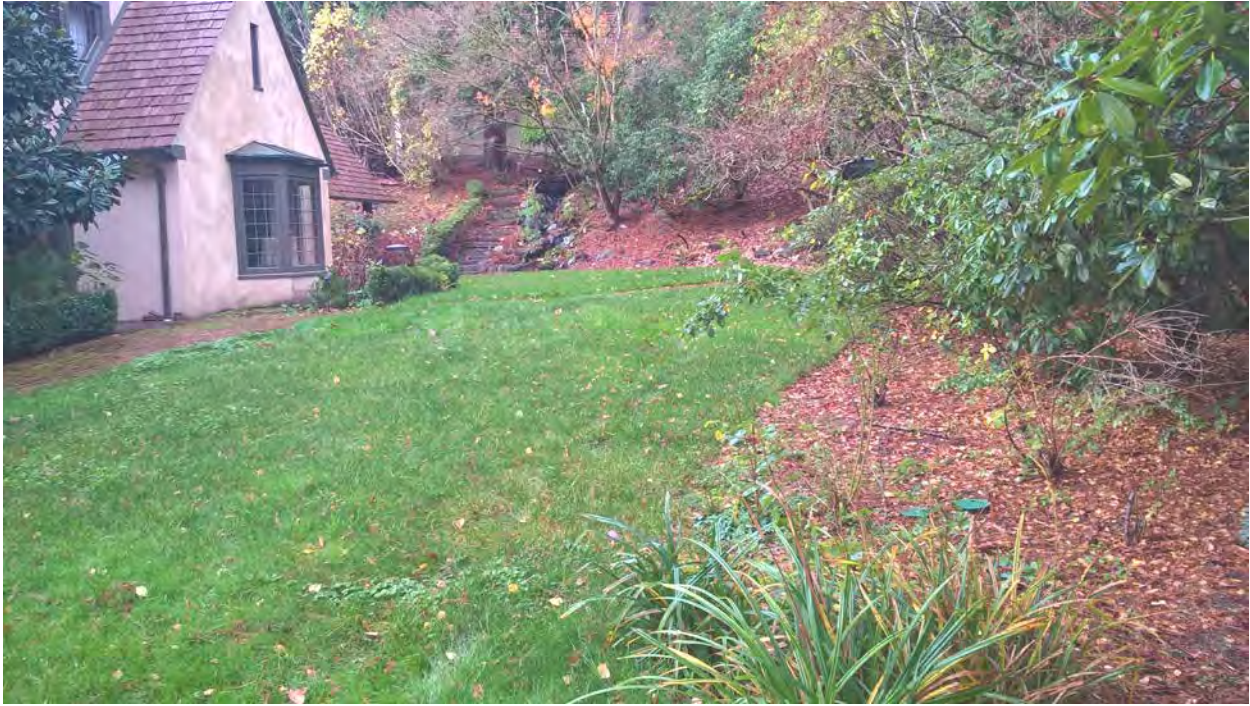
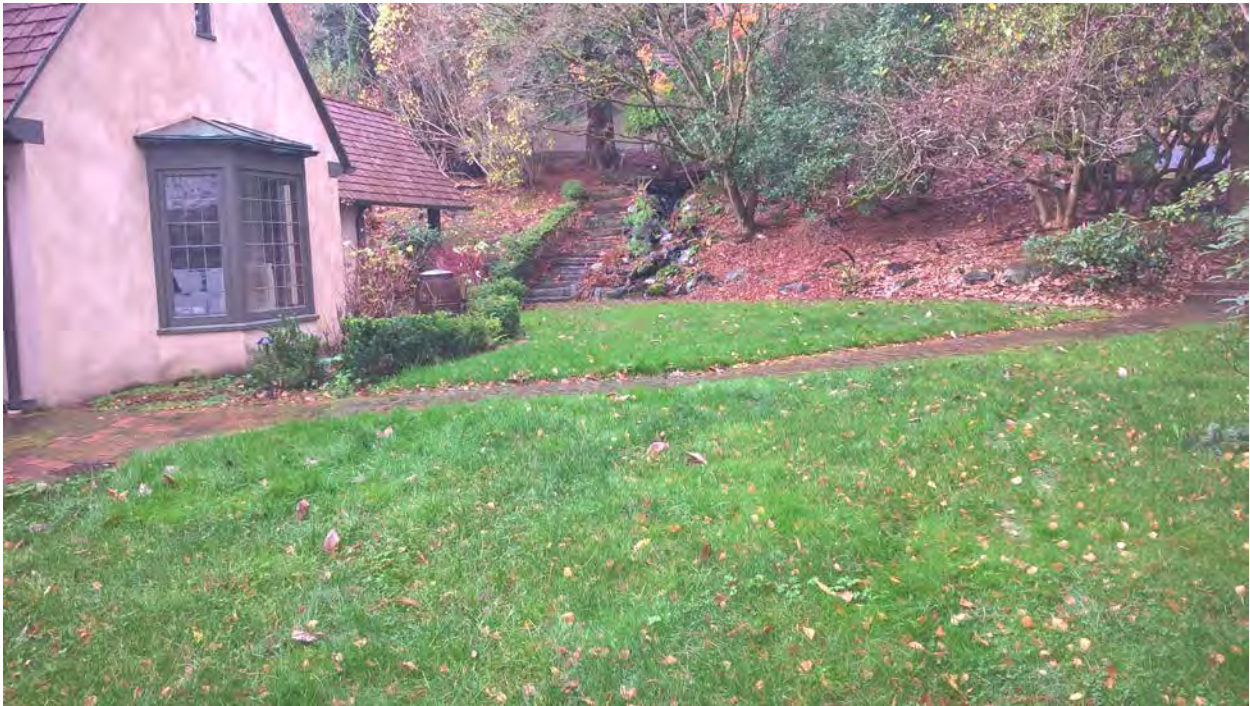
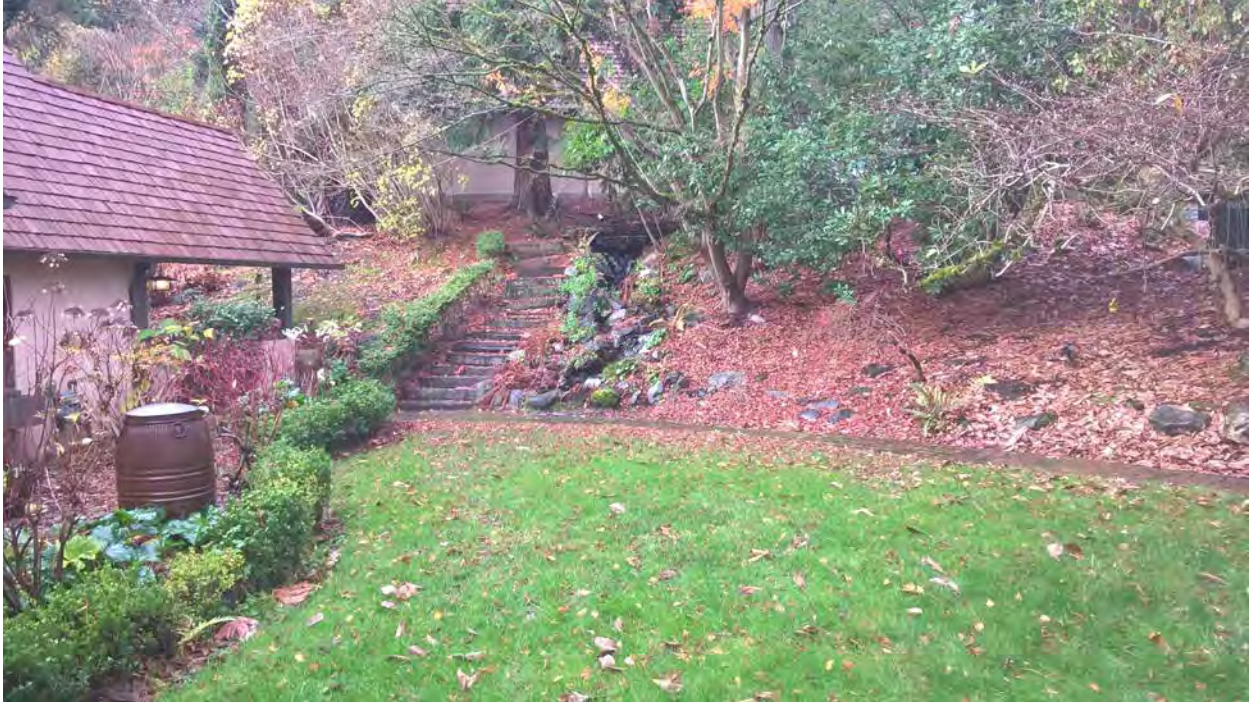
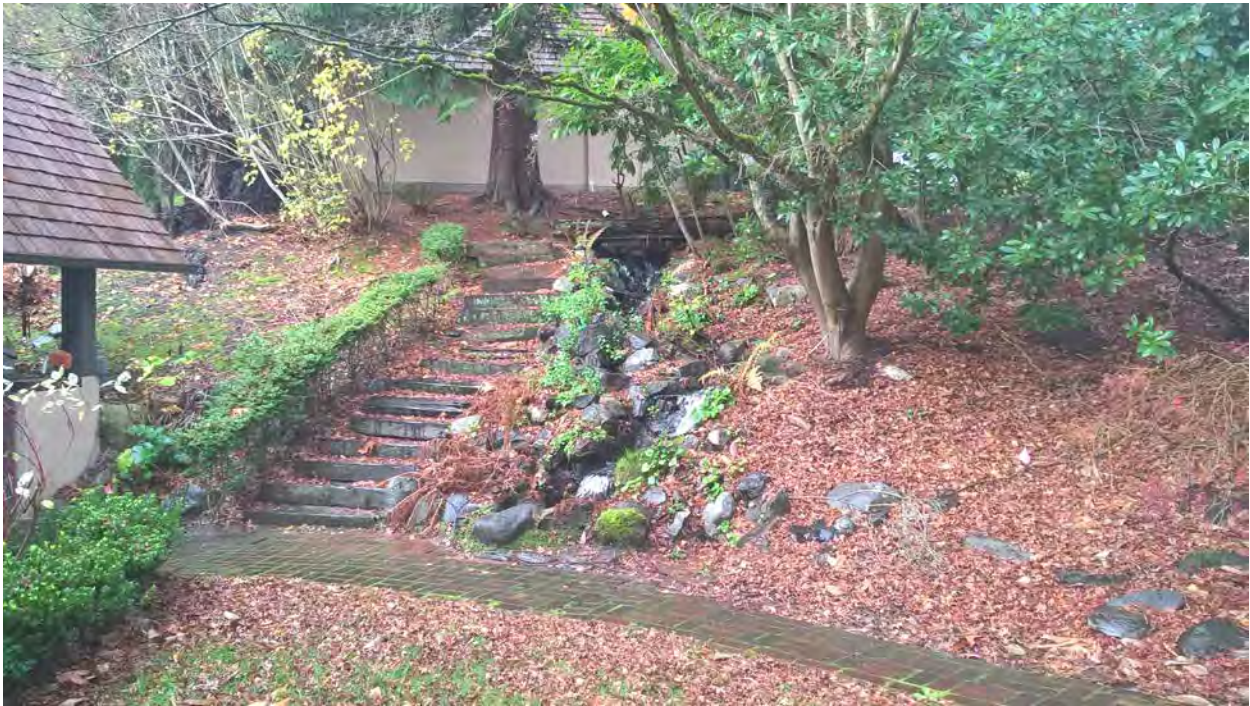
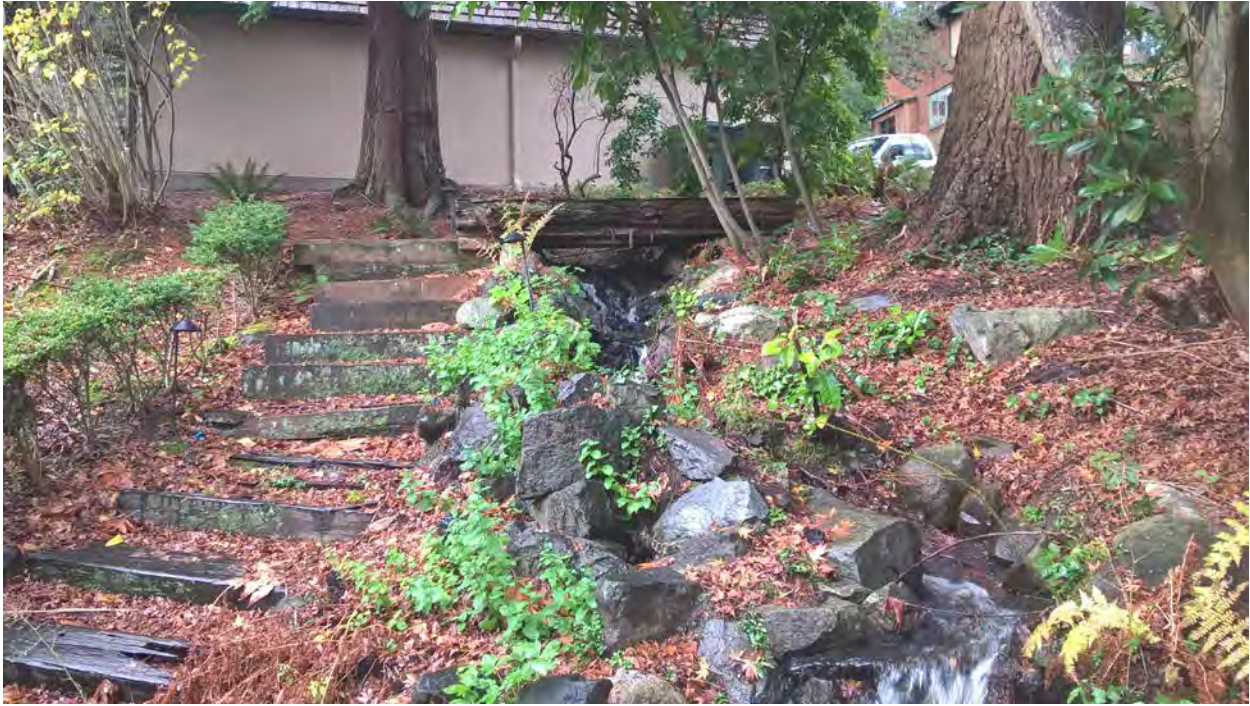
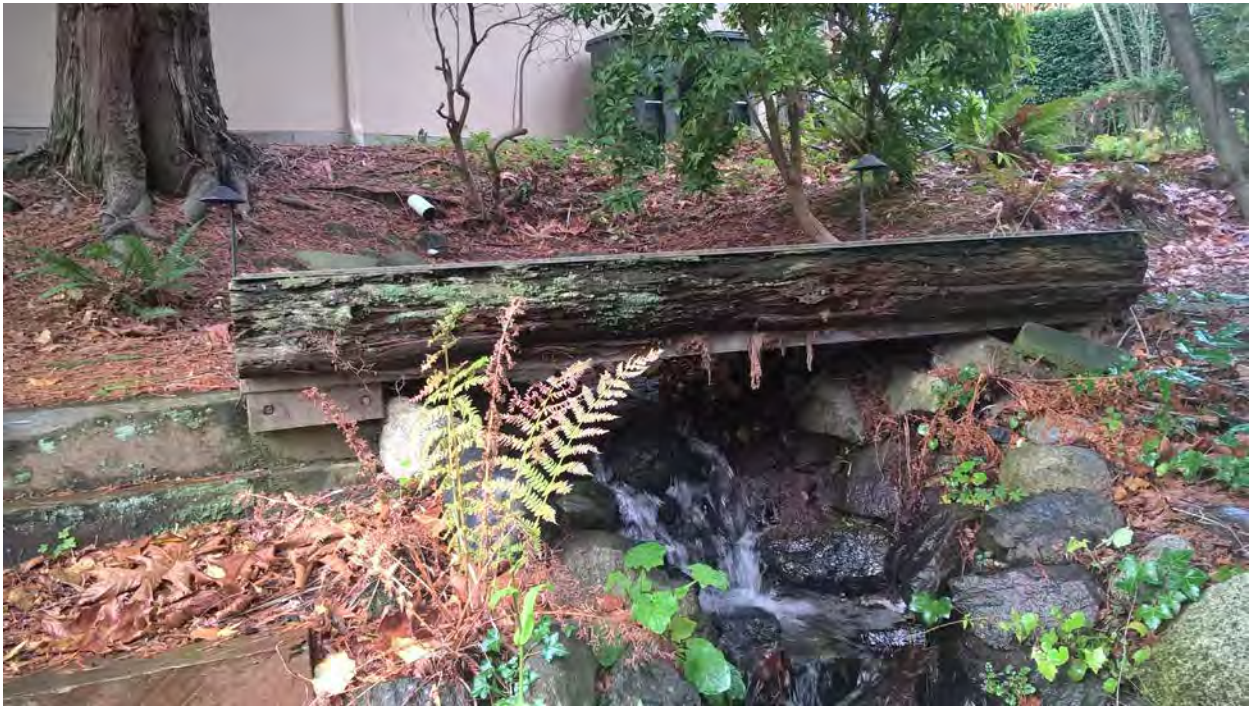
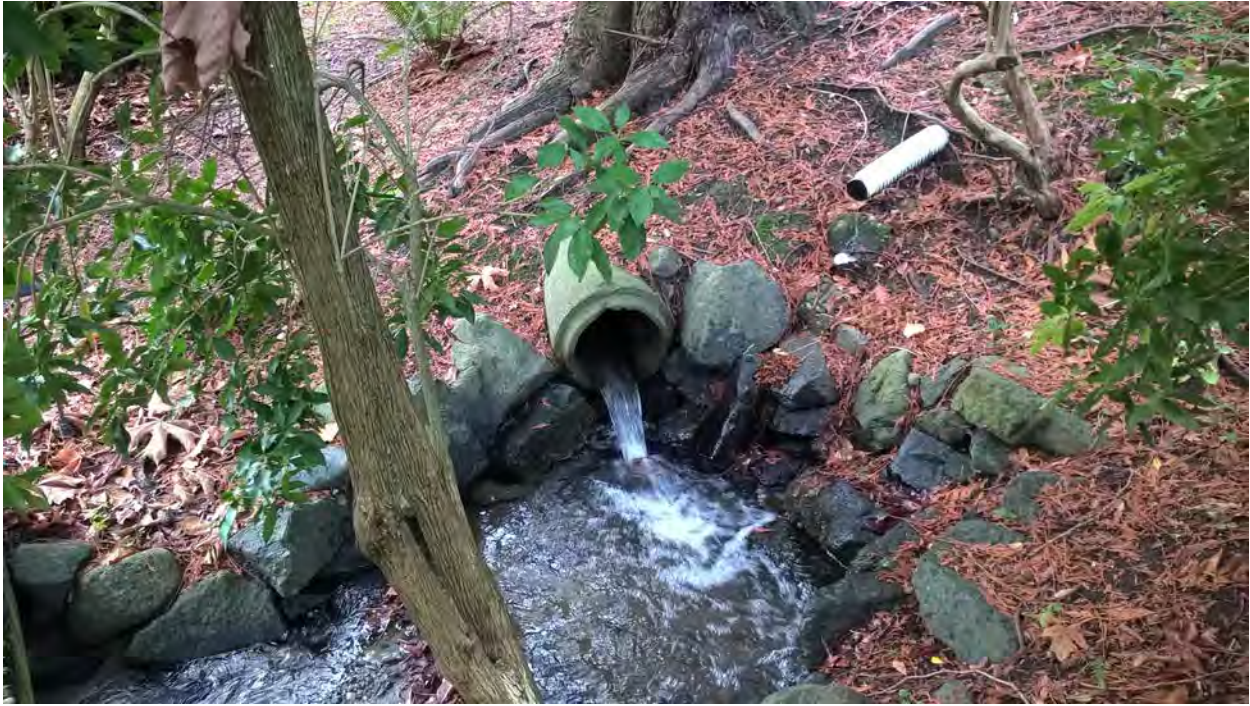
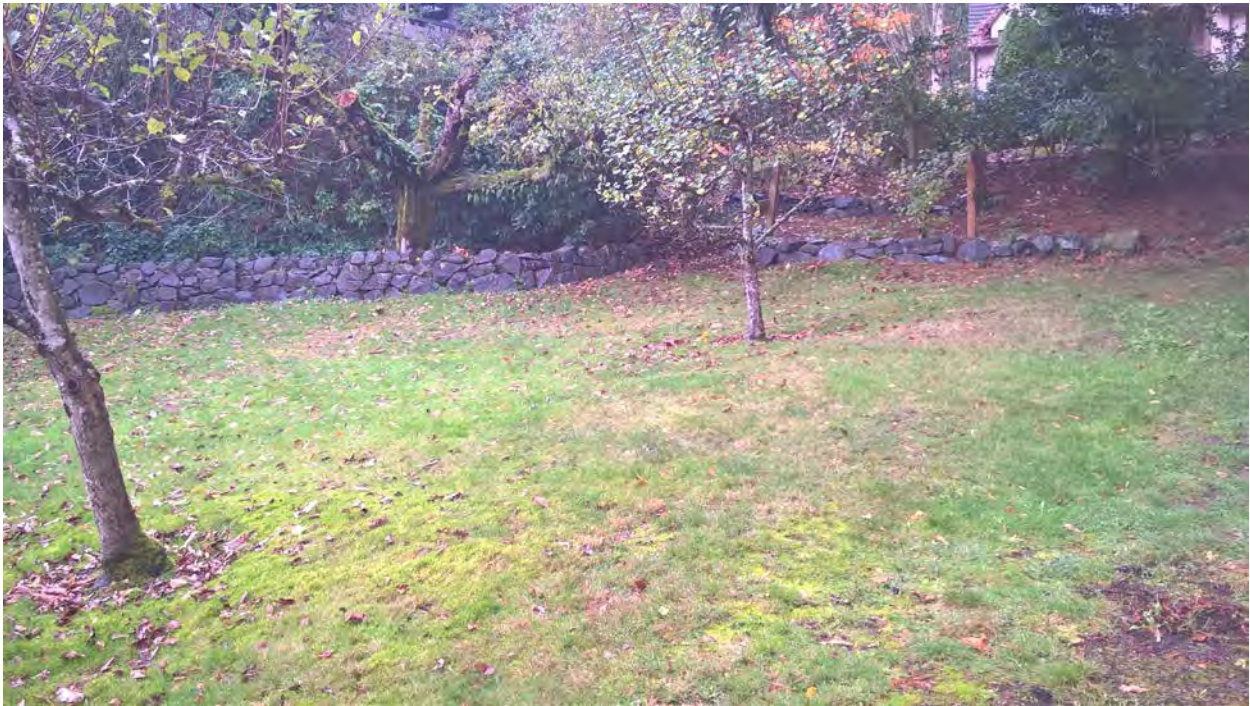
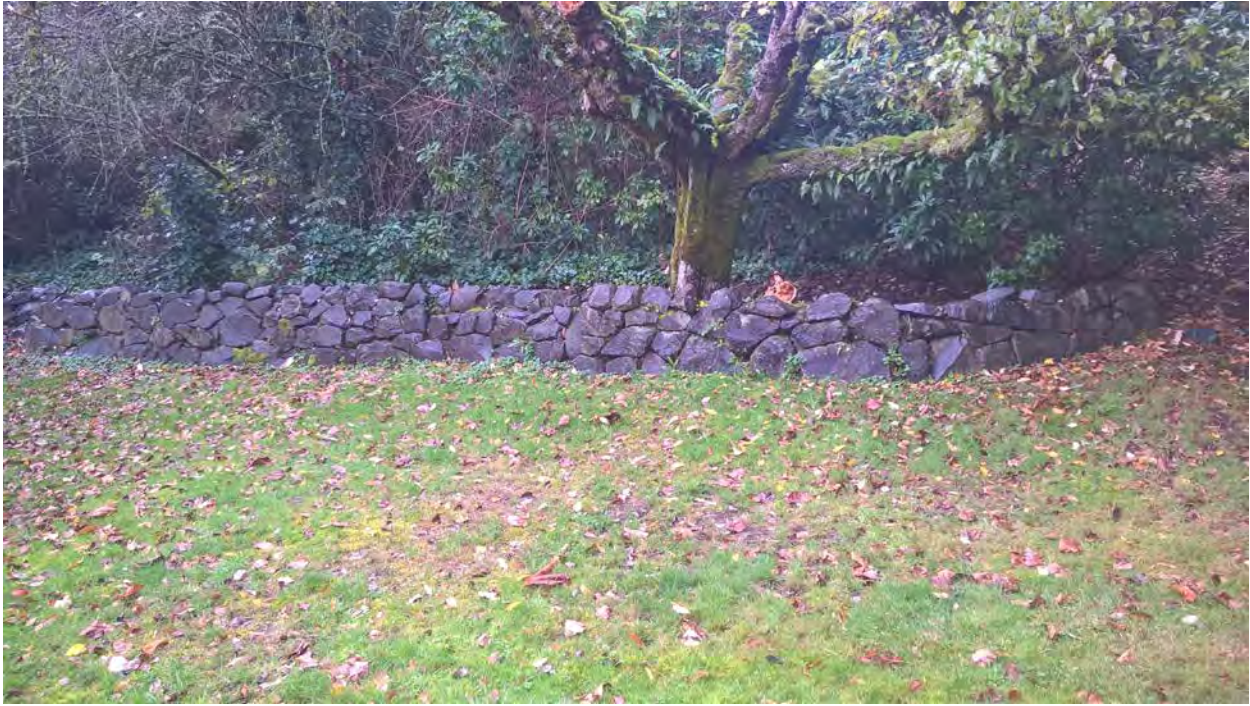
These photos were taken in sequence, approximately every 25 ft. upstream,
from where the stream flows into Lake Washington

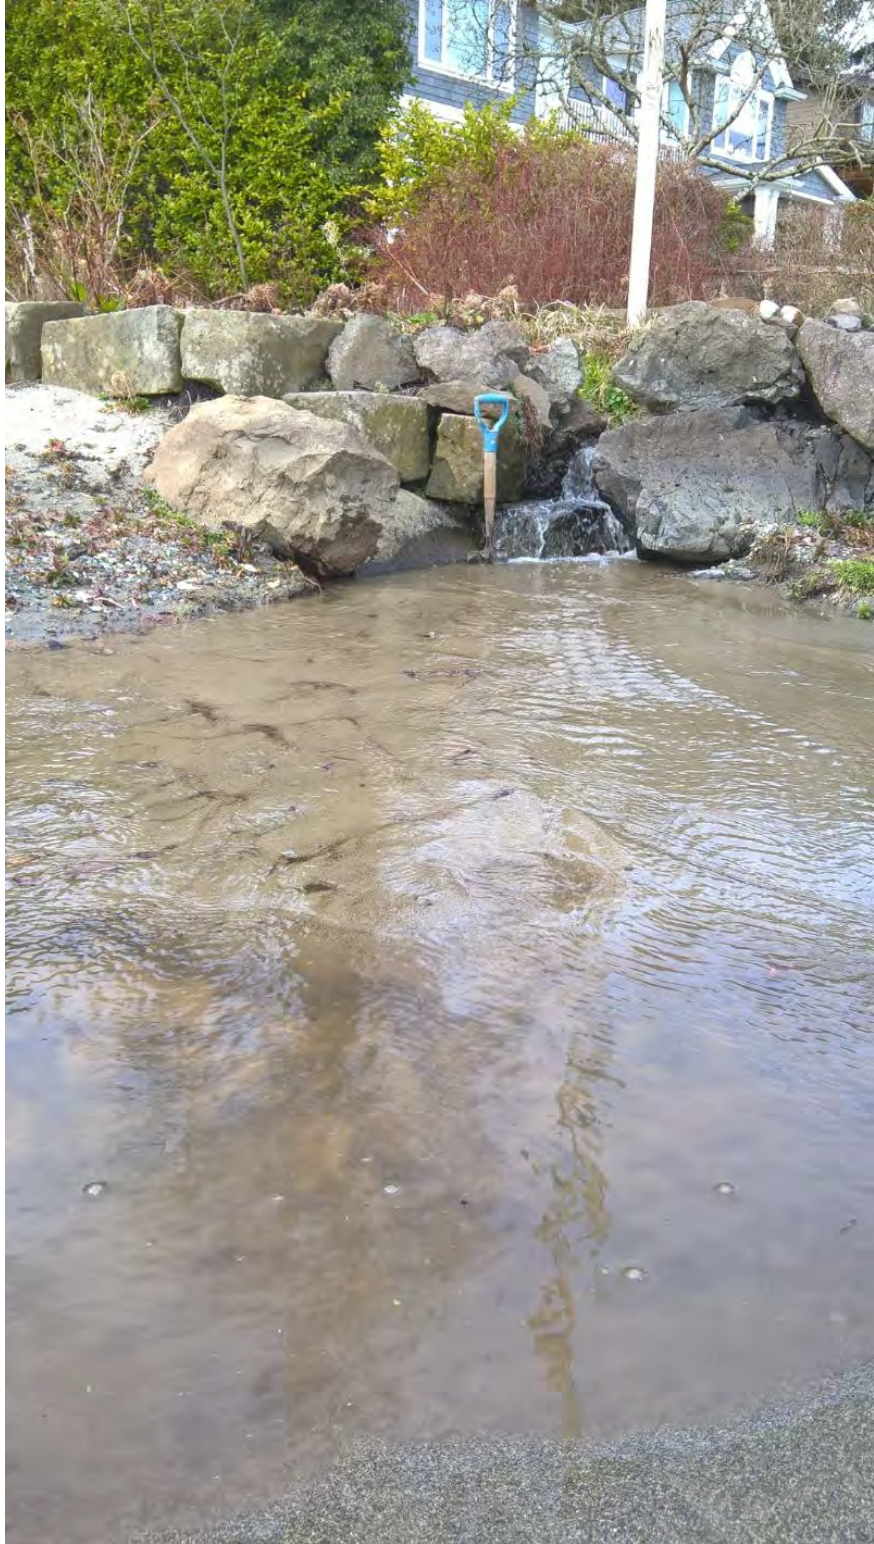
Photo 24 – Fish Blockage at OHWL

There is a two-foot rock drop at the beach, which makes the stream inaccessible to juvenile fish, see Photo 24. The water level of the lake rarely extends to the rock drop. The bottom of the drop is above the elevation of the OHWL of Lake Washington. The rock drop is impassable to fish, channel flows rates are about 1 inch depth, except in peak storm events when the velocity of the stream is high. Fish have never been observed in the ditch, including during October of 2016 and February of 2017, which had peak precipitation events. Even if fish could enter this open eroding ditch, the ditch is not a safe refuge, provides no habitat, and does not provide access to habitat upstream. Stream flows are intermittent some years.
