J. S. Jones and Associates, Inc.

***Critical Area Study
and
Watercourse and Wetland Buffer Reduction***
of the

Valentin Property
East of 4346 E. Mercer Way
Mercer Island, WA 98046

Dated: February 21, 2017
Revised: March 23, 2018

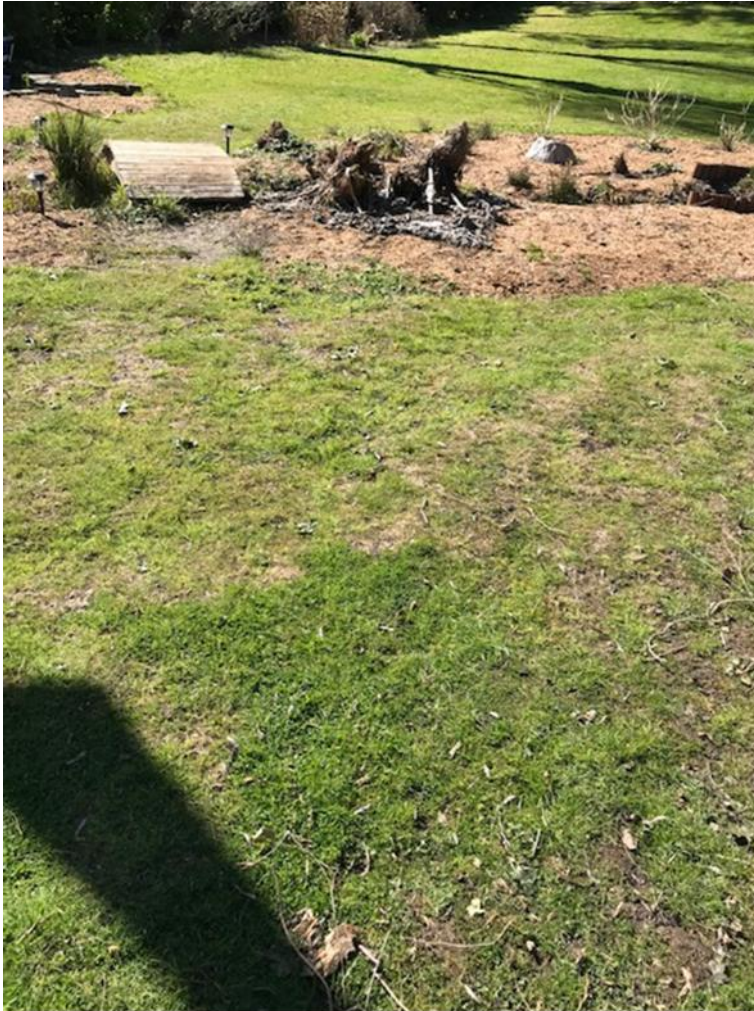
Figure 1: Wetland

The eastern portion of the lawn on parcel 004610-0150 is wetland, identified as Wetland A. Soils were observed to be saturated with a shallow perched water table. Prominent mottling and gleyed soils was observed at SL-3. The plant community is dominated by grasses, red-osier dogwood, and non-native shrubs. SL-1 and SL-2 lack hydric soils characteristics. The wetland boundary is

defined by the extent of saturated soils, topography and a low rock bulkhead. Below the bulkhead is a sand beach.

The wetland is rated as a Category IV, with a standard 35-foot buffer requirement, according to Section 19.07.080.C of the MICC.

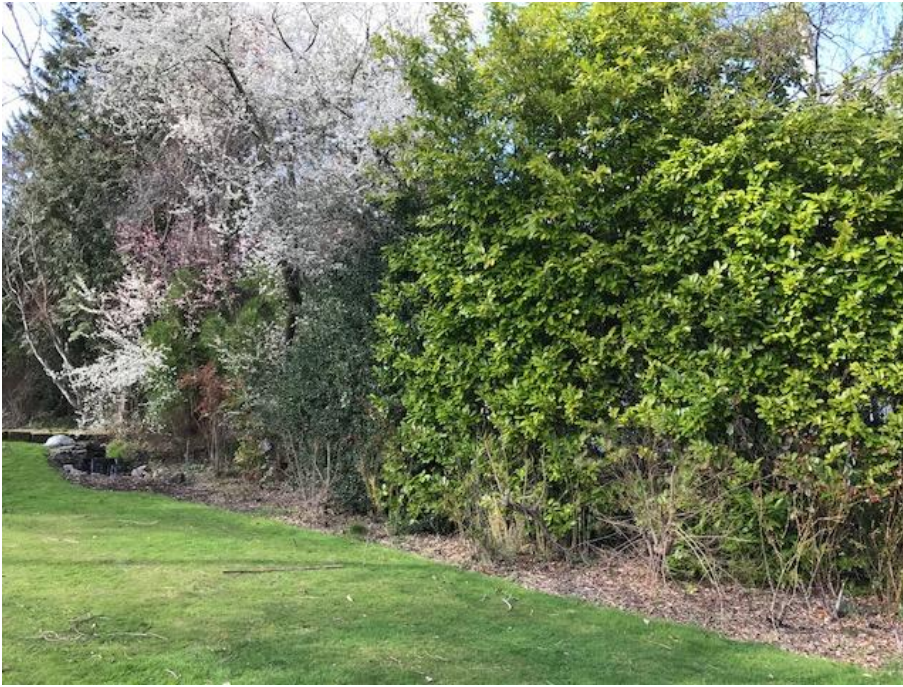
Figure 2: Natural Vegetation Barrier

The critical areas serving the wetland and watercourse are mostly surrounded by lawn or landscaped areas. The north portion of the critical area buffer consists of trees forming a natural barrier to the adjacent property. Tree species include white paper birch, plum, western red cedar as well as pacific rhododendron, roses and holly. There is an English laurel hedge along this area. See picture below. The understory consists of English ivy and ornamental plantings. Closest to the lake there is a significant weeping willow. Existing buffer intrusions include a permanent coal-fired brick/stone/steel BBQ structure within the watercourse buffer and a 150 square feet large brick patio on top of the piped watercourse (See pictures below).
