**Critical Area Study
and
Watercourse and Wetland Buffer Reduction
of the**

Valentin Property
East of 4346 E. Mercer Way
Mercer Island, WA 98046

Dated: February 21, 2017
Revised: March 23, 2018
Revised June 7, 2018
Revised July 20, 2018

Prepared by:
Jeffery S. Jones, Professional Wetland Scientist

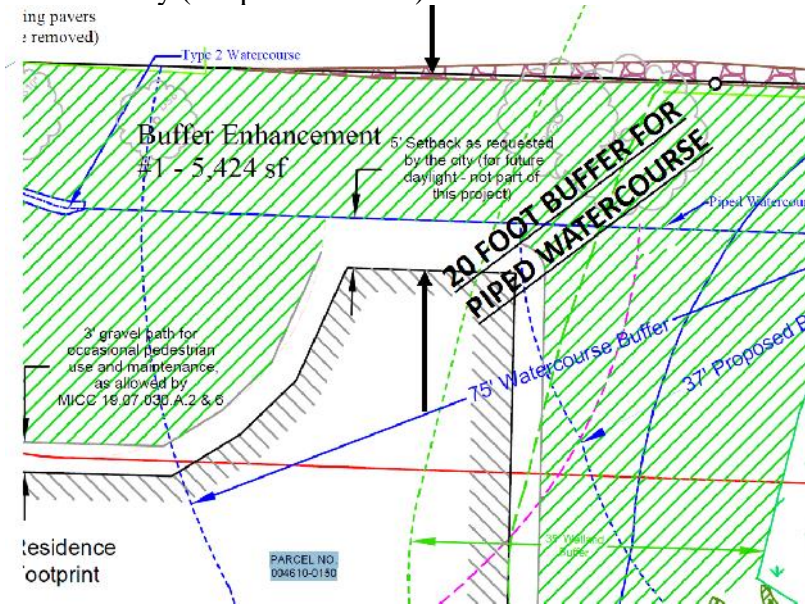
Figure 5: 20 foot wide buffer and five foot setback for potential future daylighting

1. The piped watercourse will be in a 20 foot wide area between the building envelope and the northern property line (The City's planning director had originally proposed placing the stream in a 10 foot area which would have allowed for only a maximum of five feet on each side).
2. The five foot setback/distance from the piped watercourse to the building envelope is limited to 18 feet (see picture below).
3. The slope is 1" per foot, and so the area in question is relatively flat (see picture below).
4. The depth of the pipe is less than three inches, and so is almost at the surface level already today (see picture below).

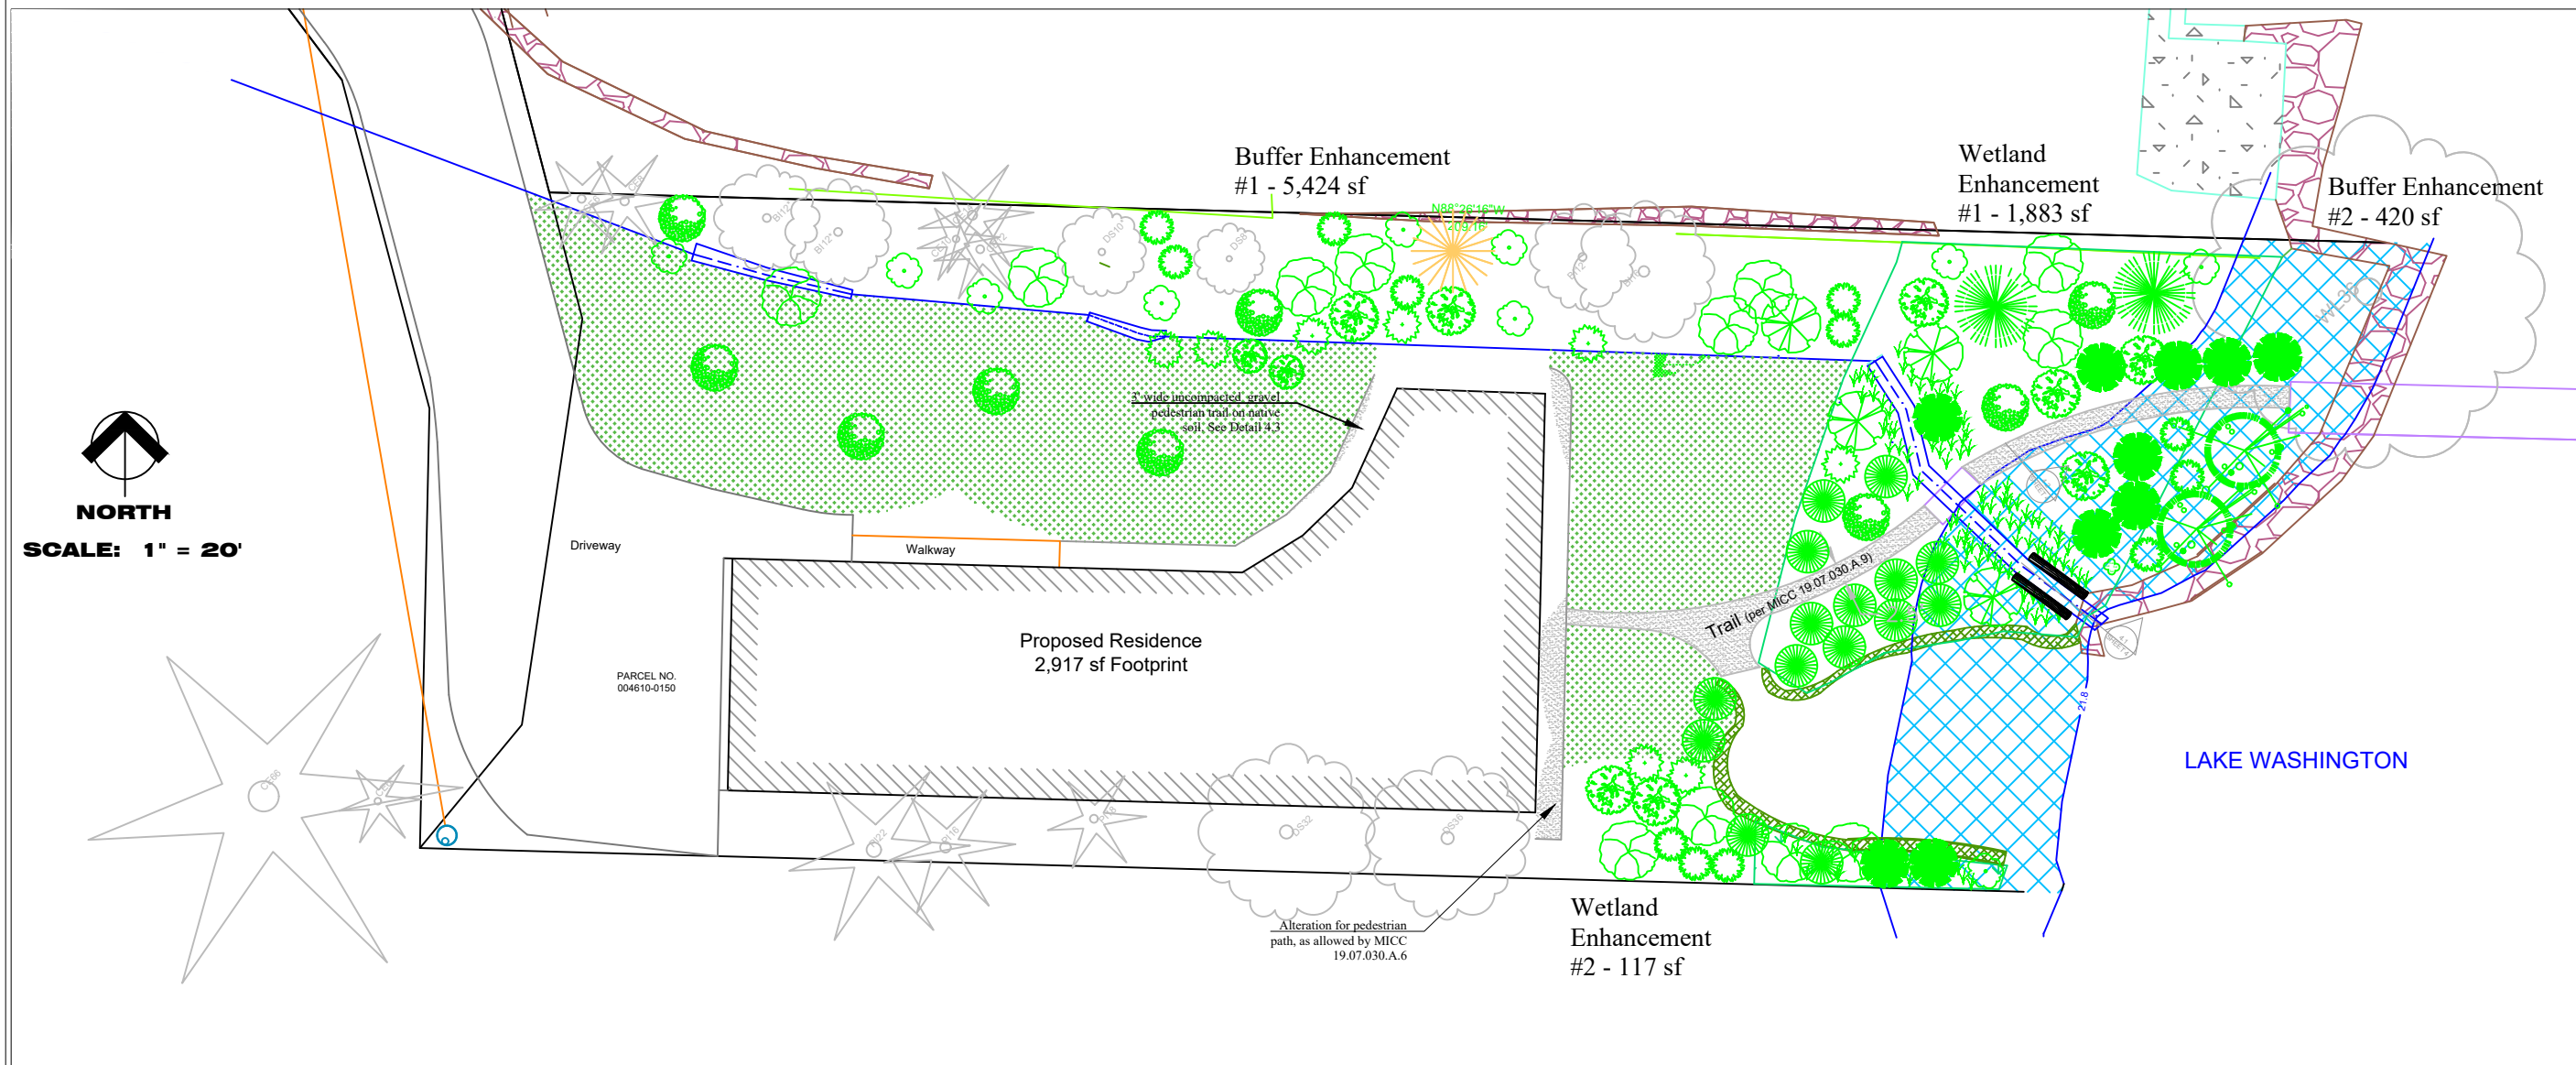
PROJECT: **Existing Condition**
STREAM BUFFER ENHANCEMENT PLAN
TAX PARCEL ID NO.: 004610-0150, 004610-0151, & 004610-0159

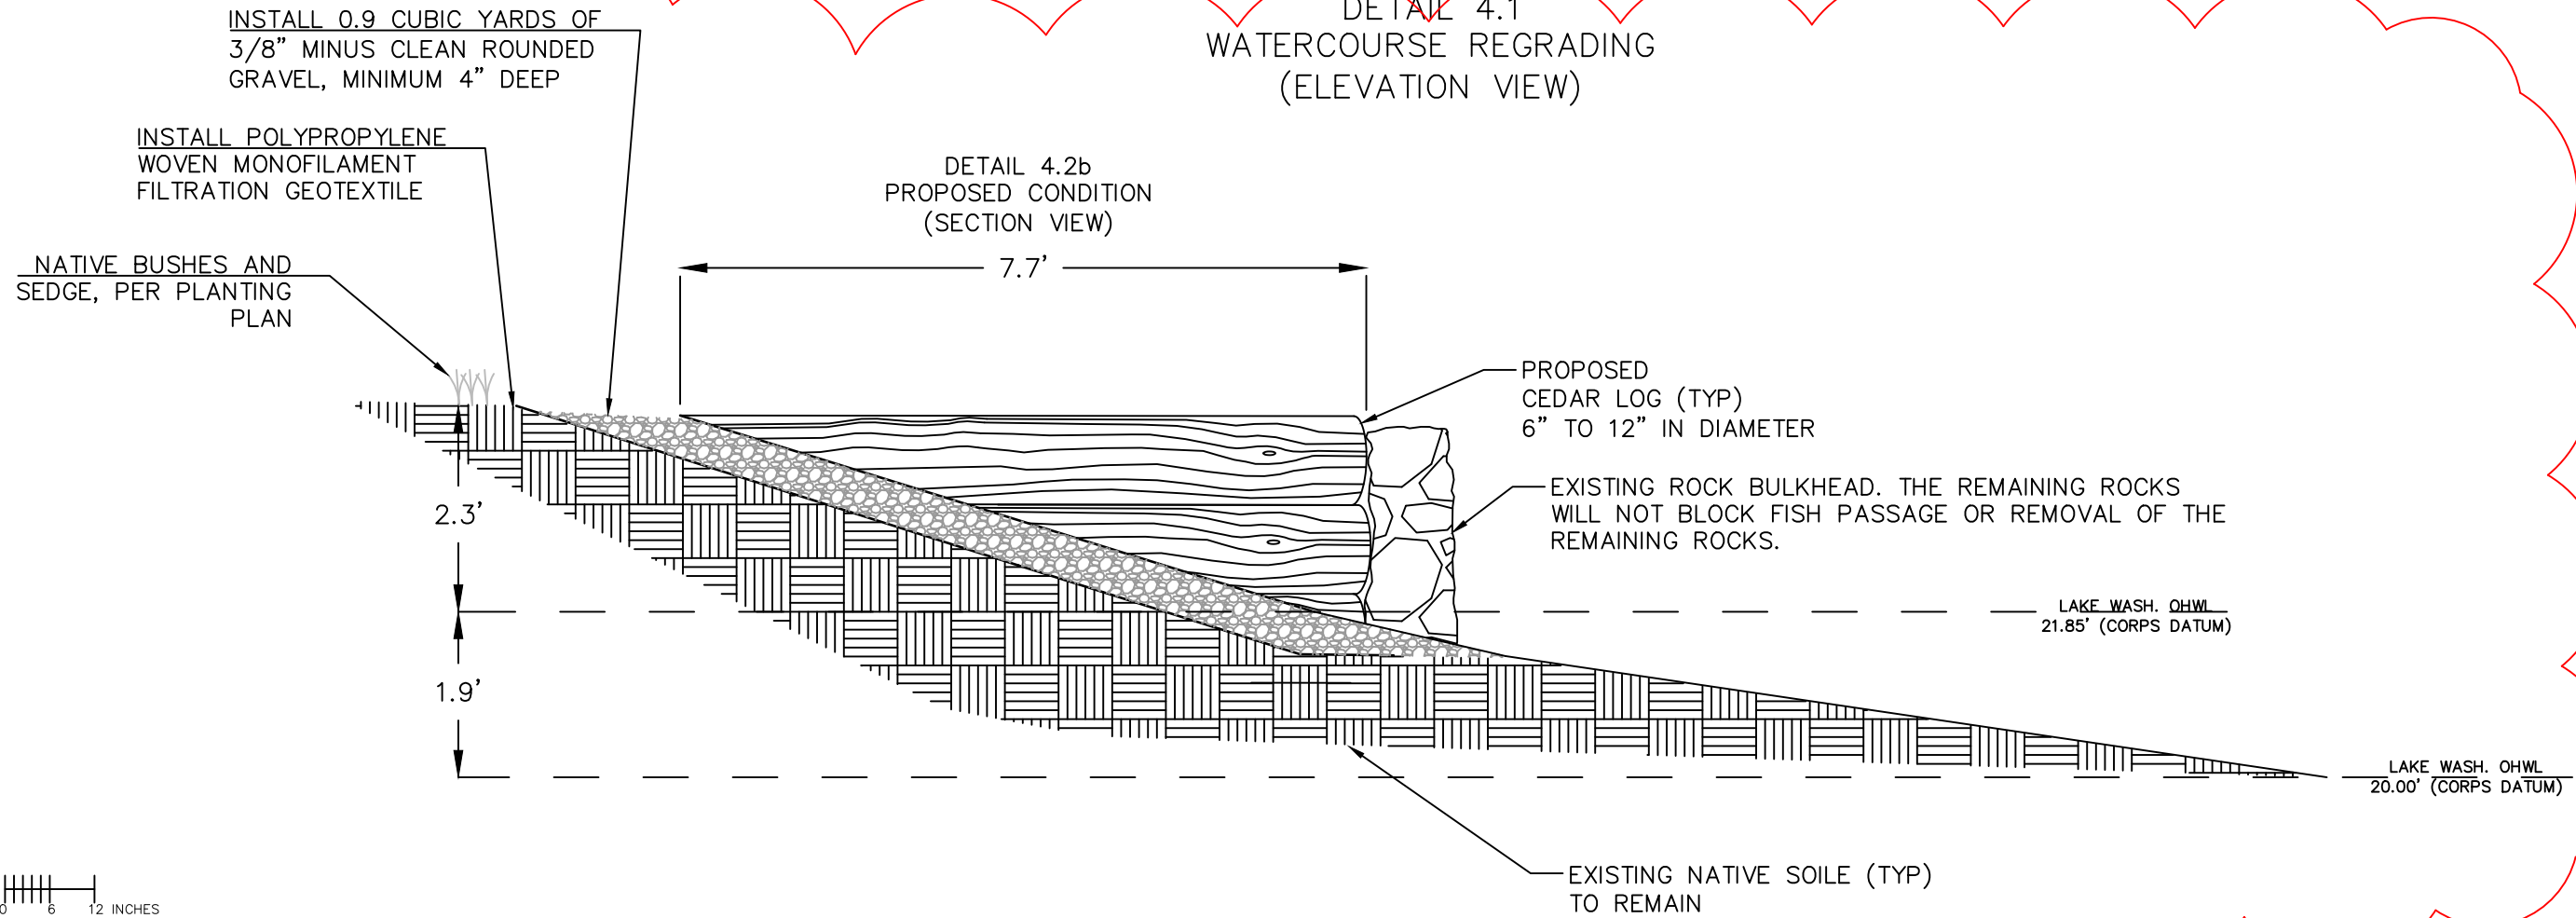
DETAIL 4.1 WATERCOURSE REGRADING (ELEVATION VIEW)

1. For portion of watercourse within 9 feet of the OHWM, temporarily divert watercourse through plastic corrugated pipe;
2. Excavate 2 cubic yards (8 ft long x 4 ft wide x 0 to 2.3 ft deep);
3. Place cedar logs, 6" to 12" in diameter (soft material) along each side of existing watercourse channel, within 8 feet of the OHWM (see Detail 4.1);
4. Backfill behind cedar logs with native soil, as necessary;
5. Grade watercourse channel, per Detail 4.1, within 8 feet of the OHWM;
6. Install polypropylene woven monofilament filtration geotextile on portion of graded watercourse, per Detail 4.1;
7. Place 4" spawning gravel on top of polypropylene woven monofilament filtration geotextile, per Detail 4.1;
8. Remove plastic corrugated pipe, and ensure water flows to regraded watercourse channel.
