SHEET #	SHEET TITLE
WI.0	EXISTING CONDITIONS PLAN
WI.1	PROPOSED SITE PLAN, IMPACTS & MITIGATION PLAN
WI.2	PLANTING PLAN, SCHEDULE, NOTES & DETAILS
WI.3	PLANTING SPECIFICATIONS
WI.4	EAGLE MANAGEMENT, MONITORING PLAN, & BONDING ESTIMATE

**CRITICAL AREAS MITIGATION PLAN
 PROPOSED SITE PLAN, IMPACTS & MITIGATION PLAN
 HOU PROPERTY
 MERCER ISLAND, WA**

CRITICAL AREAS MITIGATION PLAN
PLANTING PLAN, SCHEDULE, NOTES & DETAILS
HOU PROPERTY
MERCER ISLAND, WA

**CRITICAL AREAS MITIGATION PLAN
 EAGLE MANAGEMENT, MONITORING PLAN, & BONDING ESTIMATE
 HOU PROPERTY
 MERCER ISLAND, WA**

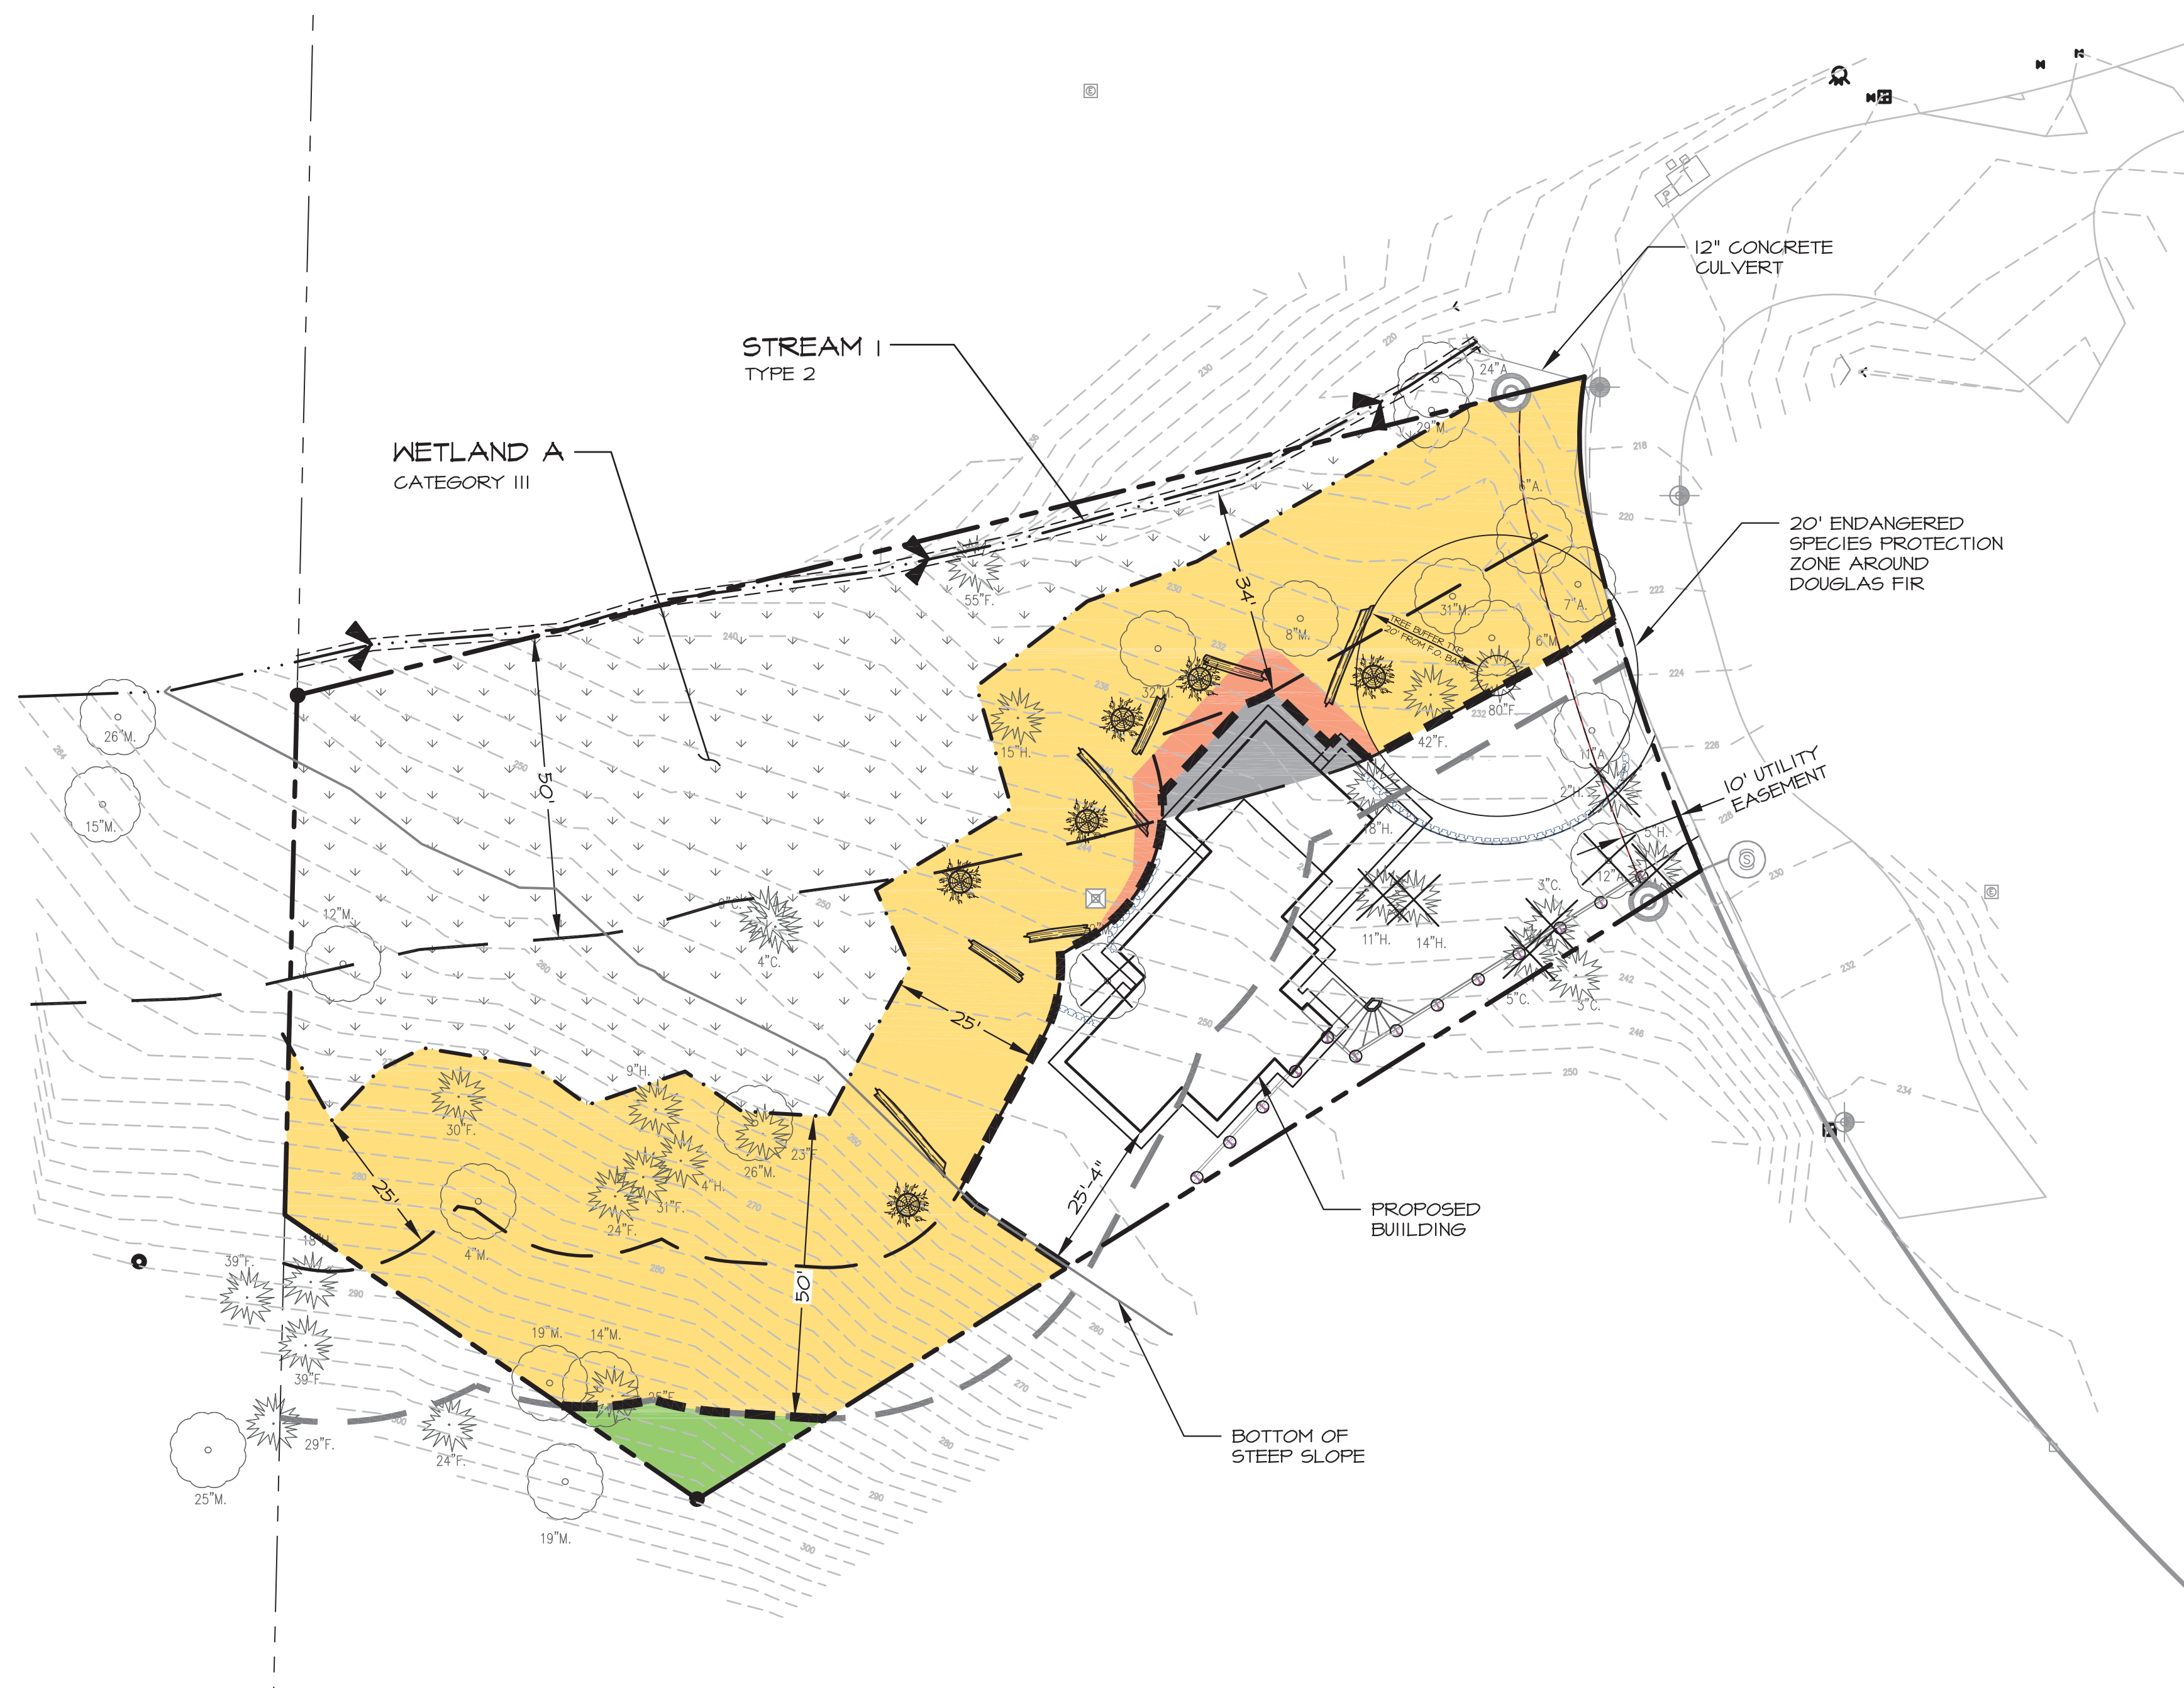
PROPOSED SITE PLAN, IMPACTS & MITIGATION PLAN

BUFFER REDUCTION	354 SF
	BUFFER REPLACEMENT	333 SF
	TEMPORARY CONSTRUCTION IMPACTS	351 SF

WETLAND BUFFER ENHANCEMENT	10,376 SF
	RESTORED BUFFER	351 SF
	LARGE WOODY DEBRIS

*DURING CONSTRUCTION HEDERA HELIX WILL BE FIELD LOCATED AND REMOVED IN ENHANCEMENT AREAS. ALL INVASIVE WEEDS WILL BE DISPOSED OF OFF SITE.
