REFERENCE: Review Comments for File No. CAO17-010 – Hou Critical Areas Determination 4825 E Mercer Way, Mercer Island, WA 98040; King County Tax Parcel #216200-0070

CRITICAL AREAS REPORT

HOU PROPERTY MERCER ISLAND, WASHINGTON

30 July 2007
(Revised 19 July 2017)
(Revised 15 January 2019)

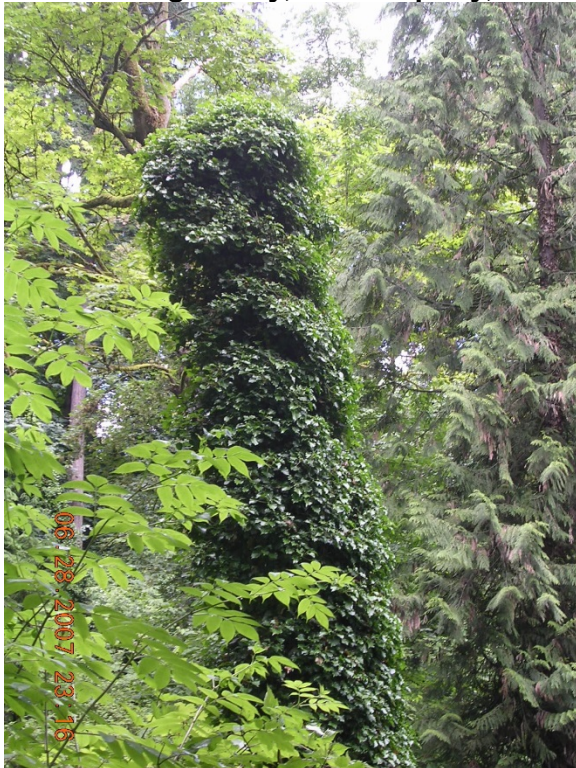
Photo 1: English Ivy, Hou Property, Mercer Island, Washington

The invasive English ivy (*Hedera helix*) is classified as a Class C Noxious Weed of Concern in King County. Removal of on-site English ivy will be achieved through manual control. Manual control consists of cutting/prying accessible vines off trees, removing all accessible flowers and seed heads, hand pulling/digging out plants, and mulching areas of ivy removal with an 8" thick mulch layer. Mulching will only occur on areas not located on steep slopes. The following photo (**Photo 1**), dated 28 June 2007, is representative of the on-site invasive species conditions.

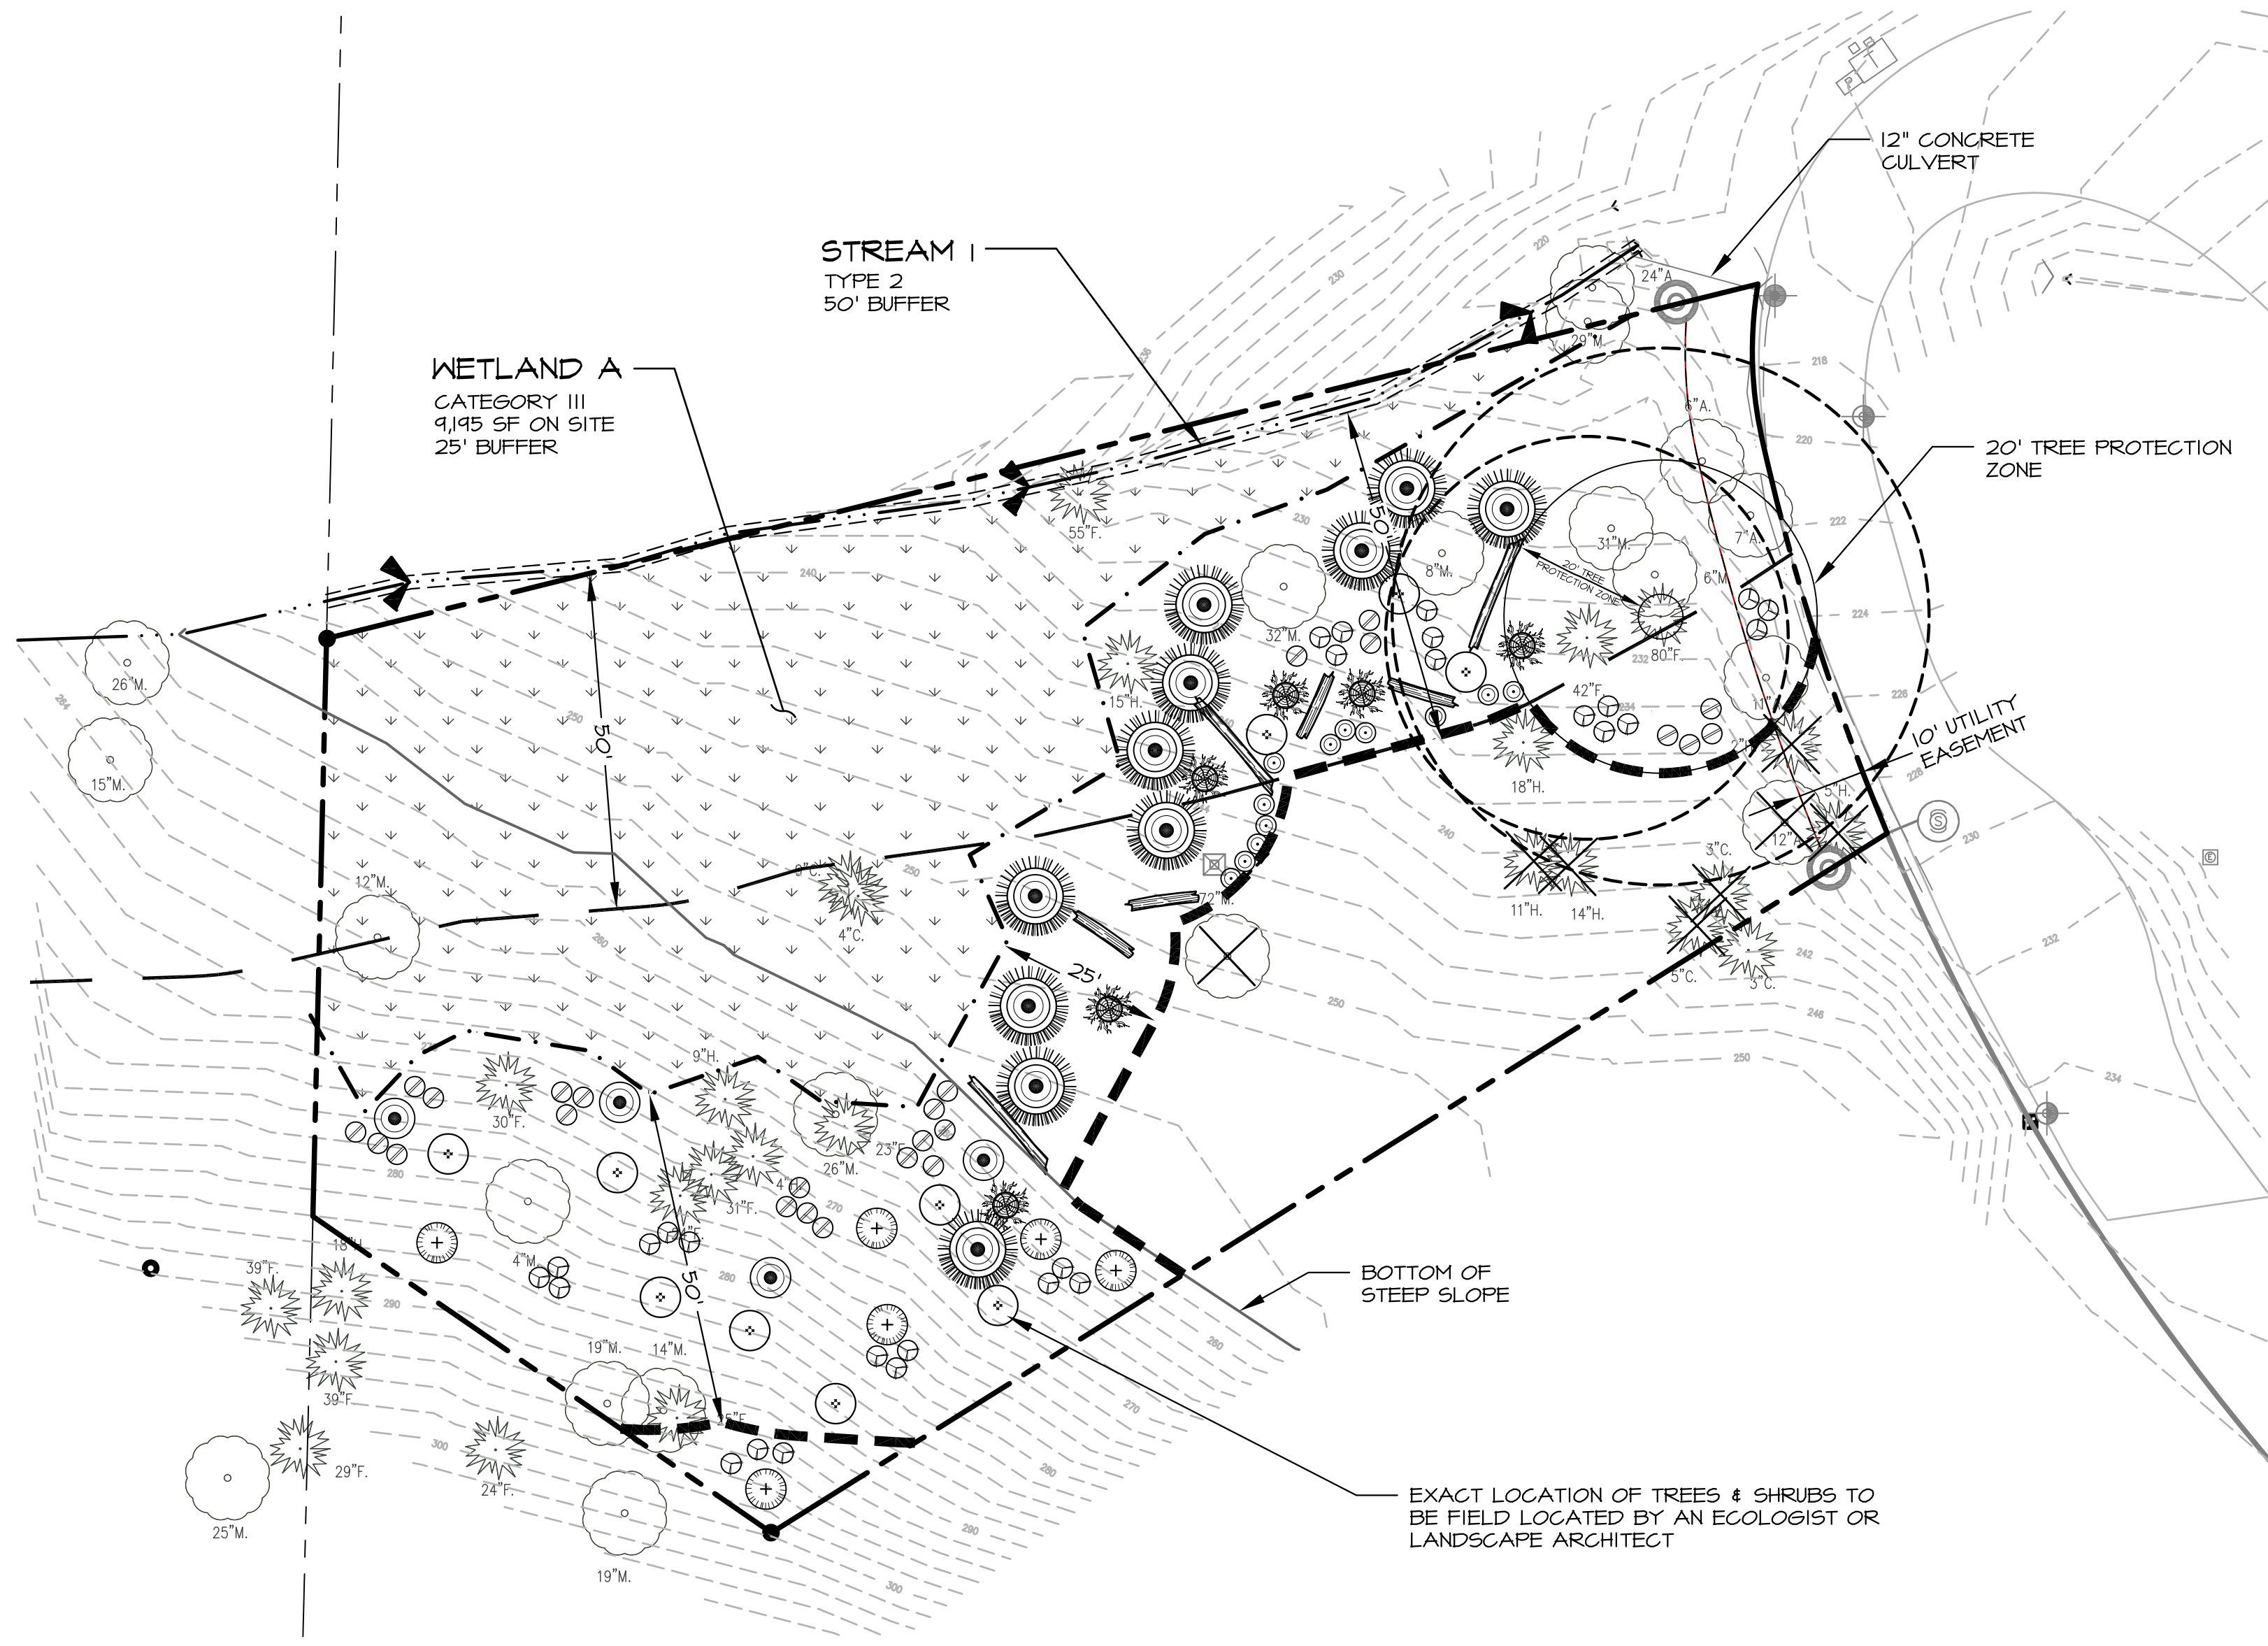
PLANTING PLAN

TREES							
SYMBOL	SCIENTIFIC NAME	COMMON NAME	WL STATUS	QTY.	SPACING	SIZE (MIN.)	NOTES
	ACER CIRCINATUM	VINE MAPLE	FAC	10	AS SHOWN	2 GAL.	FULL & BUSHY
	PSEUDOTSUGA MENZIESII	DOUGLAS FIR	FACU	6	AS SHOWN	2-3' HT.	FULL & BUSHY
	THUJA PLICATA	WESTERN RED CEDAR	FAC	11	AS SHOWN	4-5' HT.	B&B, FULL & BUSHY
	THUJA PLICATA	WESTERN RED CEDAR	FAC	4	AS SHOWN	2-3' HT.	FULL & BUSHY
SHRUBS							
SYMBOL	SCIENTIFIC NAME	COMMON NAME	WL STATUS	QTY.	SPACING	SIZE (MIN.)	NOTES
	OEMLERIA CERASIFORMIS	INDIAN PLUM	FACU	28	5' O.C.	18" HT.	MULTI-CANE (3 MIN.)
	ROSA GYMNOCARPA	BALDHIP ROSE	FACU	12	3' O.C.	1 GAL.	MULTI-CANE (3 MIN.)
	RUBUS SPECTABILIS	SALMONBERRY	FAC	25	3' O.C.	1 GAL.	FULL & BUSHY

result in the required net improvement of critical area functions. The project proposes planting the following species: vine maple, sword fern, Douglas fir, baldhip rose, salmonberry, and western red cedar (**Sheet 1.2**). 21 replacement conifer trees (minimum 6-feet high at time of planting), will be established in the buffer areas at a 1:1 ratio for conifer trees removed during construction of the house and driveway. More smaller trees are being proposed for the enhancement (and tree replacement) plantings because we have found smaller trees establish within mature forest settings better than larger plant materials. Therefore, 21 smaller conifers are currently proposed rather than the previously proposed (7) larger conifers. Post-construction, a set of as-built plans depicting plant types and locations will accompany a compliance report submitted to the City.

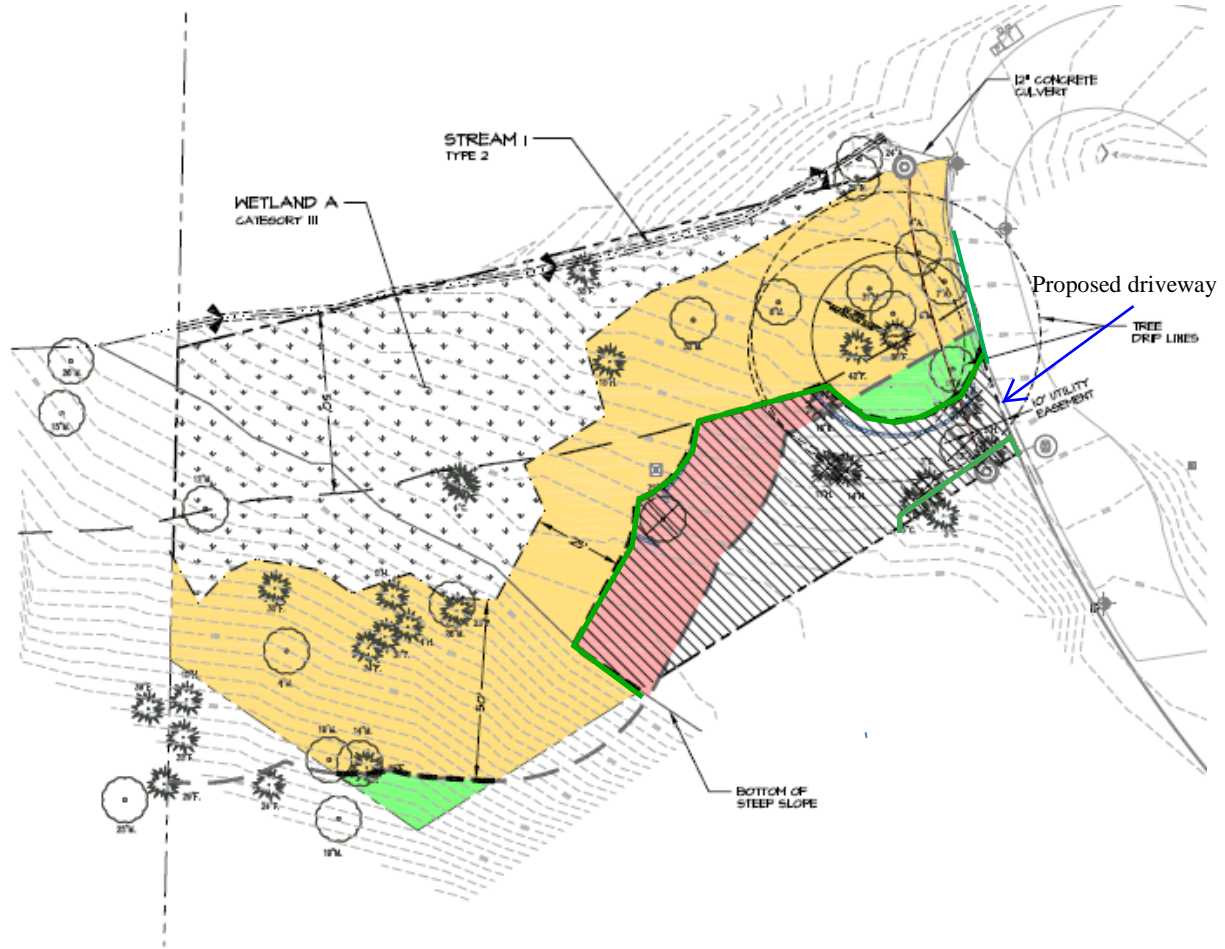
PROPOSED SITE DEVELOPMENT PLAN

Proposed Site Plan, Impacts, & Mitigation Plan, provided by Talasaea Consultants,
 Approximate locations of *Tree Protection Fences* —————
