4803 Forest Avenue SE  
**MITIGATION PLAN**

# 4803 Forest Avenue SE MITIGATION PLAN

Laurie Cropp  
4803 Forest Avenue SE  
Mercer Island, WA 98040

Kerrie McArthur, PWS  
Confluence Environmental Company

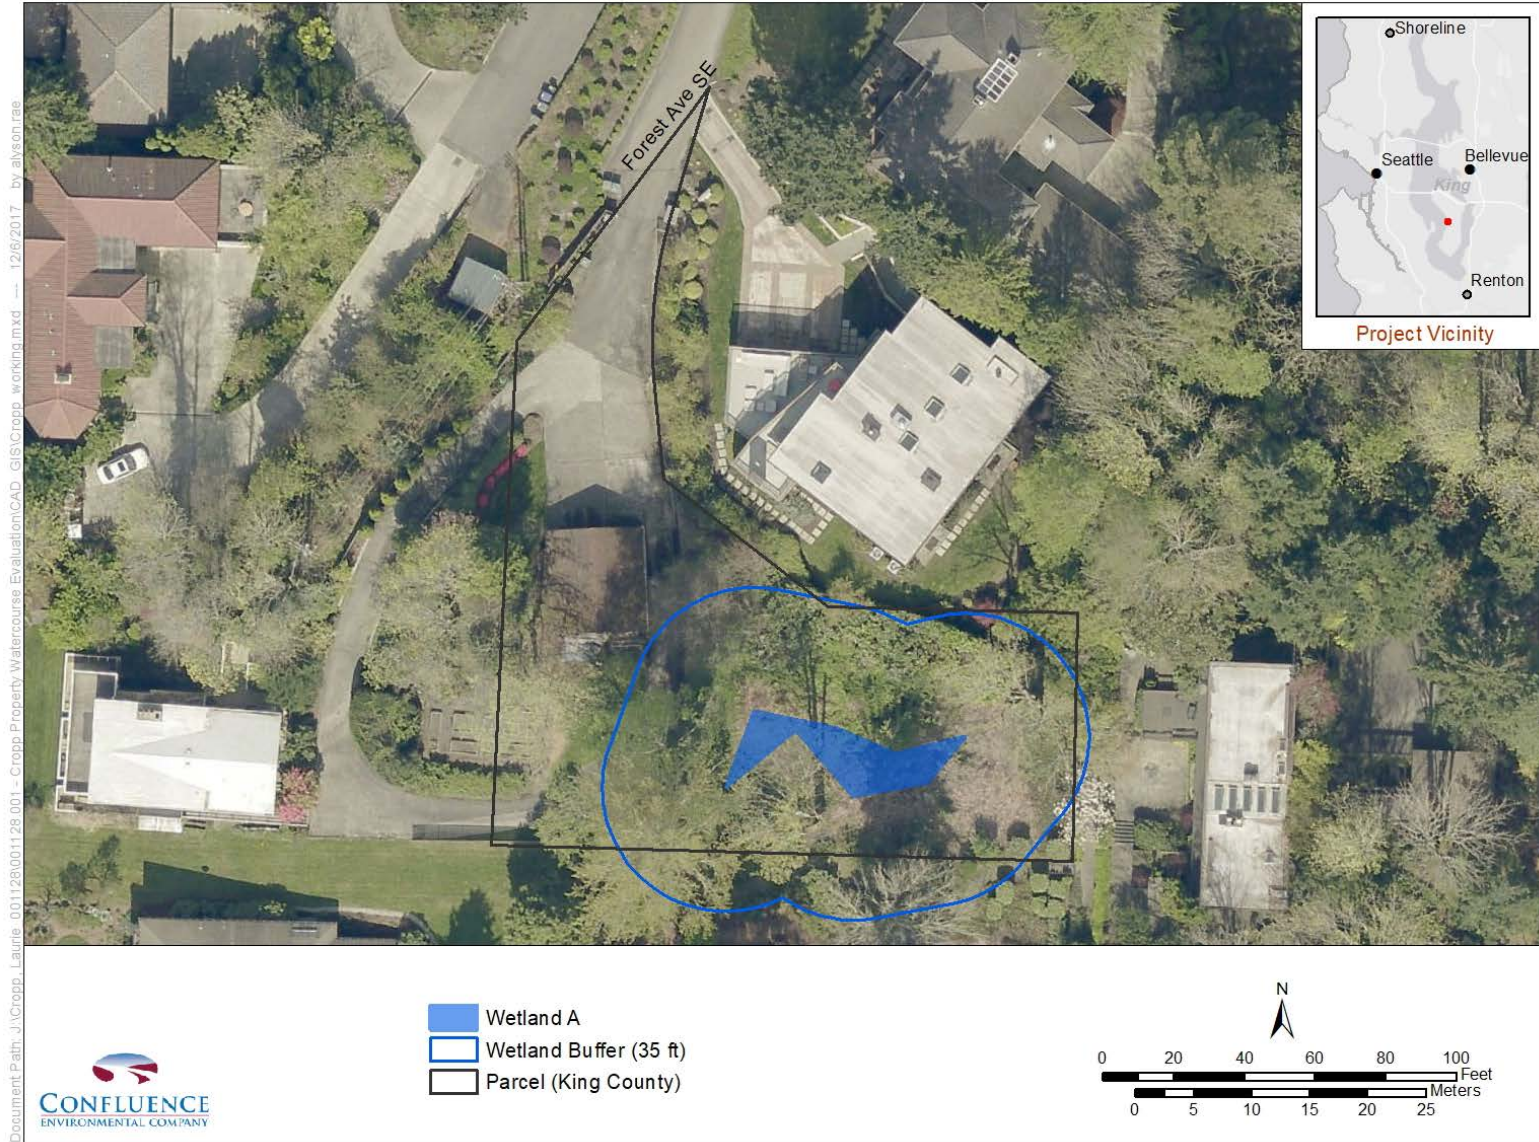
Figure 1. Site Vicinity and Delineated Wetland

One wetland, identified as Wetland A, was delineated on the property (Confluence 2017b). Wetland A is slope wetland located in the eastern portion of the property (Figure 1) and is 638 square feet in size. It begins at the outlet of the stormwater pipe in the eastern portion of the property and ends at the lined basin in the central portion of the property. The existing stormwater pipe discharging at the top of the slope appears to be the primary source of hydrology for Wetland A.

According to Mercer Island City Code (MICC) 19.07.080, Category IV wetlands have a standard buffer of 35 feet but buffers can be reduced to a minimum width of 25 feet with enhancement. The upland (including the buffer) surrounding the wetland is dominated by invasive species such as Himalayan blackberry (*Rubus armeniacus*), English ivy (*Hedera helix*) and laurel (*Daphne* sp.). Figure 1 shows the wetland and the standard buffer.

Confluence Environmental Company (Confluence) conducted site visits at 4803 Forest Avenue SE, Mercer Island, Washington (tax parcel 4045000145) (Figure 1). The purpose of the site visits was to determine the presence and extent of streams and wetlands on and the property. Critical areas such as erosion hazard areas, steep slopes, and landslide hazard areas were not evaluated (Confluence 2017a, b). The site visit identified and delineated one Category V wetland on the property (Confluence 2017a, b).

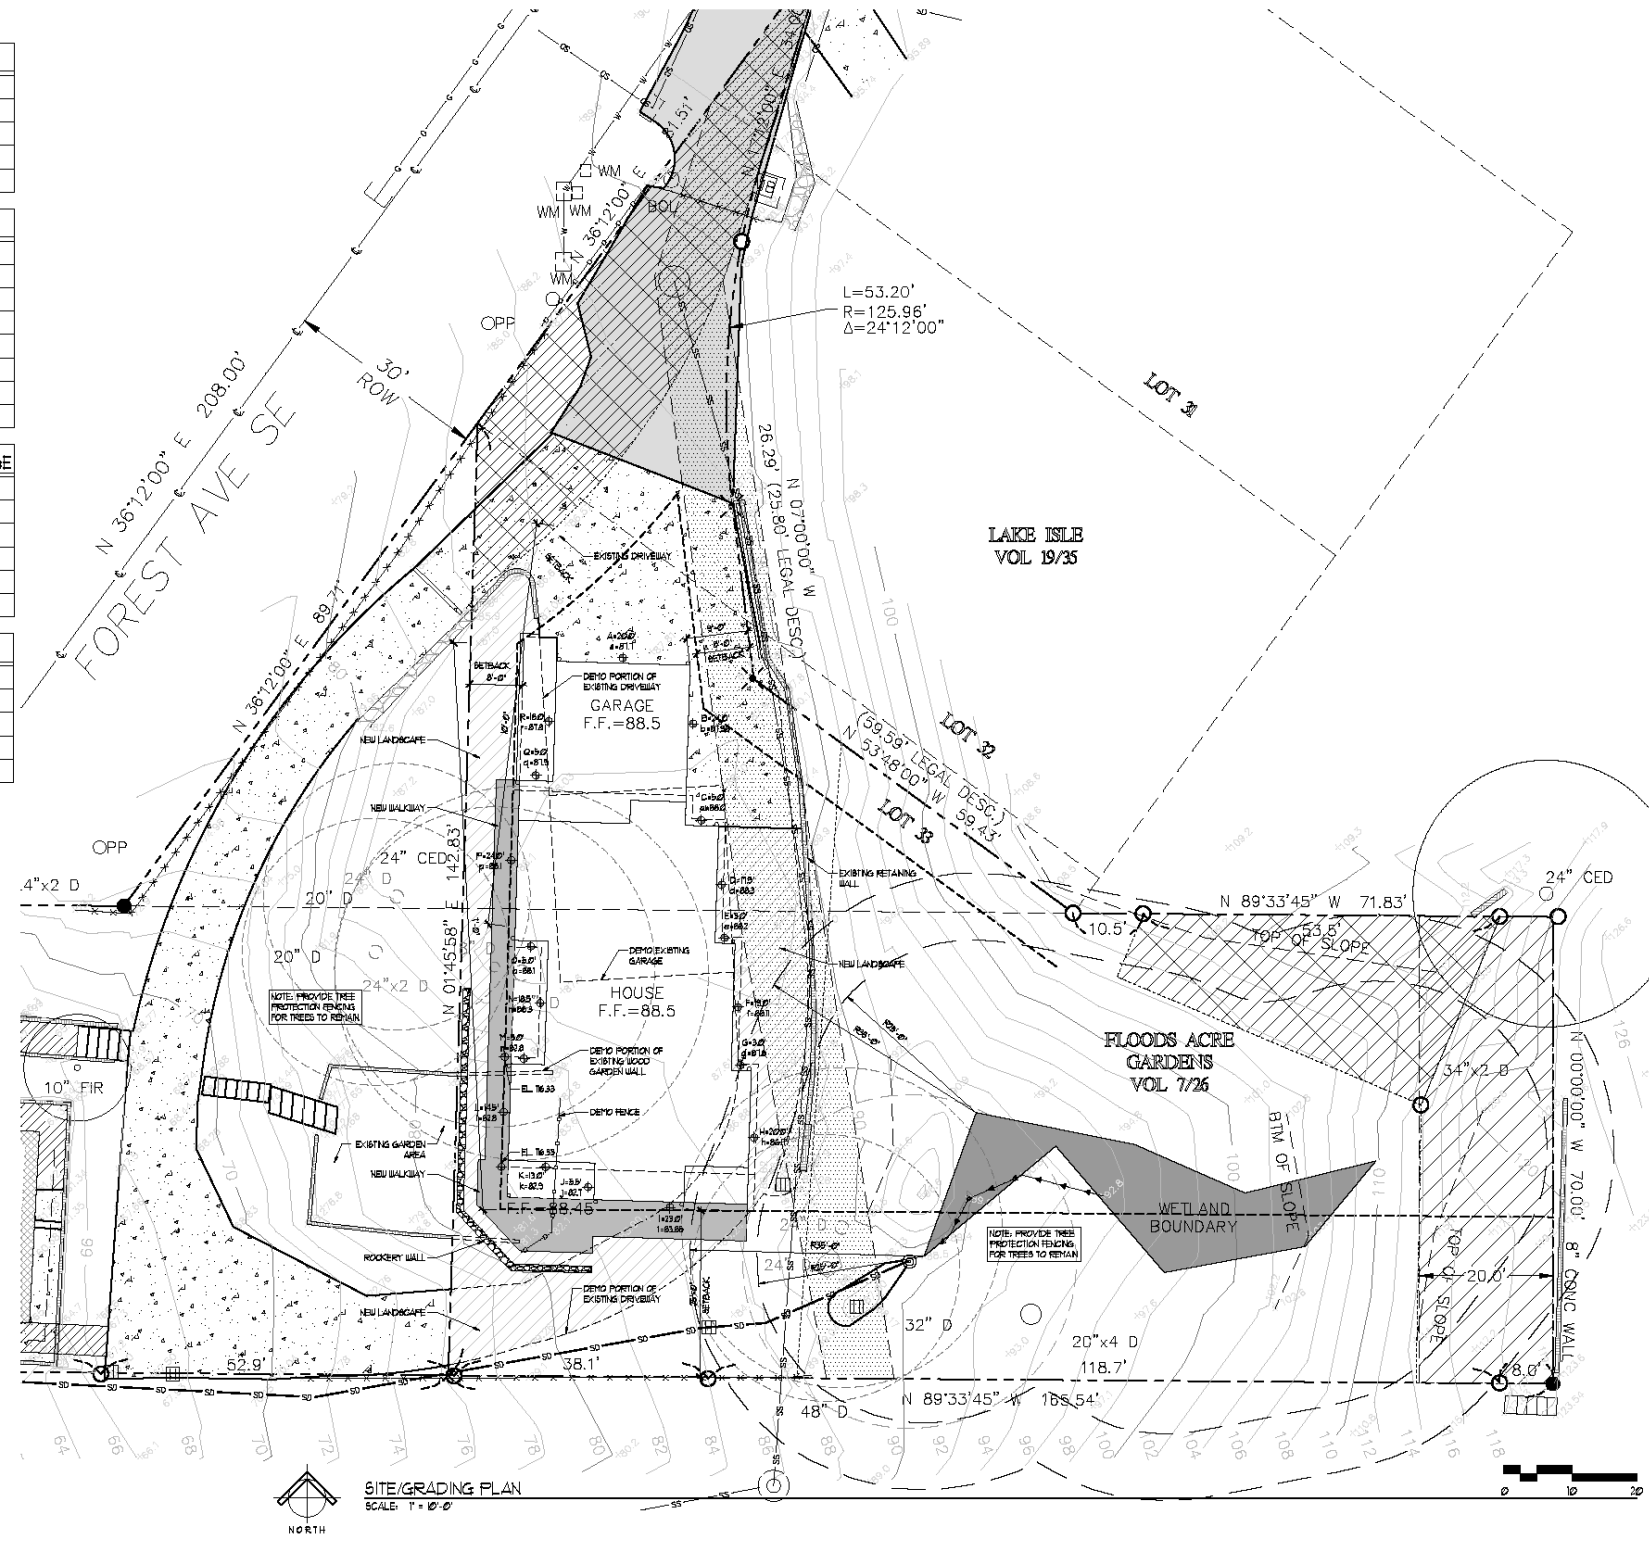
Figure 2. Proposed Development

The proposed development is a new single-family residence. As part of the development, the existing garage would be demolished and a 2,217-square-foot home would be constructed (Figure 2). Because of the unusual shape of the property and the presence of steep slopes in the eastern portion of the property, development is limited to the western portion of the property.

Figure 2 shows the proposed development in relation to the wetland and standard 35-foot buffer and reduced 25-foot buffer. Because of the unusual shape of the property and location of the wetland, the proposed development would encroach into the standard 35-foot buffer.

To avoid impacts to the wetland buffer to the maximum extent, the project proposes to reduce the standard buffer width from 35 feet to a minimum width of 25 feet in the western portion of the buffer only (Figure 2). This results in a buffer reduction of approximately 650 square feet (sq ft). Currently there is approximately 430 sq ft of impervious surface (as driveway) within the buffer reduction area. The remaining portion of the buffer within the proposed buffer reduction area is lawn. Using buffer reduction with enhancement, as allowed under MICC 19.07.00, results in no permanent impacts to the wetland buffer from the proposed development. Details on the proposed mitigation are in Section 5.0.

Rather than enhance the reduced buffer area, this mitigation proposes to enhance 650 sq ft of the buffer upslope of the reduced buffer area and within the standard buffer area (Figure 2). By enhancing the buffer in the proposed location, buffer functions are expected to increase. Since wetland buffers downslope of a slope wetland do not provide hydrology or water quality functions, enhancing the reduced buffer area would only increase the habitat function of that portion of the buffer. By enhancing the buffer on the slope, the plantings will not only increase habitat functions, they will increase water quality and hydrology functions.
