4803 Forest Avenue SE  
**CRITICAL AREAS STUDY UPDATE**

# 4803 Forest Avenue SE CRITICAL AREAS STUDY UPDATE

Kerrie McArthur, PWS  
Confluence Environmental Company

February 16, 2018

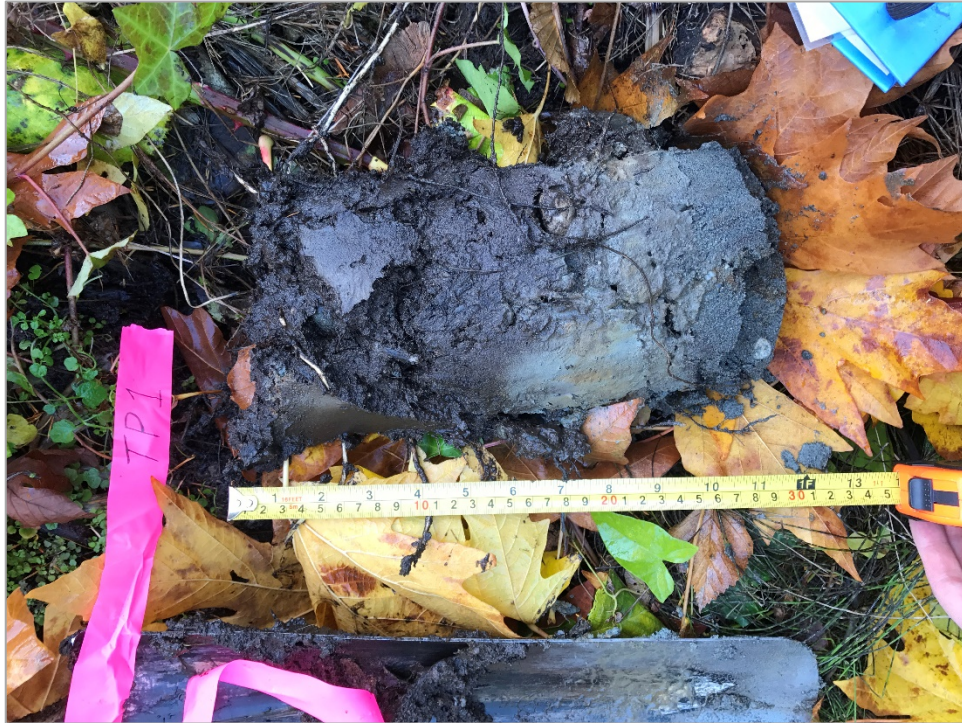
Photo 1 — Soil profile at TP-1.

Depth (inches)	Matrix		Redox Features				Texture	Remarks
	Color (moist)	%	Color (moist)	%	Type <sup>1</sup>	Loc <sup>2</sup>		
0-5	10YR 2/1	100					loam	lots of silt/clay/gravel
5-8	Gley 2.5/5G4	80	10YR 5/8	20	C	M/PL	loam	lots of organic material
8-12	Gley 7 4/10G4	80	5YR 3/4	20	C	M/PL	loamy sand w/ gravel

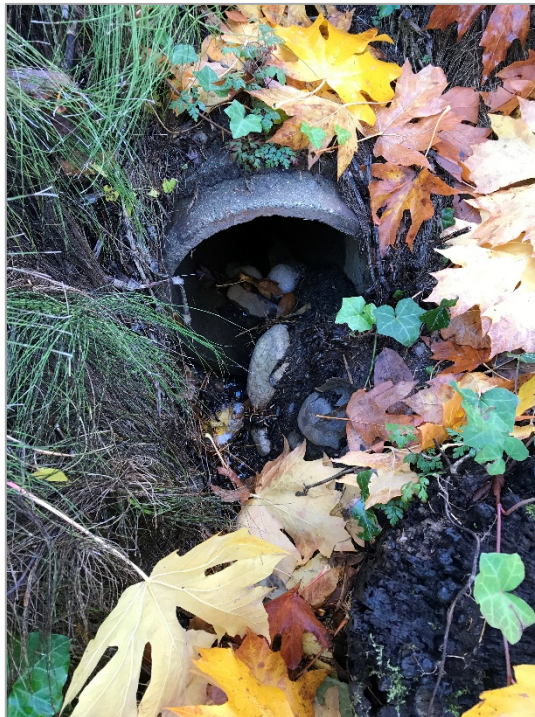
Photo 4 — SE 48<sup>th</sup> Street stormwater pipe outlet.

At the base of the hillslope is a concrete basin. The inlet of the basin is a 6-inch-diameter corrugated plastic pipe. The pipe extended upslope approximately 30 feet east before it was no longer observed. The inlet of the pipe was not found. The pipe appears to have been laid in the low spot of the hillslope. No visual indicators of a watercourse were identified adjacent to the pipe or upslope of where the pipe could be seen.

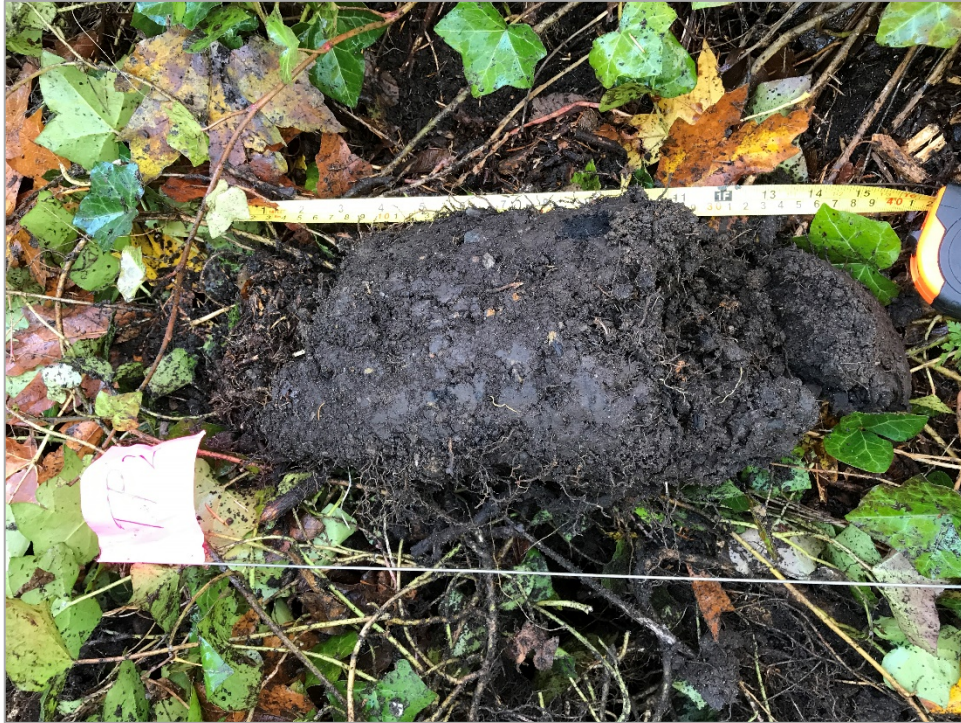
Photo 5 — Soil profile at TP-2.

Depth (inches)	Matrix		Redox Features				Texture	Remarks
	Color (moist)	%	Color (moist)	%	Type <sup>1</sup>	Loc <sup>2</sup>		
0-4	10YR2/1	100					silty loam w/ gravel	
4-11	10YR3/1	100					sand w/ gravel	
11-17	10YR4/1	98	7.5YR4/6	2	C	M	sandy loam w/ gravel

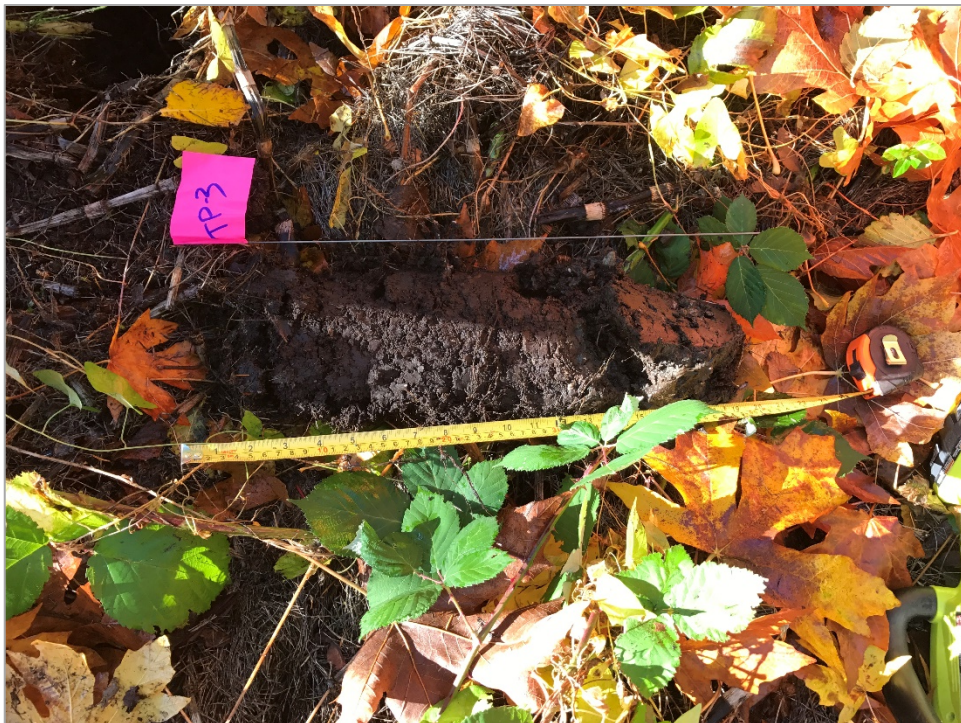
Photo 8 — Soil profile at TP-3.

Depth (inches)	Matrix		Redox Features				Texture	Remarks
	Color (moist)	%	Color (moist)	%	Type <sup>1</sup>	Loc <sup>2</sup>		
0-6	10YR2/1	100					loam	
6-17	7.5YR3/1	98	7.5YR5/8	2	C	M	sandy loam	w/ gravel

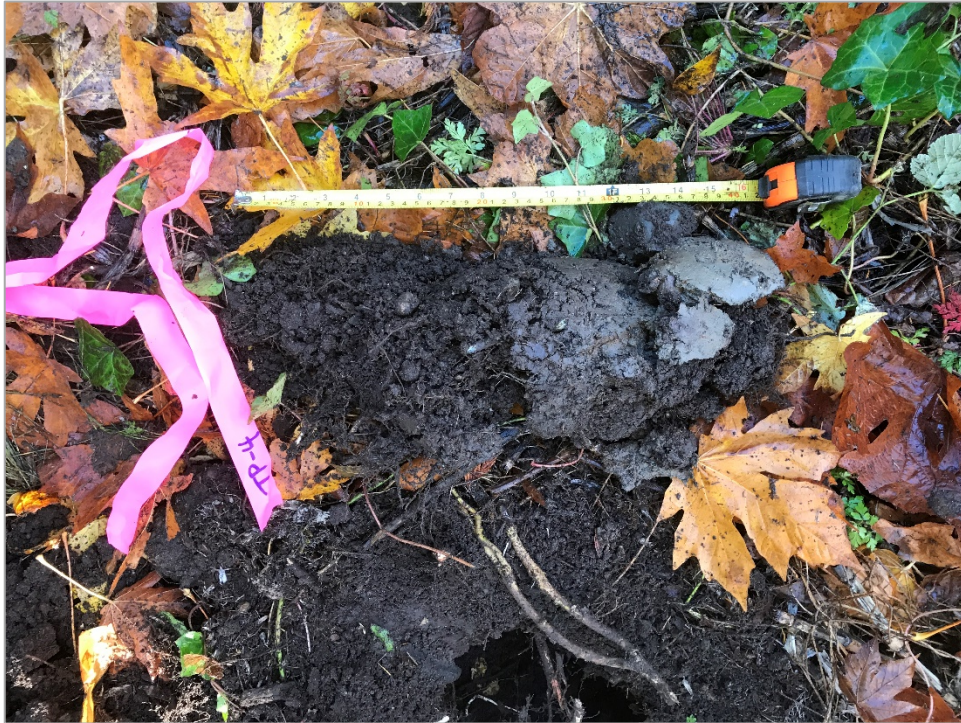
Photo 11 — Soil profile at TP-4.

TP-4 was located southwest (downslope) of TP-1, in an area dominated by giant horsetail, English Ivy and big-leaf maple. Vegetation within TP-4 did not pass the Dominance Test or the Prevalence Index Test and therefore did not meet the wetland vegetation criterion. Soil in the top layer (0-8 inches) was a very dark brown (10YR 2/2) silty loam. Soil in the second layer (8-11 inches) was a very dark grayish brown (10YR 3/2) sandy loam and gravel. Soil in the third layer (11-15 inches) was a dark gray (10YR 4/1) sandy loam and gravel with 20 percent yellowish red (5YR 4/6) redox concentrations in the matrix. Soils met the Depleted Below Dark Surface (A11) hydric soil indicator; therefore, the hydric soil criterion was met. Two primary indicators – High Water Table (A2) and Saturation (A3) – was observed. The presence of at least one primary or two secondary indicators meets the wetland hydrology criterion. Since TP-4 did not meet all three criteria, the area represented by TP-4 is not a wetland and represents the transition zone between wetland and upland.

Depth (inches)	Matrix		Redox Features				Texture	Remarks
	Color (moist)	%	Color (moist)	%	Type <sup>1</sup>	Loc <sup>2</sup>		
0-8	10YR 2/2	100					Silty loam	
8-11	10YR 3/2	100					Sandy loam w/ gravel	
11-15	10YR 4/1	80	5YR 4/6	20	C	M	Sandy loam w/ gravel

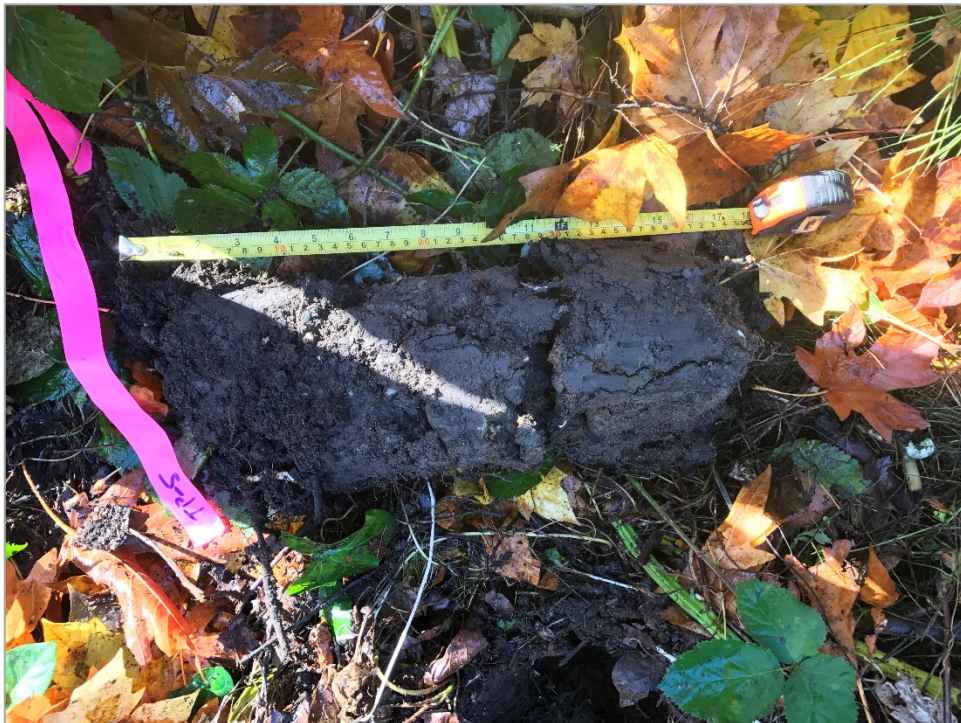
Photo 14 — Soil profile at TP-5.

TP-5 was located west (downslope) of TP-3 and north of TP-6, in an area dominated by giant horsetail and Himalayan blackberry. Vegetation within TP-5 passed the Dominance Test and therefore met the wetland vegetation criterion. Soil in the top layer (0-6 inches) was a black (10YR 2/1) loam. Soil in the second layer (6-17 inches) was a very dark gray (10YR 3/1) sandy loam and gravel with 2 percent strong brown (7.5YR 5/8) redox concentrations in the matrix. Soils met the Redox Dark Surface (F6) hydric soil indicator; therefore, the hydric soil criterion was met. No primary or secondary indicators of wetland hydrology were observed and therefore the wetland hydrology criterion was not met. Since TP-5 did not meet all three criteria, the area represented by TP-5 is not a wetland.

Depth (inches)	Matrix		Redox Features				Texture	Remarks
	Color (moist)	%	Color (moist)	%	Type <sup>1</sup>	Loc <sup>2</sup>		
1-11	10YR 2/2	100					silty loam w/ gravel & organic fibers	
11-18	10YR 3/2	100					loam w/ lots of gravel

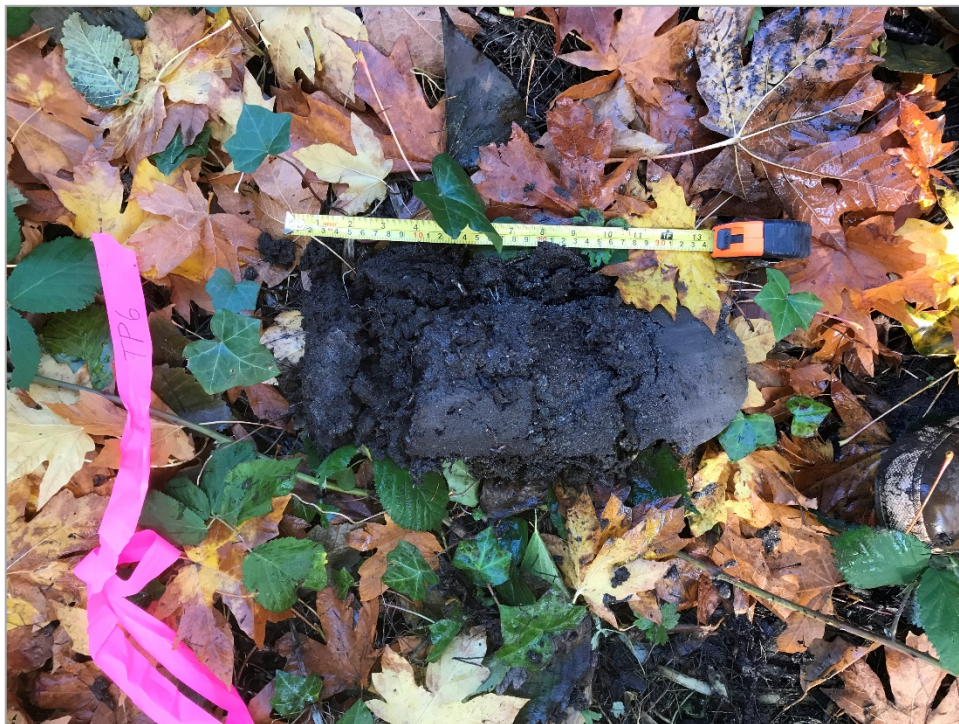
Photo 17 — Soil profile at TP-6.

TP-6 was located south of TP-5 and west of TP-4, in an area dominated by giant horsetail, English ivy, and big-leaf maple. Vegetation within TP-1 did not pass the Dominance Test but did pass the Prevalence Index, and therefore meets the wetland vegetation criterion. Soil in the top layer (0-4 inches) was a black (10YR 2/1) silty loam with gravel. Soil in the second layer (4-11 inches) was a very dark gray (10YR 3/1) sand and gravel. Soil in the third layer (11-17 inches) was a dark gray (10YR 4/1) sandy loam and gravel with 2 percent strong brown (7.5YR 4/6) redox concentrations in the matrix. Soils met the Depleted Below Dark Surface (A11) hydric soil indicator; therefore, the hydric soil criterion was met. Three primary indicators – Surface Water (A1), High Water Table (A2), and Saturation (A3) – were observed. The presence of at least one primary or two secondary indicators meets the wetland hydrology criterion. Since TP-6 met all three criteria, the area represented by TP-6 is a wetland, and is located in the western portion of Wetland A.

Depth (inches)	Matrix		Redox Features				Texture	Remarks
	Color (moist)	%	Color (moist)	%	Type <sup>1</sup>	Loc <sup>2</sup>		
<u>D-5</u>	<u>10YR2/1</u>	<u>100</u>					<u>Sandy loam w/ gravel</u>	
<u>5-15</u>	<u>10YR2/1</u>	<u>98</u>	<u>10YR4/6</u>	<u>2</u>	<u>C</u>	<u>M</u>	<u>Sandy loam w/ gravel</u>

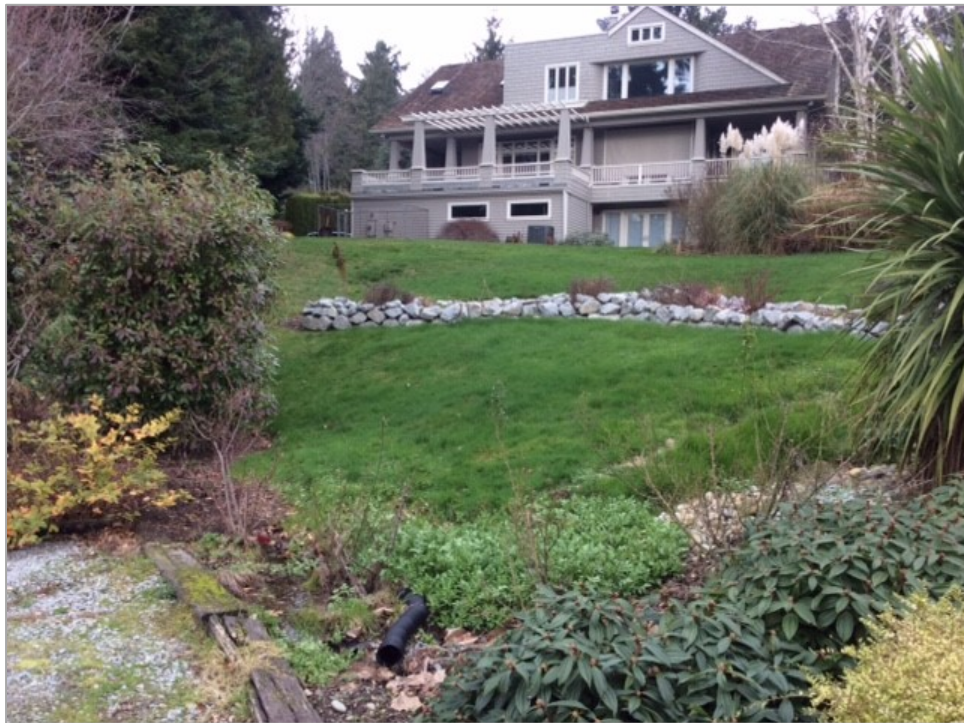
Photo 2 — 4803 W Mercer Way backyard. Note pipe, which discharges runoff onto parking pad and contributes runoff directly down drive to 8101 to subject stormwater pipe.

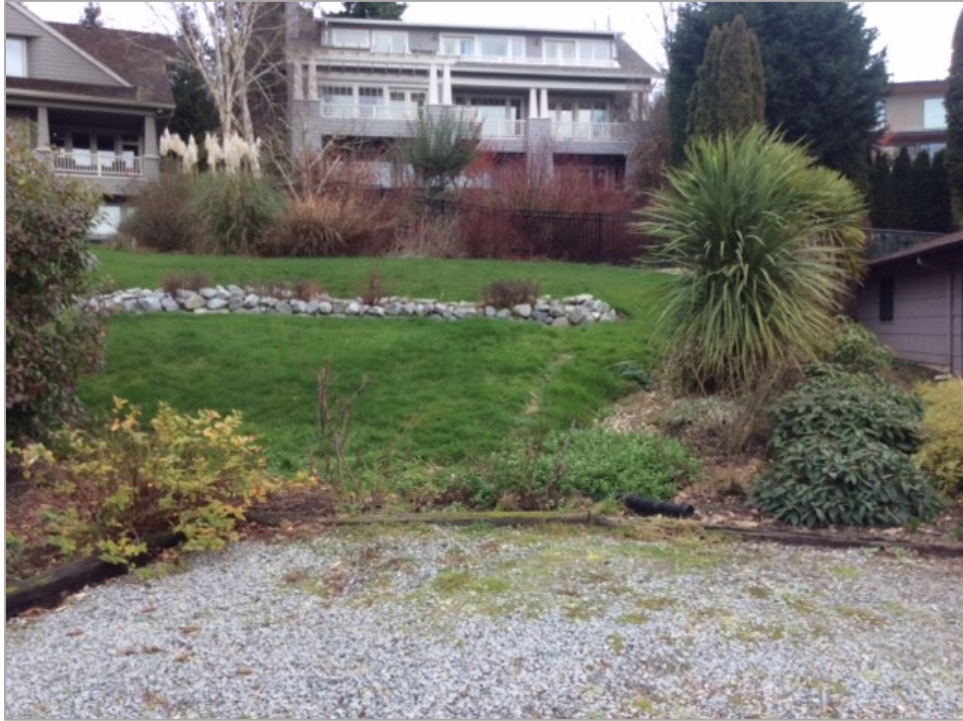
Photo 3 — Parking pad at 8201 SE 48<sup>th</sup> Street (note pipe).

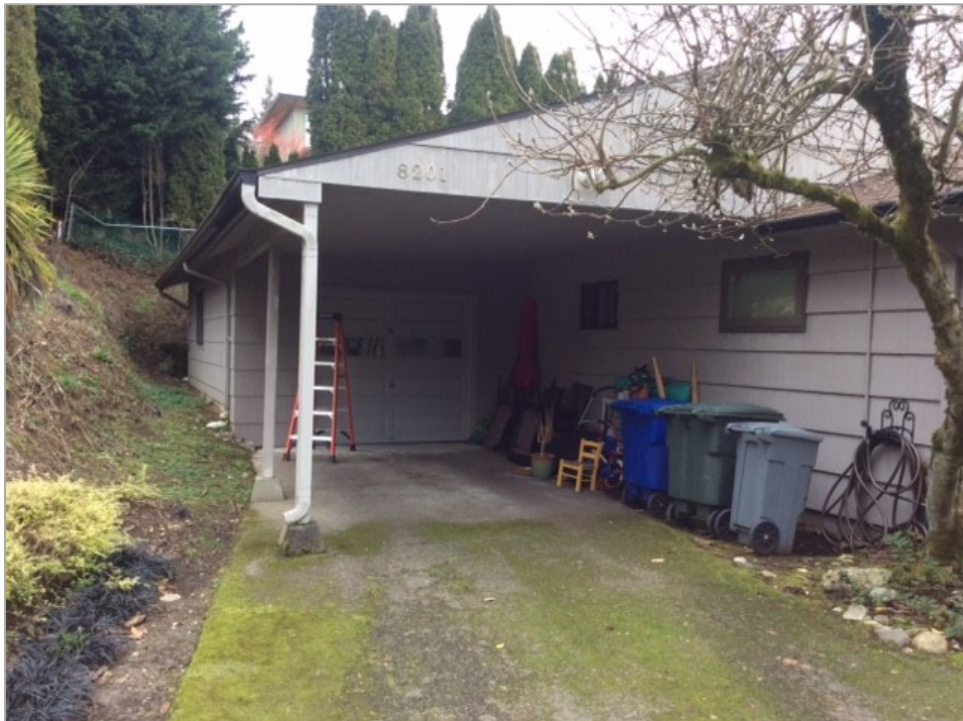
Photo 4 — Driveway and roof drains at 8201 SE 48<sup>th</sup> Street, which contribute runoff into subject stormwater pipe.

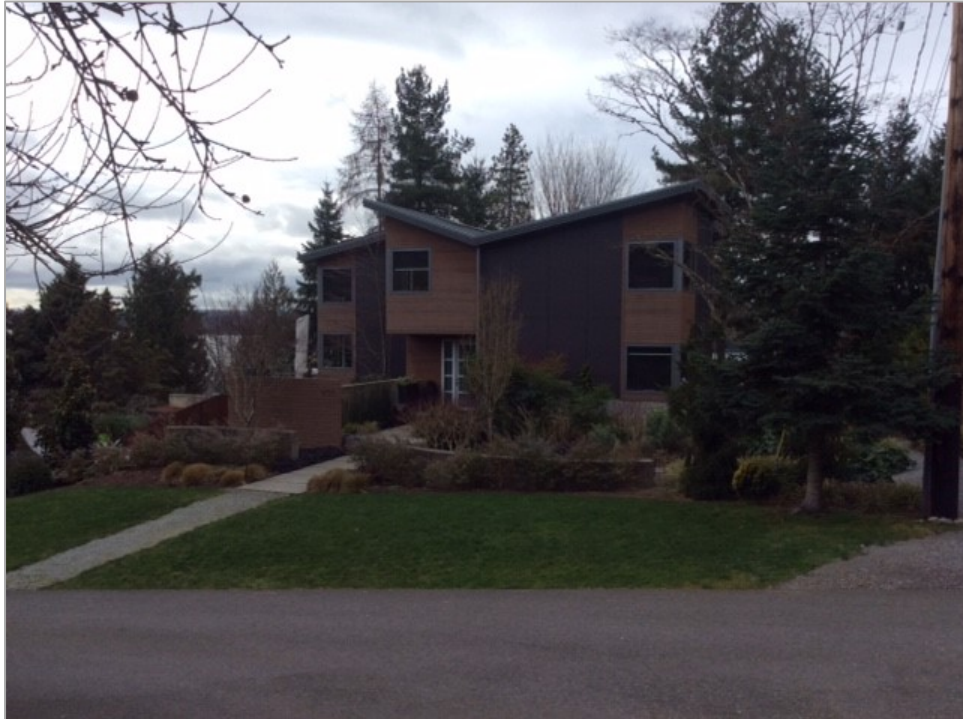
**Photo 5 — New construction at 8105 SE 48<sup>th</sup> Street, which contributes runoff into subject stormwater pipe. See photo for rear/side yard and driveway.**

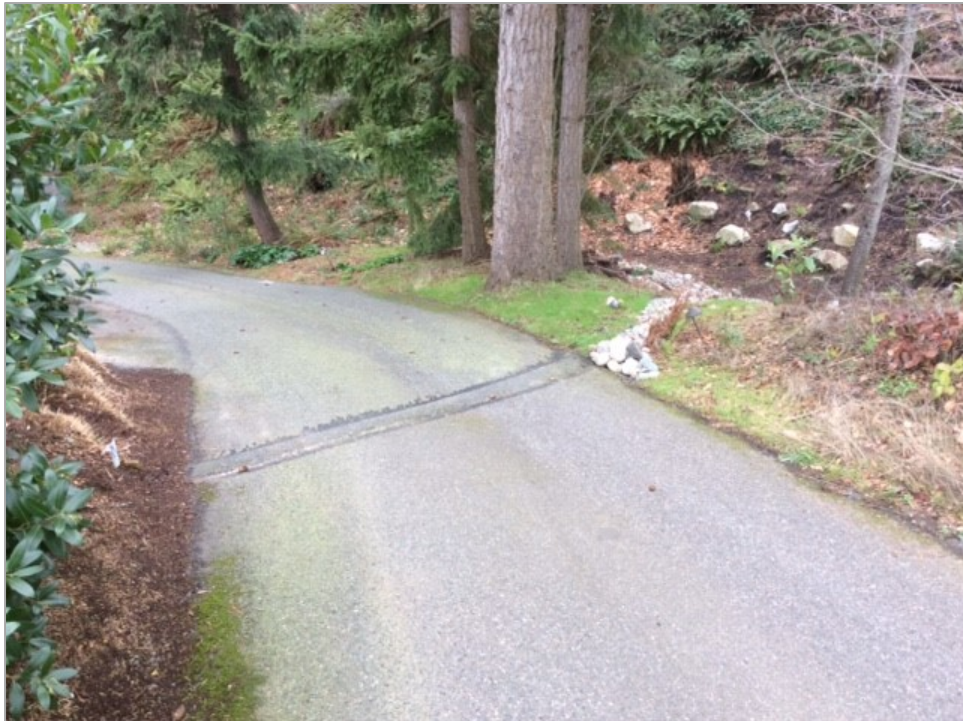
**Photo 6 — New runoff collection on private shared drive to 8101 and 8105 SE 48<sup>th</sup> Street, which contributes runoff into subject stormwater pipe, which appears relatively recent.**

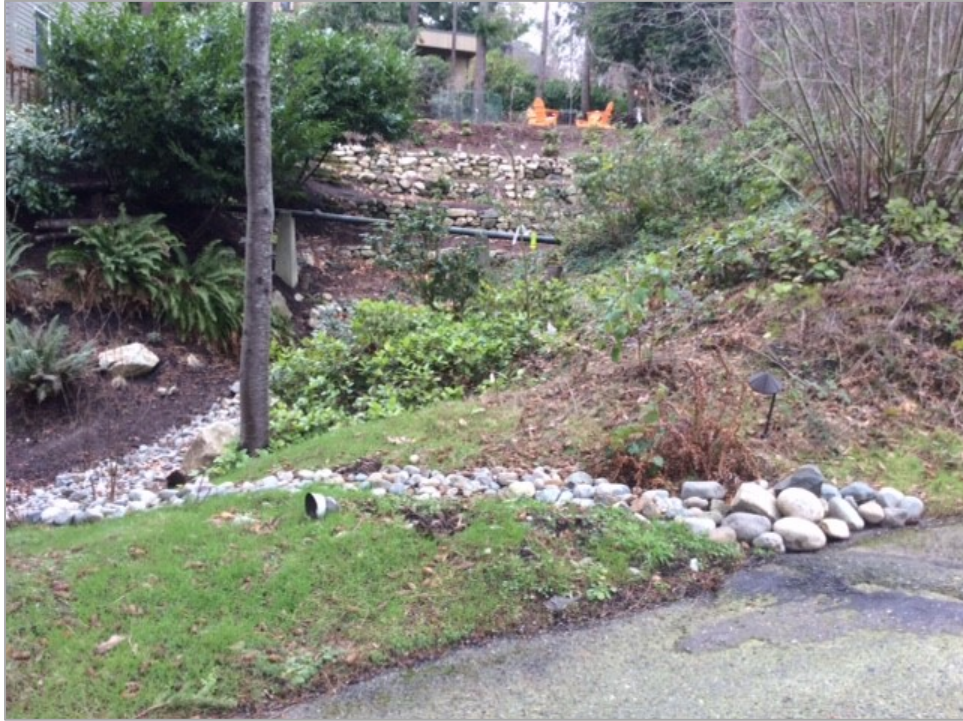
Photo 7 — View of new runoff collection gravel from 8100 SE 48<sup>th</sup> Street, which contributes runoff into subject stormwater pipe.

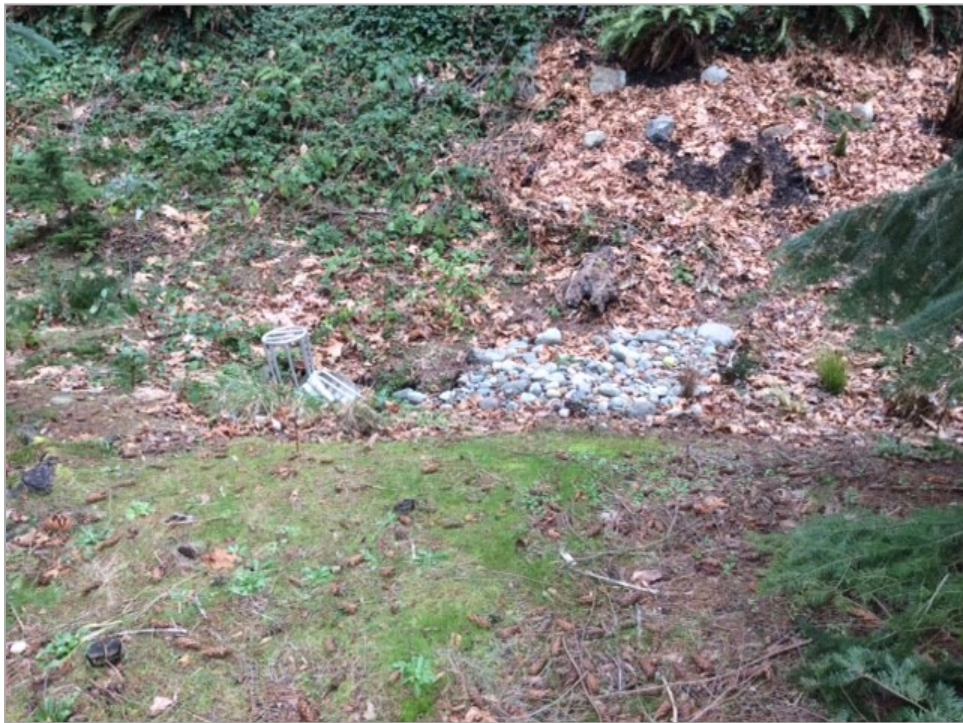
Photo 8 — New catch basin and stormwater pipe at 8100 SE 48<sup>th</sup> Street, which contributes runoff into subject stormwater pipe. Catch basin drains directly downhill through 8101 SE 48<sup>th</sup> Street to subject .

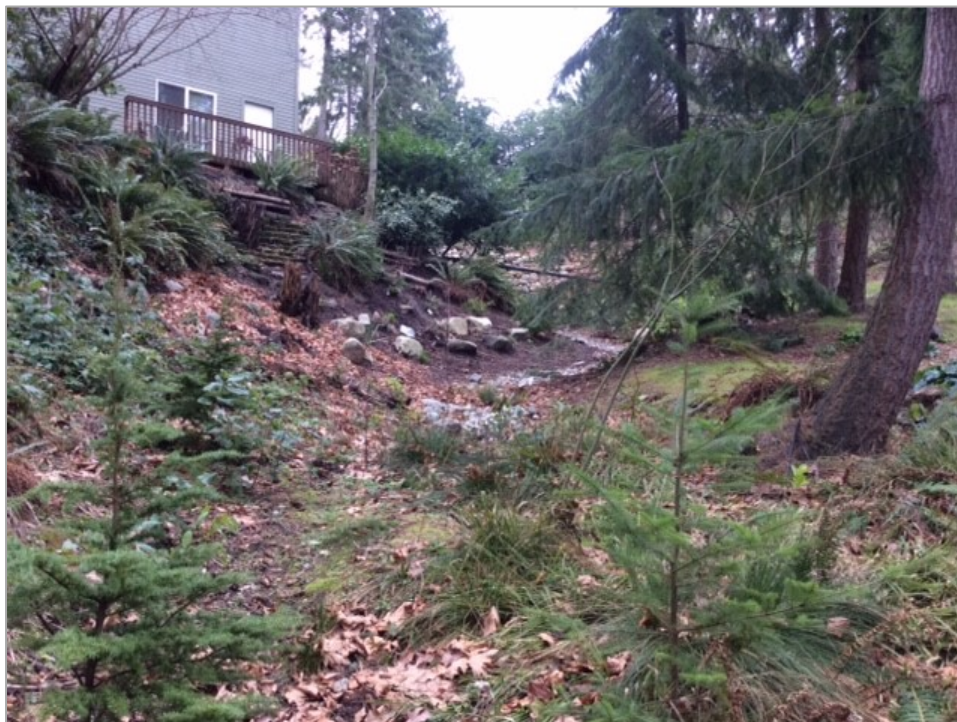
Photo 9a — View of new catch basin and stormwater pipe from downslope. Several trees were removed during installation of drain, causing an increase in runoff as well.

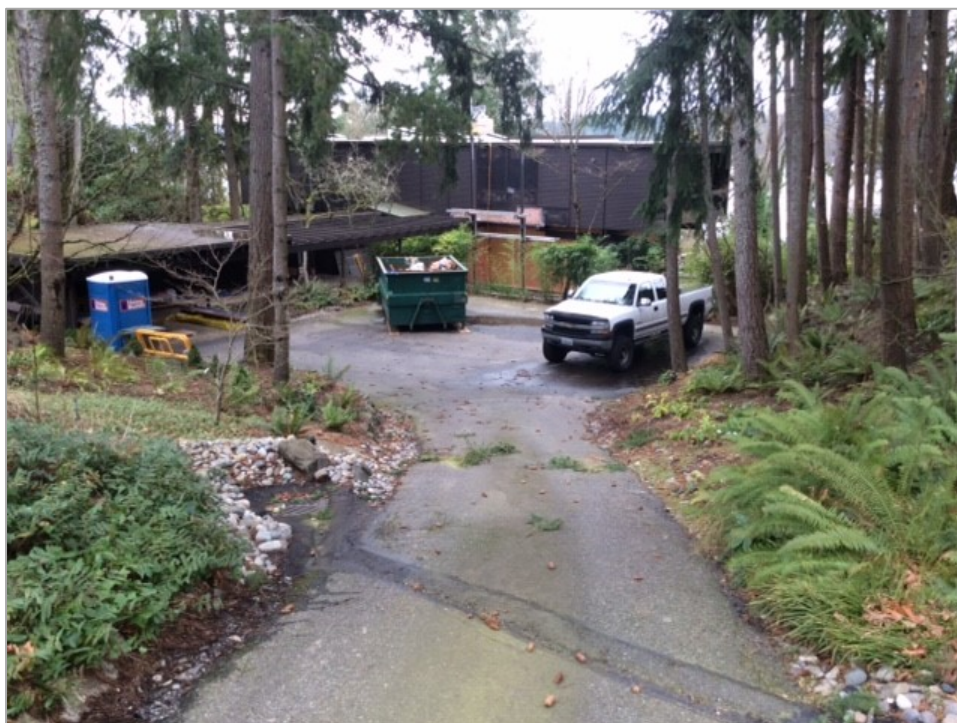
Photo 9b — Paved driveway of 8101 SE 48<sup>th</sup> Street with new catch basin, which contribute runoff into subject stormwater pipe.

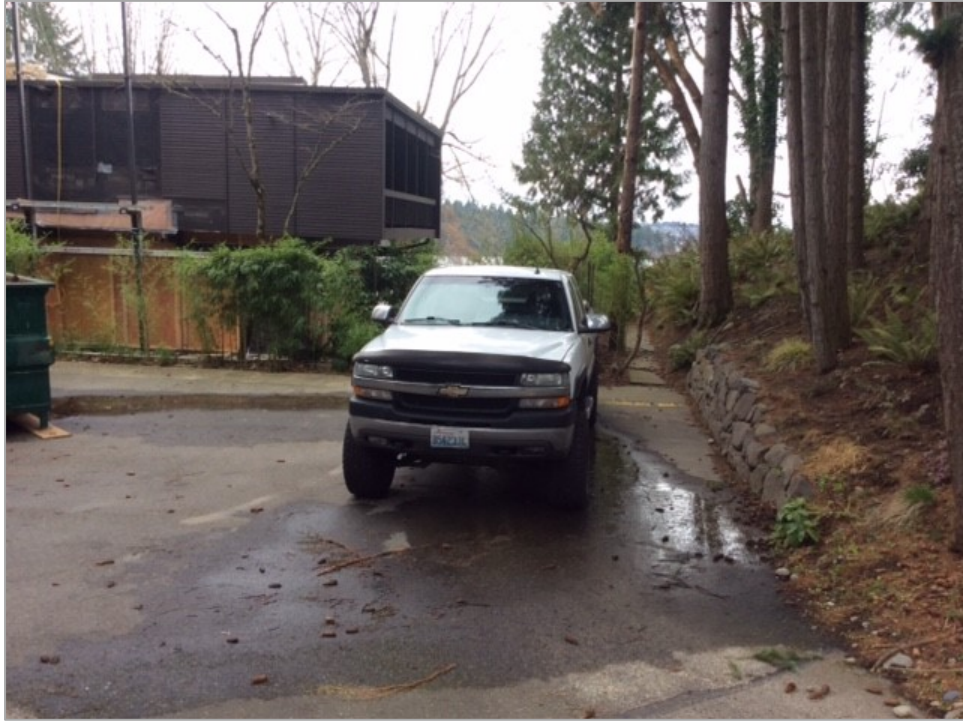
Photo 10 — Paved driveway at 8101 SE 48<sup>th</sup> Street, which contributes runoff into subject stormwater pipe.

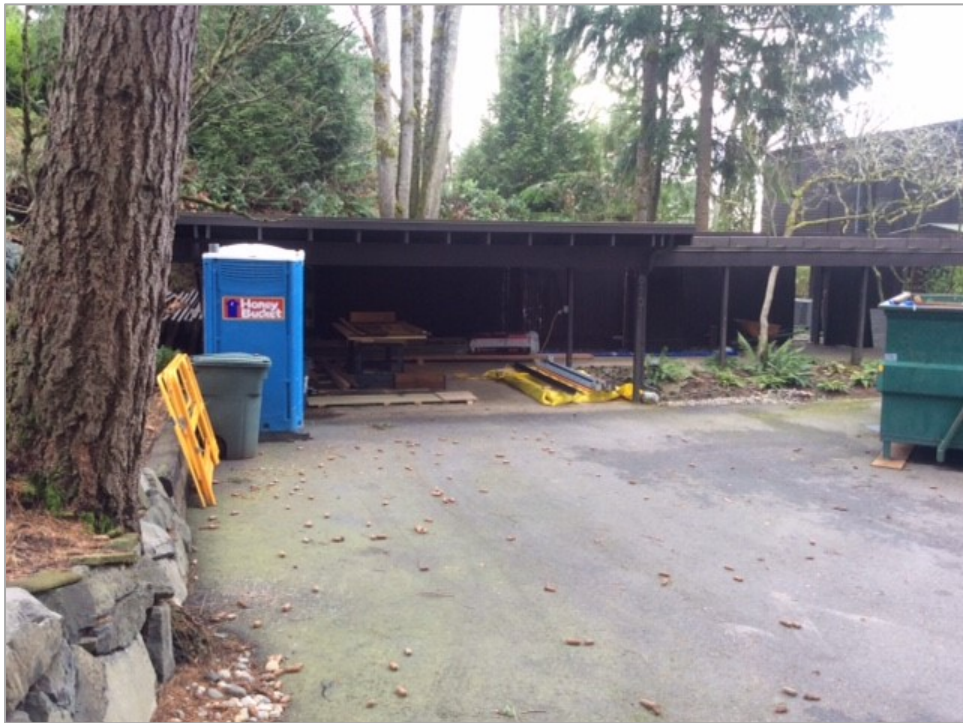
Photo 11 — Paved driveway at 8101 SE 48<sup>th</sup> Street, which contributes runoff into subject stormwater pipe.

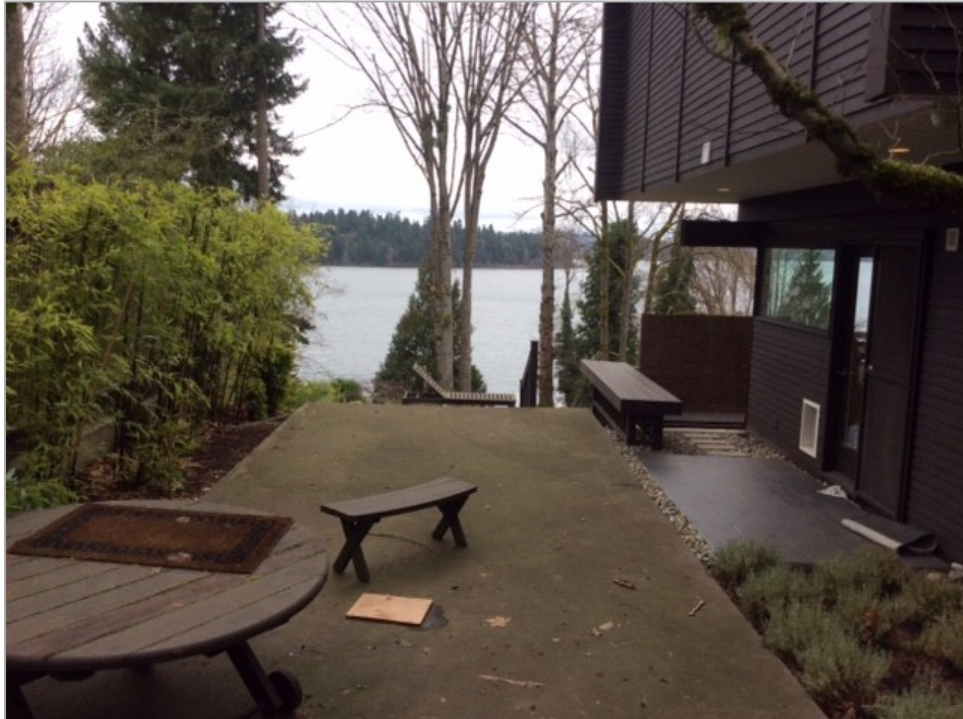
Photo 12a — Paved patio at 8101 SE 48<sup>th</sup> Street, which contributes runoff into subject stormwater pipe.

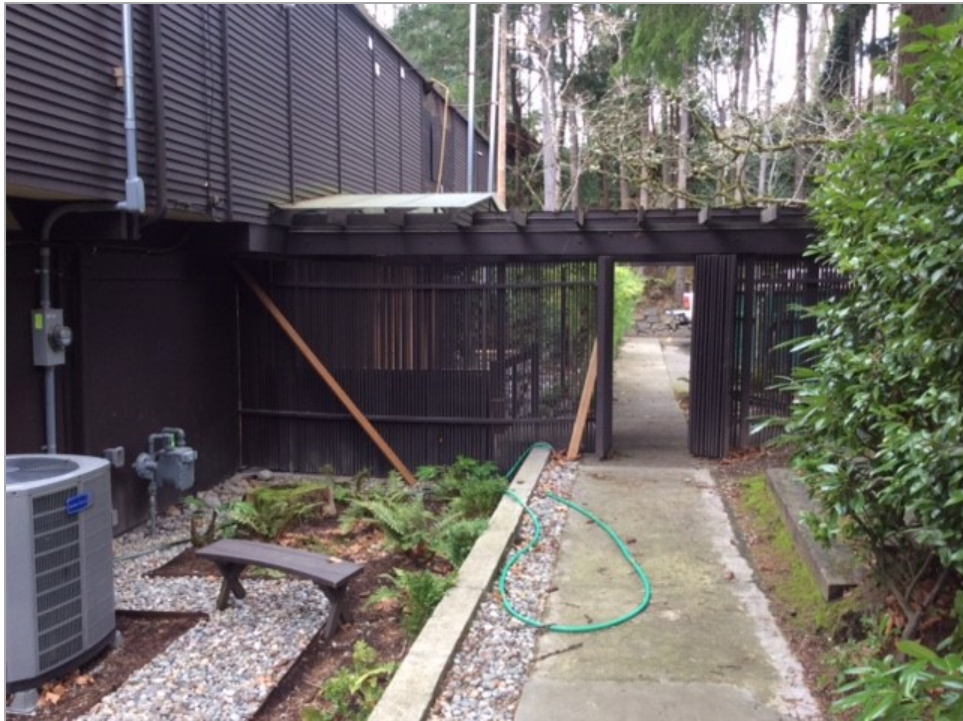
Photo 12b — Paved walkway at 8101 SE 48<sup>th</sup> Street, which contributes runoff into subject stormwater pipe.

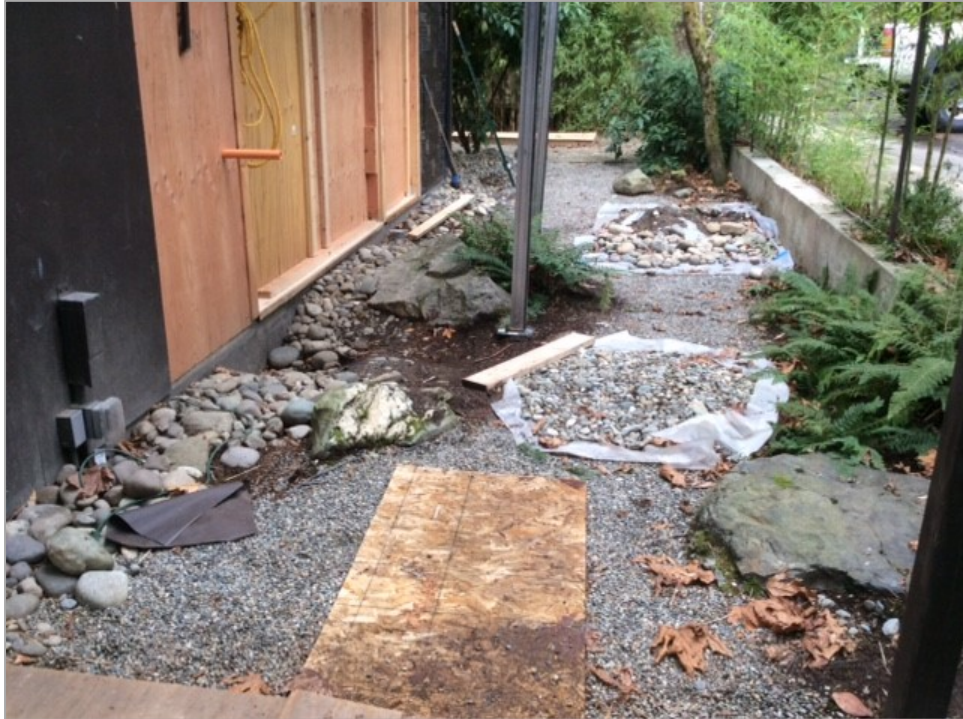
Photo 13 — New gravel and landscape area on east side of 8101 SE 48<sup>th</sup> Street, looking north. Area captures runoff from paved driveway (See Photos 10 and 11).

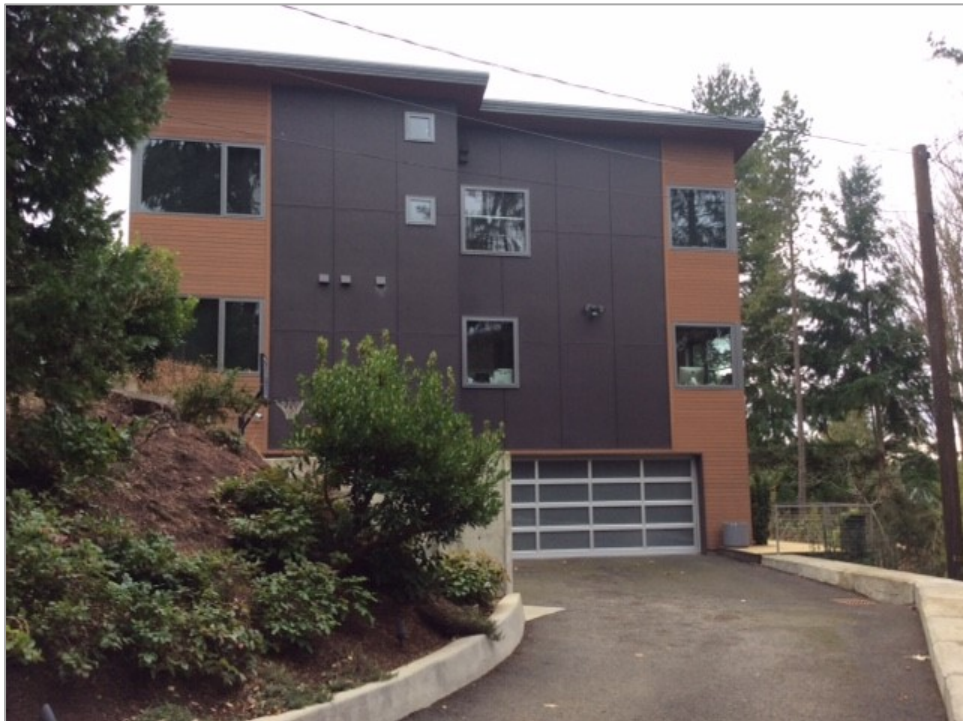
Photo 14 — New construction at 8105 SE 48<sup>th</sup> Street, which contributes runoff into subject stormwater pipe. Note new catch basin in driveway (See Photo 9b).

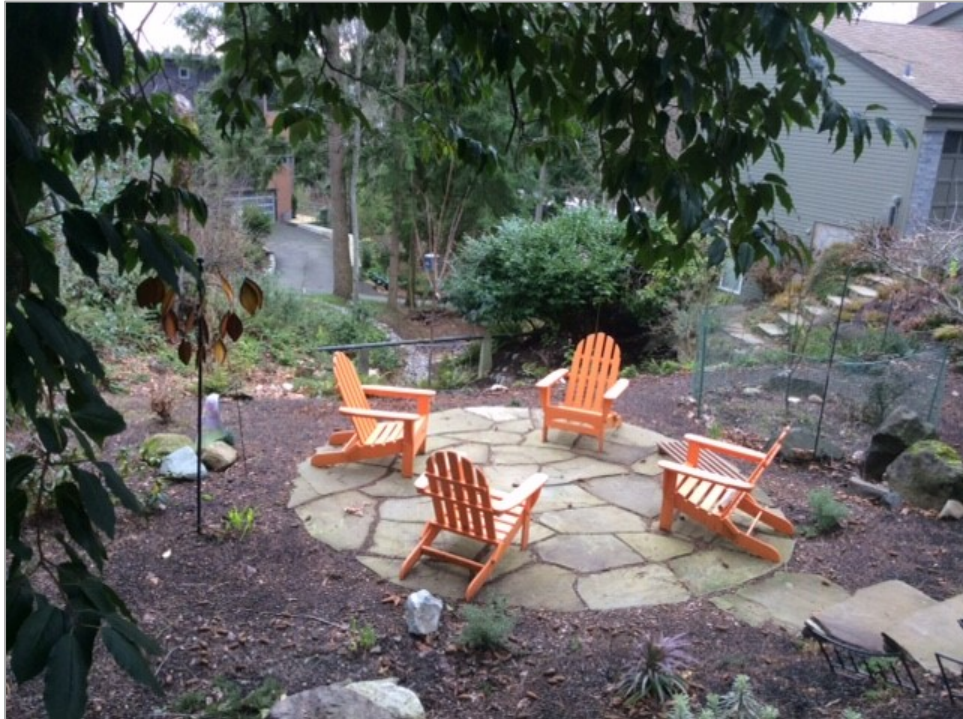
Photo 15 — New impervious surface at 8100 SE 48<sup>th</sup> Street, which contributes runoff into subject stormwater pipe. This area represents the easterly extent of the drainage basin we are representing as contributing to the subject stormwater pipe. The drainage basin may actually extend further northeast, but without additional survey, we are unsure and therefore did not include the area in our analysis.
