CRITICAL AREAS DETERMINATION

NOTICE OF DECISION

Project Number:	CAO18-003
Description:	Request to reduce Category IV wetland buffer to 25 feet to accommodate a new Single-Family Residence. The City's GIS map indicates a piped watercourse, however following review, the findings indicate there is not a regulated watercourse present on-site. A regulated Category IV wetland is present on site.
Applicant:	Benny Kim 7415 Lake Ballinger Way Edmonds WA 98026
Owner:	Benny Kim 7415 Lake Ballinger Way Edmonds WA 98026
Site Address:	8114 West Mercer Way, Mercer Island WA 98040; Identified by King County Assessor tax parcel number 335850-0974
Zoning District:	R-15
SEPA Compliance:	A Determination of Non-Significance (DNS) for SEP18-024 will be issued on March 11 th , 2019, concurrent with this Notice of Decision.
Exhibits:	<ol style="list-style-type: none">1. Development Application for a Critical Area Determination, received on May 2, 2018.2. Watercourse Assessment prepared by C2MY Engineers received on May 2, 2018.3. Wetland Delineation prepared by Bradford Shea a Senior Ecologist at Westech Company received on May 2, 2018.4. Wetland Buffer Reduction Mitigation Plan prepared by Bradford She

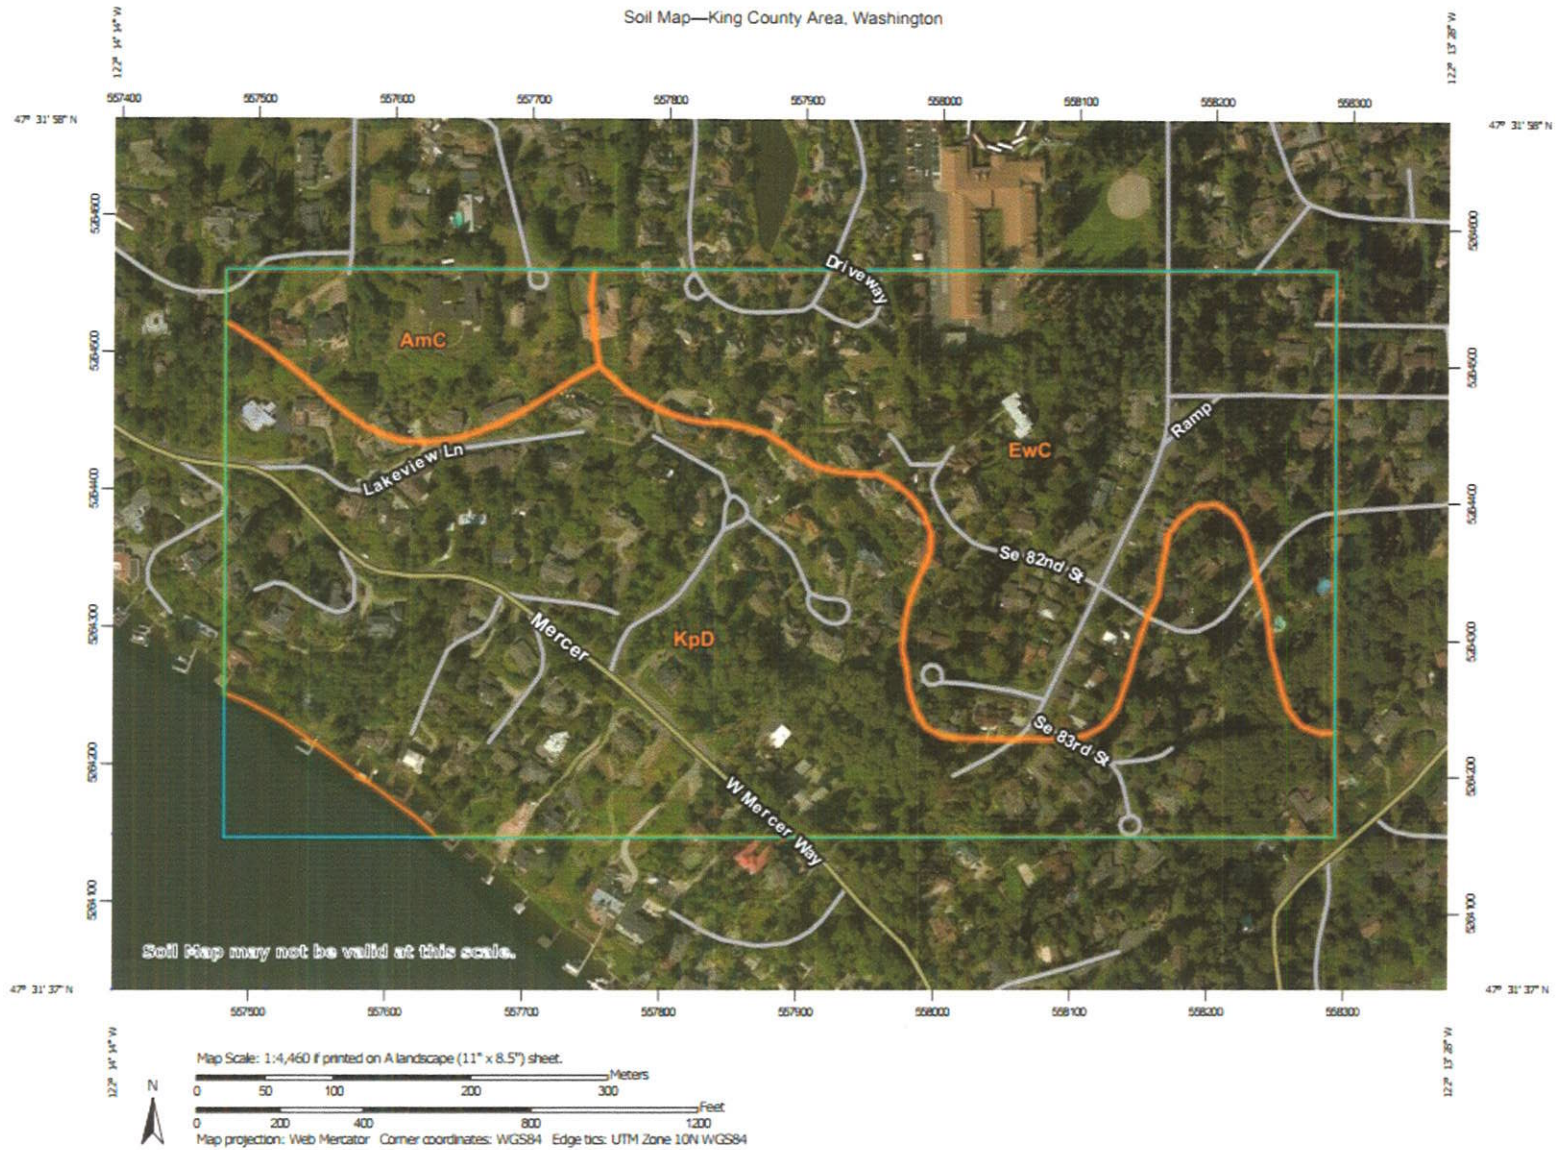
Figure 6. Soil Map

Arents, Alderwood material 6 – 15 percent slopes:

These soils formed from basal till within a landform known as “Till plains”. They are moderately well drained soils with a depth of 20-40 inches to underlying glacial till which forms a restrictive layer. The till layer has a very low to moderately low ability to transmit water (0.0 – 0.6 inches/hour). Depth to water table is 16 – 36 inches. There is no frequency of ponding or flooding in this soil type. Availability of water storage in the profile is very low (2.3 inches).

Everett-Alderwood gravelly sandy loam 6 – 15 percent slopes:

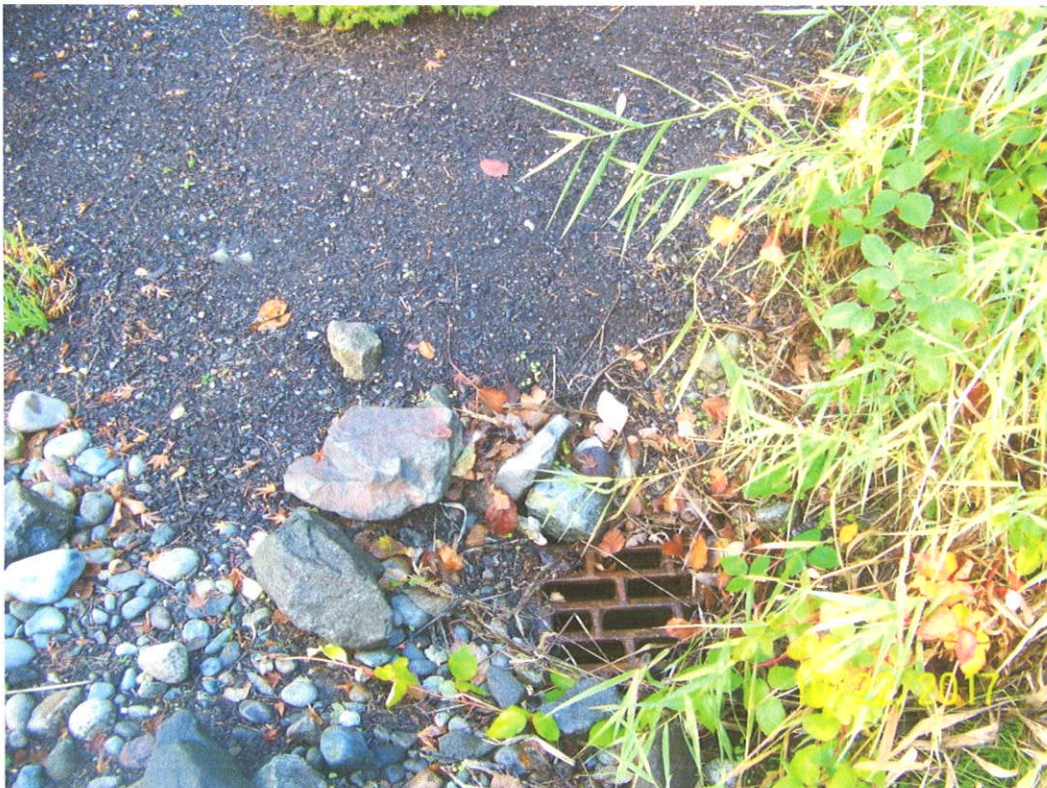
2) Storm drain at southeast corner of Property.

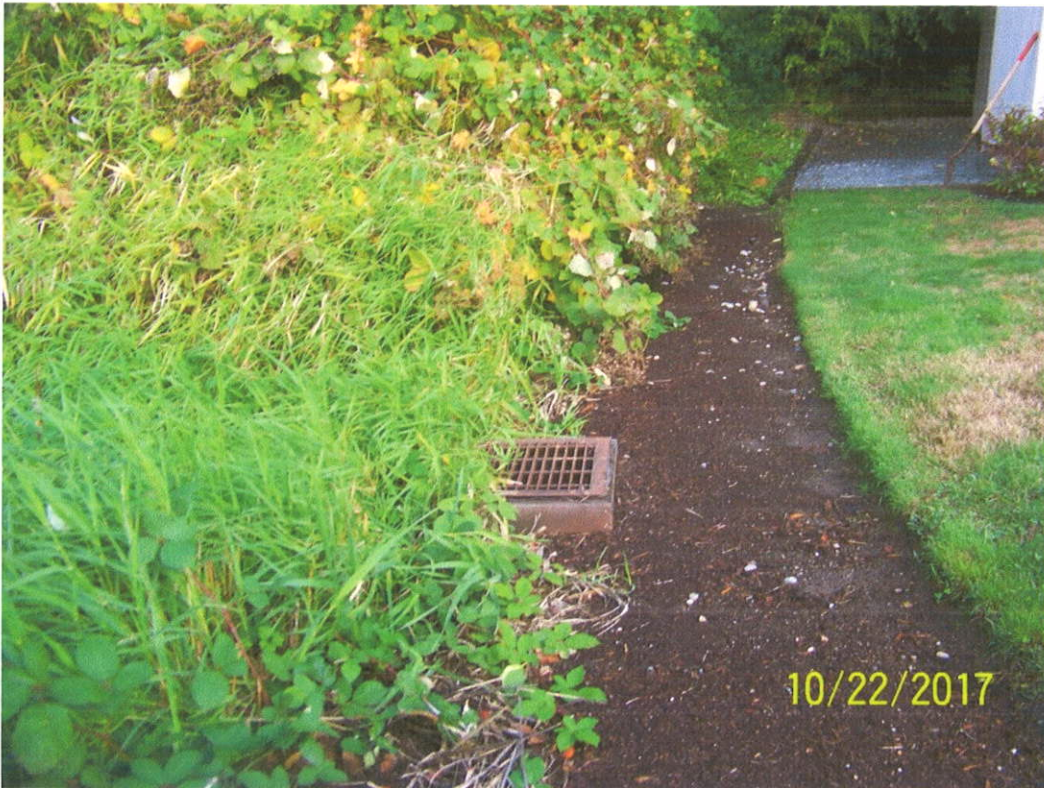
3) Storm drain on eastern Property boundary, intercepting stormwater from residence to the east.

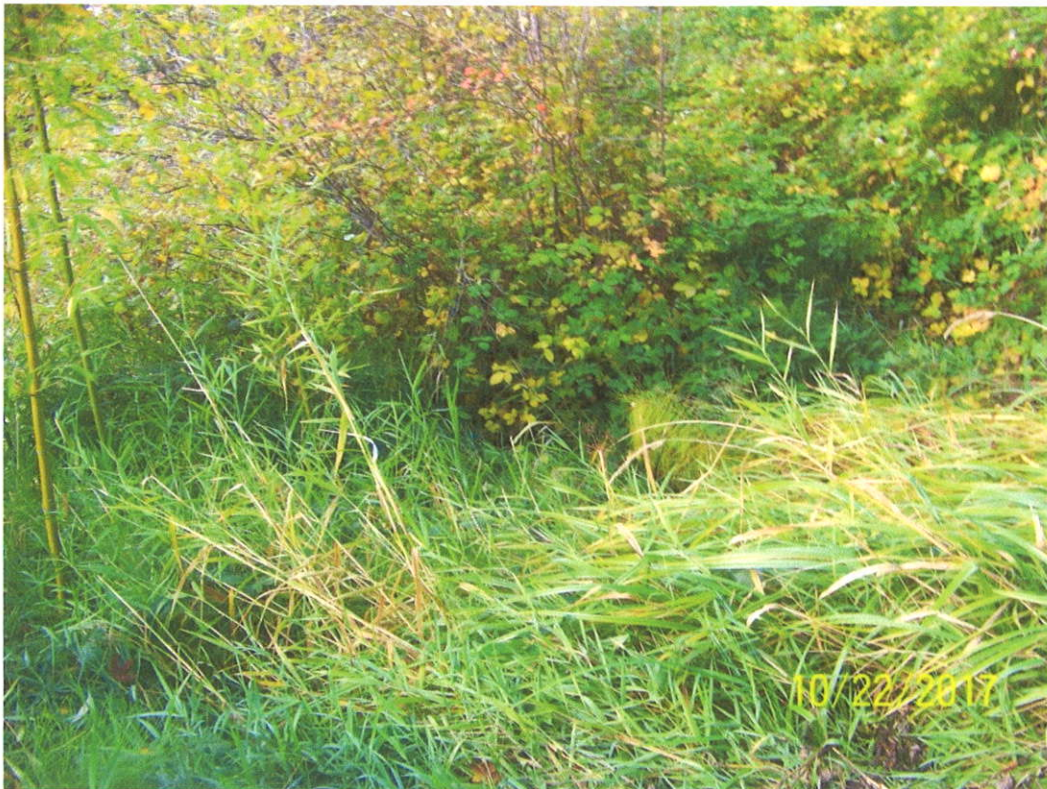
4) On-site wetland along eastern boundary of the Property.

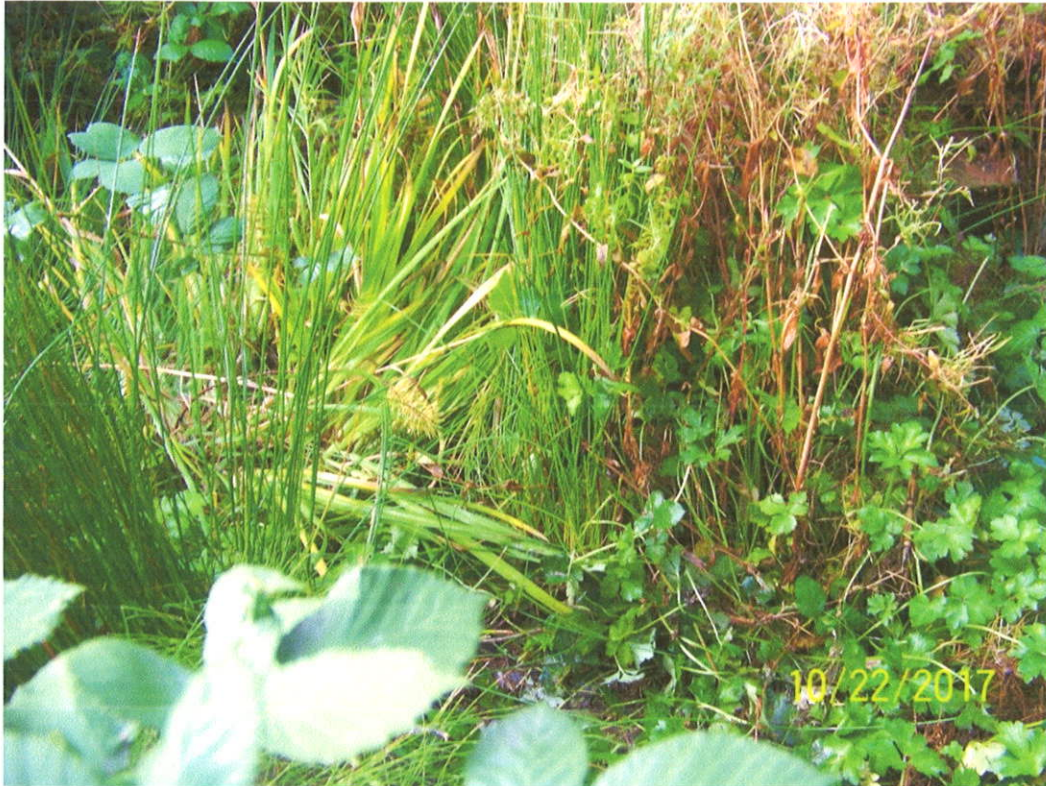
5) Wetland area showing sedges, bulrush, reed canary grass and soft rust.
