STAFF REPORT

CRITICAL AREA DETERMINATION

Project No.:	CA019-013
Description:	Request for a critical area determination to average the buffer of a Type 3 watercourse and category IV (4) wetland to replace and expand an existing patio with a new covered patio and stairs. The applicant is proposing to conduct development activity within 60 square feet of the watercourse's buffer, while adding 60 square feet to the buffer elsewhere on the property. In addition, the proposal also includes substantial 2,800sf buffer enhancement on the steep slope.
Applicant / Owner:	Josh Brincko (Josh PS) / Jonathan Lai
Site Address:	7505 92 nd Ave SE, Mercer Island, WA 98040; Identified by King County Assessor tax parcel number 257950-0188.
Zoning District:	Single Family Residential (R-9.6)
Staff Contact:	Lauren Anderson, Planner
Exhibits:	<ol style="list-style-type: none">1. Development Application, received by the City of Mercer Island on June 25, 2019.2. Revised Development Plan Set, received by the City of Mercer Island on May 20, 2020.3. Project Narrative, received by the City of Mercer Island on June 25, 20194. Revised Critical Areas Report, received by the City of Mercer Island on July 8, 2020.

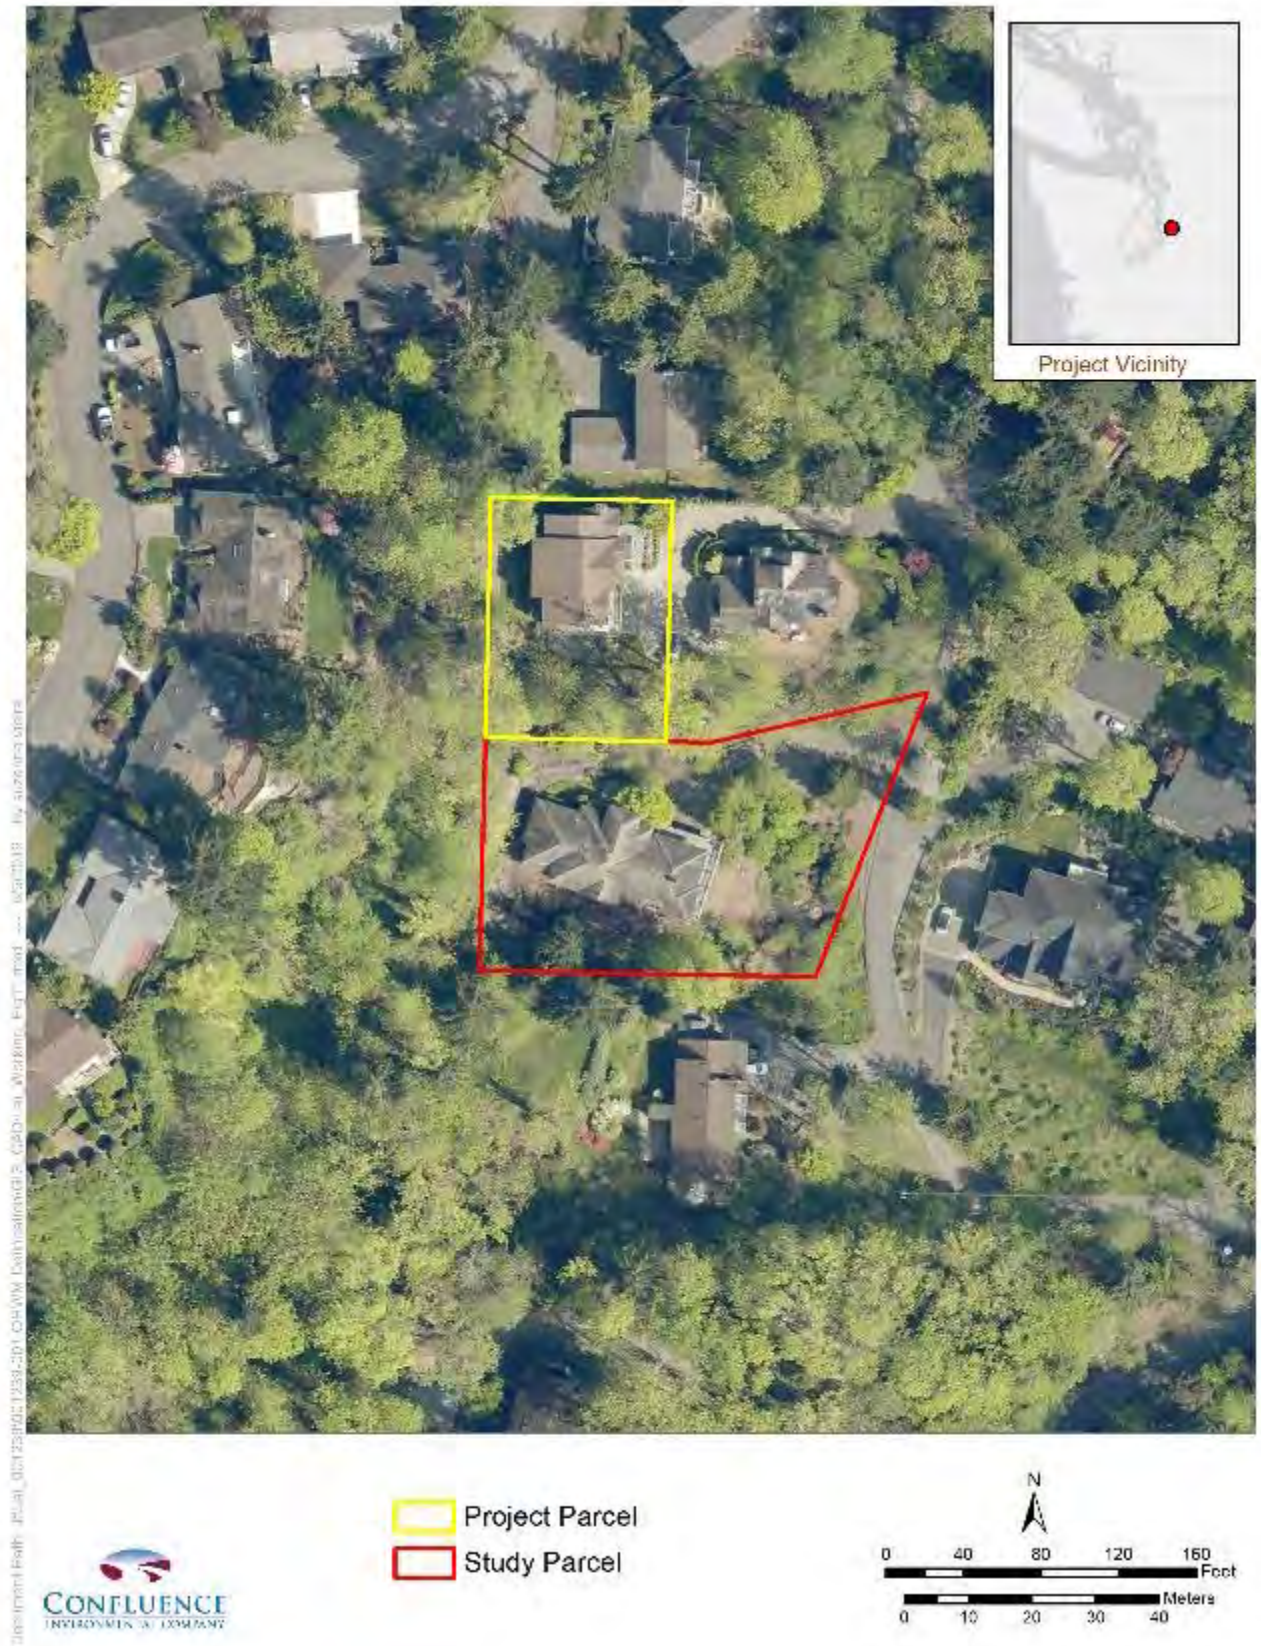
Figure 1. Project Parcel, Study Parcel, and Vicinity Map

On March 1 and March 15, 2019, Confluence Environmental Company (Confluence) conducted site visits at 7511 92nd Avenue SE (tax parcel 2579500190) (Figure 1). The purpose of the site visits was to determine the presence and extent of critical areas on and adjacent to the property. The effort focused on wetlands and streams. Critical areas such as erosion hazard areas, steep slopes, and landslide hazard areas were not evaluated in this study. This report discusses the results of the site visits.

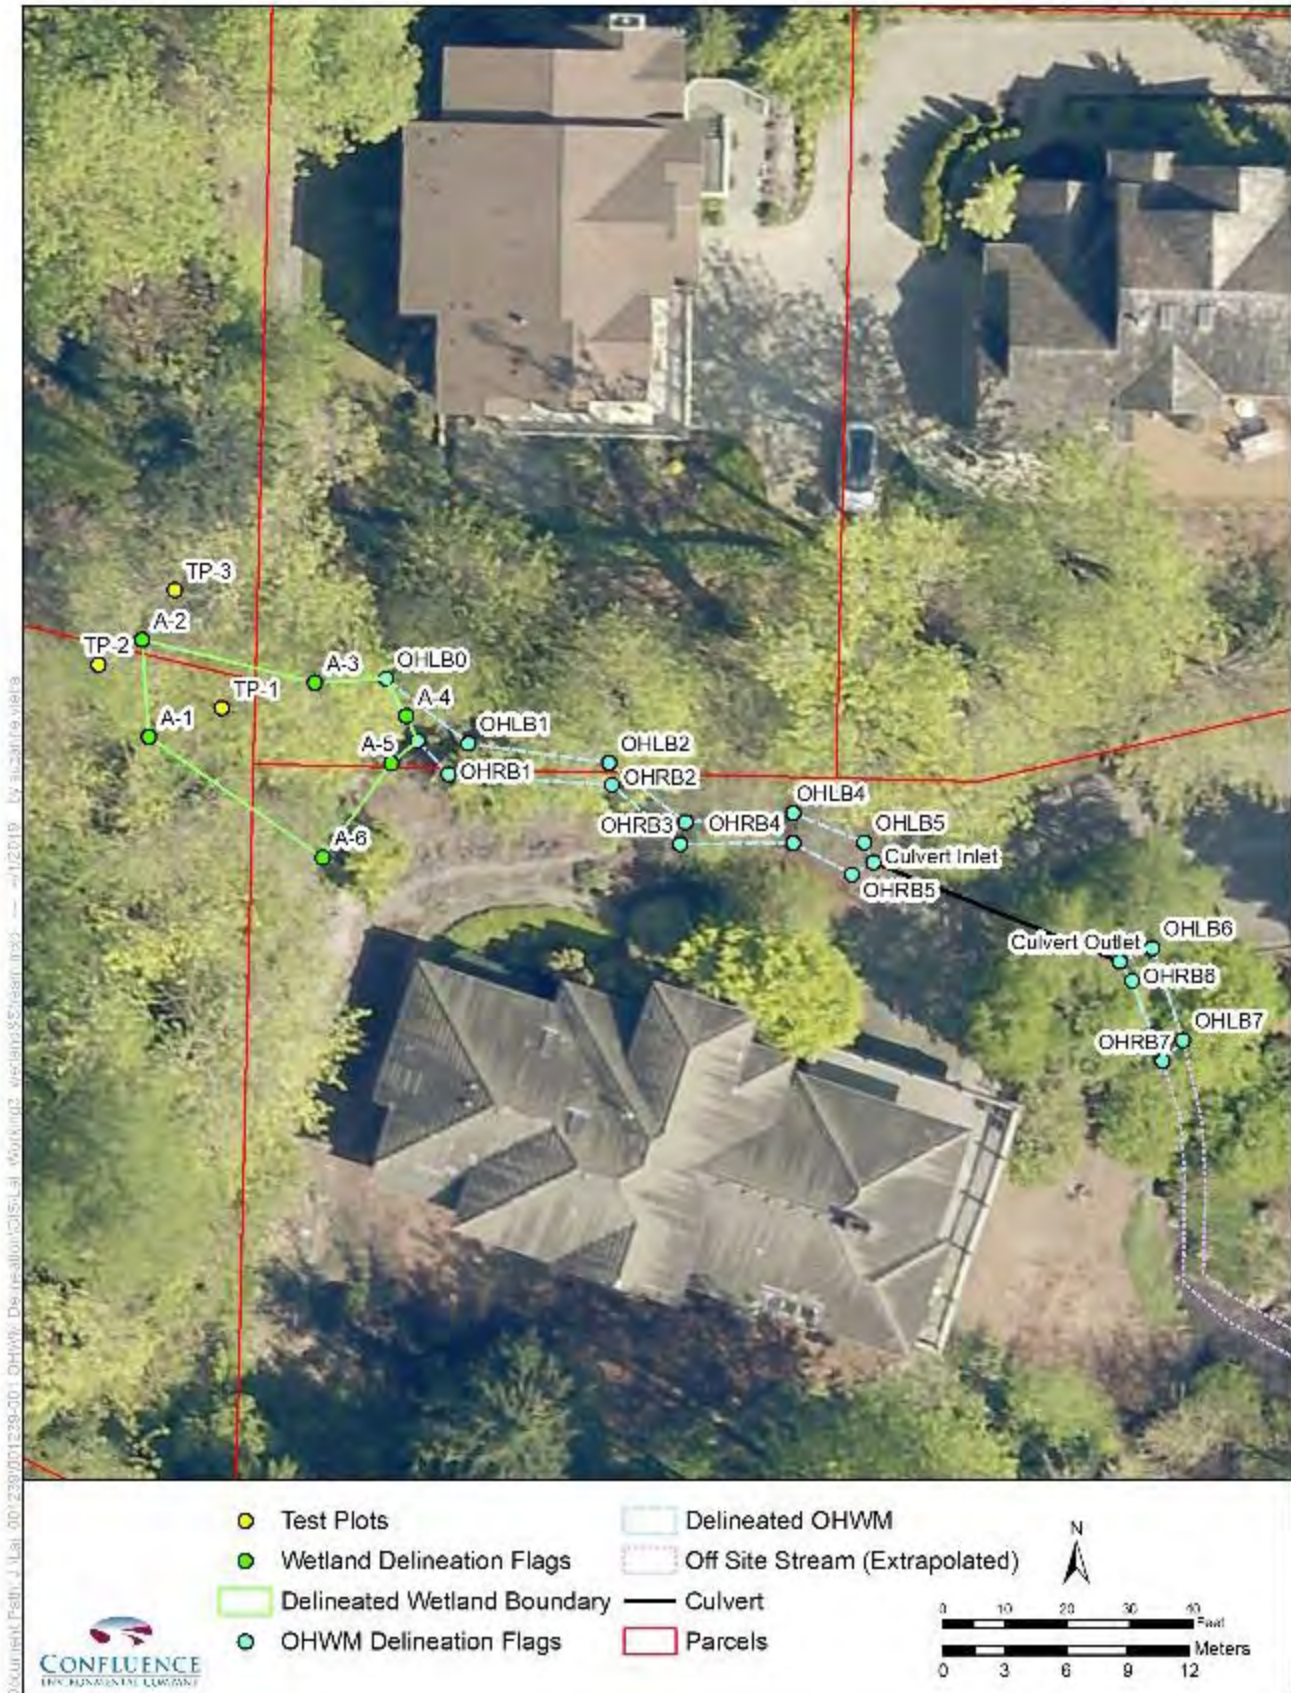
Figure 2. Location of Test Plots and Critical Area Boundaries

During the site visit, 3 test plots were established in both uplands and wetlands. Test plots are shown in Figure 2. The locations of the test plots were based on the presence of visual wetland indicators, such as wetland vegetation or evidence of standing water, or were chosen to represent vegetative communities on the property. Test plot summaries are detailed below. Appendix B provides the wetland determination data sheets recorded in the field.

Test Plot 1 (TP-1) was located at the northeastern corner of parcel no. 8566100140 at the base of the steep slope in an area dominated by invasive Himalayan blackberry. Vegetation within TP-1 passed the Dominance Test and therefore meets the wetland vegetation criterion. Soil in the top layer (0-3 inches) was a brown (7.5YR 4/2) silty clay loam with no redox features. The second layer (3-12 inches) contained grayish brown (10YR 5/2) silty clay loam with 40% yellowish brown (10YR 5/6) redox concentrations in the matrix. The soils therefore met the hydric soil indicator for depleted matrix (F3) and the hydric soil criterion was met. The primary wetland hydrology indicators of saturation (A3) and oxidized rhizospheres along living roots (C3) were observed; therefore, the wetland hydrology criterion was met. Since TP-1 met all 3 criteria, the area represented by TP-1 is a wetland identified as Wetland A.

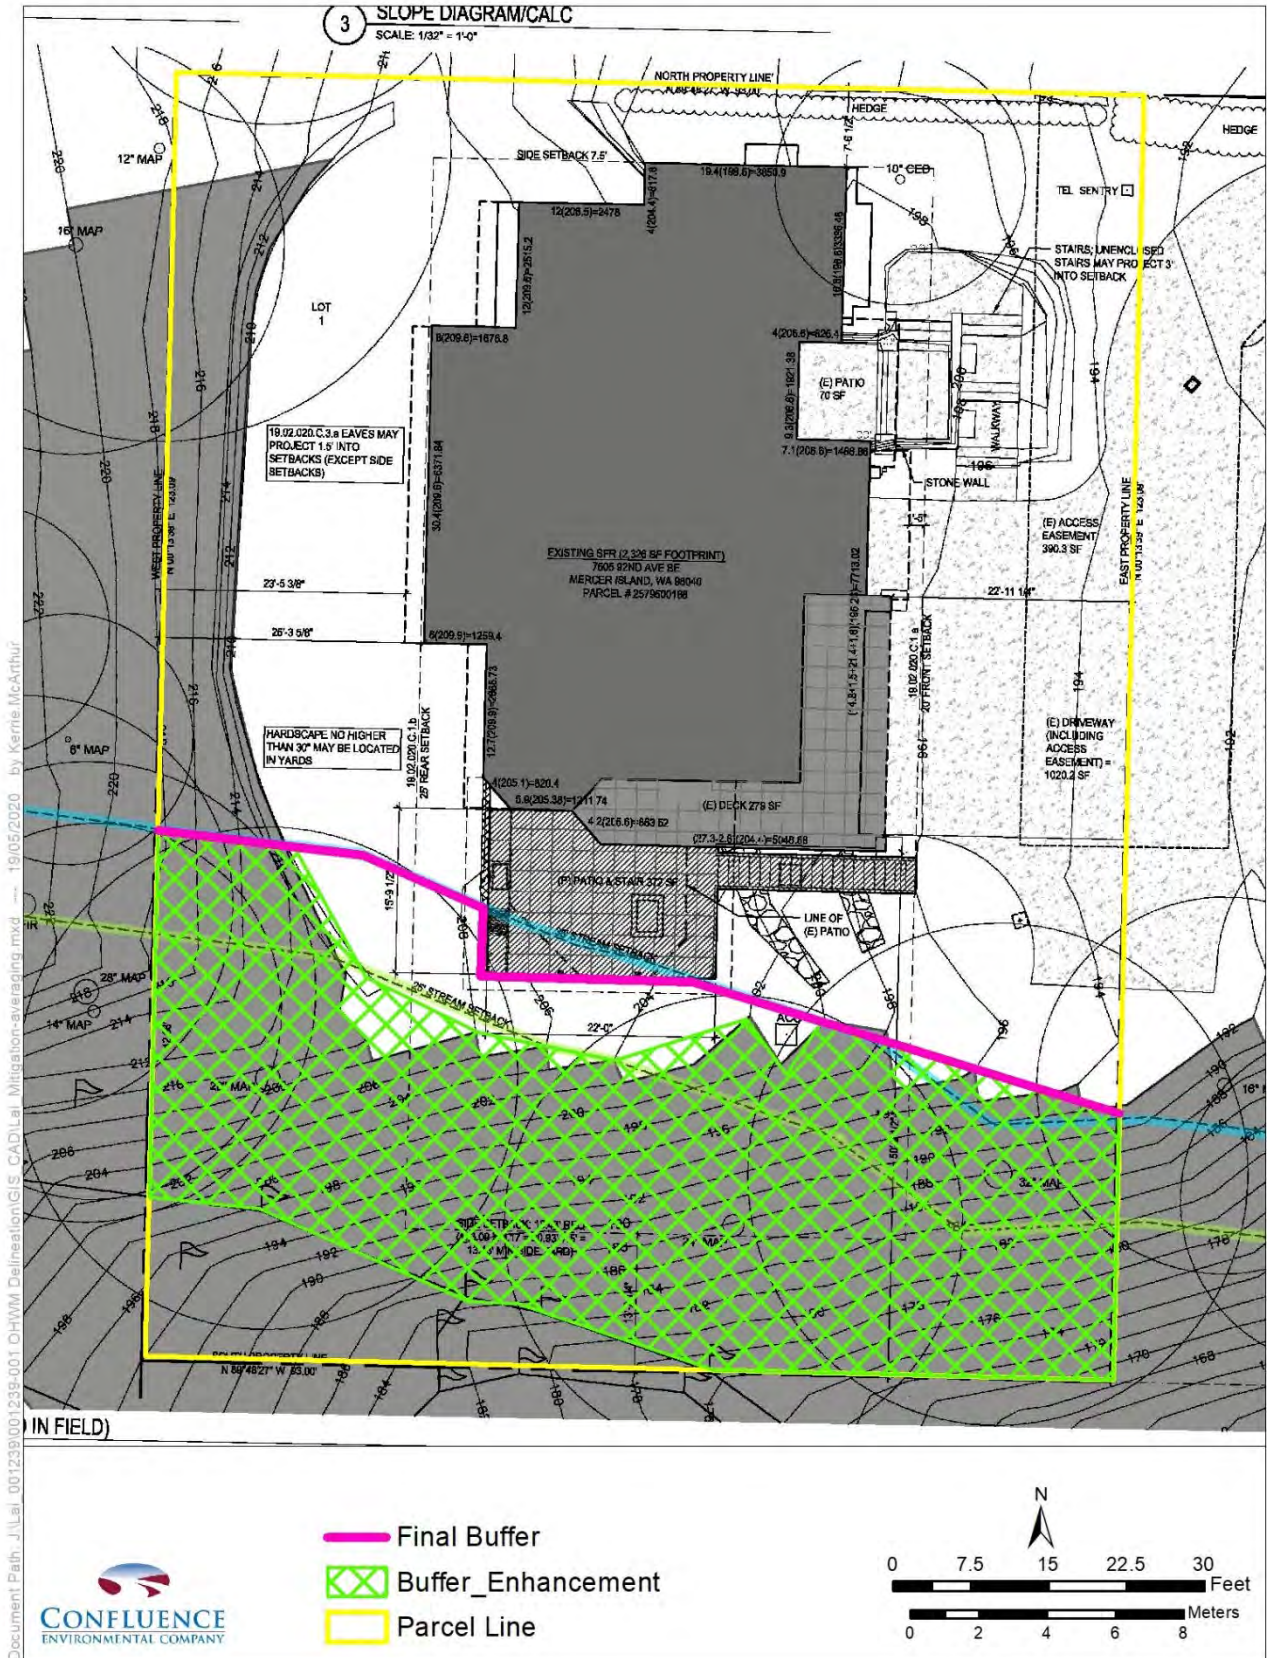
Figure 5. Buffer Enhancement Area

This mitigation proposes to enhance approximately 2,800 SF of the buffer upslope of the critical areas (Wetland A and the unnamed stream) (Figure 4). See Section 7.2, below for more details. Thus, this condition is met.

The existing steep slope consists of a very dense Himalayan blackberry thicket, with the on-site tree canopy almost entirely composed of deciduous species. While the Himalayan blackberry is a non-native species, it is providing slope stability by its binding of soils in their roots. Removing the Himalayan blackberry and replanting with immature native plants in its entirety has the potential to create unstable slopes. Therefore, the proposed enhancement is to plant only conifers within the steep slope buffer. The conifers will grow above the Himalayan blackberry, eventually shading out much of the Himalayan blackberry, while maintaining slope stability as the conifer's roots grow and bind the soil in their roots, thus taking the place of the bioengineering function that the Himalayan blackberry provided. The addition of Douglas-fir and western red-cedar will also provide enhanced habitat options for wildlife, as these species provide species diversity compared to the existing conditions and provides the basis of forest conversion from a deciduous forested community to a coniferous forested community.

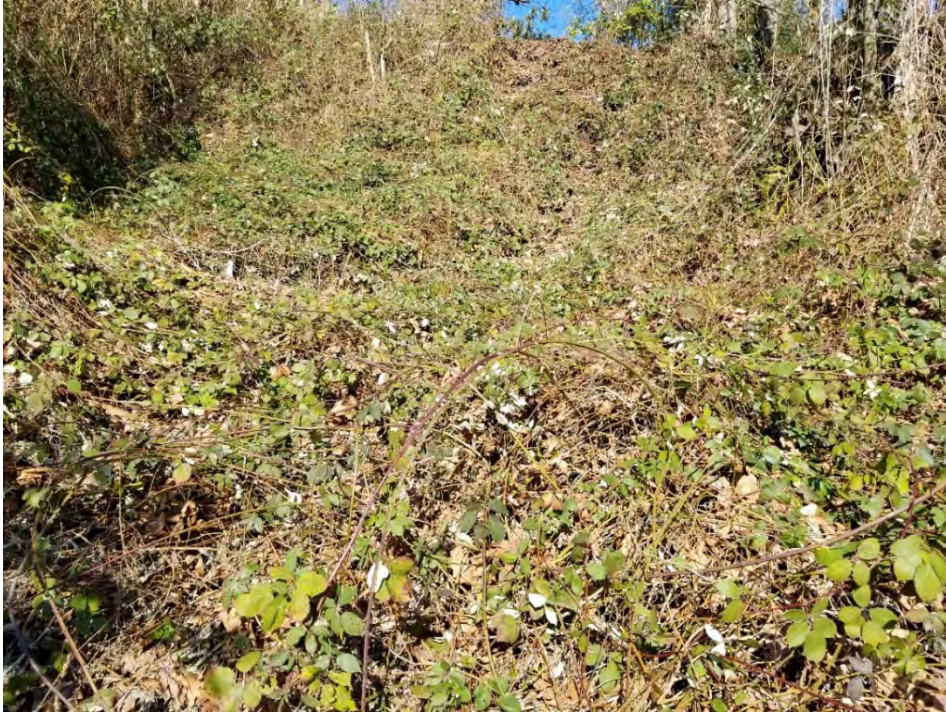
Photo 2—Steep slope to west of stream channel. This slope is the location of Wetland A. Note the dense Himalayan blackberry cover.

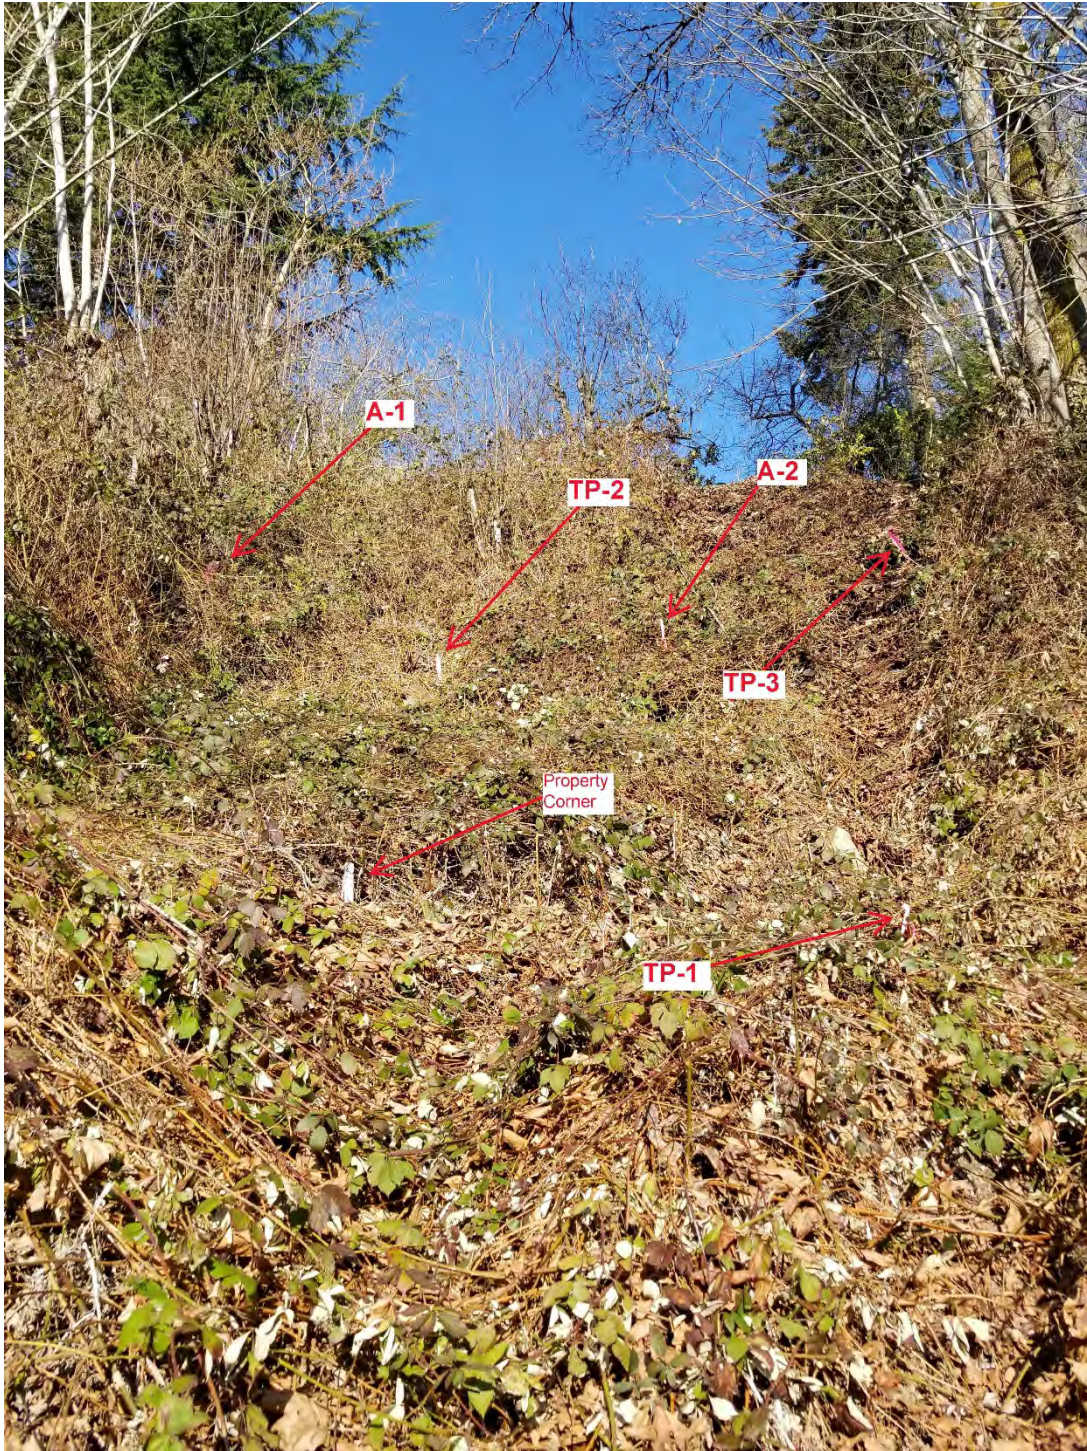
Photo 4—Wetland A, looking upslope and westward. Red arrows indicate the location of test plots (TP) and wetland boundary flags.

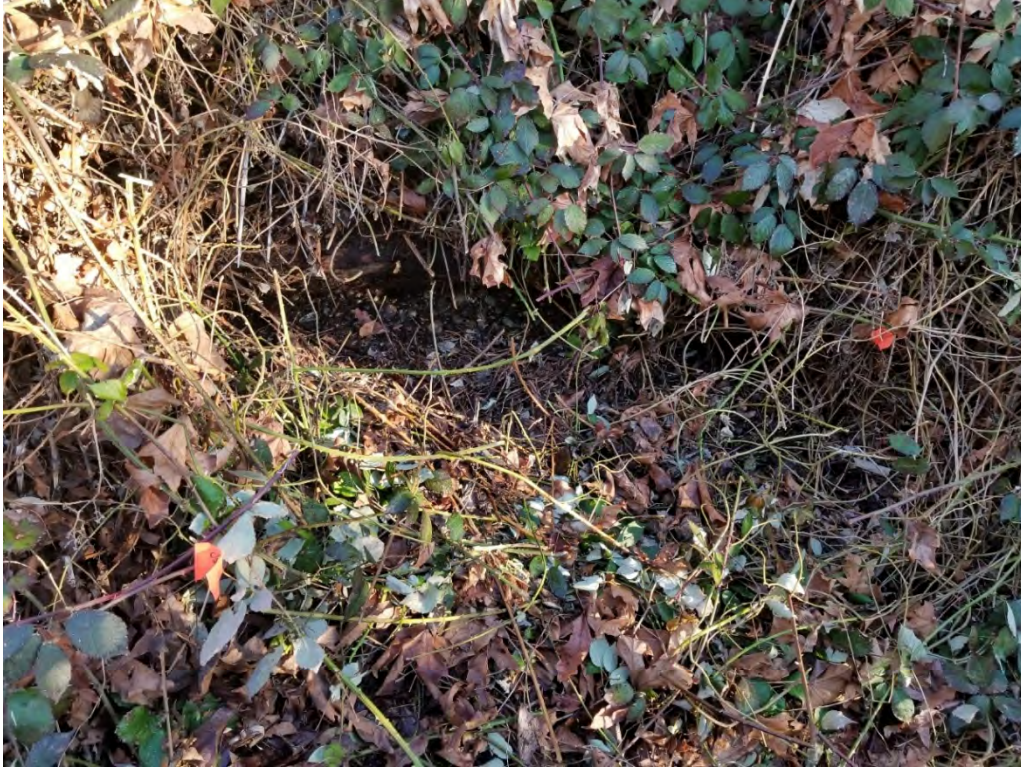
Photo 5—OHWM flags OHLB0 and OHHRB0. This image shows the headwaters of the stream channel where the wetland outlets, looking northwest.

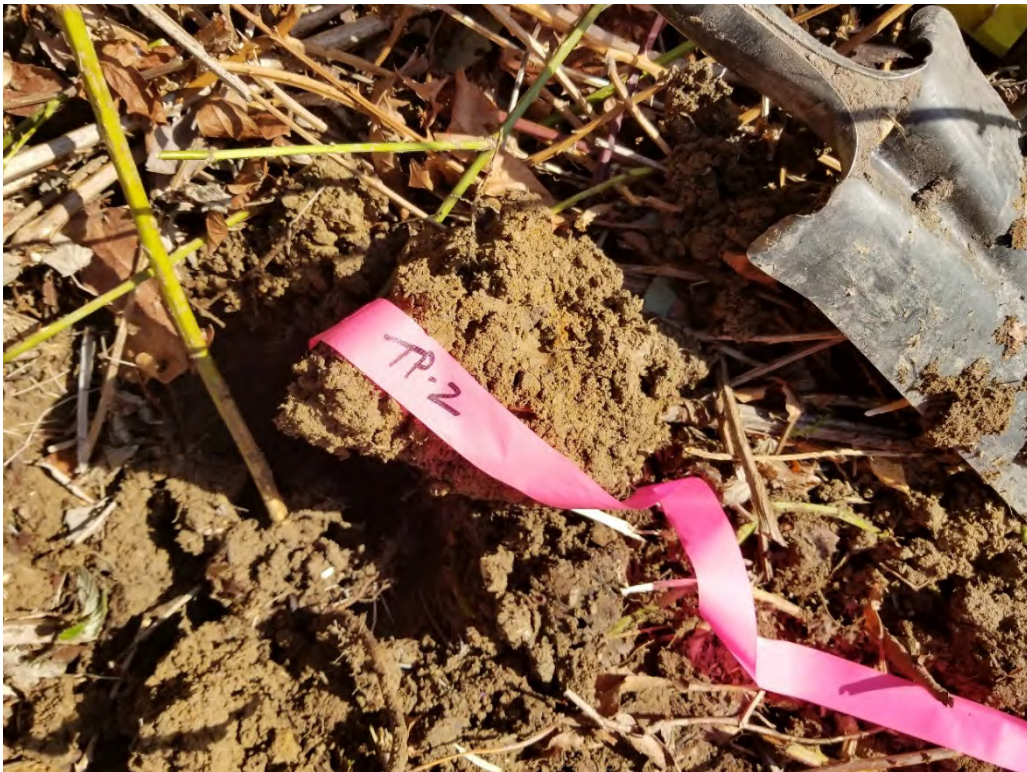
Photo 6—Non-hydric soils at TP-2.

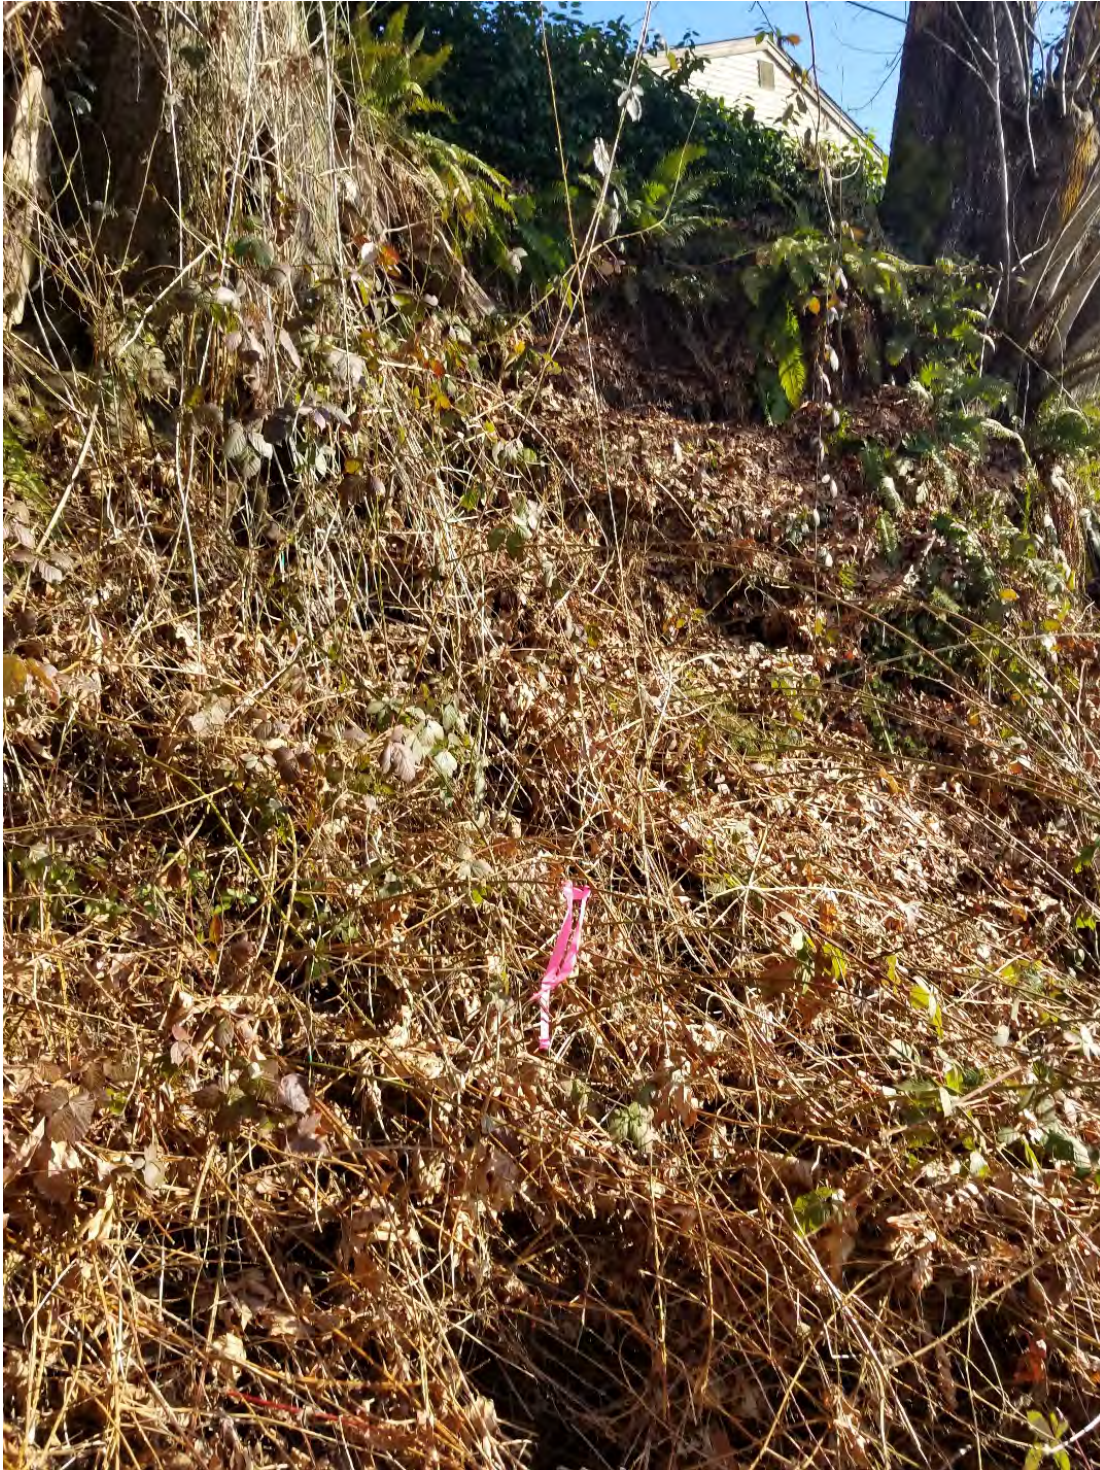
Photo 7—Location of TP-1 on blackberry-covered steep slope to north of stream headwaters.

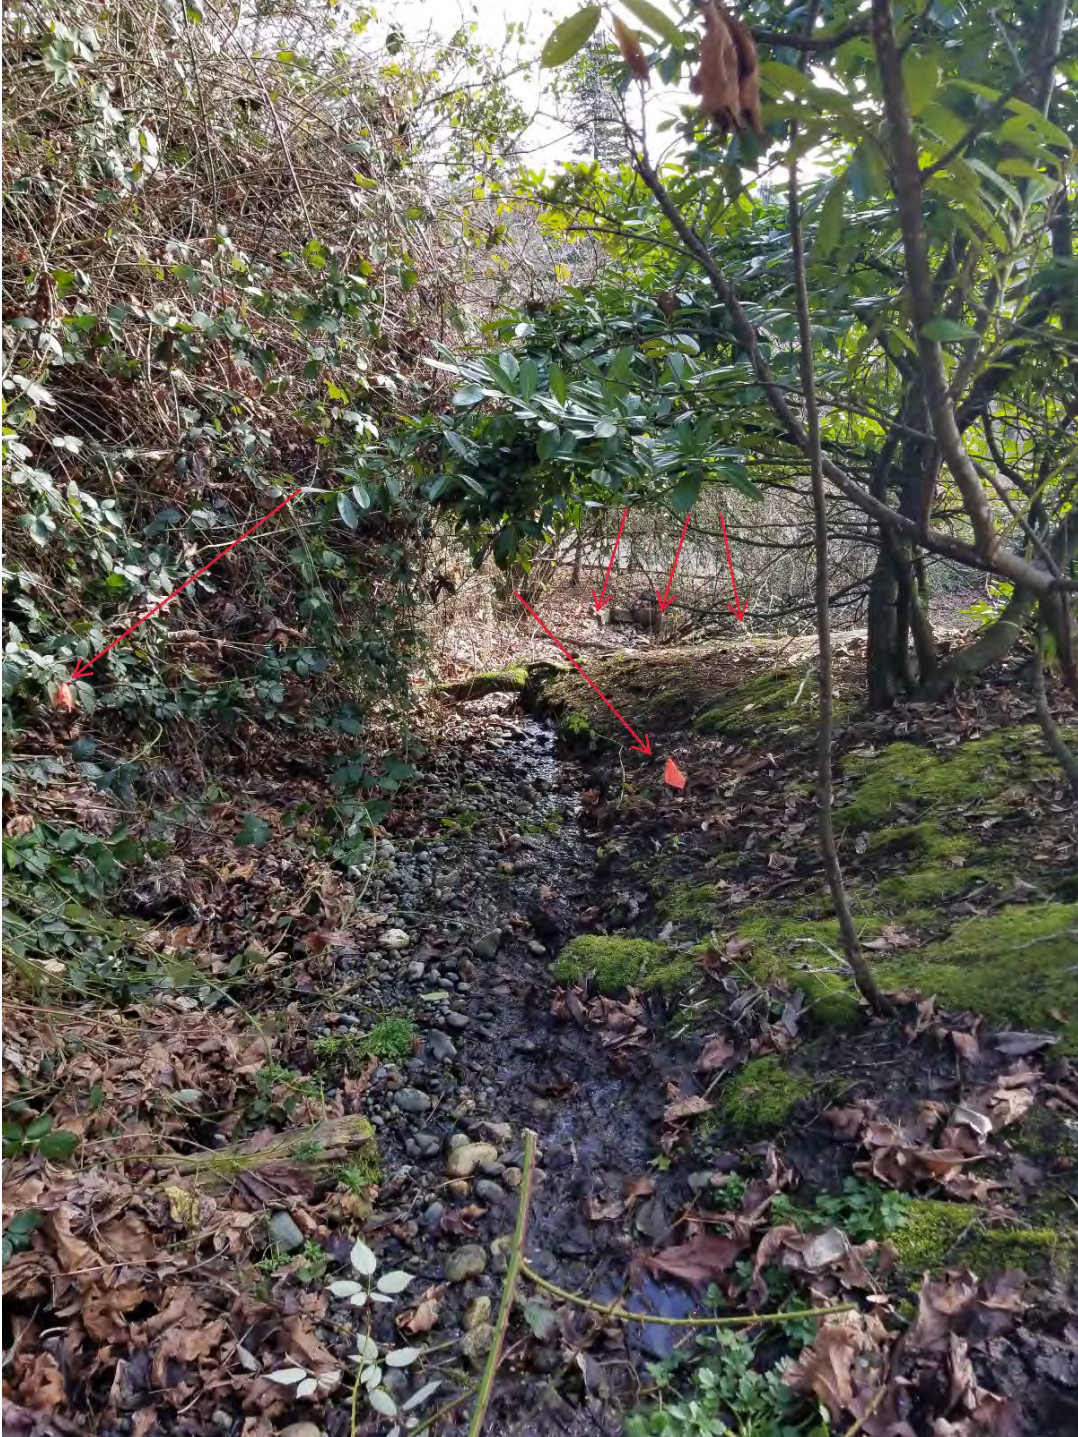
Photo 8—Delineated OHWM, facing east. Red arrows show location of visible pin flags.

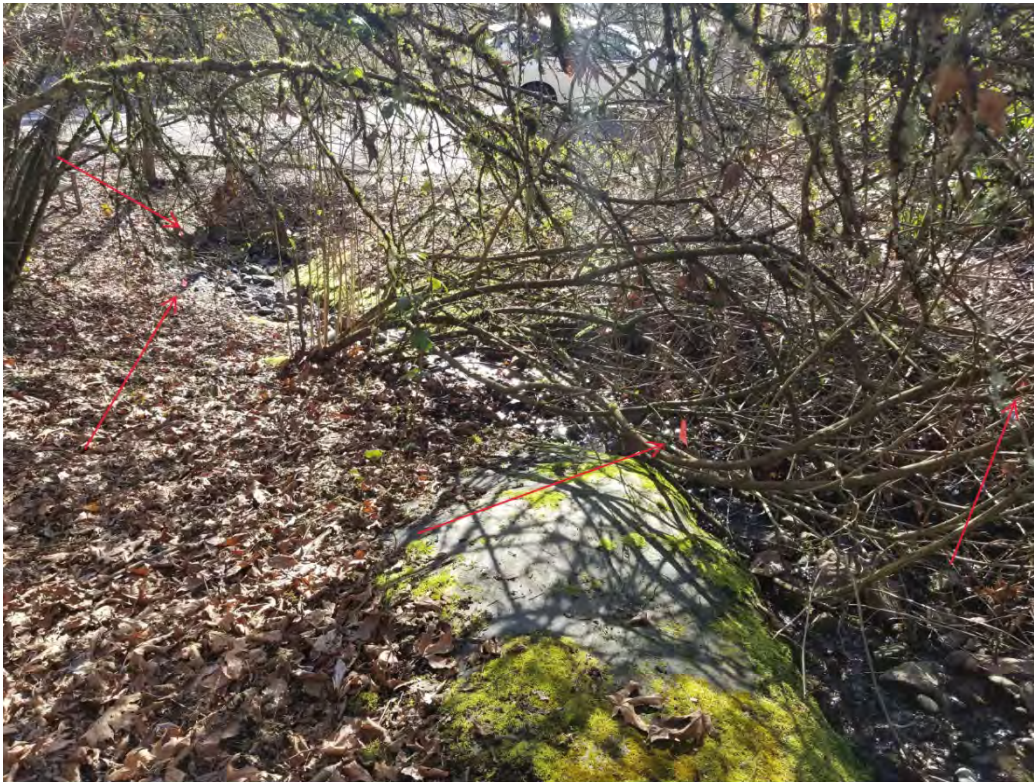
Photo 9—Delineated OHWM, facing east. Red arrows indicate the location of visible pin flags.

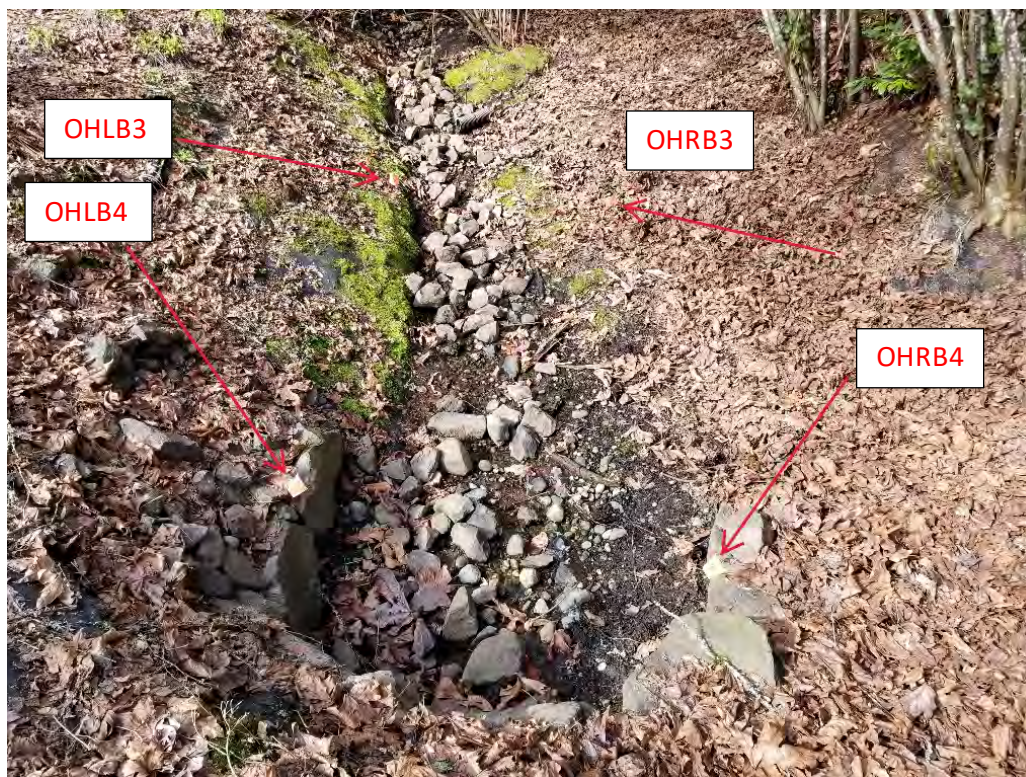
Photo 10—Delineated OHWM, facing west. Red arrows show location of visible pin flags. Note dry stream channel. (Photo taken March 4, 2020)

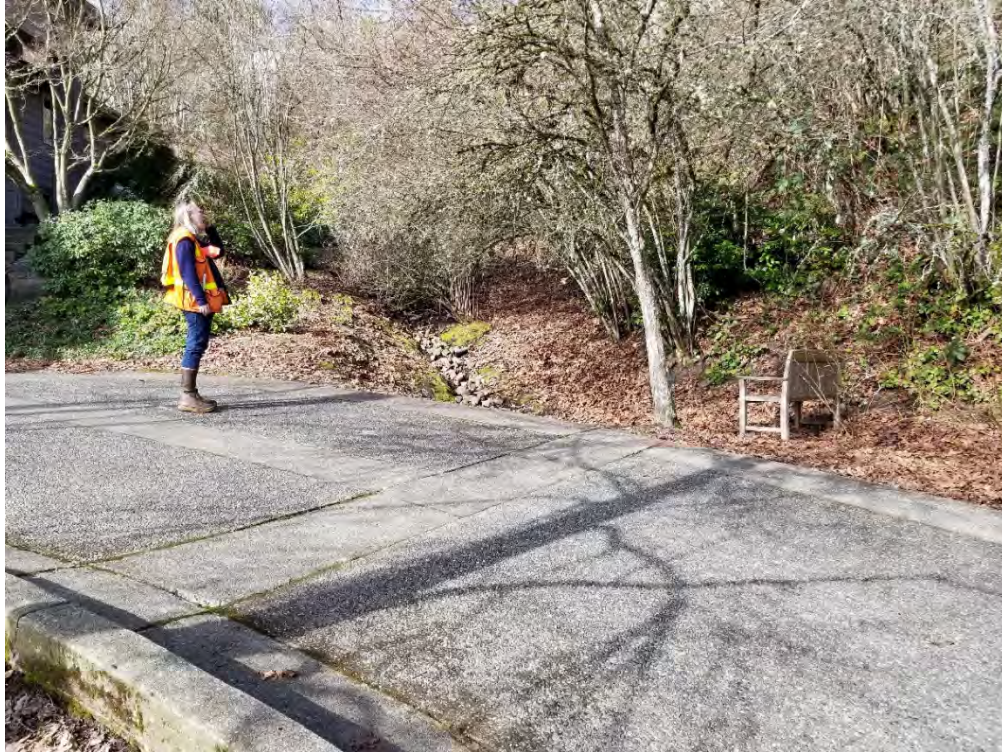
Photo 11—Driveway to 7511 92nd Avenue Southeast. The stream channel is conveyed under this driveway by a culvert.

Within the study site and adjacent parcel, the channel of the unnamed stream is mostly exposed cobbles and gravels. The stream banks were largely not armored, although some boulders were placed along the culvert inlet and outlet under the driveway to provide structural protection. Black landscaping fabric was also evident on both banks. This fabric may play a part in controlling streambed erosion. The primary indicators used to delineate the OHWM included the top of bank and darker stains on fixed objects such as boulders and landscaping fabric. As the vegetation was largely landscaped along the stream channel, plant species were not used as indicators of OHWM.

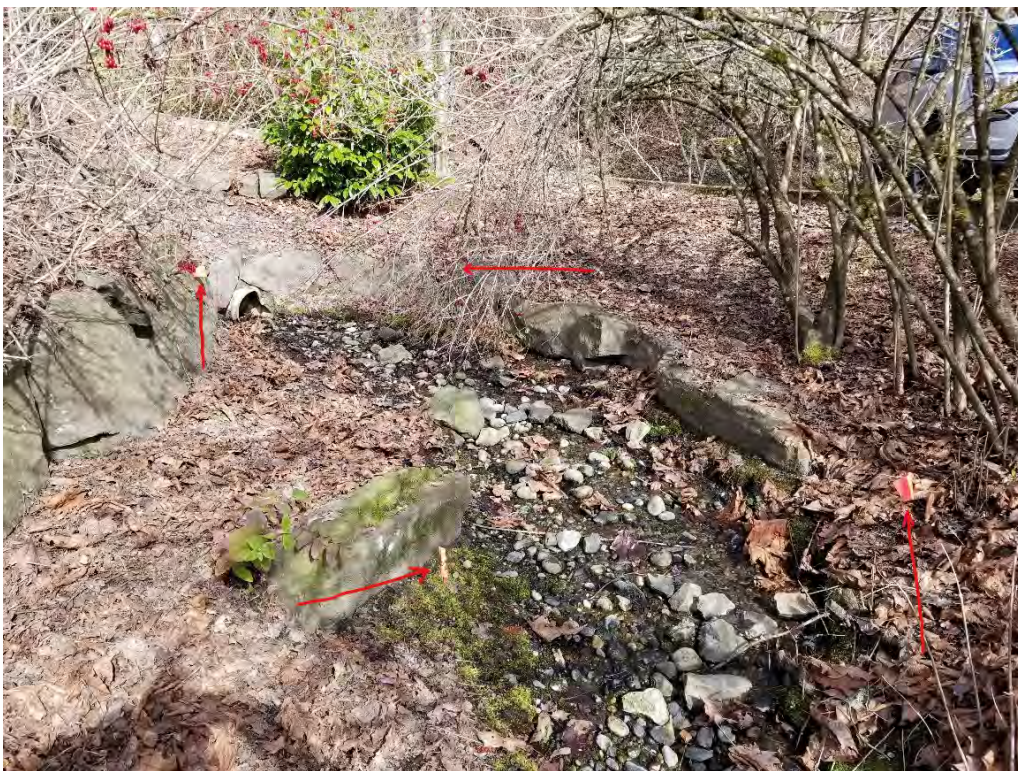
Photo 12—Delineated OHWM below the driveway, facing north.
Red arrows show location of pin flags.

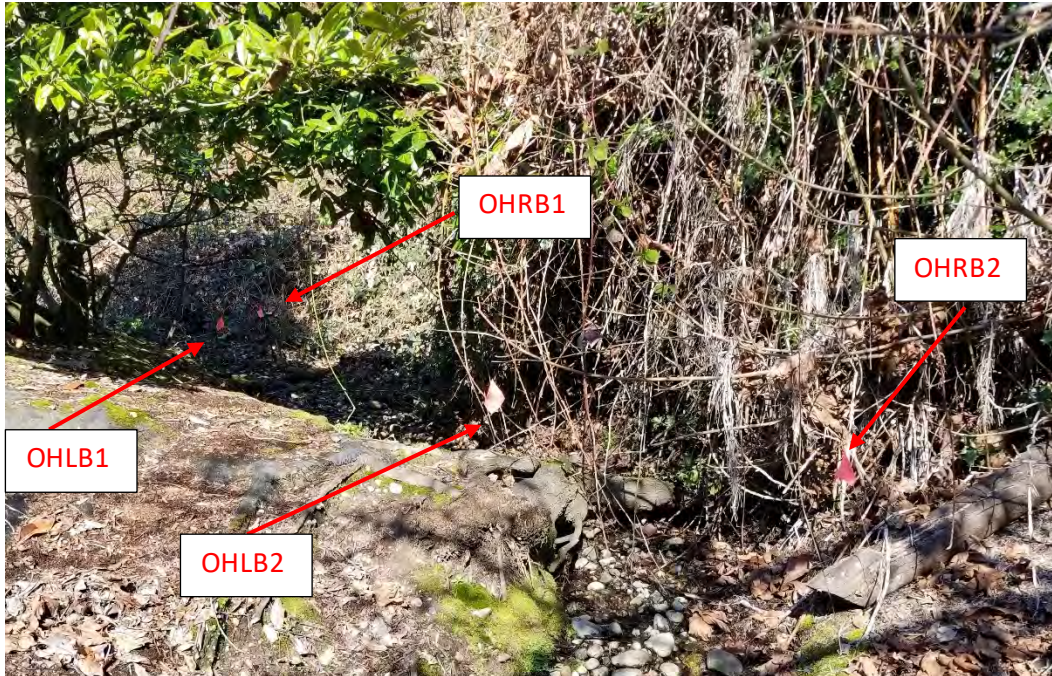
Photo 14—Delineated OHWM, facing west. Red arrows show location of visible pin flags. Note dry stream channel. Photo taken March 4, 2019.

This stream is defined as a Type 2 stream according to the City of Mercer Island GIS Portal (City of Mercer Island 2019). A Type 2 stream is described as a watercourse with year-round flow and not used by fish, according to MICC 19.07.070A.2. However, anecdotal evidence provided by the property owner and the Project surveyors indicated that the stream does dry up and ceases to flow in the summer months. Additionally, during the surveyors' site visit to record the location of wetland and OHWM flagging, the surveyors observed a dry streambed (see photographs 10, 14, and 15 in Appendix D). Photo 10 is shown on page D-7. Photo 10 was taken on March 4, 2020 and shows the dry streambed on the adjacent property between the OHWM flag series 3 and 4. Photo 14 is shown on page D-10. Photo 14 was taken on March 4, 2020 and shows the dry streambed on the subject property between the OHWM flag series 1 and 2. Because the dry streambed is hard to see on Photo 14 because of the shadows, Photo 15 was created. Photo 15 is a cropped and zoomed in image of Photo 14 of the dry streambed.
