CRITICAL AREA STUDY

Headrick Garage and Pool Addition – 8822 SE 62nd St Mercer Island, WA

Wetland Resources, Inc. Project #18303

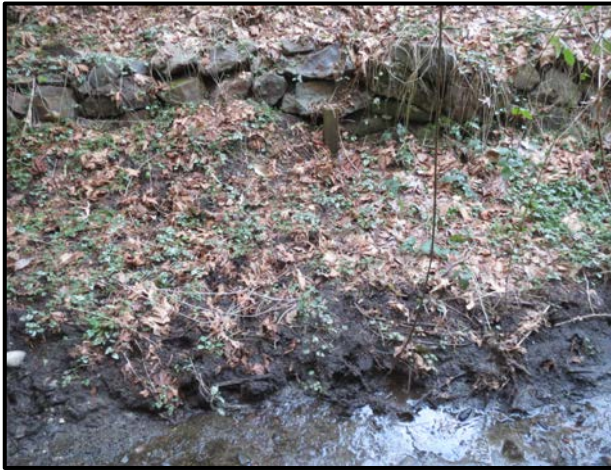
Figure 4: Facing East Towards Wetland A

Wetland A is 123 square feet in total area. The feature is located along the east property line of the subject property, on the left bank of Stream A. The feature forms from groundwater discharge at the toe of an existing retaining wall, and is also supported by the hyporheic zone associated with Stream A. Groundwater was observed in data site S-1 at the same elevation as the stream bed. Wetland A was rated as a slope wetland due to lack of evidence of overbank flooding. Vegetation was not flattened or otherwise marked, scour marks and recent or layered sediment deposits were not observed in the soil profile.

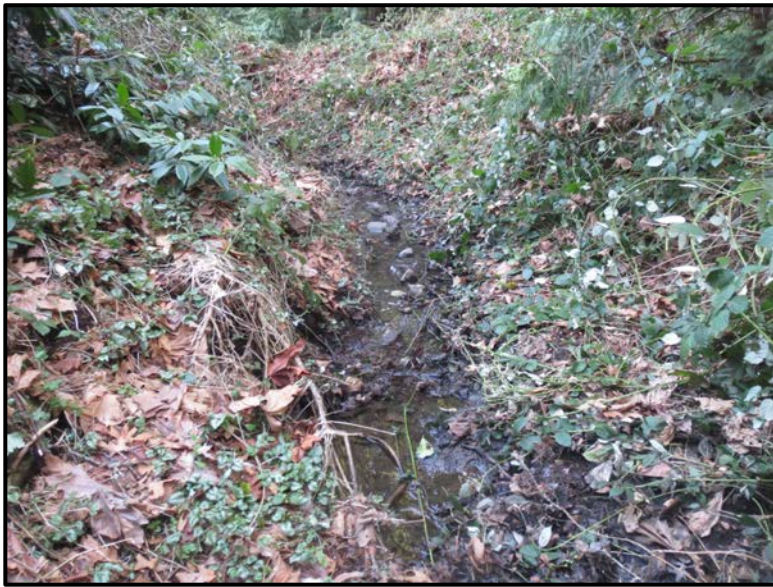
Figure 6: Facing South Along Stream A

The open channel of Stream A originates at the outlet of a large-diameter culvert located near the northeast corner of the subject property. The channel terminates where it enters another culvert located in the southeast corner of the subject property. The open channel consists of mixed cobble, bricks, and mud. The feature is an intermittent stream based on physical observation of a dry bed during the March site visit. Piped watercourses require 25-foot protective buffers, and Type 3 watercourses require 35-foot protective buffers. Based on comparison with the Mercer Island GIS Portal, it appears that Stream A outlets directly to Lake Washington on the east side of Mercer Island.

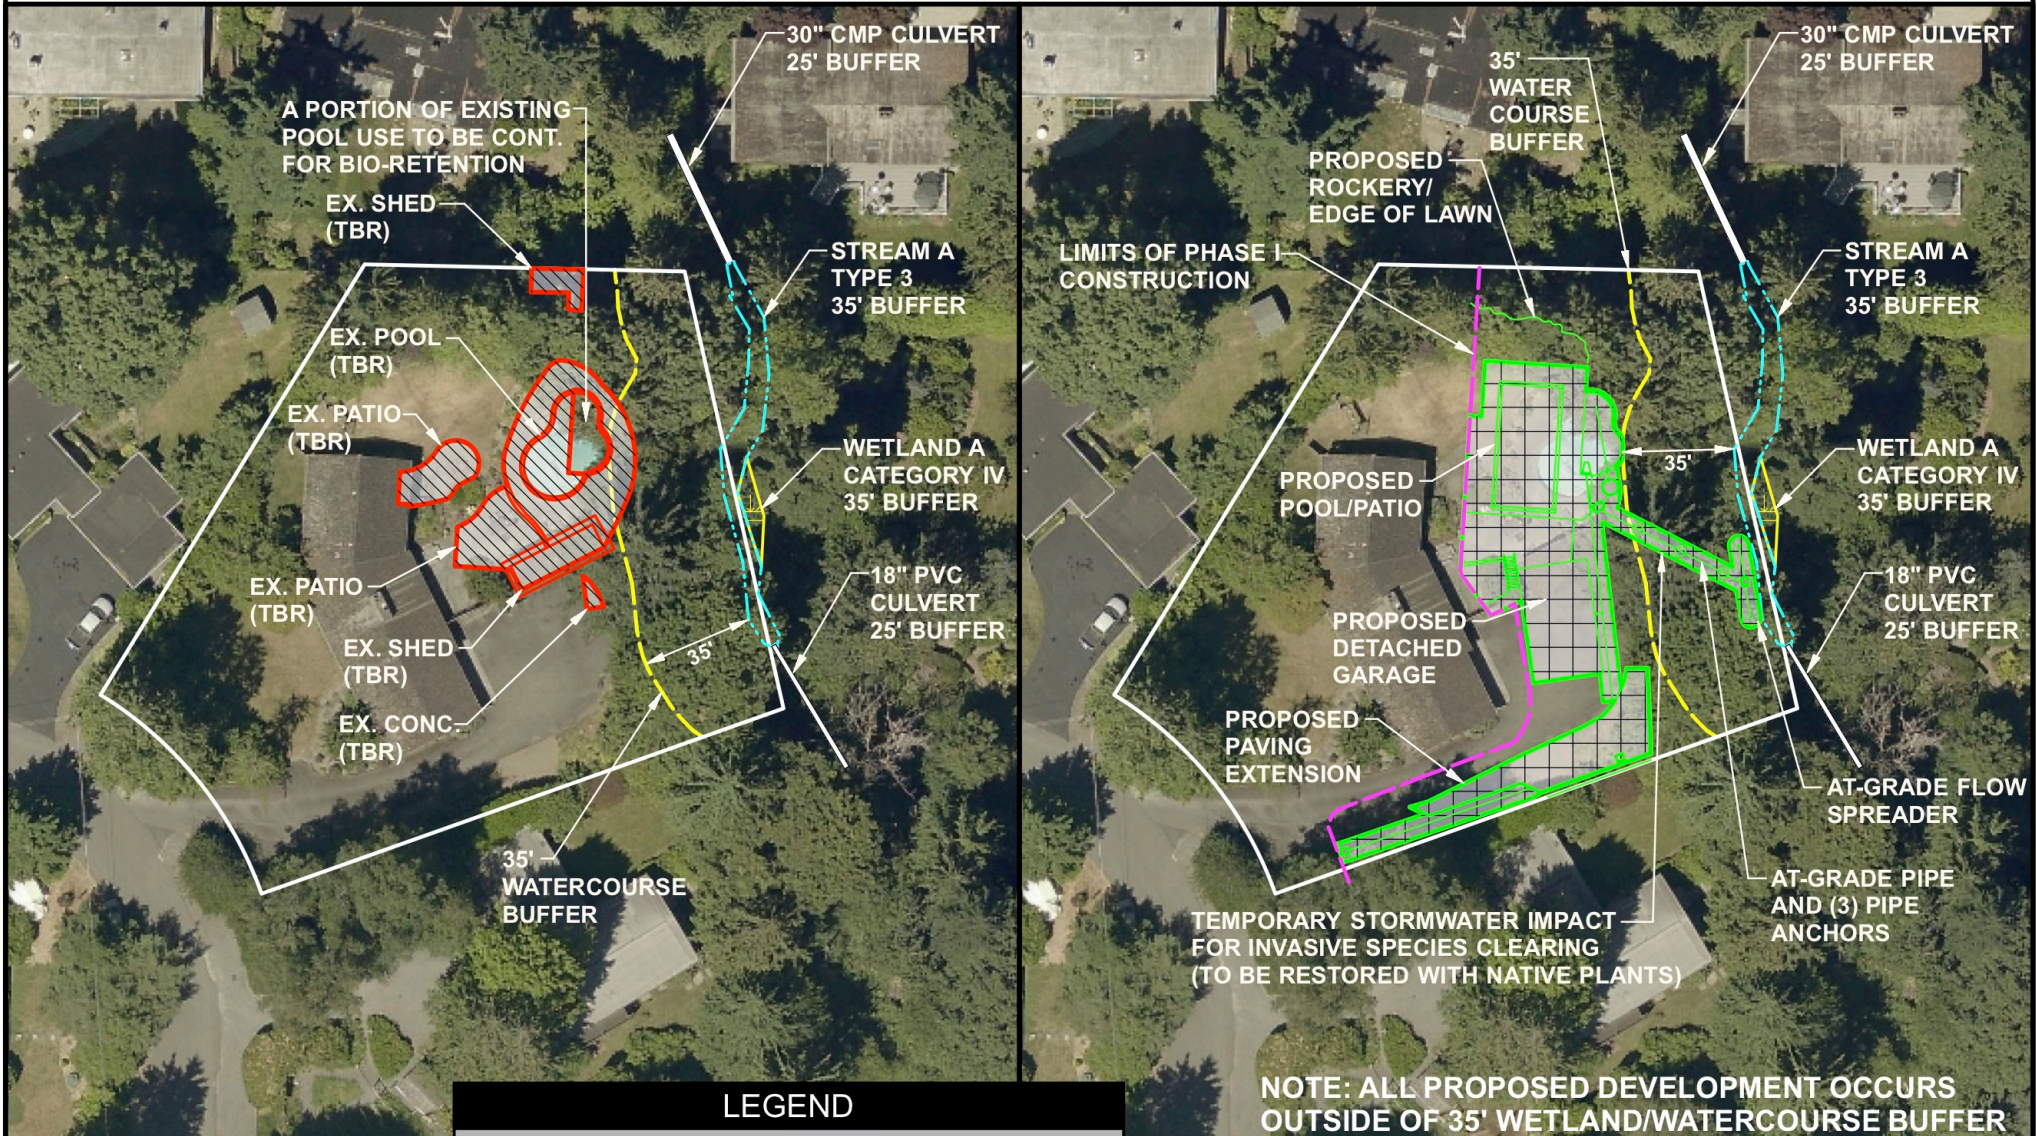
NOTE: ALL PROPOSED DEVELOPMENT OCCURS OUTSIDE OF 35' WETLAND/WATERCOURSE BUFFER
