CRITICAL AREA STUDY

Headrick Garage and Pool Addition – 8822 SE 62nd St Mercer Island, WA

Wetland Resources, Inc. Project #18303

First Submittal: May 1, 2019
Revision 1: October 25, 2019

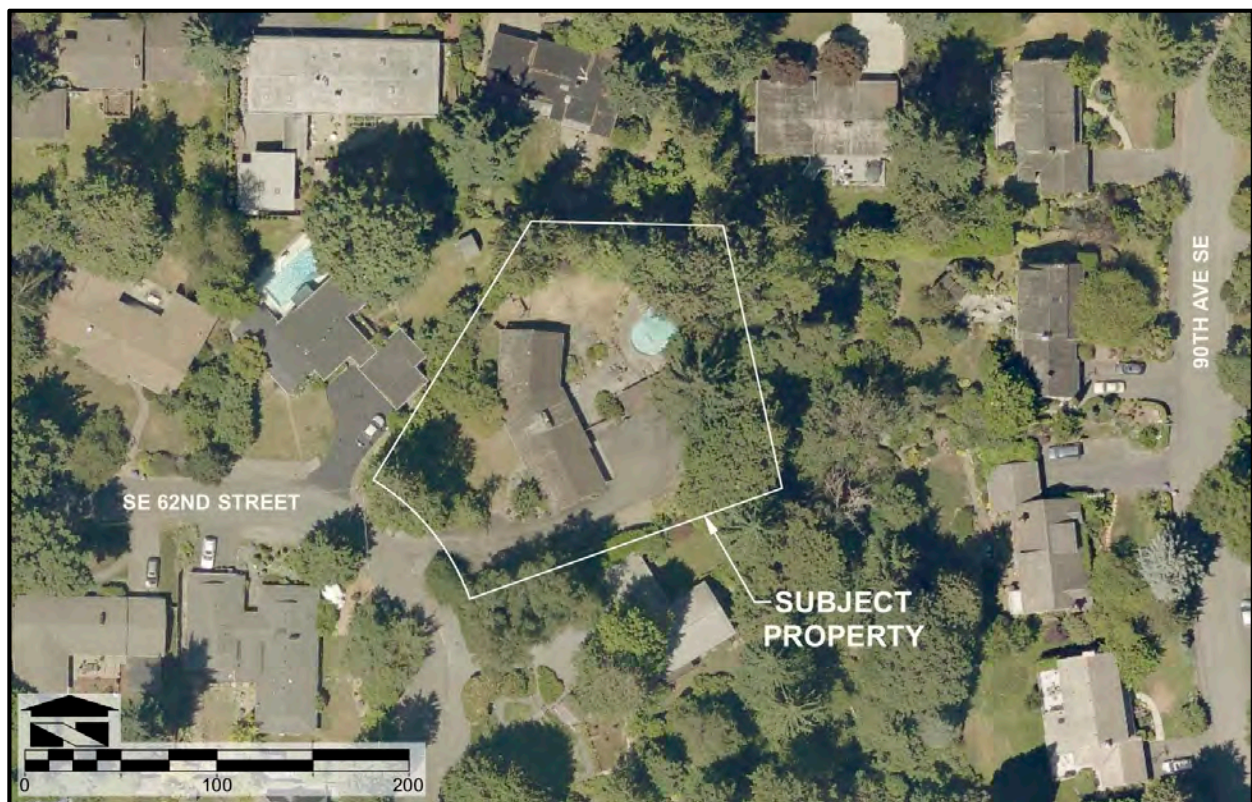
Figure 1: Aerial Overview of Subject Property

The subject property is a relatively level lot that slopes towards a shallow north-to-south oriented ravine in the eastern portion of the property. The level portion of the site is developed with a single-family residence and appurtenant structures/uses, including access/parking, storage sheds, ornamental landscaping, lawngrass, paved areas, and a pool. A seasonal stream channel and a 123 square-foot wetland were identified along the east property line. The stream originates from a large-diameter culvert located near the northeast property boundary, and enters another culvert near the southeast property boundary. The small wetland is supported by groundwater discharge at the toe of the ravine, along the face of an existing retaining wall. The wetland also receives hydrology from a hyporheic connection with Stream A.

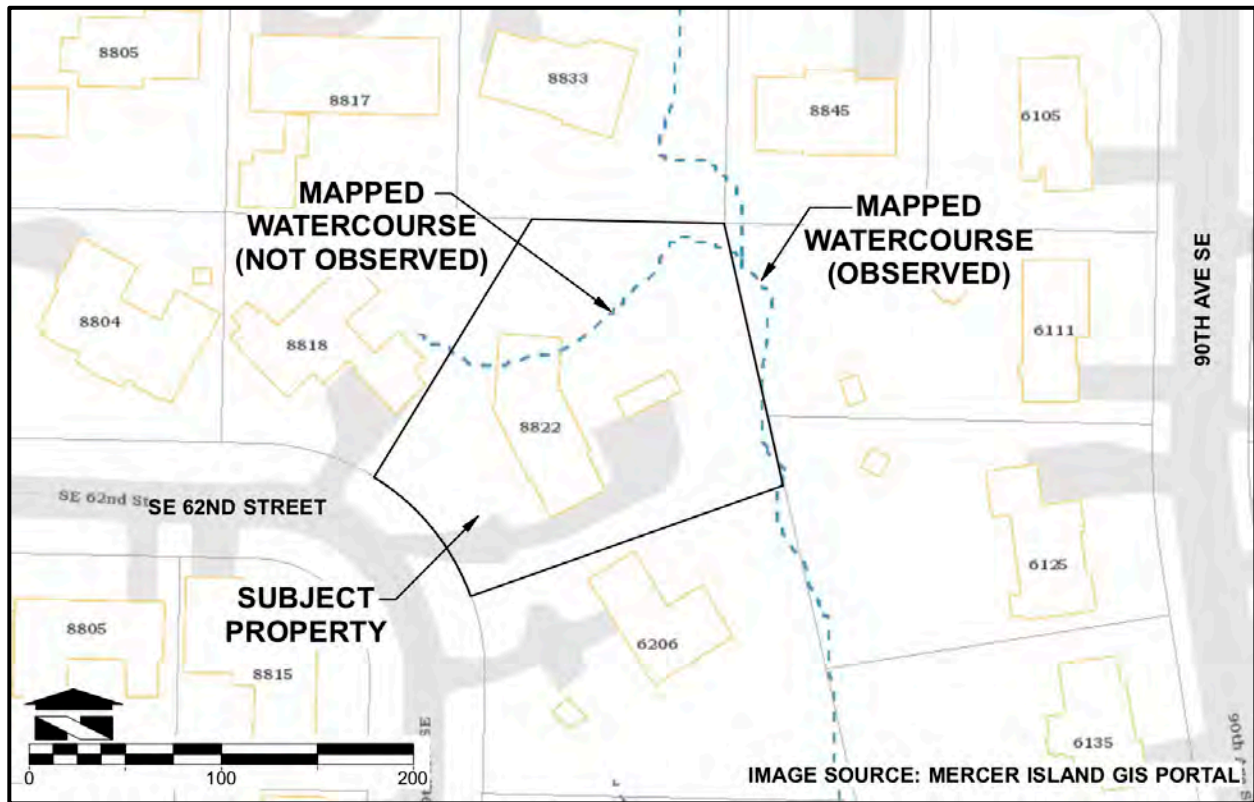
Figure 2: City-Mapped Watercourses

thought to be unlikely. Special care was taken during the site inspection to confirm or deny the presence of the mapped tributary. See Figure 2 below, which shows the location of City-mapped watercourses in the vicinity of the subject property.

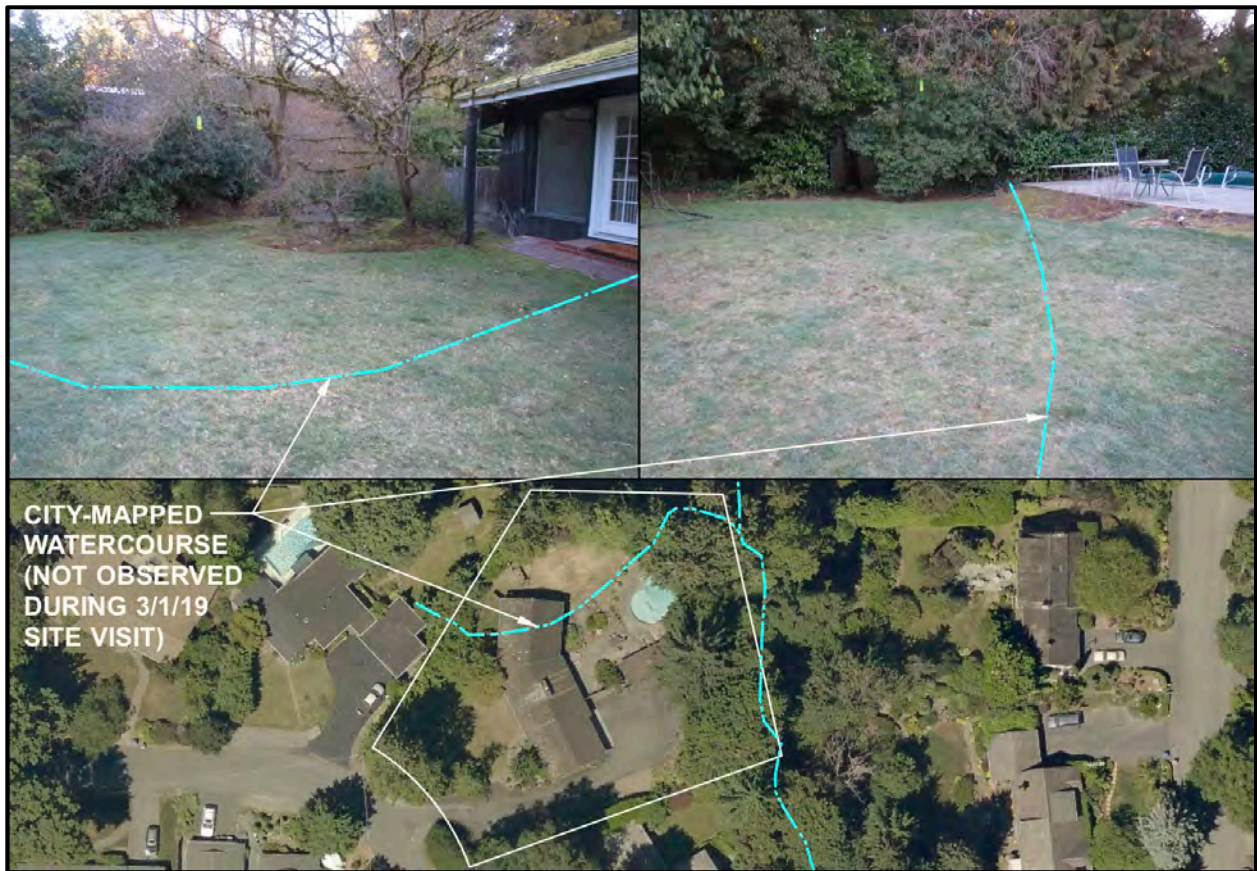
Figure 3: Site Photos of City-Mapped Watercourse

The mapped location of the tributary to Stream A was physically inspected on March 1, 2019. Best available science suggests that directly observed hydrology or evidence of recent surface flow support a stream presence determination. Evidence of flow includes defined bed and banks, scour marks, fine and coarse sediments deposited on existing vegetation, flattened vegetation in the direction of flow, and the presence of wet-tolerant vegetation.

Perennial streams in Puget Sound typically contain hydrology in early March. Given the absence of hydrology or indicators of surface flow along the entire path of the City-mapped watercourse during the March visit, WRI staff has determined that the mapped watercourse does not exist. The City's map error should be corrected by removing the mapped tributary to Stream A. Figure 3 below shows site photos from the March visit, and provides visual evidence that the mapped stream does not exist. No additional discussion of the (non-existent) tributary to Stream A is included in this report.

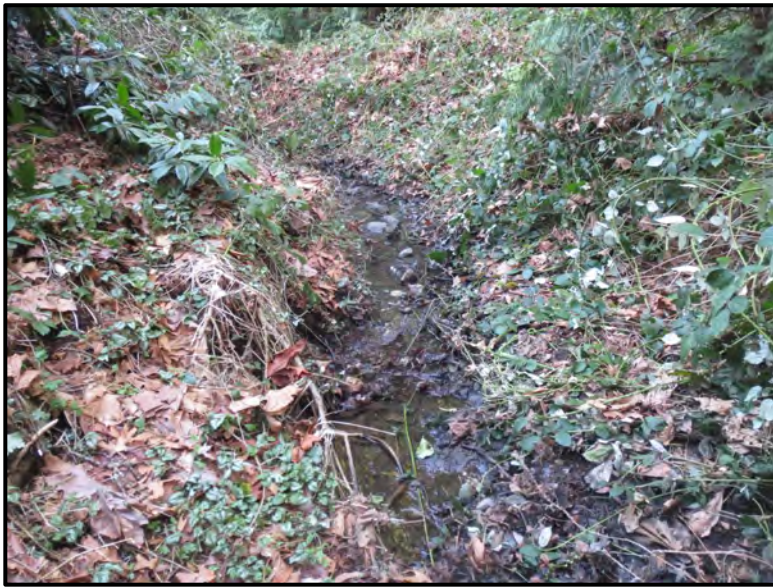
Figure 6: Facing South Along Stream A

The open channel of Stream A originates at the outlet of a large-diameter culvert located near the northeast corner of the subject property. The channel terminates where it enters another culvert located in the southeast corner of the subject property. The open channel consists of mixed cobble, bricks, and mud. The feature is an intermittent stream based on physical observation of a dry bed during the March site visit. Piped watercourses require 25-foot protective buffers, and Type 3 watercourses require 35-foot protective buffers. Based on comparison with the Mercer Island GIS Portal, it appears that Stream A outlets directly to Lake Washington on the east side of Mercer Island.

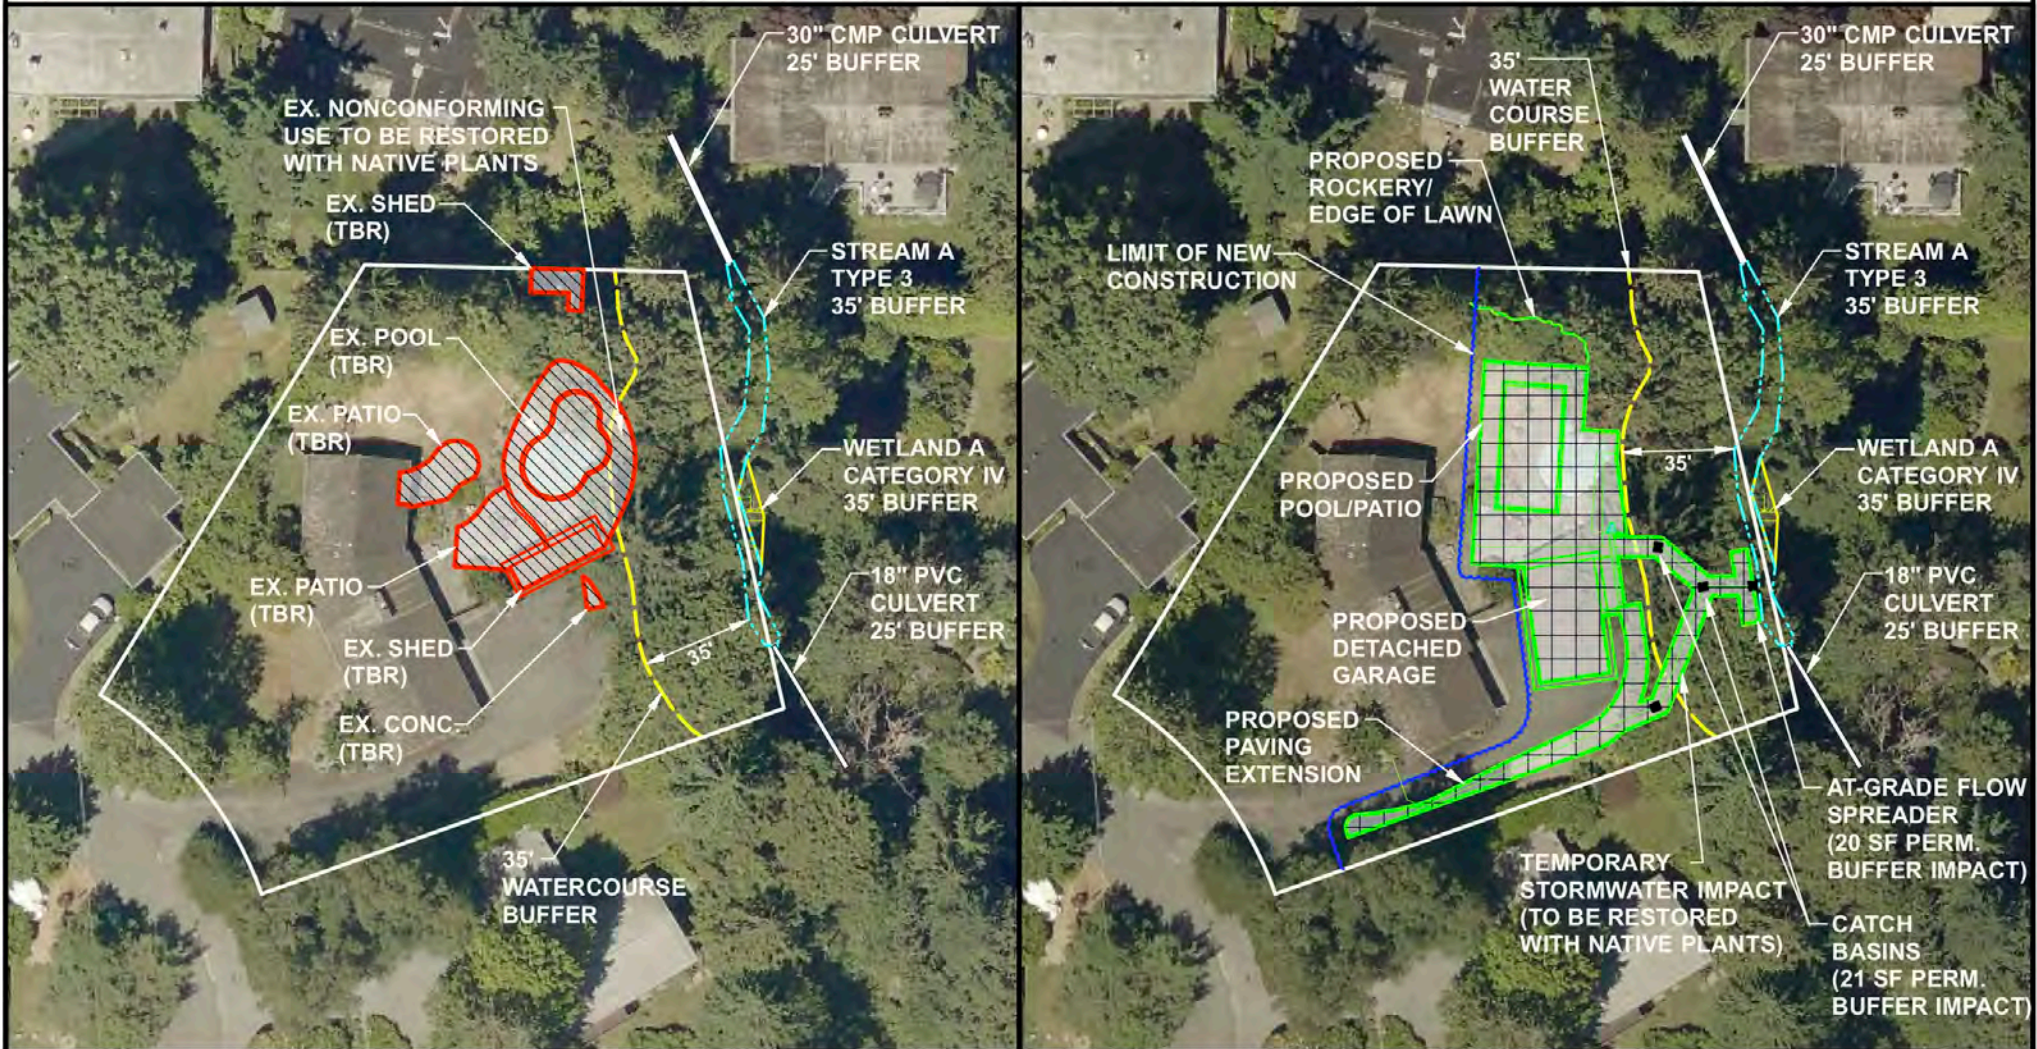
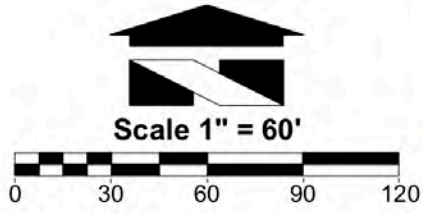
CRITICAL AREA STUDY MAP
HEADRICK GARAGE AND POOL ADDITION - 8822 SE 62ND ST
PROPOSED DEVELOPMENT

NOTE: ALL PROPOSED DEVELOPMENT OCCURS OUTSIDE OF 35' WETLAND/WATERCOURSE BUFFER

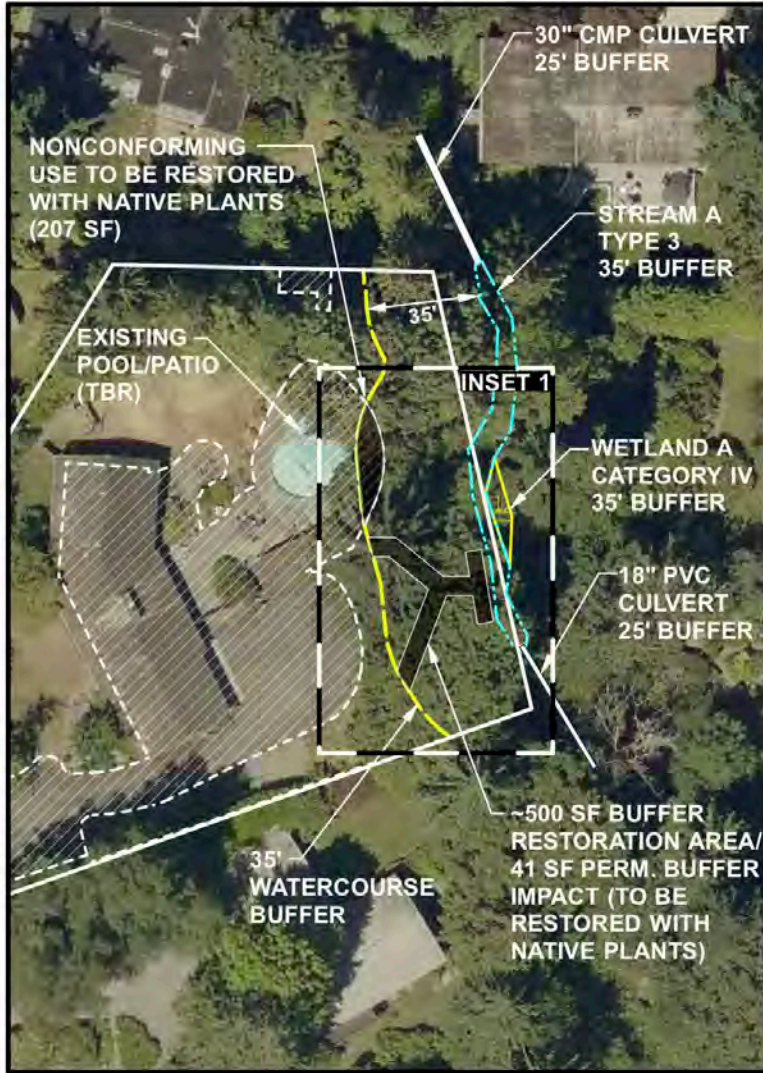
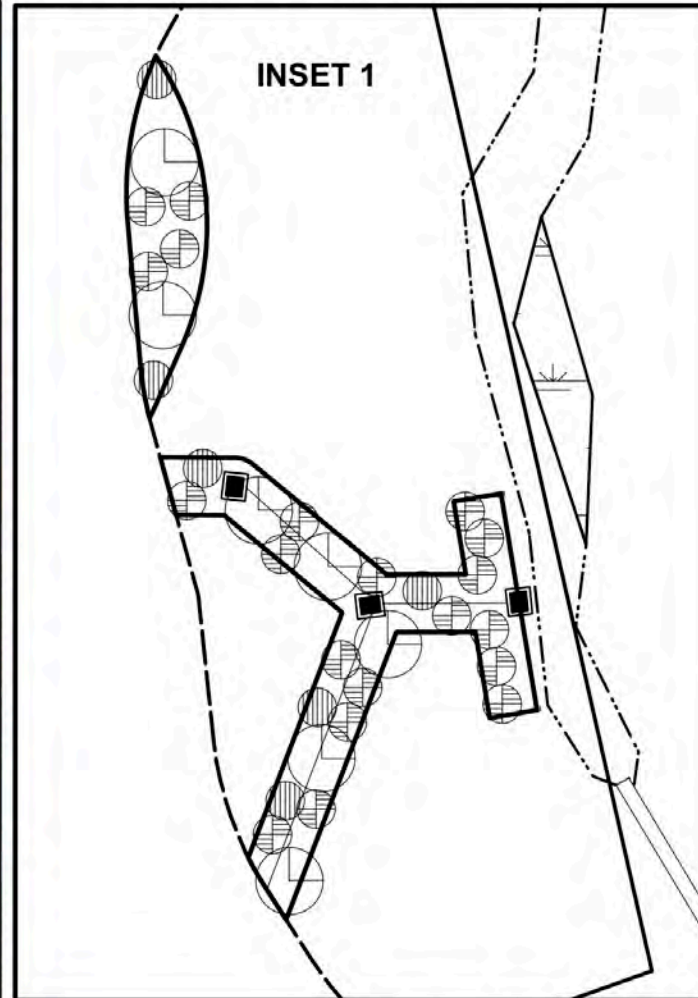
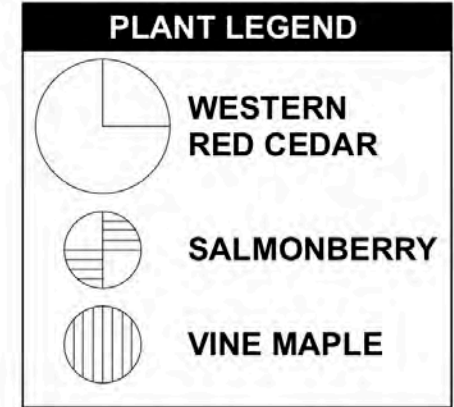
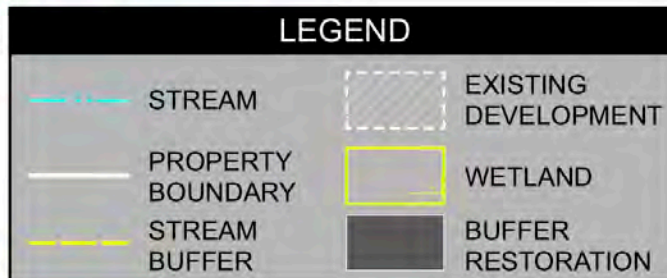
BUFFER RESTORATION PLAN

Common Name	Latin Name	Size	Spacing	Qty.
Western red cedar	<i>Thuja plicata</i>	1 gallon	10'	7
Salmonberry	<i>Rubus spectabilis</i>	1 gallon	5'	20
Vine maple	<i>Acer circinatum</i>	1 gallon	5'	6
